**NATIONAL TRANSPORTATION SAFETY BOARD
OFFICE OF RESEARCH AND ENGINEERING
WASHINGTON, D.C. 20594**

Vehicle Dynamics and Visualization Study

Vehicle: 1999 Prevost H3-45 56- Passenger Motorcoach

NTSB # : HWY-11-MH-005

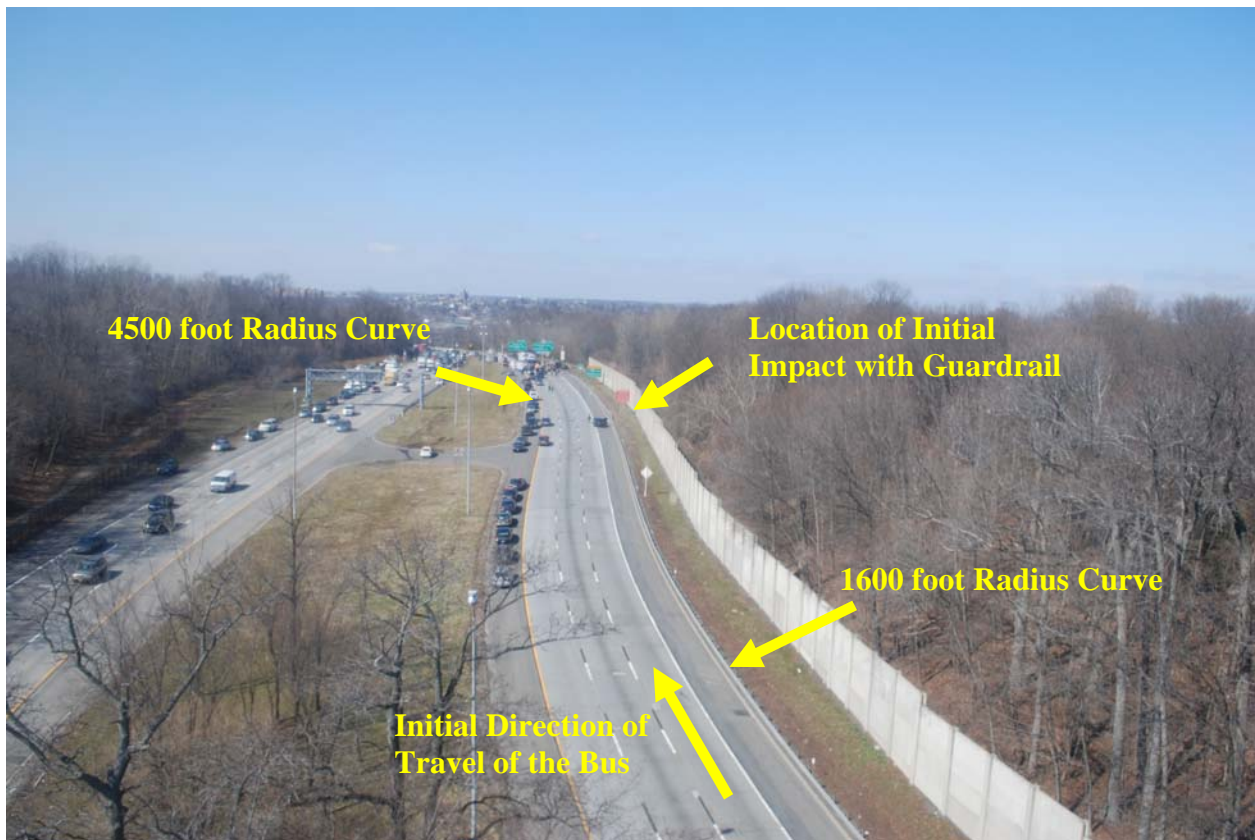
The geometry of the section of roadway where the accident occurred is shown in figure 1 below. According to information contained in the Highway Group Chairman's Factual Report the horizontal curvature on the southbound lanes of I-95 just prior to the accident consisted of a 1,600 foot radius curve that turned to the right in the direction of travel. The 1,600 foot radius horizontal curve ended approximately 770 feet prior to the accident location. The horizontal curvature transitioned to a 4,500 foot radius curve that turned to the left in the direction of travel. The accident location was within the 4,500 foot radius curve

Figure 1 – Aerial view of roadway looking southbound.

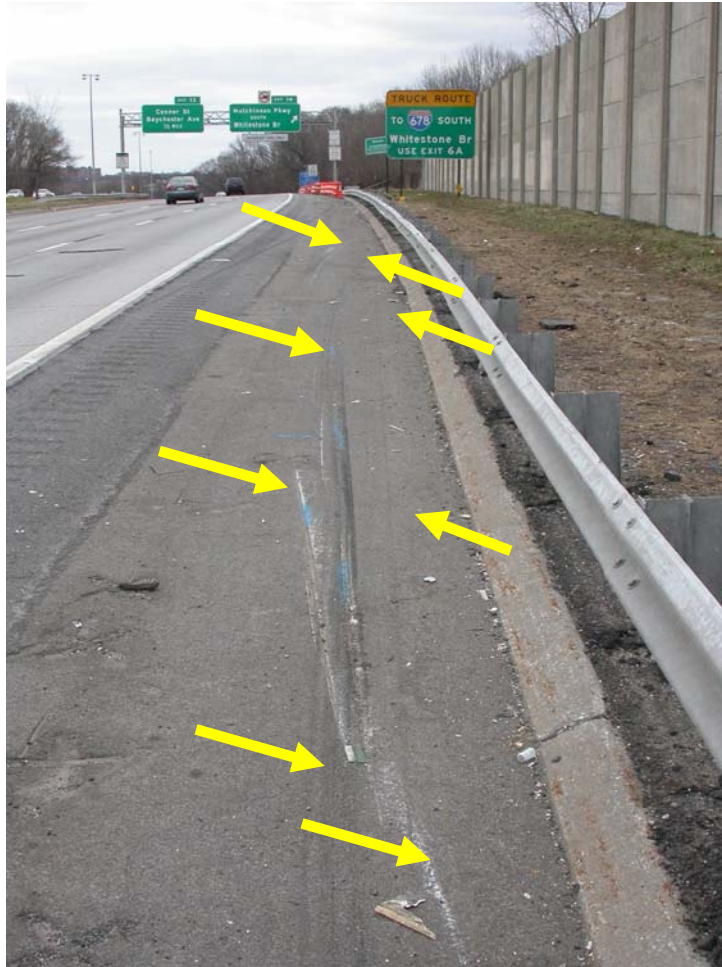
Figure 3 – After initially striking the guardrail the bus veered away from the guardrail and lost contact the guard rail for short distance. The arrows shown in the photograph indicate evidence of the path of the bus during the time it lost contact with the guardrail. Note that there is no evidence of contact damage from the bus visible on the guardrail. (Unless indicated by an arrow, tiremarks and scrapemarks shown in the photograph are not associated with this accident.)

After initially striking the guardrail in the video, the bus veers away from the guardrail along the marks shown in figure 3. (These marks are depicted as black lines in the video.) The maximum roll angle orientation of the bus along its longitudinal axis during the initial impact with the guardrail in the video was estimated from the location of the tiremarks on the roadway and the damages to the guardrail⁴. After veering away from the guardrail in the visualization, the bus veers back towards the guardrail along the marks shown in figure 4. (Again, the marks on the shoulder are depicted as black lines in the video.) After striking the guardrail the second time the simulated bus continues to travel forward while leaning on the guardrail for several hundred feet before overturning onto its right side. The roll angle orientation of the bus around its longitudinal axis during this portion of the video was calculated from the marks on the road, the damage to the guardrail, and the damage from the bus found on the two signs shown in figure 6. (Again, the marks on the shoulder are depicted by black lines.) After overturning onto its right

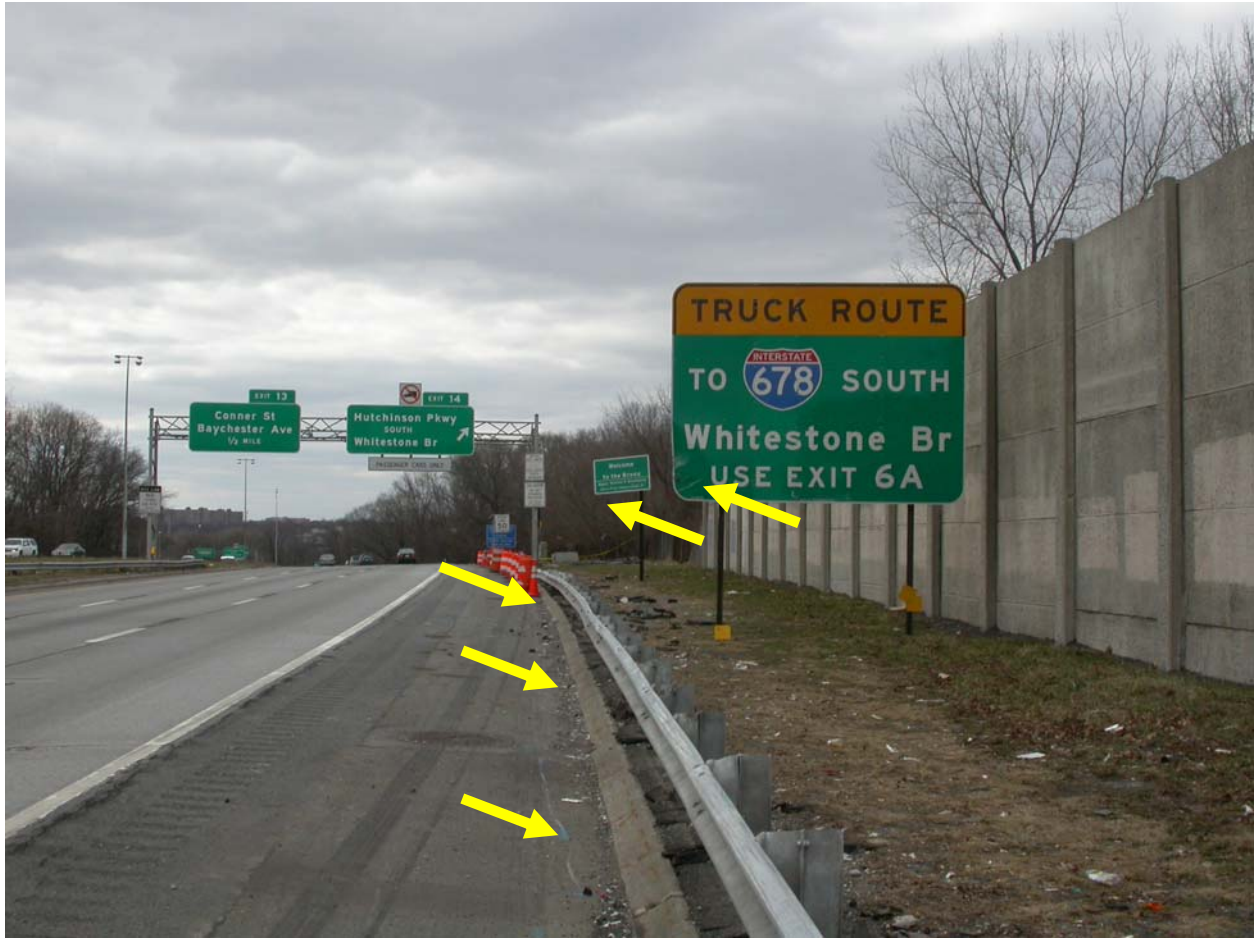
Figure 5 – After striking the guardrail again a second time the bus made contact with the two signs the right of the road shown in this photograph. The arrows on the right highlight damage to the signs caused by impact with bus. Note that the location of the damage indicates that the bus was leaning heavily to the right when it contacted these signs. Arrows on the left point to evidence found on the shoulder indicating the path of the bus after striking the guardrail a second time. Note also the damage visible on the guardrail indicating that the bus was in contact with the guardrail. (Unless indicated by an arrow, tiremarks and scrapemarks shown in the photograph are not associated with this accident.)
