**VEHICLE FACTORS GROUP CHAIRMAN'S
FACTUAL REPORT**

HWY17MH005

**NATIONAL TRANSPORTATION SAFETY BOARD
OFFICE OF HIGHWAY SAFETY
WASHINGTON, D.C.**

Location: Westbound Interstate 10 (I-10) in the vicinity of post mile marker 32.5,
near Desert Hot Springs, Riverside County, California

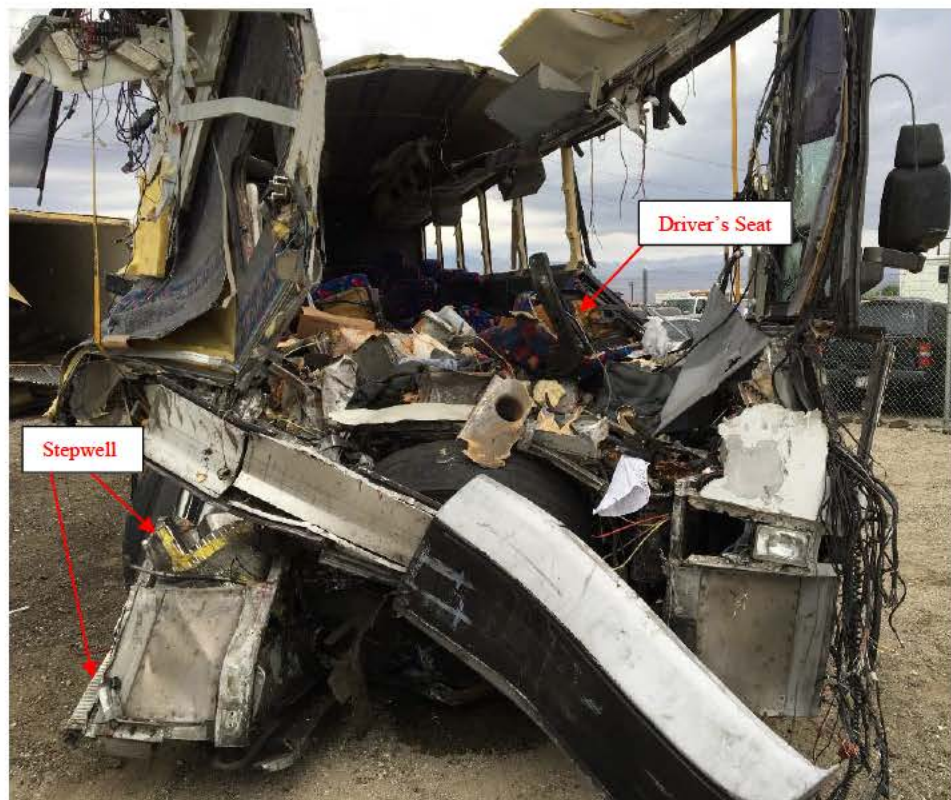
The motorcoach sustained extensive front-end damage. The upper glass (front destination sign windscreen) above the windshields was missing. The left and right windshields were missing. The right side of the front bumper cover was missing. The right-side rear-view mirror was missing. The right-front headlamp and turn signal assemblies were missing. The left side high beam headlamp case was broken and found separated from its mounting location. The filament for the high beam headlamp was slightly distorted. The left side low beam headlamp was found still attached at its proper mounting location. The low beam headlamp was removed and transferred to the NTSB Research and Engineering staff on scene, for further analysis. The left side turn signal assembly was missing. The front motorcoach body panels were missing. The steering wheel, steering wheel column, instrument panel, and the passenger loading door, were found separated from the motorcoach and were found in the debris pile. The electrical wiring for the driver controls and instrument panel were found hanging down the outside of the motorcoach by the left side low beam headlamp. The passenger entrance stepwell was crushed rearward. The right side of Axle 1 had been crushed rearward trapping the tire and wheel inside the right-side wheel well. The roof of the passenger compartment was separated from the left side panels for approximately 12 feet from the leading edge of the bus. Numerous side panels had been cut and removed from both sides of the motorcoach. **See Figure 1**

Figure 1: The Front of the 1996 MCI Motorcoach

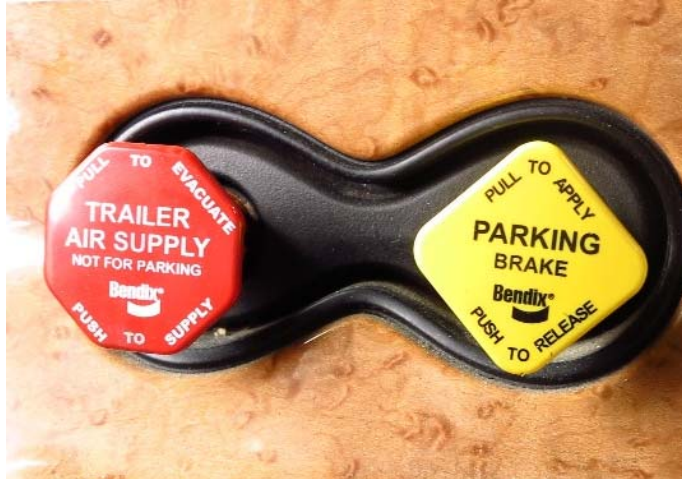
Figure 3: Truck Tractor Push-Pull Valve Brake Knobs
