**VEHICLE FACTORS GROUP CHAIRMAN'S
FACTUAL REPORT**

Chattanooga, Tennessee

HWY17MH009

**NATIONAL TRANSPORTATION SAFETY BOARD
OFFICE OF HIGHWAY SAFETY
WASHINGTON, D.C.**

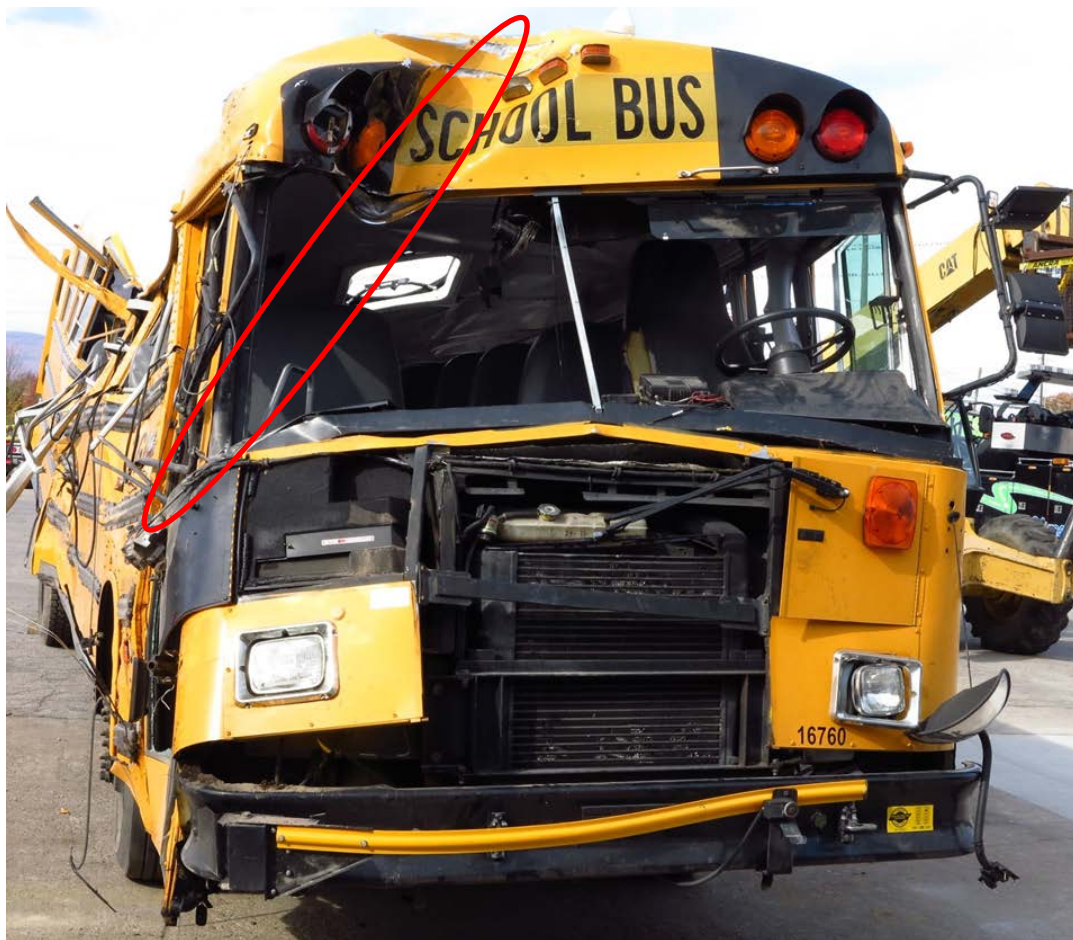
The front of the bus sustained damage that broke out both windshield panels and the front portion of the roof was displaced rearward. The damage to the front of the bus was concentrated from the bottom of the windshield panel mounting locations towards the roof. **Figure 1** is the front of the bus and the red, oblong circle indicates the approximate location of the impact between the bus and the utility pole.

Figure 1: The Front of the Bus

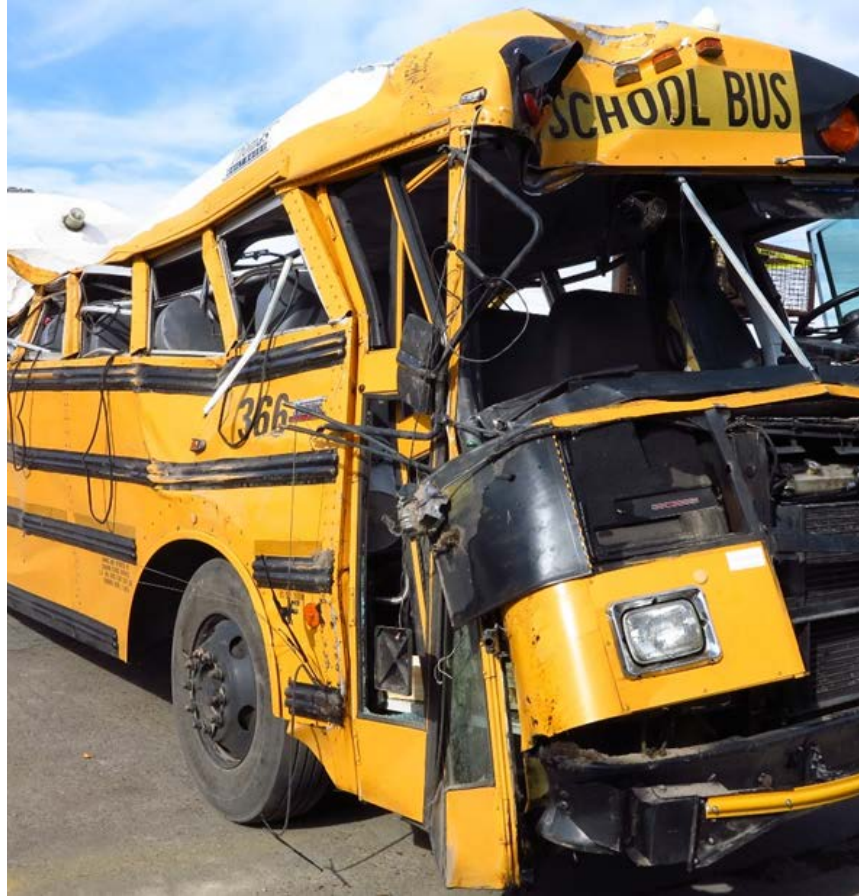
The bus sustained extensive damage, but the most of the damage was concentrated to the right side of the bus and the roof. The impact with the utility pole crushed the right-front corner of the bus rearward which caused the entrance doors to be displaced rearward, blocking the entrance stairwell. The utility pole was in contact with the bus from the bottom of the right-side “A” pillar and between the top, right-side amber warning lamp and extreme right amber identification lamp.

Figure 2 shows the right-front corner of the bus and displacement of the entrance doors.

Figure 2: Right-Front of Bus

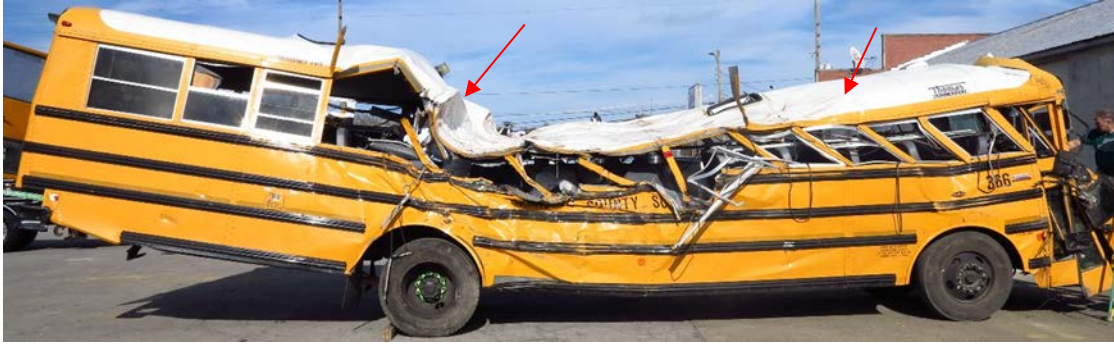
The roof was collapsed down almost to the tops of the seat backs and bottom of the window frames. The roof escape hatch covers were missing. The contact between the tree and the bus started rear of the second passenger window on the right side and stopped at the rear axle (axle 2). The top of the bus to the bottom of the side window line, was significantly displaced rearward. The exterior skin on the bus body and the roof top were stretched rearward and collected into wrinkles above axle 2. The rear body-to-frame mounting plates were bent and broken. The rear of the bus body was separated from the rear frame assembly and arched upward. The rear emergency exit door was still operational. **Figure 3** shows the right side of the bus with the red arrows indicating where the contact between the tree and the bus started and stopped.

Figure 3: The Right Side of the Bus
