**VEHICLE FACTORS GROUP CHAIRMAN'S  
FACTUAL REPORT**

**MULTIPLE VEHICLE CRASH  
Chattanooga, TN**

**HWY15MH009**

**NATIONAL TRANSPORTATION SAFETY BOARD  
OFFICE OF HIGHWAY SAFETY  
WASHINGTON, D.C.**

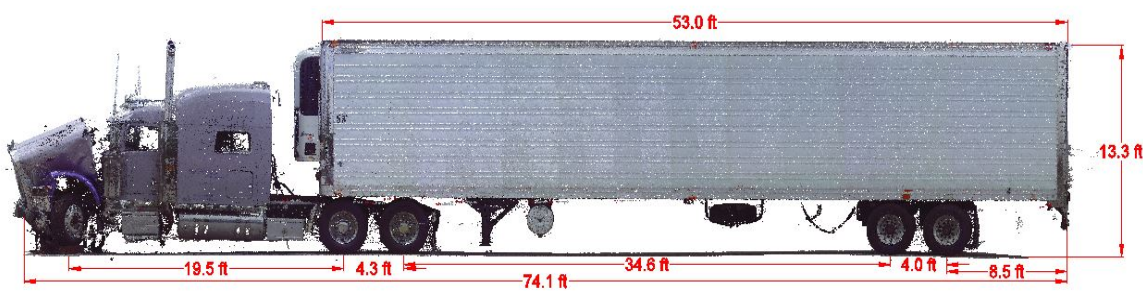
**Figure 1** Driver (left) side profile from the 3-dimensional model of the damaged 2007 Peterbilt combination unit.

The 2007 Peterbilt truck tractor sustained extensive front end damage, displacing the bumper and hood.<sup>4</sup> The headlamps, turn signals, and forward-mounted marker lights were all destroyed in the crash. The right pane of the windshield was cracked. The front-end damage pushed the radiator into the engine fan and accessory drive belts; damage then continued into axle 1 steering and suspension systems. The left- and right-front spring eye mounting brackets were broken and separated from the frame rails. At the time of inspection, the wheels on axle 1 were noted to be at full left rotation and out of alignment with each other. The engine cradle was broken allowing the engine to rest on axle 1. The leading edges of the left and right frame rails were displaced to the right. The driver's side lower step was displaced rearward. The left fuel tank sustained a small dent on the outboard leading edge. The left fuel tank also sustained black transfer and scuff marks along the outboard side. The right-side rear view mirror was damaged, the upper support brace was broken and the lower mount was separated from the cab.<sup>5</sup> The steering gear box was removed from the truck tractor and underwent a detailed external and internal examination at the manufacturer's facility.

The semitrailer was empty at the time of the crash. The refrigeration unit which was mounted on the front of the semitrailer, sustained minor damage and its left door was missing. In addition to the observed damage, the NTSB Evidence Documentation Team mapped the combination unit using a FARO laser scanner, which generated a 3-dimensional model of the damaged vehicle (see **Figure 1.**)
