**SHERMAN, TEXAS**

**HWY-08-MH-022**

**VEHICLE GROUP CHAIRMAN'S  
FACTUAL REPORT**

**Accident:** Motorcoach Run-Off Roadway Bridge and Rollover  
**Location:** U.S. Highway 75 Northbound at Milepost 208.0236 on Post Oak Creek Bridge  
Sherman, Texas  
**Vehicle #1:** 2002 MCI 56-Passenger Motorcoach  
**Carrier:** Iguala Busmex, Inc  
**Date:** August 8, 2008  
**Time:** 12:42 a.m. CDST  
**NTSB #:** HWY-08-MH-022

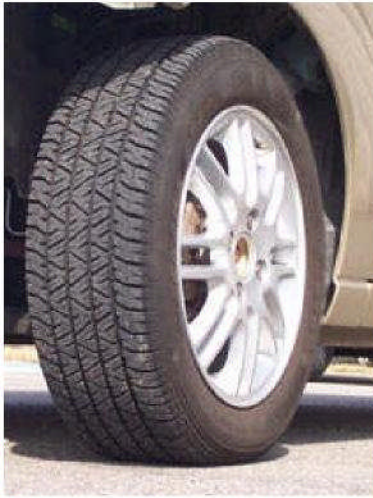
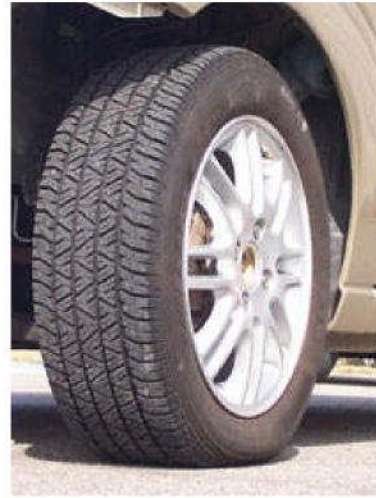
The NHTSA has demonstrated that visual inspection of “passenger car and light truck” tires failed to detect under inflation levels as low as 50%.<sup>xxvi</sup>

Tire inflated to required 32 psi    Tire inflated at 50% to 16 psi

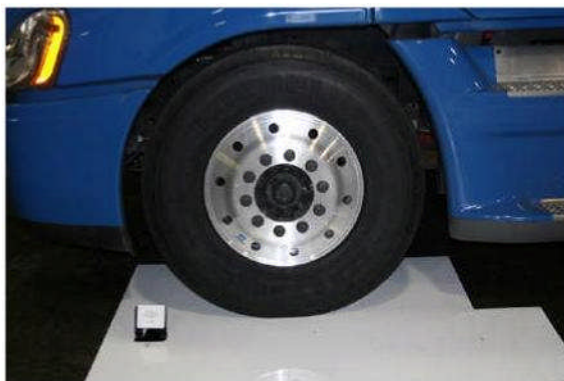
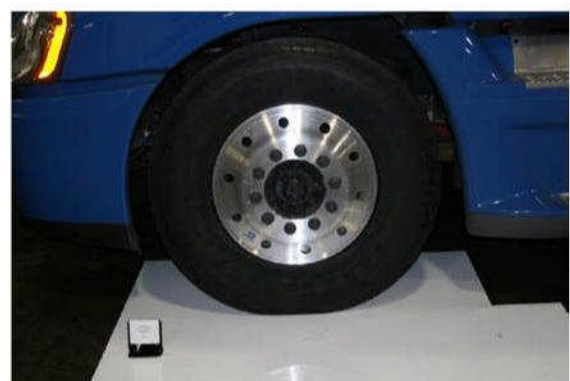
The two photographs below depict the Michelin XZA2 Energy tire size 315/80R 22.5 inflated at both 130 psi and at 85 psi, in an effort to document the visual difference within the tire when subjected to a 50 psi pressure differential. <sup>xxvii</sup>

Tire Inflated to 130 PSI    Tire Inflated to 85 PSI

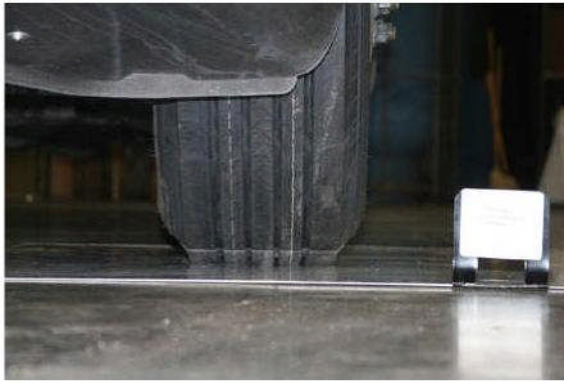
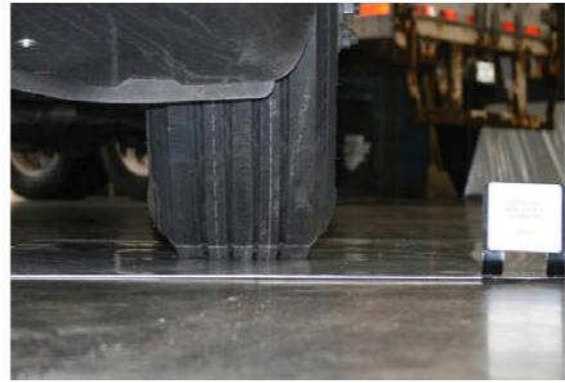
Tire Inflated to 130 PSI Tire Inflated to 85 PSI fix image

As observed within the Michelin study, the difficulty in visually detecting proper tire inflation is not isolated to passenger vehicles but also presents itself in commercial vehicle tires as well. Commercial vehicle tires utilize stronger materials including stiffer sidewalls, steel belting materials and harder rubber compounds.
