**NATIONAL TRANSPORTATION SAFETY BOARD
OFFICE OF HIGHWAY SAFETY
WASHINGTON, D.C.**

**VEHICLE FACTORS GROUP CHAIRMAN'S
FACTUAL REPORT**

Location: Northbound US Highway 83 (US-83) near milepost 553.4 in Uvalde County, 6.5 miles north of Concan, Texas

NTSB #: **HWY17MH011**

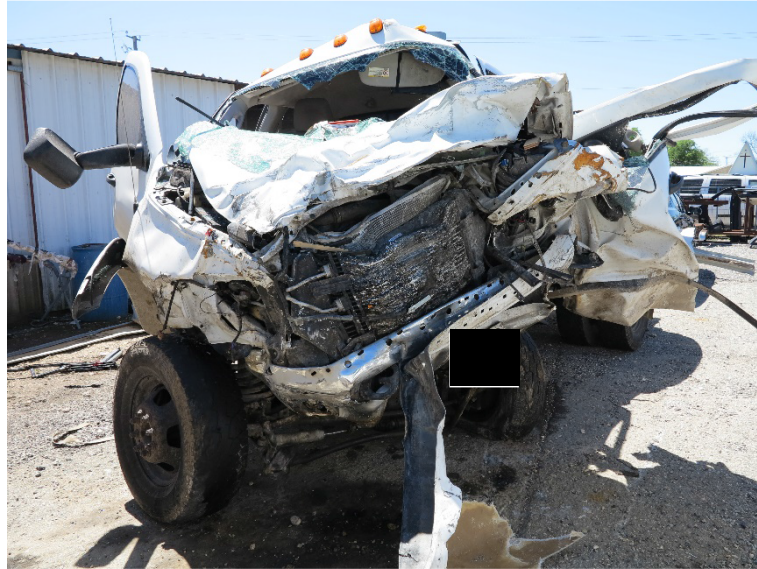
The truck sustained contact damage to the front end with induced damage extending down the left side and roof of truck cab, as shown in **Figure 1** and **Figure 2**. The front end was shifted aft and to the left. The driver’s door was separated at the upper hinge and the door frame was collapsed. The left rear passenger door was also displaced rearward and jammed until a first

Figure 1- Front view to the 2007 Dodge Ram 3500 pickup truck showing contact and induced damage the front end

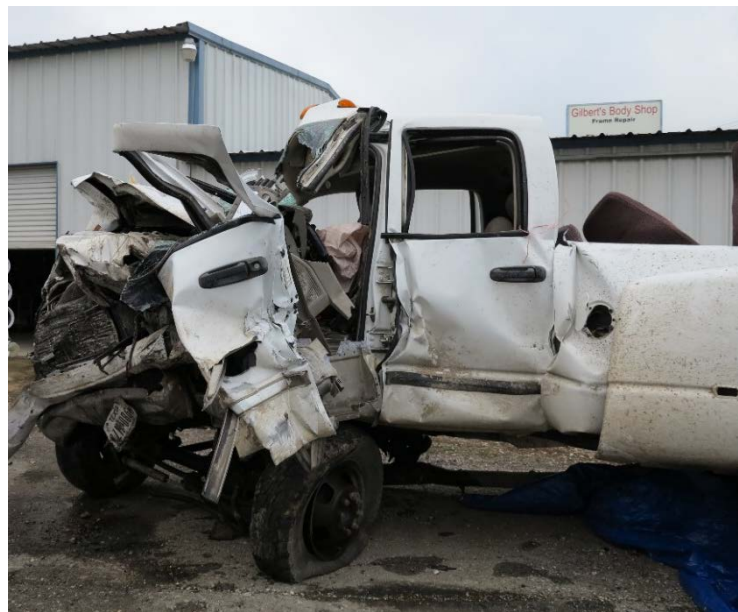
Figure 2 – Left-side view of the 2007 Dodge Ram 3500 pickup truck showing contact and induced damage to the left side of the vehicle

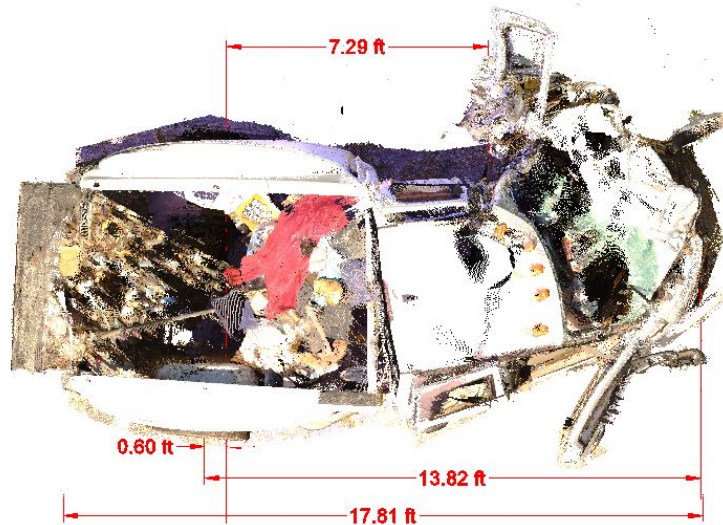
The truck was scanned by the Technical Reconstruction Group using a FARO 3-dimensional laser scanner that will allow for the creation of a 3-D model. From this 3-D model, scaled measurements were taken as shown in **Figure 3**. Measurements shown are 7.29 ft. (87 in) left-side wheel base, 13.82 ft. (165 in) right-side wheel base with a 0.60 ft. (8in) offset and a 17.81 ft. (213 in) overall length.

Figure 3 - 3D laser scan of the 2007 Dodge Ram 3500 pickup truck showing post collision axle deformation

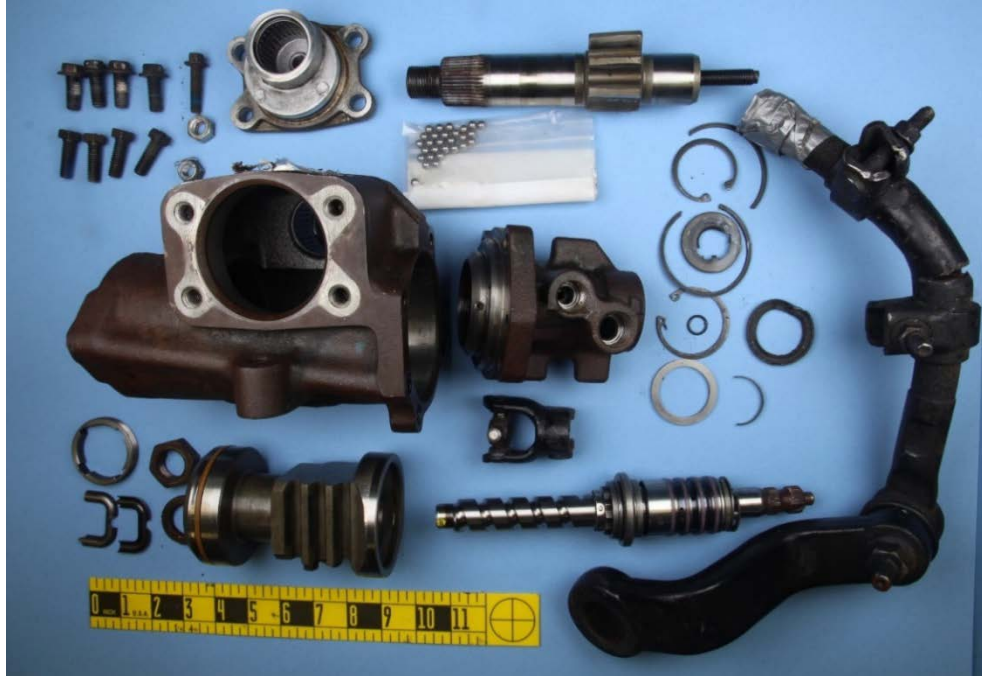
On Thursday May 25, 2017, a detailed external and internal examination and component teardown of the steering gear was conducted at the NTSB, Office of Research and Engineering, Materials Laboratory in Washington DC, as shown in **Figure 4**.

These examinations were conducted by NTSB investigative and engineering staff. The exam found the steering gear to be mechanically functional, with no worn or defective components.

Figure 4 – Disassembled steering gearbox of the 2007 Dodge Ram 3500 pickup truck

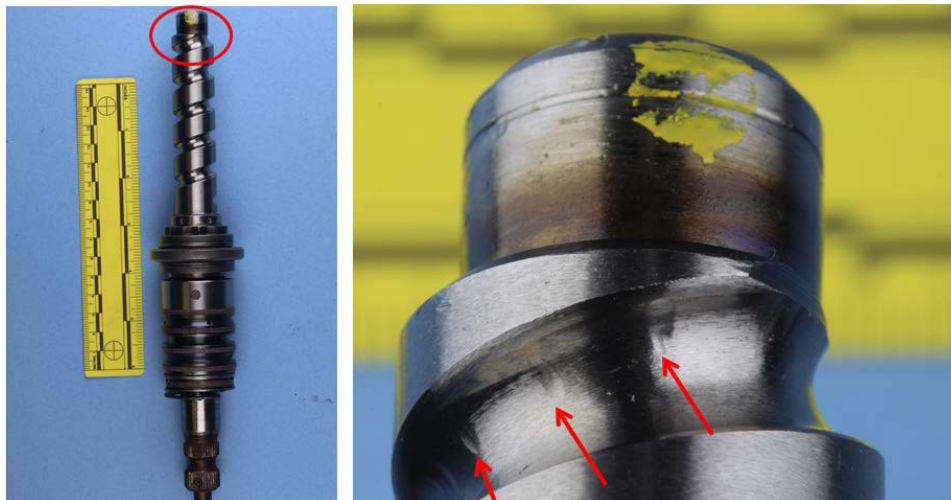
Examinations concluded that the steering gear did receive an impact load, significant enough to cause indentations from recirculating ball bearings on the internal helical worm gear. As shown in **Figure 5**. The location of the recirculating ball bearing impacts, at the lower limits of the helical worm gear, correspond to the front wheels being turned to the maximum steering wheel rotation to the left, at the time the steering gear was subjected to the impact load.

Figure 5 - The helical worm gear of the 2007 Dodge Ram 3500 pickup truck with a close-up view of the recirculating ball bearing indentations (shown by red arrows)

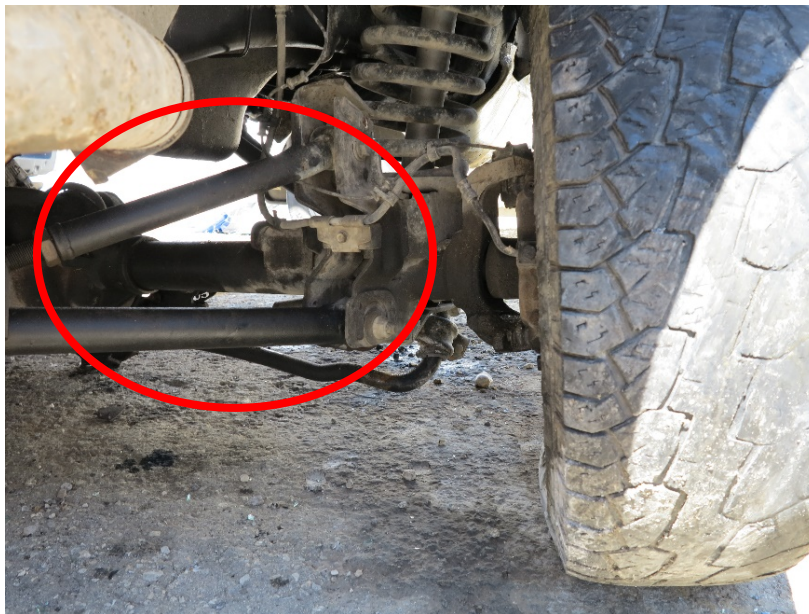
The front axle was equipped with aftermarket adjustable long control arms and longer front coil springs as shown in **Figure 6**. The rear suspension was equipped with aftermarket 4-inch lift blocks installed between the axle housing and leaf spring pack as shown in **Figure 7**. These modifications altered the trucks suspension by raising the vehicle approximately 4-inches.¹⁰

Figure 6 – Right-side aftermarket adjustable control arms (circled in red) of the 2007 Dodge Ram 3500 pickup truck

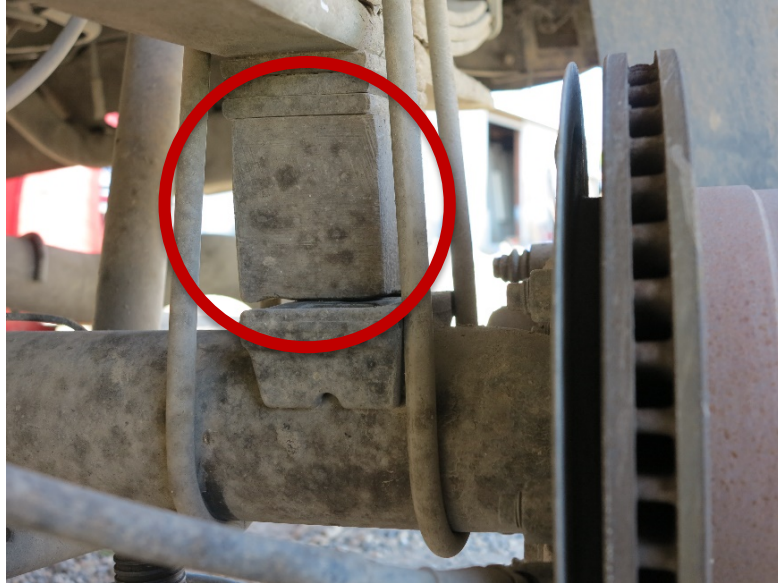
Figure 7 - Left-side aftermarket 4-Inch lift block (circled in red) on rear axle of the 2007 Dodge Ram 3500 pickup truck

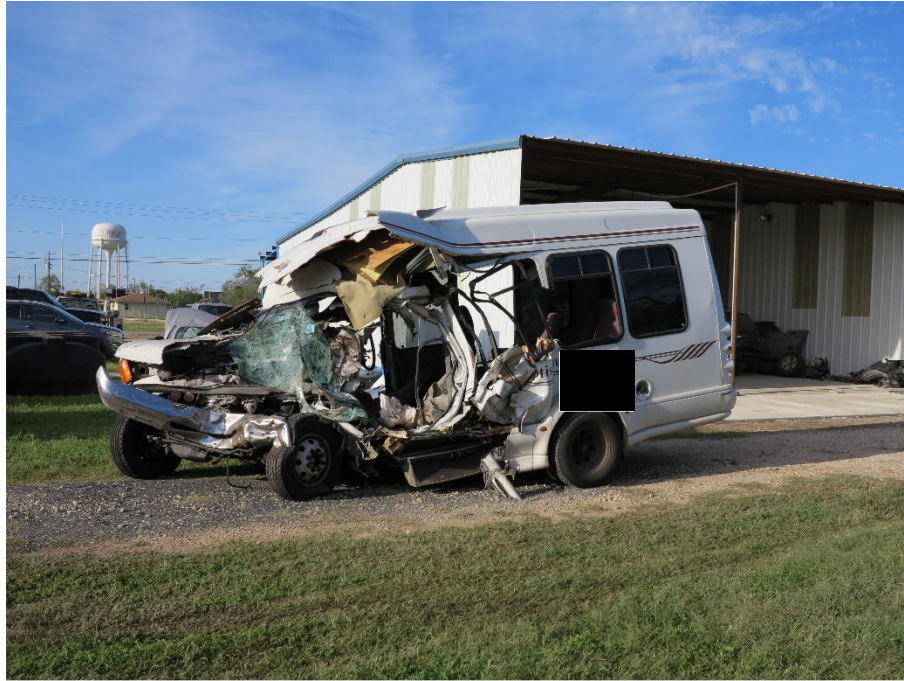
The bus sustained extensive front end damage that extended down the left side resulting in extensive intrusion as shown in **Figure 8**. The entire driver’s compartment collapsed such that the A-pillar on the driver’s side was aligned with the B-pillar on the passenger side of the bus. Similarly, the B-pillar on the driver’s side was displaced rearward such that it was aligned with the rear window bow of the first window on the right side of the bus. The rear right bumper corner, made of fiberglass, had a 5-inch x 11-inch section torn away with the underlying structure also being displaced.

Figure 8 - Left side view of the 2004 Turtle Top bus showing the front and left side contact and induced damage

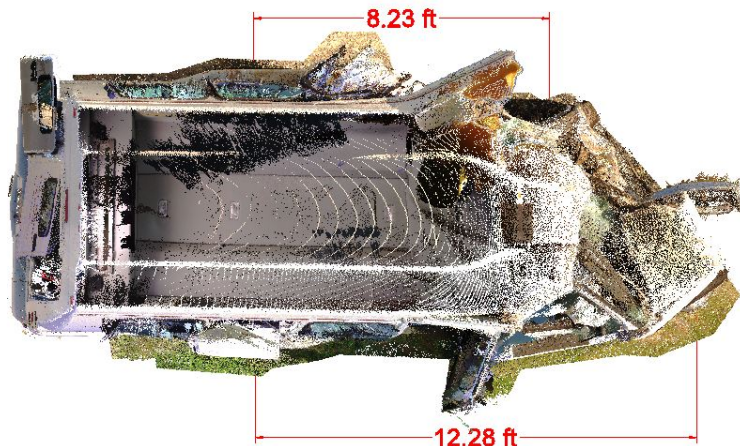
The bus was scanned by the Technical Reconstruction Group using a FARO 3-dimensional laser scanner that will allow for the creation of a 3-D model. From this 3-D model, scaled measurements were taken as shown in **Figure 9**. Measurements shown are 8.23 ft. (99 in.) left-side wheel base and 12.28 ft. (147 in.) right side wheel base.

Figure 9 – 3D laser Scan of the 2004 Turtle Top bus showing post collision axle deformation
