**VEHICLE FACTORS
GROUP CHAIRMAN'S FACTUAL REPORT**

**Multiple Fatality Motorcoach Collision
With Vertical Poles Supporting an Overhead Bridge Sign
New York, NY; 03/12/2011**

HWY-11-MH-005
(12 Pages)

**NATIONAL TRANSPORTATION SAFETY BOARD
OFFICE OF HIGHWAY SAFETY
WASHINGTON, D.C. 20594**

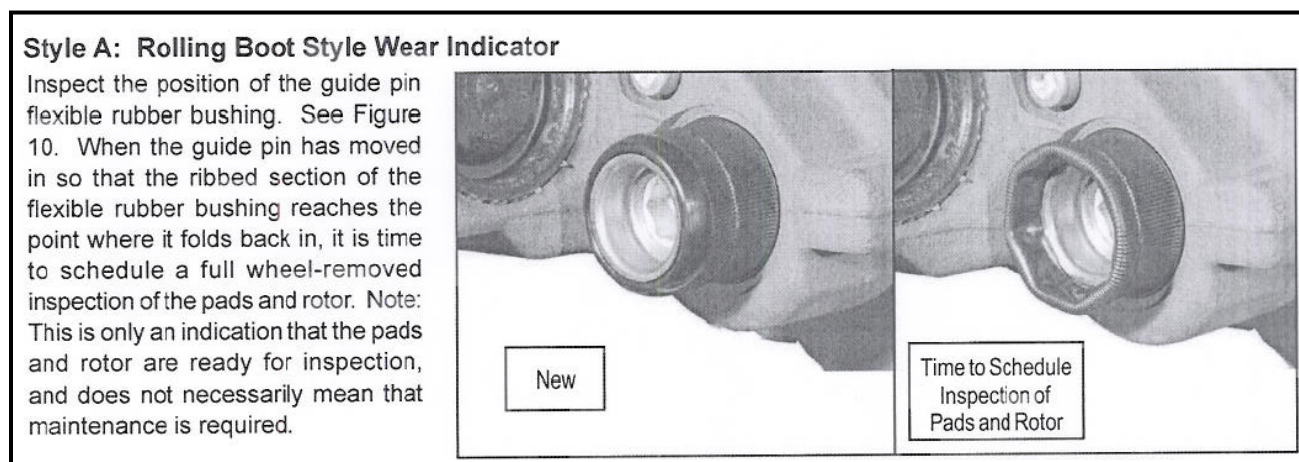
Figure 1: Disc Brake Wear Indicator Image from Bendix Service Data Sheet

According to the Service Data Sheet for type SN7 air disc brakes, there are one of three different types of wear indicators available as a visual indicator of brake pad and rotor wear; rolling boot, solid rubber, and caliper notch style wear indicators. The accident bus was equipped with "Style A: Rolling Boot Style Wear Indicators" on all axles. The Service Data Sheet does not provide a measurement of the boot or guide pin to determine if the brake rotors or pads are worn, however it does provide an image of what "new" and "time to schedule an inspection" wear indicators look like, shown in **Figure 1**.¹⁶

On the accident bus, the guide pin had pulled away from the rolling boot as it had begun to recess into the caliper housing on all but the right side tag axle wear indicator. The right side tag axle wear indicator appeared to look more like the "new" image above than the "time to schedule an inspection" image above.¹⁷ The guide pin on the remainder of the calipers could be

seen when looking into the boot, but they were no longer attached at the face of the pin.¹⁸ This detachment prevented the boot from rolling in with the guide pin, making all but one of the wear indicators on the accident bus ineffective in assessing the level of wear.
