**VEHICLE FACTORS GROUP CHAIRMAN'S
FACTUAL REPORT**

Chesterfield Twp, NJ

HWY-12-MH-007
(33 Pages)

**NATIONAL TRANSPORTATION SAFETY BOARD
OFFICE OF HIGHWAY SAFETY
WASHINGTON, D.C. 20594**

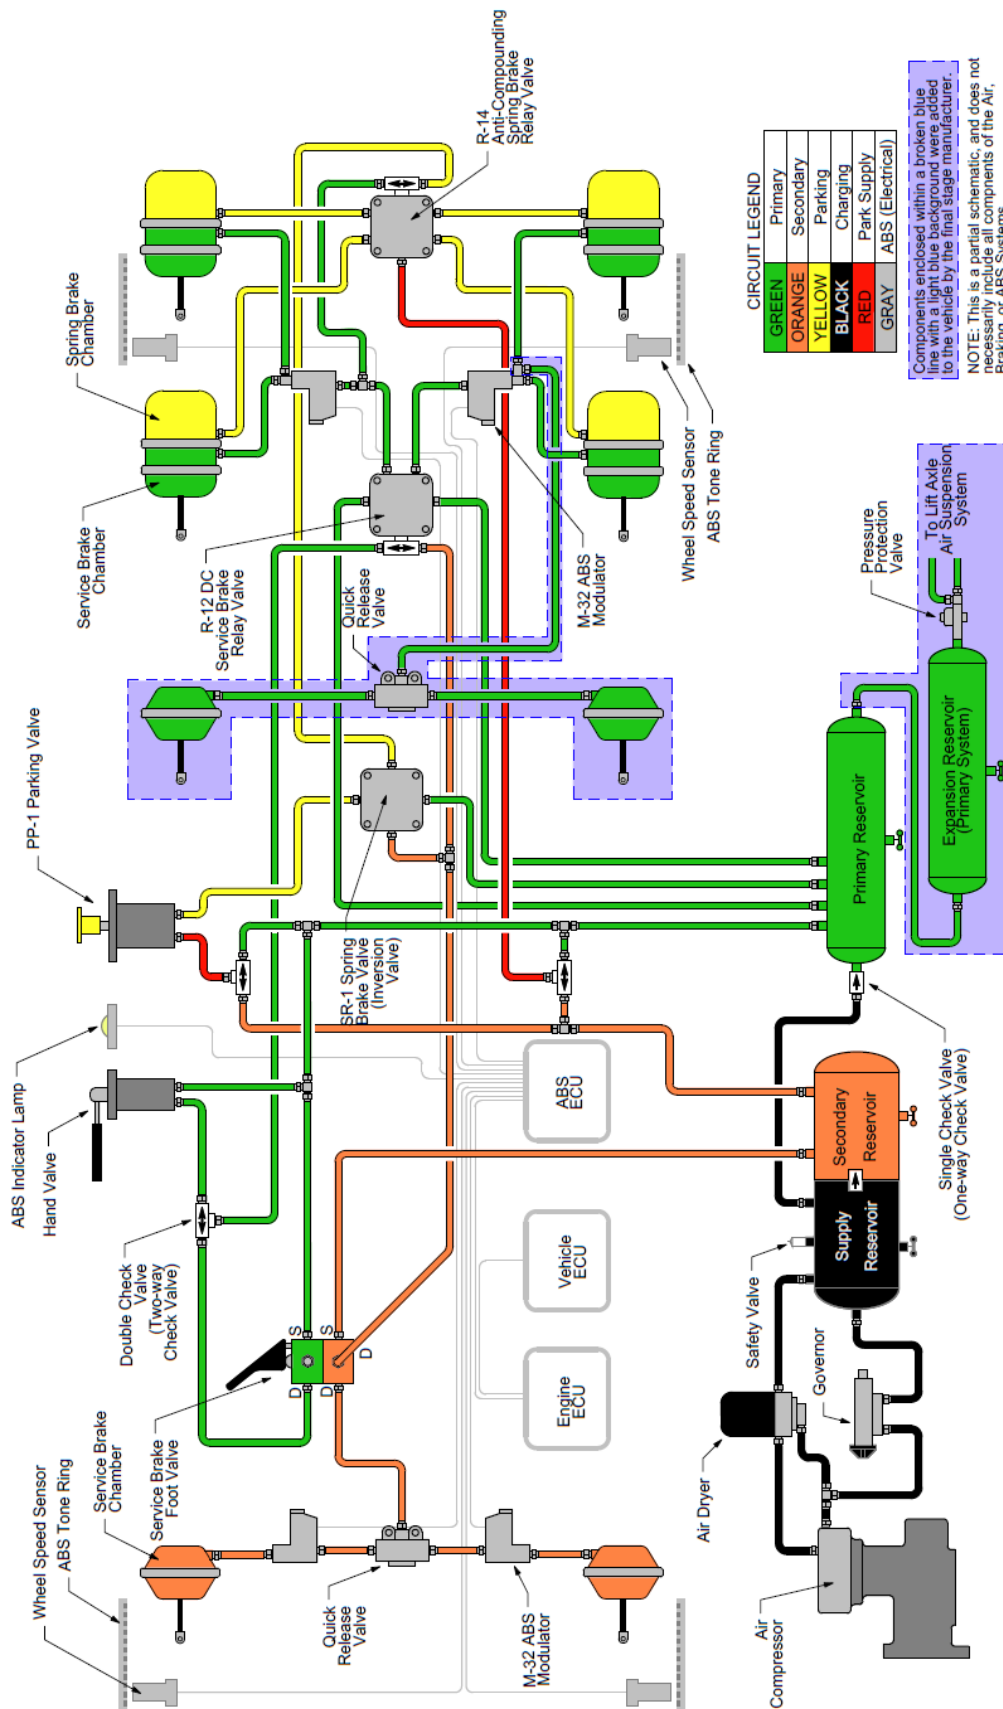
Figure 1: Accident Truck Air System Schematic

The low air pressure warning sensors for both the primary and secondary systems were checked. With air pressure supplied to both systems, the pressure in each system was drained until the low air pressure warning device activated. The low air pressure warning activated when the primary system dropped to approximately 70 psi. The low air pressure warning device also activated when the secondary system dropped to approximately 68 psi. The parking brake valve was automatically applied when the entire air system dropped to approximately 40 psi. During the testing of the low air pressure warning sensors, an added result of draining the individual service systems is a check of the isolation systems. The draining of either the primary or secondary system did not result in the depletion of the other system. The function of the accident truck's spring brake valve was also tested. With a lack of air pressure in the primary air system, operation of the brake treadle valve resulted in an application of the truck's spring brakes.

A pressure protection valve was present between the expansion air reservoir and the lift axle and power take off air supply lines. The purpose of a pressure protection valve is to maintain sufficient air pressure for brake system operation in the case of a failure or pressure loss in one of the accessory systems.⁵³ A test of the pressure protection valve was performed by simulating a failure or leak in the air suspension system. With both the primary and secondary systems pressurized to 120 psi, an air leak was induced in the system at the supply port to the left air spring/suspension cushion. The secondary system pressure held, while the primary system pressure drained to 0 psi.
