**VEHICLE FACTORS GROUP CHAIRMAN'S
FACTUAL REPORT**

**Bridge Collapse
Mount Vernon, WA; 05/23/2013**

HWY13MH012

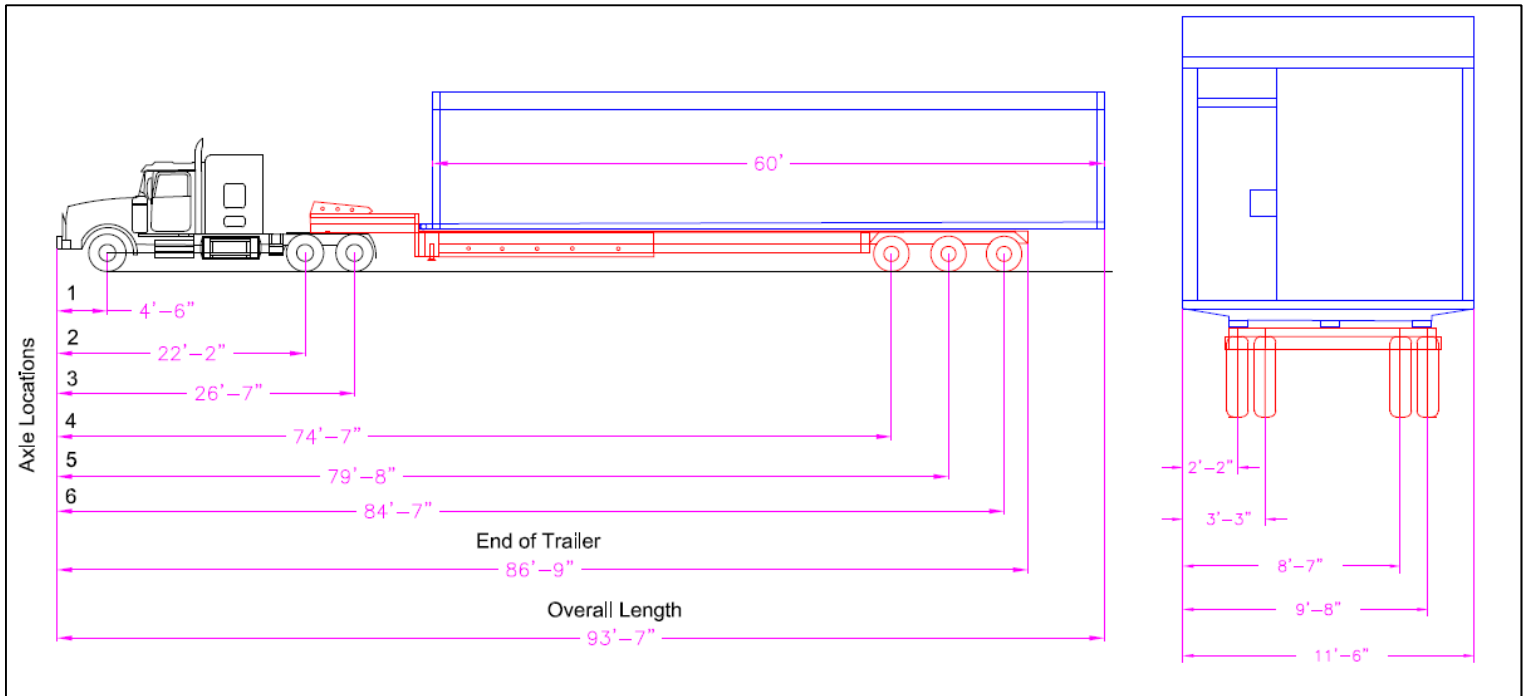
Figure 1. Diagram of the 2010 Kenworth combination unit, showing left side and rear dimensions

Once the accident combination unit was moved to the inspection site, it was placed on a level surface. The WSP and NTSB collected height measurements taken at the four top corners of the load using a height stick and metal tape measure. Since the height stick was only 15 feet long, the metal tape measure was used to measure the additional distance from the bottom of the height stick to the ground. **Table 2** contains the measurements at the top four corners of the accident load. Since these measurements were taken after the accident, with the load damaged and distorted, the measurements do not reflect exact pre-crash conditions.

Additional measurements were taken of the accident combination unit. **Figure 1** depicts left side and rear dimensions of the accident combination unit as it was documented during the post-crash inspection. Additional dimensions and documentation of the accident combination unit are contained in the *Technical Reconstruction Group Chairman's Factual Report*, which can be found in the docket for this investigation.

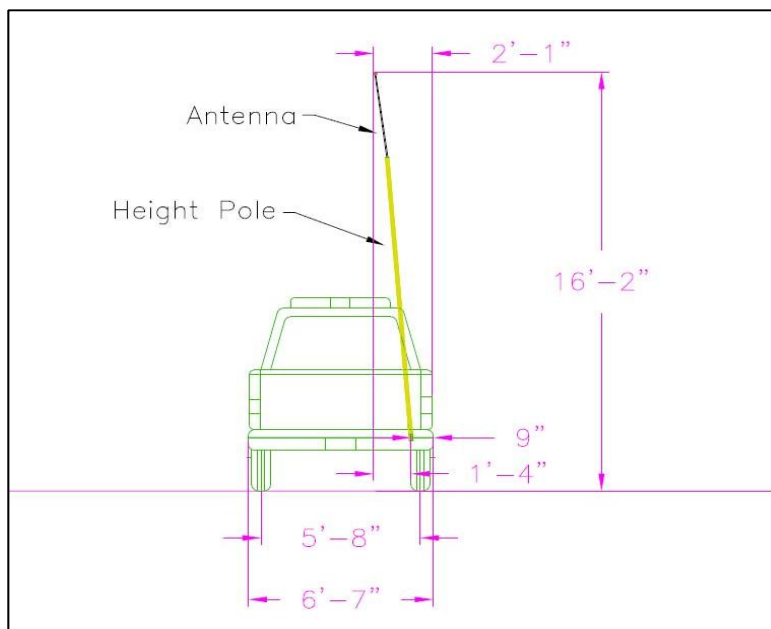
Figure 2. Rear view diagram of the pilot car

with a roof mounted light bar, oversize load banner, and a single height pole.³⁵ The height pole was attached to the front bumper of the pickup truck, about 9 inches in from the right side. The height pole consisted of a yellow plastic telescoping pole with a 39-inch black radio antenna attached to the top of it. On top of the antenna was a ½-inch diameter red rubber ball. When NTSB investigators examined the pilot car, the vertical distance from the top of the height pole (rubber ball) to the roadway surface was found to be 16-feet 2-inches.

While still on the on scene of the accident at the south side of the bridge, WSP measured the height from the ground to the top of the pilot car height pole and found it to be 16 feet.³⁶

The attachment point where the height pole was secured onto the front bumper of the pickup truck was a metal tube (holder), which was leaned slightly in toward the center of the vehicle. As a result, the height pole also leaned in toward the center of the vehicle, with the rubber ball at the top of the pole being about 1 foot 4 inches inward from the holder, or just over 2 feet inward from the right side of the pickup truck. **Figure 2** depicts a rear view of the pilot car and dimensions of the vehicle and height pole as they were documented during the inspection.
