**VEHICLE FACTORS GROUP CHAIRMAN'S
FACTUAL REPORT**

HWY17MH007

**NATIONAL TRANSPORTATION SAFETY BOARD
OFFICE OF HIGHWAY SAFETY
WASHINGTON, D.C.**

Location: Eastbound Frederick Avenue between South Monastery Avenue and South Morley Street, Baltimore, Baltimore County, Maryland

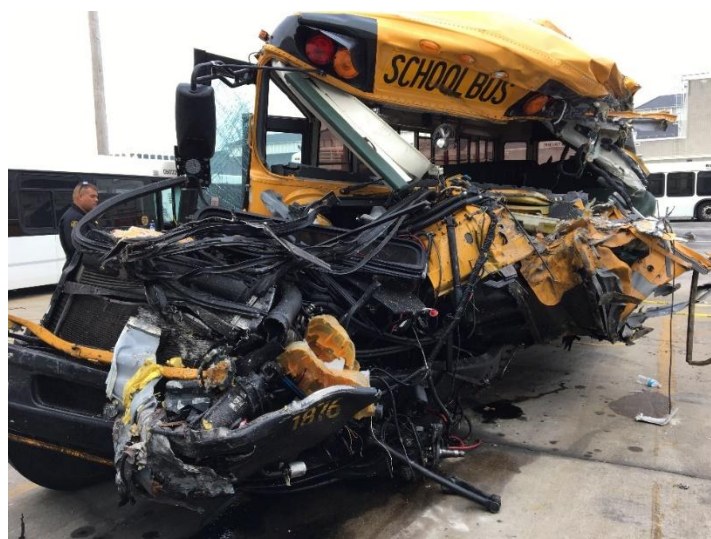
The school bus sustained two impacts. The first impact was to the bus’s front from impacting the 2012 Mustang. The second impact was also to the front when it impacted the transit bus, causing significant damage to the front end and extended down the left side as shown in **Figure 1**.

Figure 1 – Front view of the 2015 IC School Bus

The deformation to the bus’s front with the rear of the Mustang could not be measured because the secondary impact with the transit bus masked it. The overall impact resulted in the left

frame rail being bent to the right approximately 27 inches as measured at the upper front shock absorber mount, with an upward deflection.⁶

The impact resulted in buckling of the roof that extended to the mid-point of the bus.

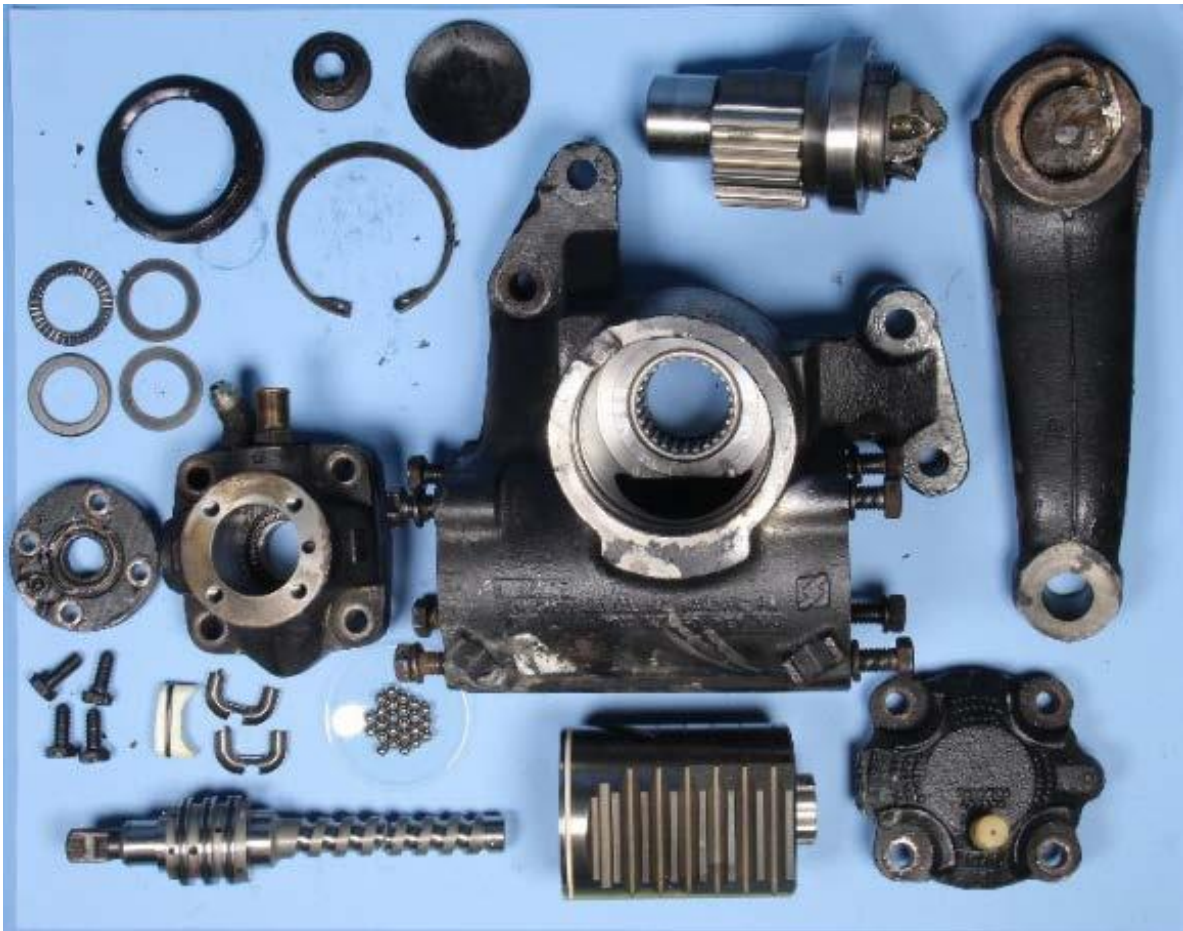
On Friday December 9, 2016, a detailed external and internal examination and component teardown of the steering gear was conducted at RH Sheppard Facilities in Hanover, Pennsylvania as shown in **Figure 2**.

These examinations were conducted by RH Sheppard staff under the direction and in the presence of NTSB and Baltimore Police Department investigators. The exam found the steering gear to be mechanically functional, with no worn or defective components.¹⁰

Examination concluded that the steering gear did receive an impact load, significant enough to cause indentations from recirculating ball bearings on the internal helical worm gear.¹¹ From the location of the recirculating ball bearing impacts, the steering wheel angle at collision

was determined to be 187 degrees of steering wheel rotation to the left, corresponded to the front wheels being at about 10 degrees to the left, at the time the steering gear was subjected to the impact load.

Figure 2 - Disassembled Steering Gearbox of the 2015 IC School Bus

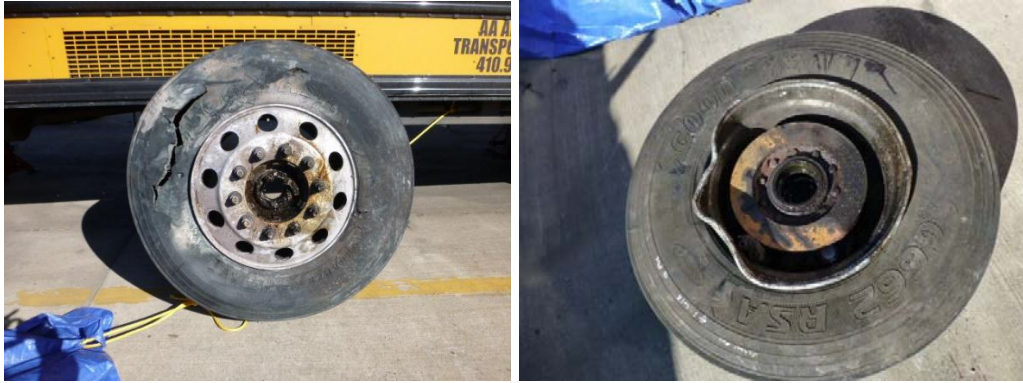
The only tire damage observed during the examination was that the left front tire assembly was detached from the vehicle during the collision sequence. As shown in **Figure 3**.

- At 1:00 there was a 4-inch tear to the outer sidewall.
- At 9:00 extending to 12:00 there was a jagged 20-inch tear along the outer sidewall.
- At 6:00 there was a 3-inch gouge to the outer sidewall.

The left front rim had two impacts to the inboard flange displacing the flange inward.

Figure 3 – Left front tire assembly of the 2015 IC school bus

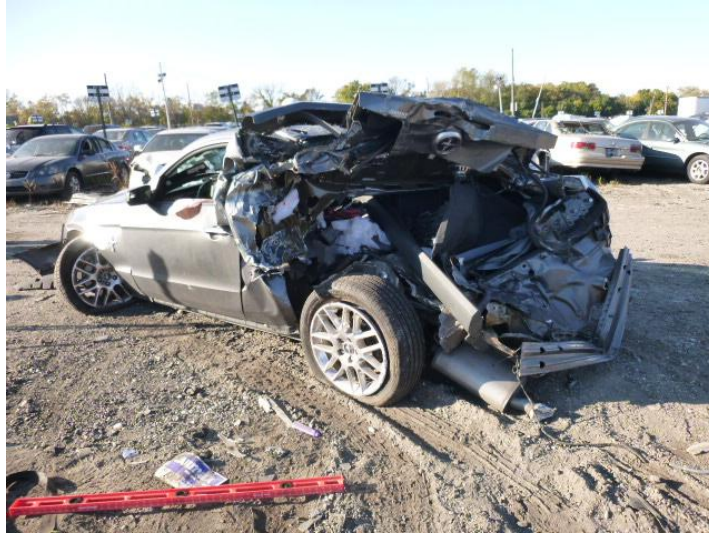
The Mustang sustained three impacts with the initial impact from the bus being the most significant. The initial impact and most severe was to the rear, shown in **Figure 4**. The rear impact resulted in the driver's door being jammed closed. The right door was operational. The second impact was with a curb, resulting in damage to the left front wheel assembly. The third impact was to the front bumper and edge of the hood from colliding a brick wall and fence simultaneously.

Figure 4 – Rear damage of the 2012 Ford Mustang

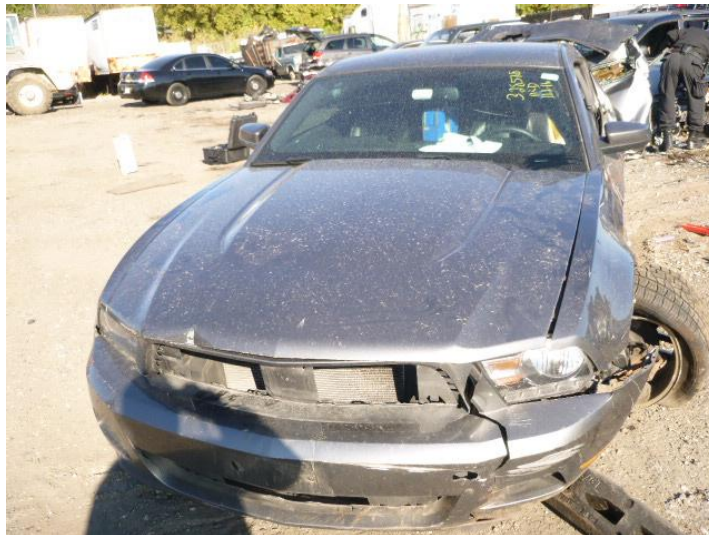
The direct damage width to the front bumper was approximately 35 inches. The left front wheel assembly sustained significant damage from the curb impact as shown in **Figure 5**.

Figure 5 - Front end damage of the 2012 Ford Mustang

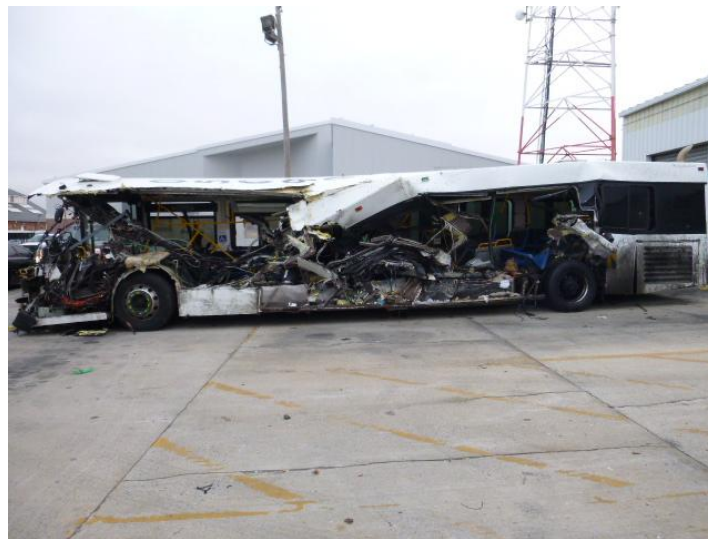
The impact started at the front left bumper corner and extended vertically to the windshield header. The damage extended down the left side, tearing away the windows, sheet metal, and fiberglass resulting in an approximate 6-foot-tallop opening as shown in **Figure 7**.

Figure 7 - Left side view of the 2005 New Flyer Transit Bus
