NTSB Vehicle Photographs

Palm Springs, CA

HWY17MH005

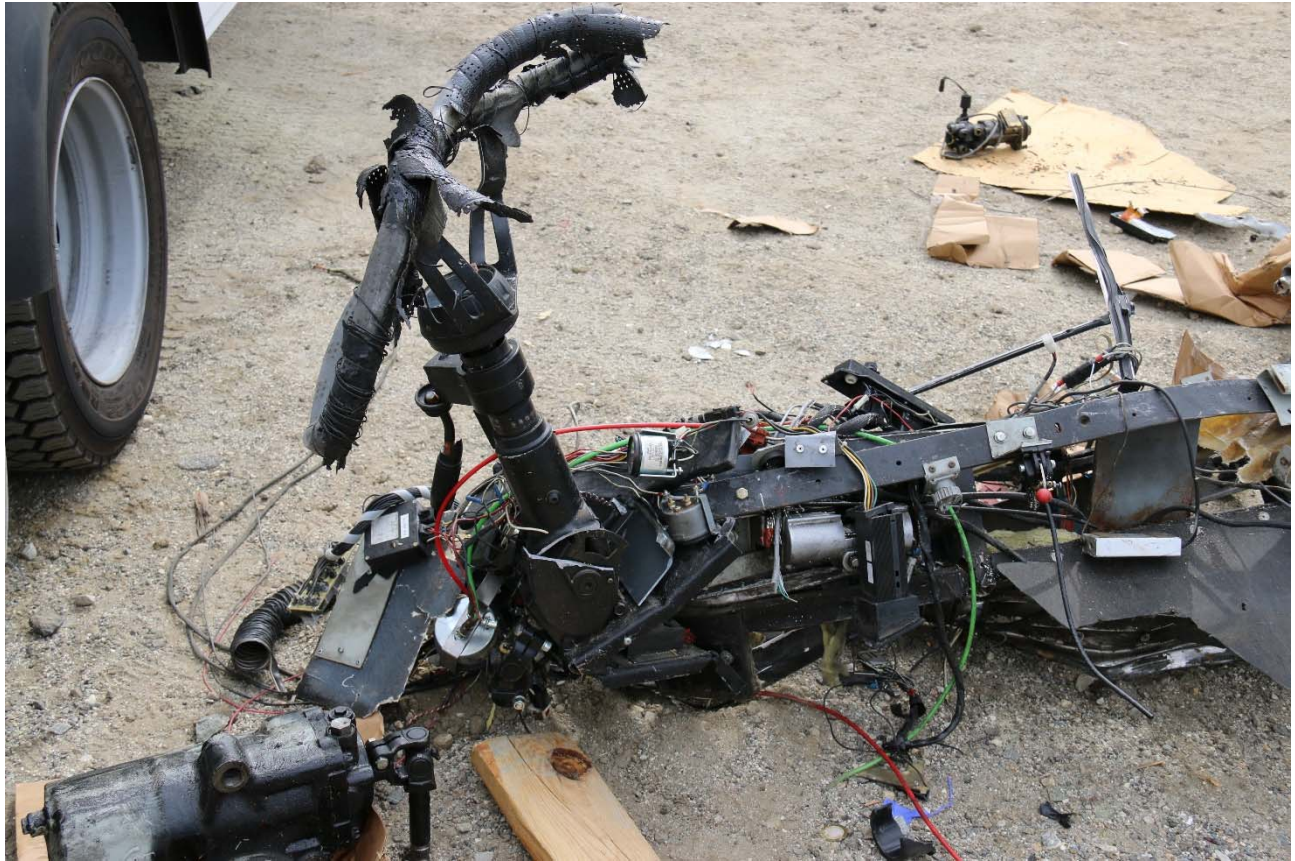
This is a view of the collapsed steering wheel ring, broken steering column, and what is left of the dash and instrument panel. The gauges and switches are either broken or missing

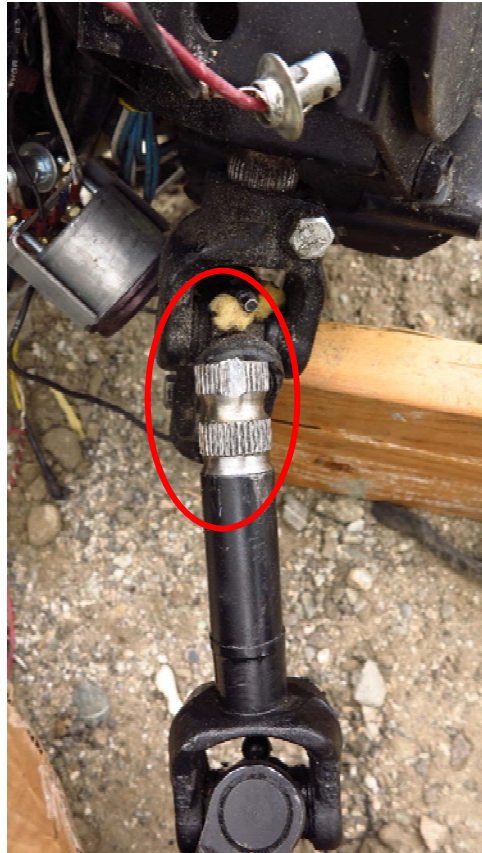
This is a view of the steering intermediate shaft. The red circle shows the damaged splines from having been pulled from the universal joint during the crash.

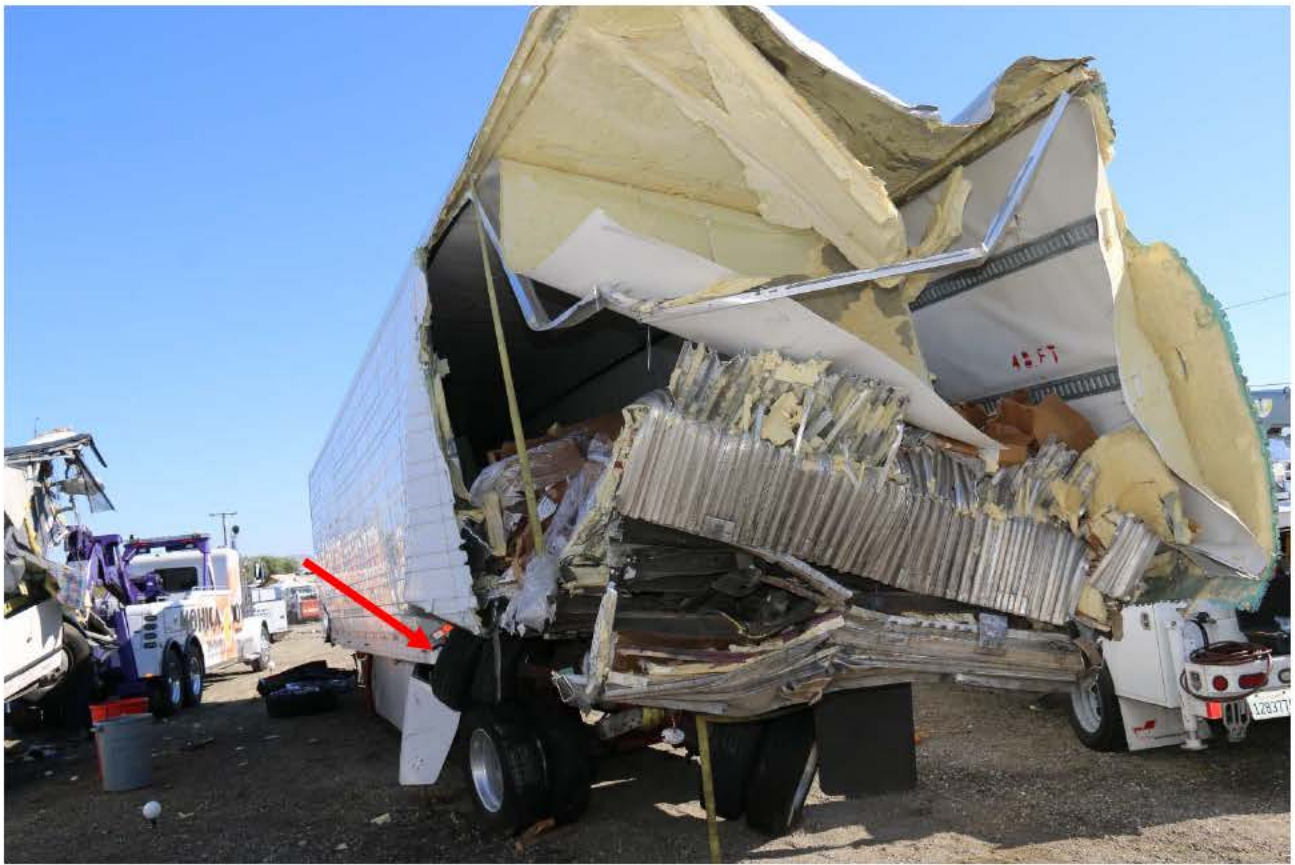
This view is looking from the left rear to the left front of the semitrailer. The rear of the semitrailer shows extensive crash damage. A portion of the left sidewall is missing. The red arrow is pointing to the left side of axle 5 tires which were displaced forward and on top of axle 4 tires. The cargo doors and frame are missing.

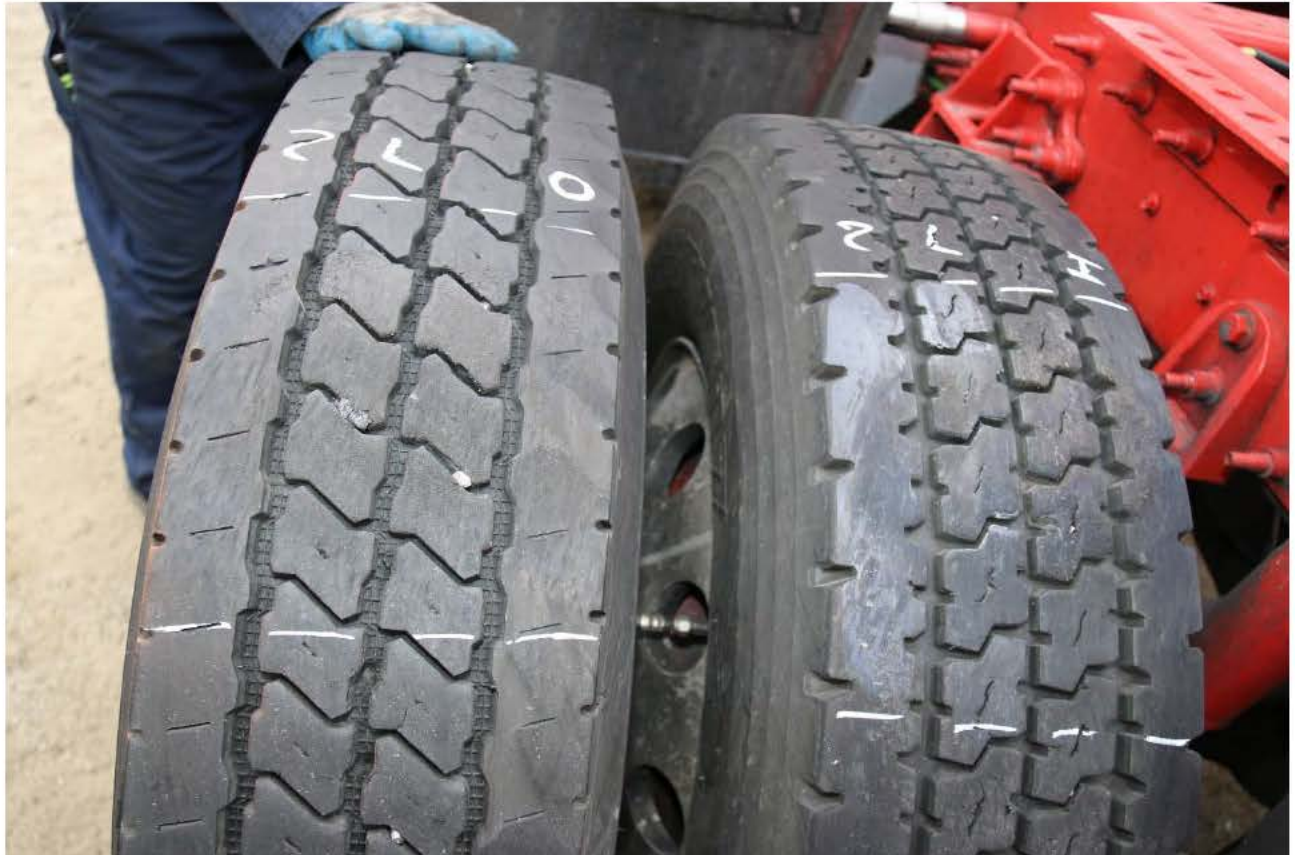
This is a view of the roadway abrasions on the tires on the left side of axle 2.

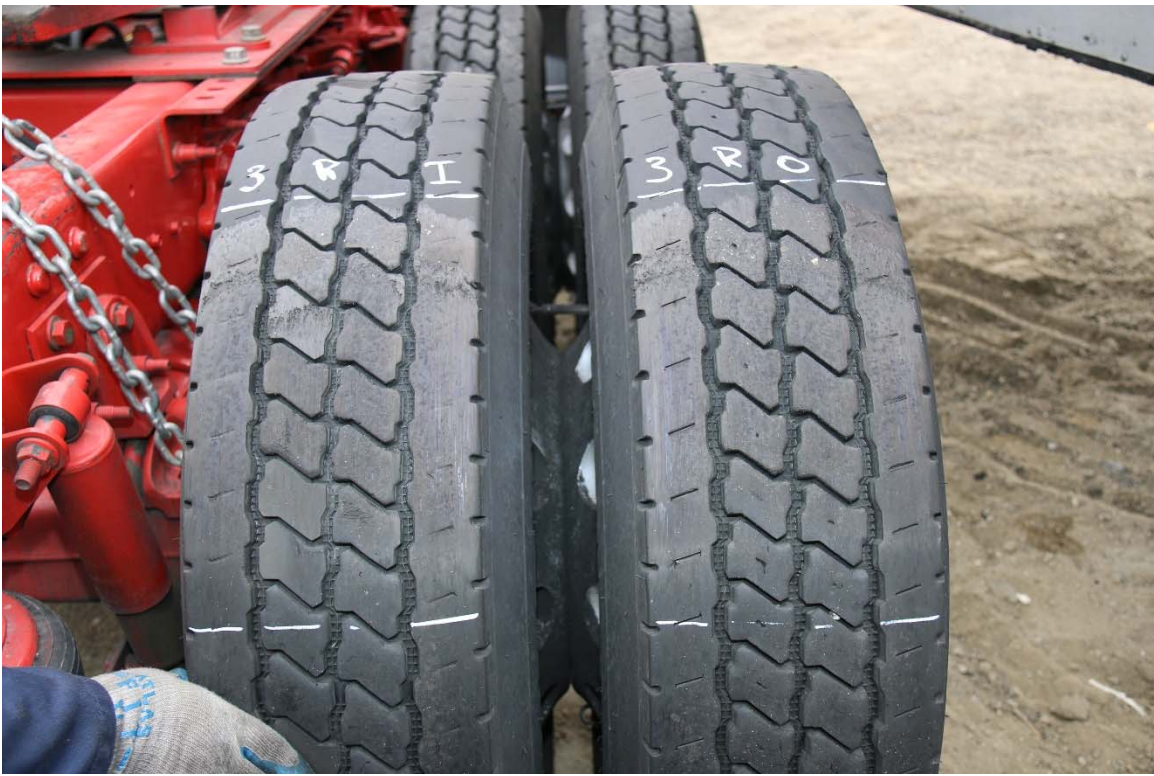
This is a view of the roadway abrasions on the tires on the right side of axle 3.

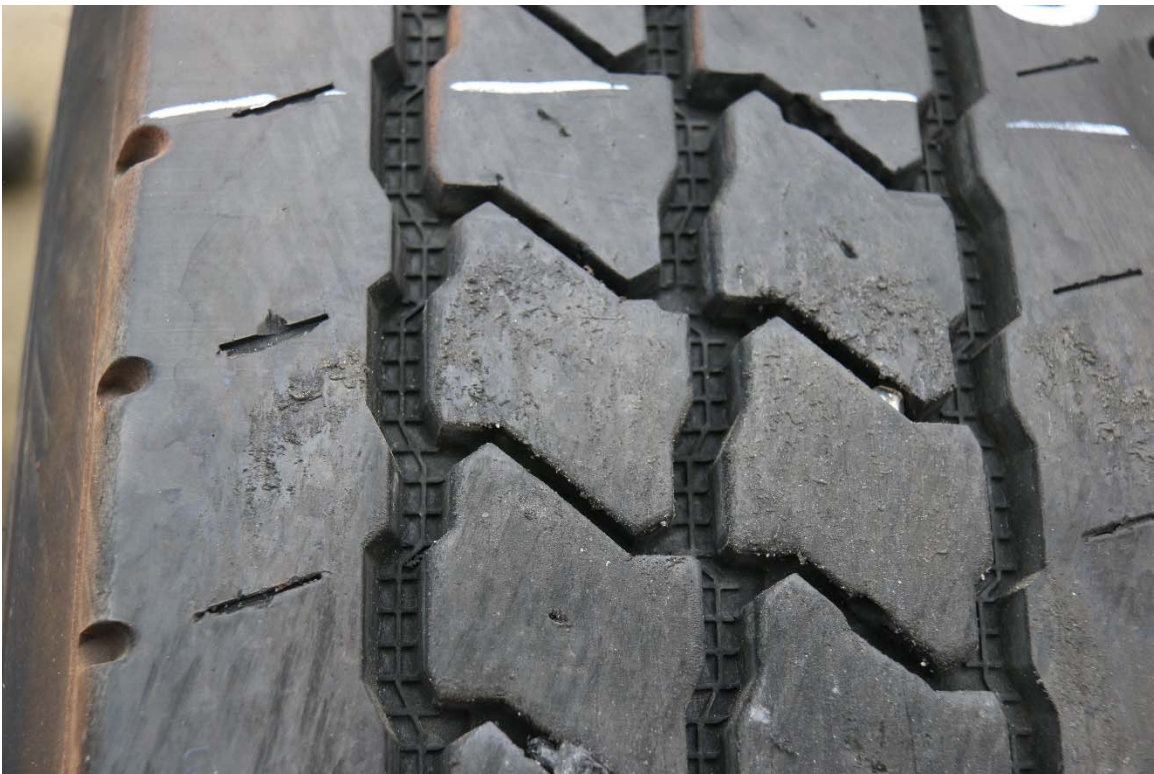
This is a close-up view of the roadway abrasion on one of the drive tires showing the balled up rubber and striations.
