**VEHICLE FACTORS GROUP CHAIRMAN'S  
FACTUAL REPORT**

**Oxnard, CA**

**HWY15MH006**

**NATIONAL TRANSPORTATION SAFETY BOARD  
OFFICE OF HIGHWAY SAFETY  
WASHINGTON, D.C.**

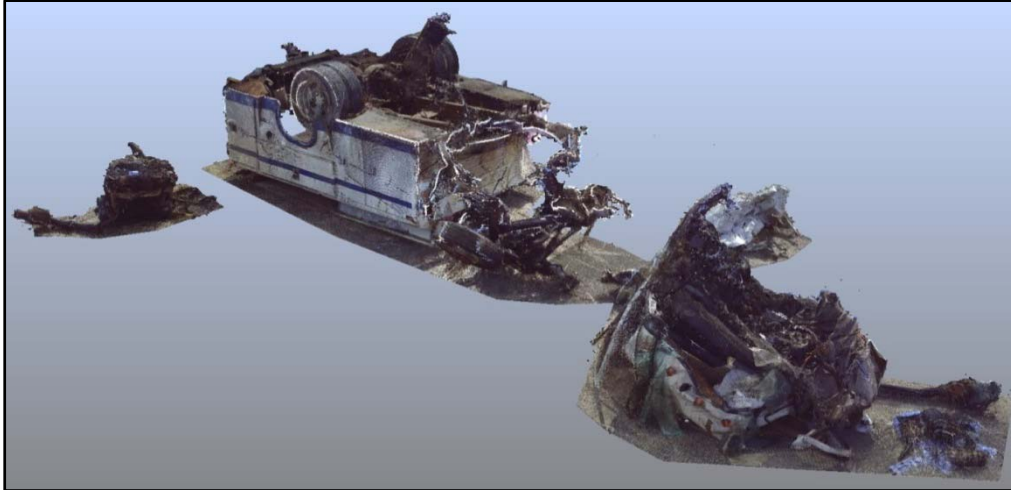
**Figure 1:** Image of 3-D Laser Scan of Ford F-450 Utility Truck

Due to the post-crash condition and damage to the vehicle combination, meaningful axle weights were unable to be obtained. Both the Ford F-450 and Wells Cargo utility trailer were scanned using a 3-dimensional laser scanner that will allow for the creation of a 3-D model. From this 3-D model, scaled measurements can be taken at a later time. **Figure 1** and **Figure 2** show images of the 3-D scans performed on the truck and trailer respectively.

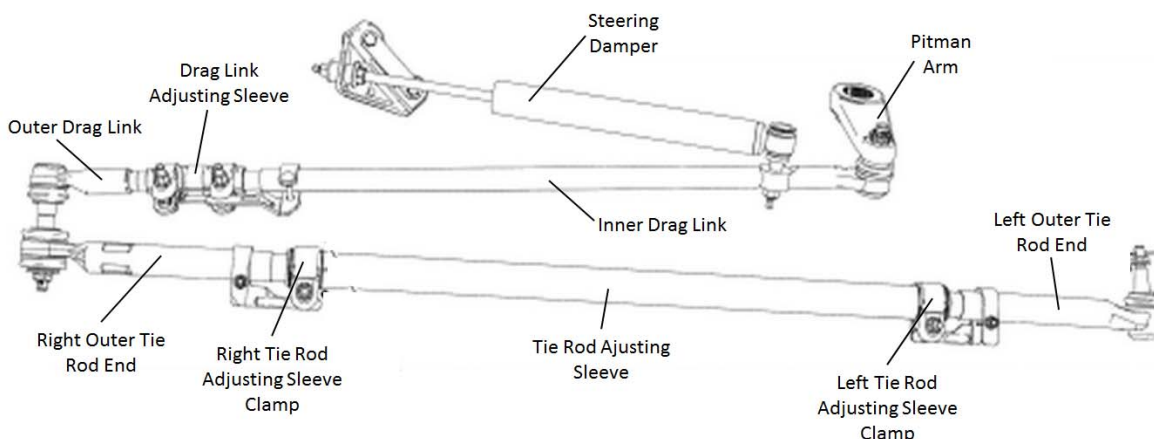
**Figure 3:** Diagram of 2005 Ford F-450 Steering Linkages (modified from: justanswer.com)

The steering wheel was found to be deformed as described in the *Driver Controls* section of this report. The steering wheel connection to the steering column was broken. The steering column connected to an intermediate steering shaft by means of a universal joint within the cab of the truck. Rotating the broken steering wheel connection caused the appropriate rotation of the upper portion of the telescoping intermediate shaft that transcended through the firewall. The lower portion of the telescoping intermediate steering shaft was pulled out of the upper portion of the shaft, and was disconnected.

The lower portion of the intermediate shaft was bent; however, it remained partially attached to the input shaft of the hydraulically assisted steering gear box by means of a dampening coupler. The output shaft from the steering gear was securely connected to the pitman arm using a splined connection. The ball joint that connects the pitman arm to the inner drag link was separated at the joint, with the ball stud remaining attached to the pitman arm, and the socket remaining attached to the inner drag link. Rotation of the lower input shaft caused smooth and unencumbered movement of the pitman arm across the full range remaining between portions of the wreckage.

The front right wheel assembly, including the steering knuckle, the right outer tie rod end and the drag link assembly (inner drag link, drag link adjusting sleeve, and outer drag link), were separated from the vehicle, and were located in the wreckage. The originally straight drag link assembly was bent significantly, and resembled a “U” shape. The drag link was connected simultaneously to the right steering knuckle and right outer tie rod end by means of another ball joint. The right outer tie rod end had been separated from the tie rod adjusting sleeve, which had also been separated from the left outer tie rod end, and was found loose in the wreckage. The tie rod adjusting sleeve was also found to be bent. The left steer axle assembly, including the left steering knuckle and left outer tie rod end remained attached to the frame of the vehicle. The left outer tie rod end remained connected to the left steering knuckle by means of a ball joint.
