**VEHICLE FACTORS GROUP CHAIRMAN'S
FACTUAL REPORT**

HWY17MH010

**NATIONAL TRANSPORTATION SAFETY BOARD
OFFICE OF HIGHWAY SAFETY
WASHINGTON, D.C.**

Location: Rail crossing, Main Street, Biloxi, Harrison County, Mississippi
Vehicle #1: 2016 Van Hool CX45 Motorcoach
Operator #1: Echo Transportation
Vehicle #2: CSX Freight Train, consisting of 3 locomotives, 27 loaded cars, 25 empty cars
Operator #2: CSX Railroad
Date: March, 7, 2017
Time: 2:12 p.m. CST
NTSB #: **HWY17MH010**

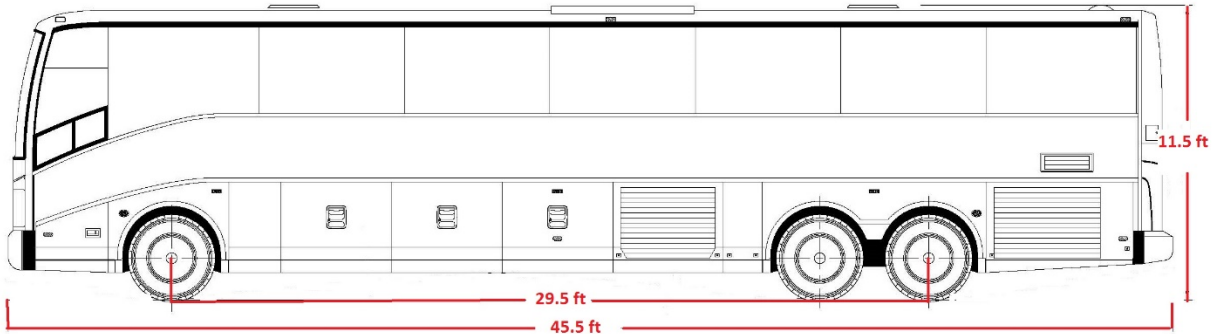
Figure 1: Profile View of Motorcoach with Dimensions Added

Hand measurements were taken of the motorcoach. **Figure 1** shows a side profile of the motorcoach with select dimensional information added. The ground clearance of the motorcoach at the loading door was 12-inches from the ground to the bottom step of the stepwell.
