**VEHICLE FACTORS GROUP CHAIRMAN'S
FACTUAL REPORT**

NTSB Vehicle Photographs

Williston, Florida

HWY16FH018

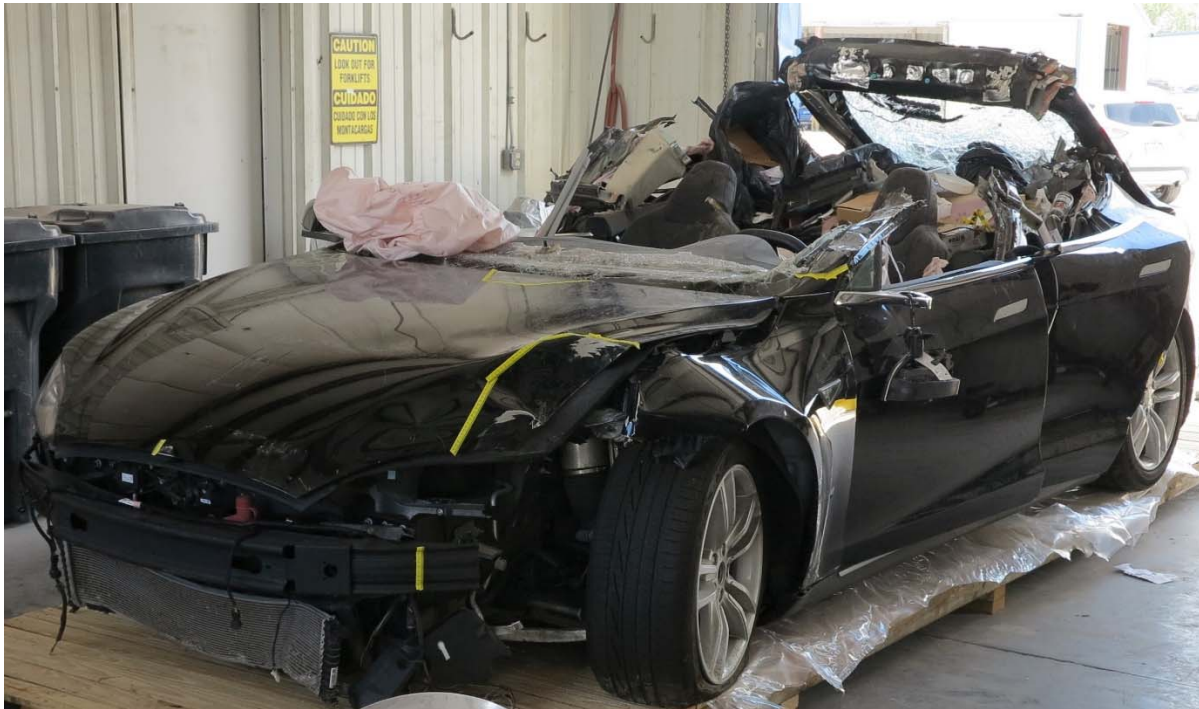
Vehicle Photograph #1 – Left Front of Tesla

This is a photograph showing the damage to the left front of the Tesla. The front plastic bumper cover is missing. The leading edge of the left side of the hood is bent rearward and slightly upward. The leading edge of the left fender has been crushed rearward to approximately the center of the tire. The forward lower control arm and air spring are visible behind the tire and wheel. The left-front tire is deflated and the left side rearview mirror has been displaced from its mounting bracket.

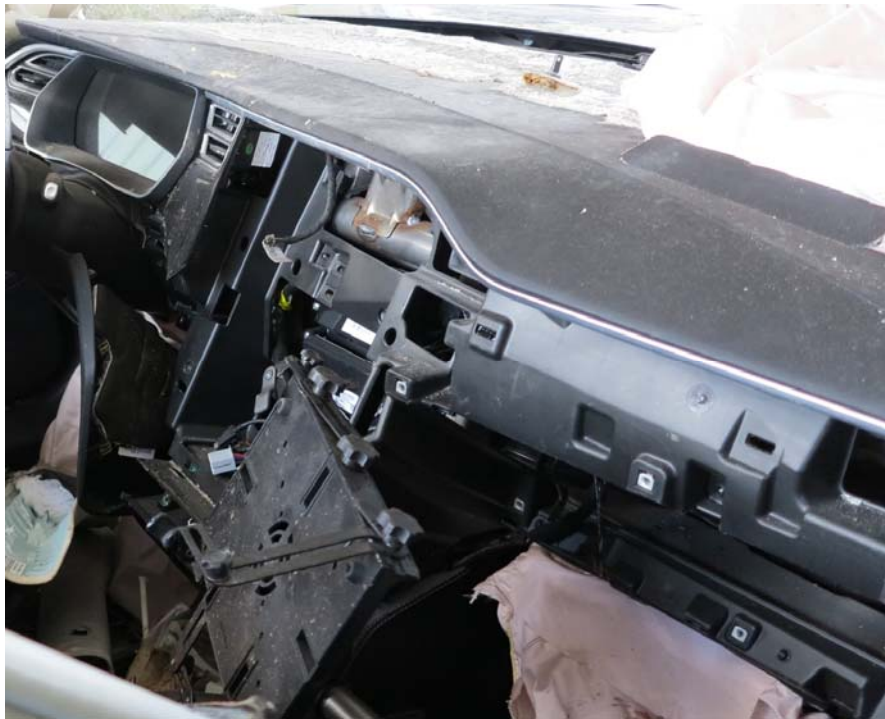
Vehicle Photograph #2 – Instrument Panel of the Tesla

This photograph was taken from the passenger's side looking towards the steering column and shows the condition of the instrument panel at the time of inspection by NTSB. The instrument panel to the right of the driver and in front of the passenger, along with the center stack console, had all been removed. The photograph also shows the lap top computer stand which had been mounted to the passenger side floorboard.

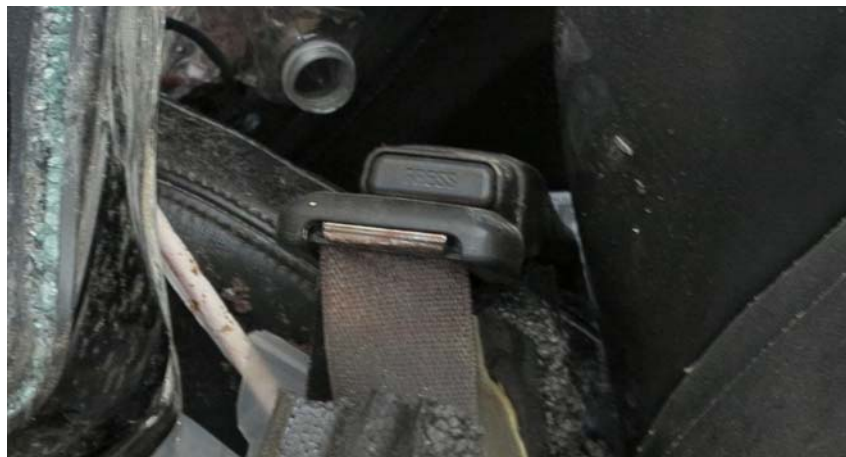
Vehicle Photograph #3 – Driver's Seat Belt Latch Plate and Buckle

This photograph shows the driver's seat belt latch plate securely locked inside of the buckle assembly.

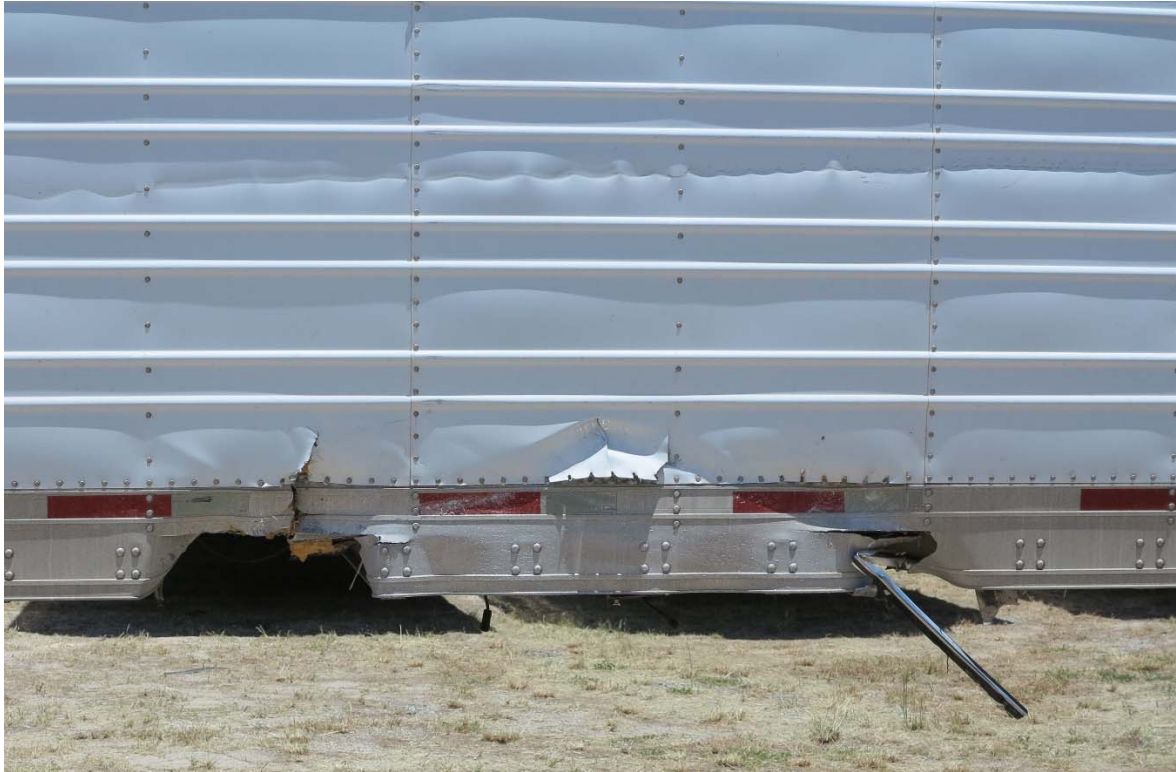
Vehicle Photograph #4 – The Right Side of the Semi-Trailer

This picture was taken at the initial contact location, which was located at the approximate center of the right side of the semi-trailer. The front of the trailer is to your right and the rear to your left. The photograph was taken in the same direction the Tesla was traveling at the time of the crash. The damage to the semi-trailer outboard rail corresponds to the locations of the “A” pillars on the Tesla. You can see a chrome piece of trim still attached to the forward damaged section. The upside-down U-shape embedded on the siding of the trailer corresponds with the buckled portion of the Tesla’s roof.

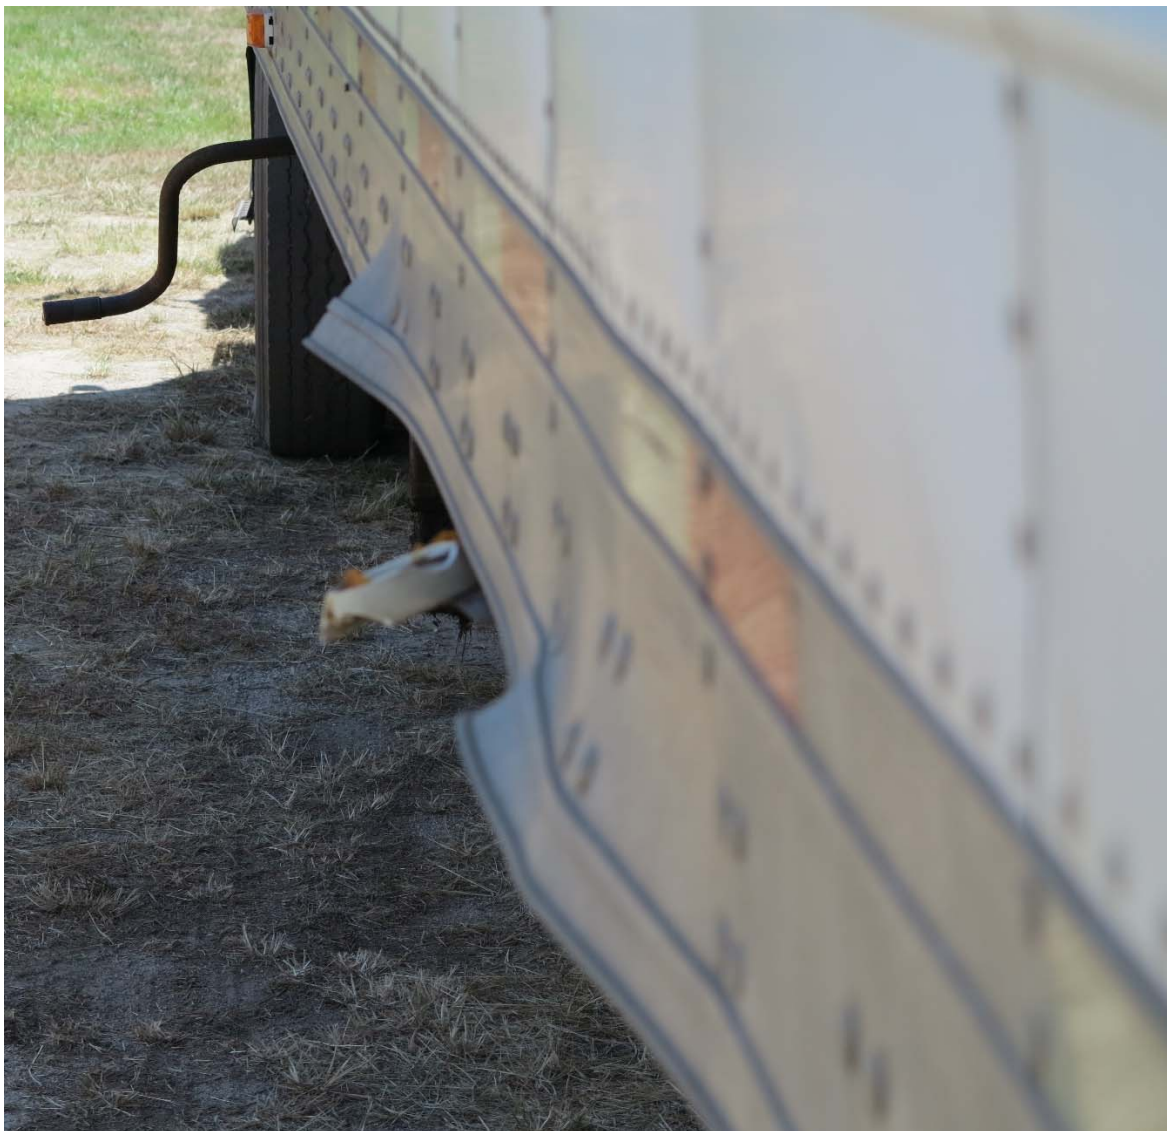
Vehicle Photograph #5 – The Left Side of the Semi-Trailer

This photograph was taken looking forward from the rear of the semi-trailer. The photograph shows the exit location of the Tesla from beneath the semi-trailer. The outboard trailer rail is bent outward, to the left, in two locations. The semi-trailer's center marker/turn signal light is broken and the mounting bracket is bent upward.
