**VEHICLE FACTORS GROUP CHAIRMAN'S  
FACTUAL REPORT**

**HWY15FH010**

**NATIONAL TRANSPORTATION SAFETY BOARD  
OFFICE OF HIGHWAY SAFETY  
WASHINGTON, D.C.**

Location: Eastbound Interstate 610 (I-610) overpass above Telephone Road, Houston, Harris County, Texas

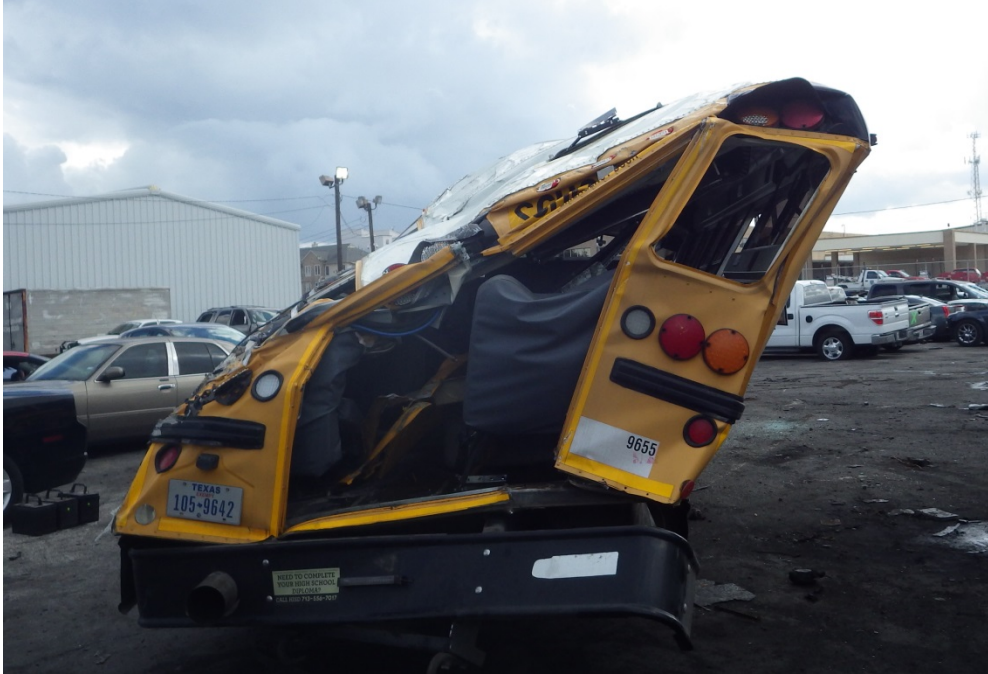
The right side of the HISD bus from the passenger door back, had little damage. The second emergency window exit was open at the time of inspection, but all windows were intact. The entire body of the bus was shifted to the right due to the impact damage to the left side. **Figure 1** shows the damaged school bus from the rear.

**Figure 1.** View showing contact damage to the top left corner of the HISD bus.

The right side of the rear bumper of the bus had been torn away from its connection to the frame rail. The rear emergency exit was no longer attached to the bus exposing the seat backs of the rear bus seats. Due to the damage to the left side and top of the bus, the roof was crushed to the top of the left side seat backs.

The left side of the bus had extensive contact damage with crush concentrated at the left rear corner near the roofline. Crush at the left rear corner measured approximately 48 inches with an additional 24 inches due to the body shifting to the right from impact. The crush decreased from the rear of the bus to the front, with little crush at the left front roofline. There was approximately 12 inches of body shift to the right measured at this location.

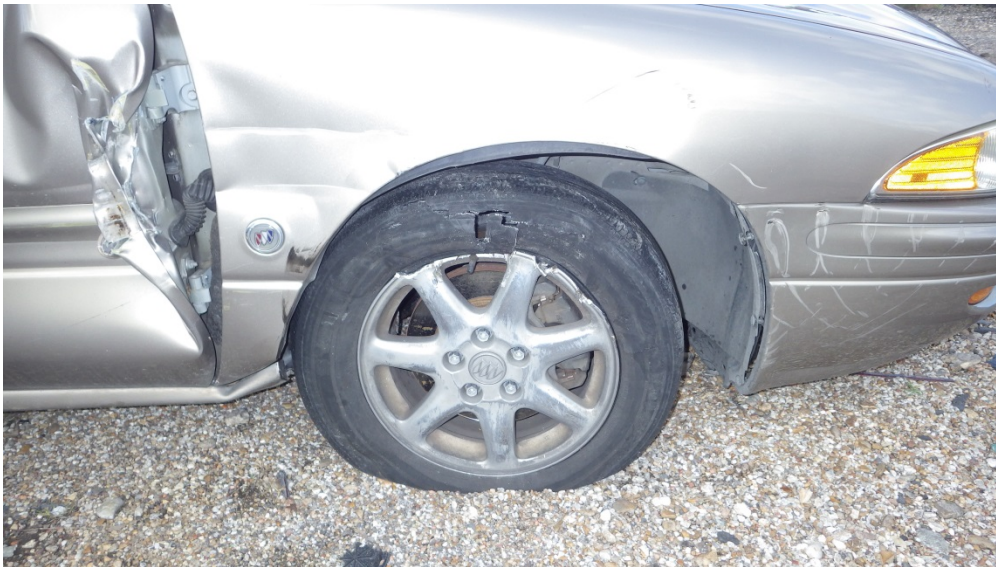
The damage to the Buick LeSabre was entirely on the right side of the vehicle. There were pattern scratches in the paint on the right front fender near the wheel well. There were creases in the right front fender leading to the front passenger door. The front portion of the door was peeled back, away from the side of the vehicle, causing some induced damage below the rearview mirror. The rear passenger door had light scrapes and blue paint transfer leading into the right rear wheel well. The NTSB and HPD investigators were unable to determine the source of the blue paint transfer. The right rear bumper and fender area was undamaged. There was no damage to the interior of the vehicle. The driver's seatbelt was retracted but not locked.

The right front rim had portions of the outside flange broken away. There was an approximate 3 inch x 3 inch tear in the sidewall near the valve stem. The pattern scratches and the tear were caused by contact with the wheel studs on the rotating left front wheel of the HISD bus. **Figure 2** shows the damage on the Buick LeSabre caused by the wheel studs. A portion of the right side control arm of the steering system was fractured through at a fitting near the frame.<sup>6</sup>

**Figure 2.** Pattern scratches and tire damage from contact with the HSID bus.
