## **NTSB Vehicle Photos**

**Oakland, Iowa**

**HWY18MH003**

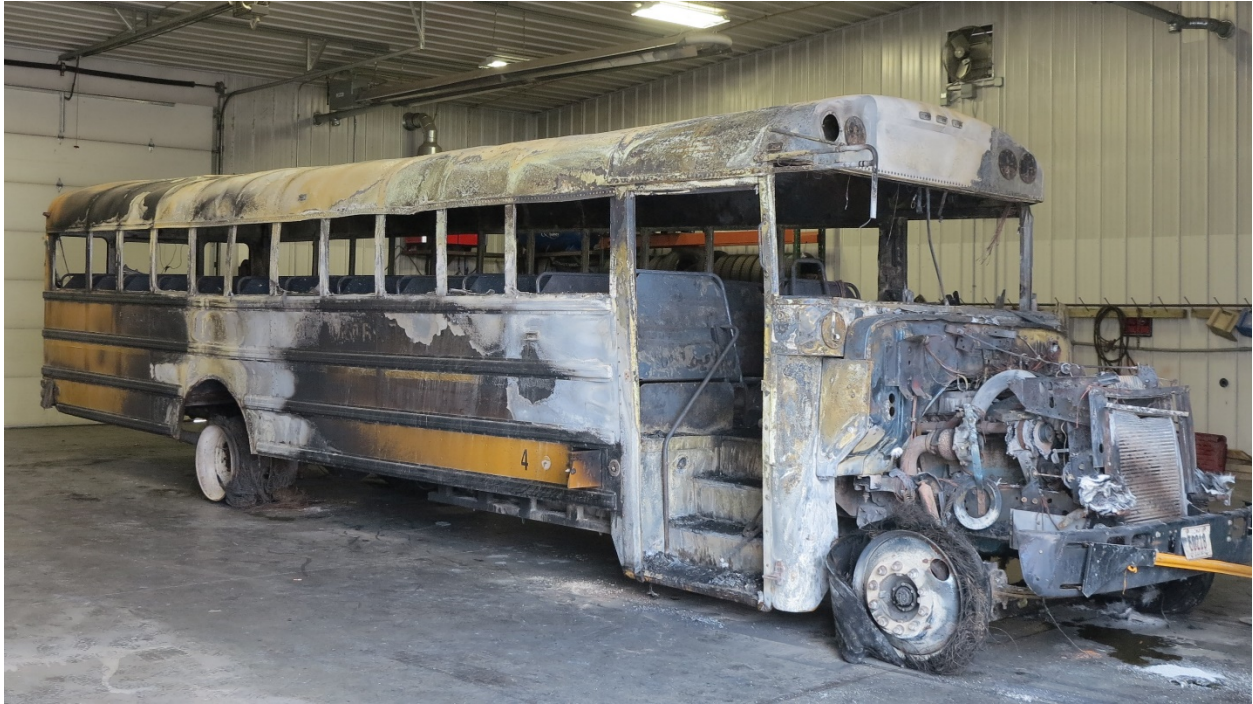
Vehicle Photo #1 – Overall view of the damage to the right side of the 2004 IC School Bus during inspection at Arrow Towing in Council Bluffs, Iowa.

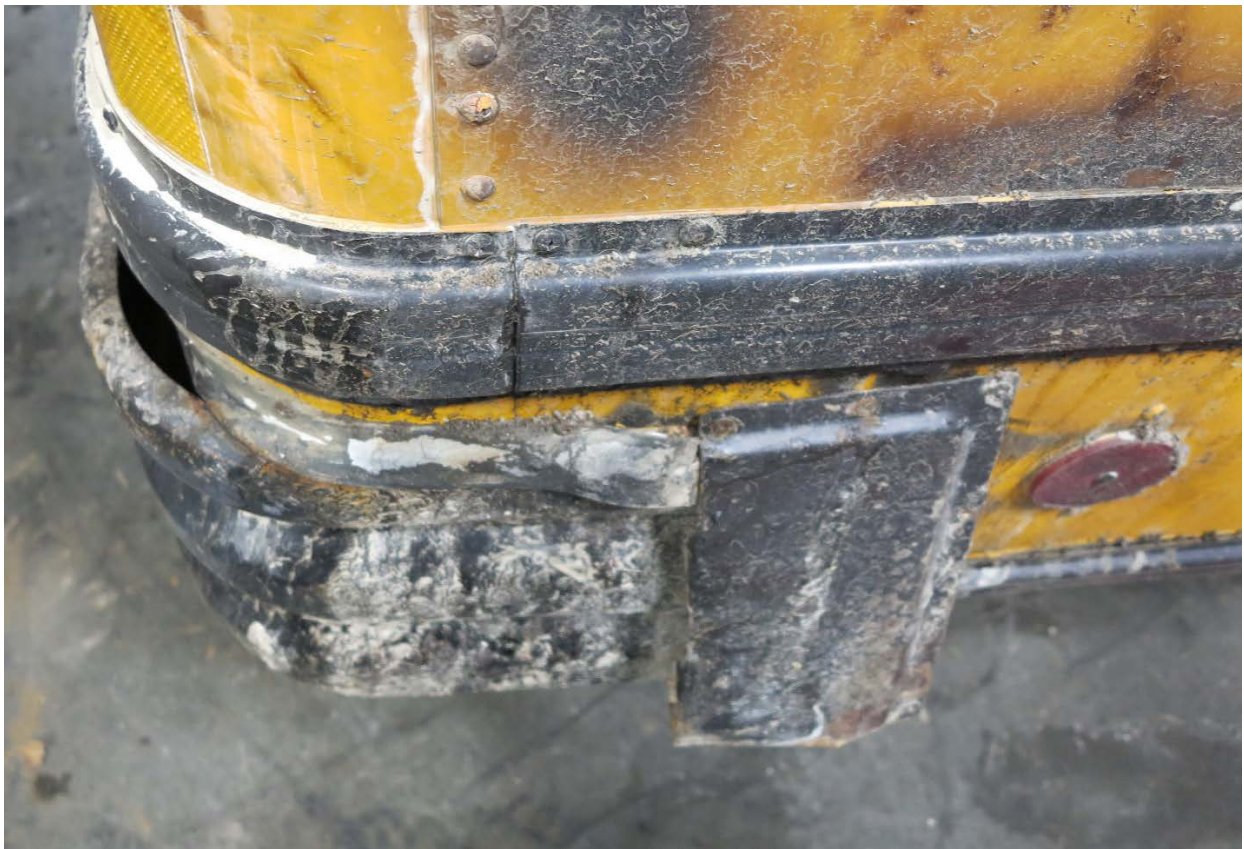
Vehicle Photo #2 – View of the damage to the right rear corner of the school bus.
