## **VEHICLE PHOTOGRAPHS**

**Flushing, NY  
HWY17MH015**

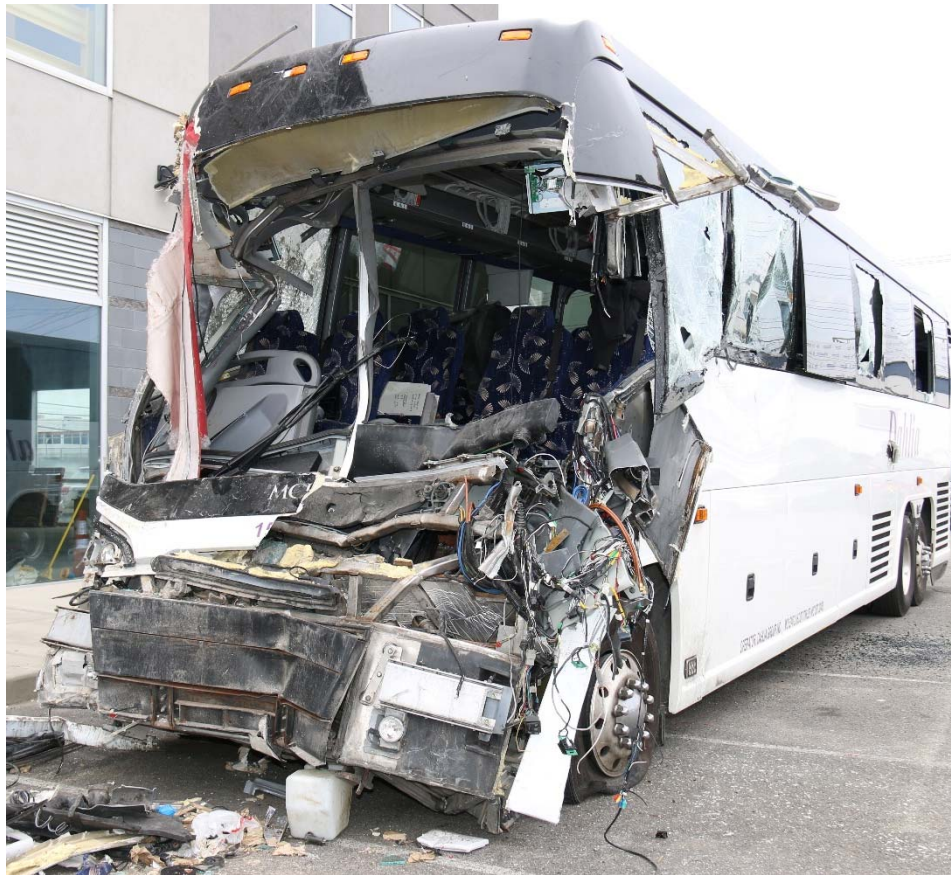
**Photograph 1:** This is a view of the overall, substantial damage sustained by the left-front corner of the motorcoach.

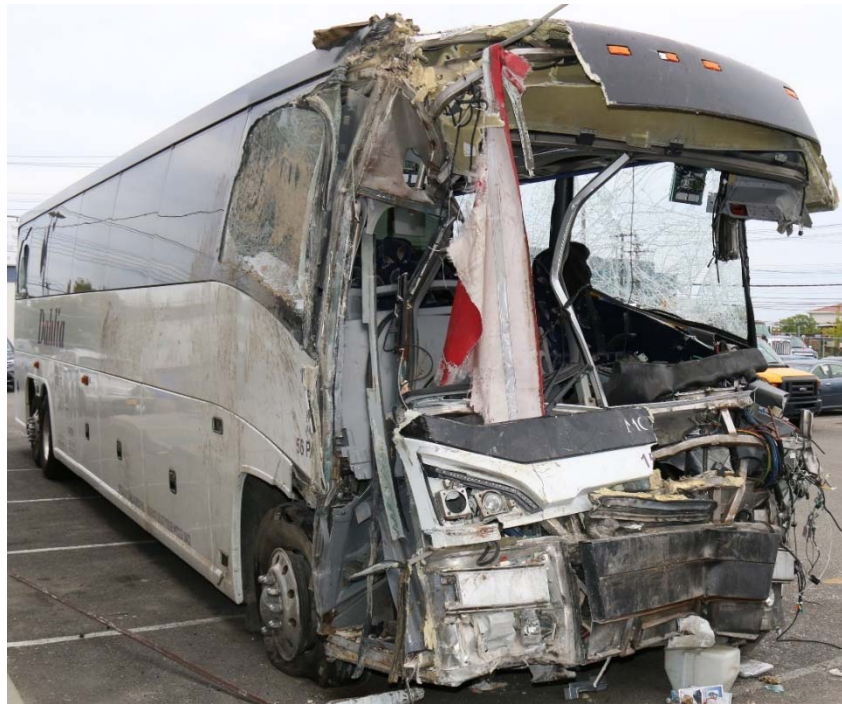
**Photograph 2:** This view is showing the overall damage sustained to the right-front corner of the motorcoach. The red cloth in the picture is the awning from the front of the business that the motorcoach had impacted.

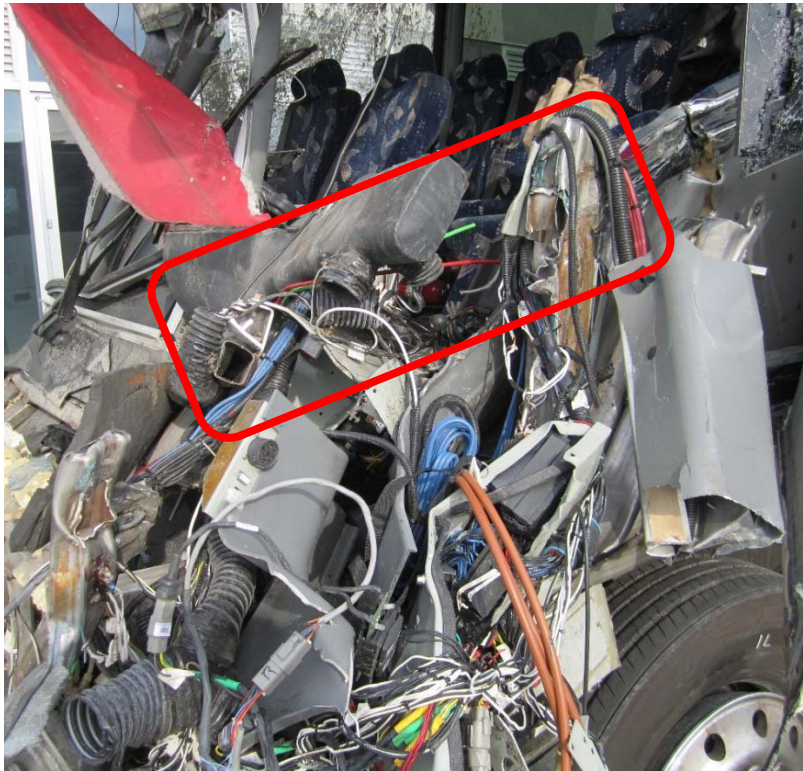
**Photograph 3:** This is a view looking at where the instrument panel would have been located on the Left side of the driver's seat (red box).

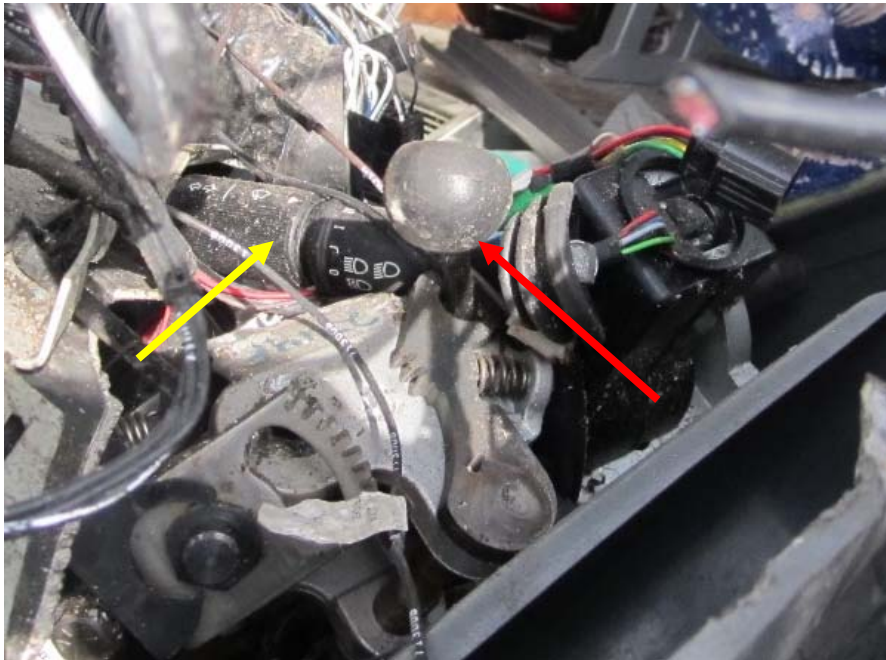
**Photograph 4:** This is a view of the tilt/telescoping control lever (red arrow) and the multifunctional turn signal control lever (yellow arrow).

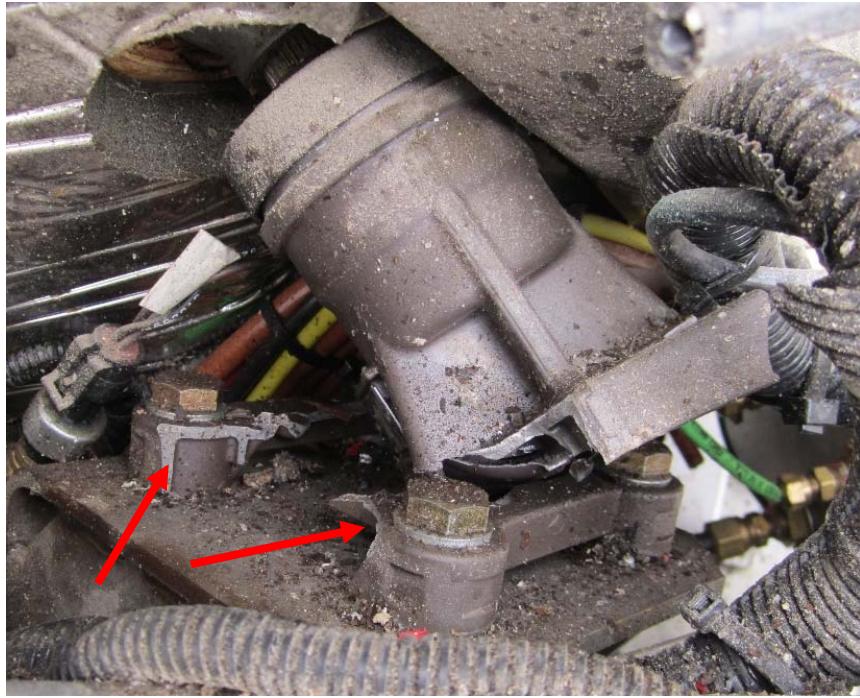
**Photograph 5:** This is a view of the miter box steering assembly. The mounting bolsters for the miter box were broken (red arrows).

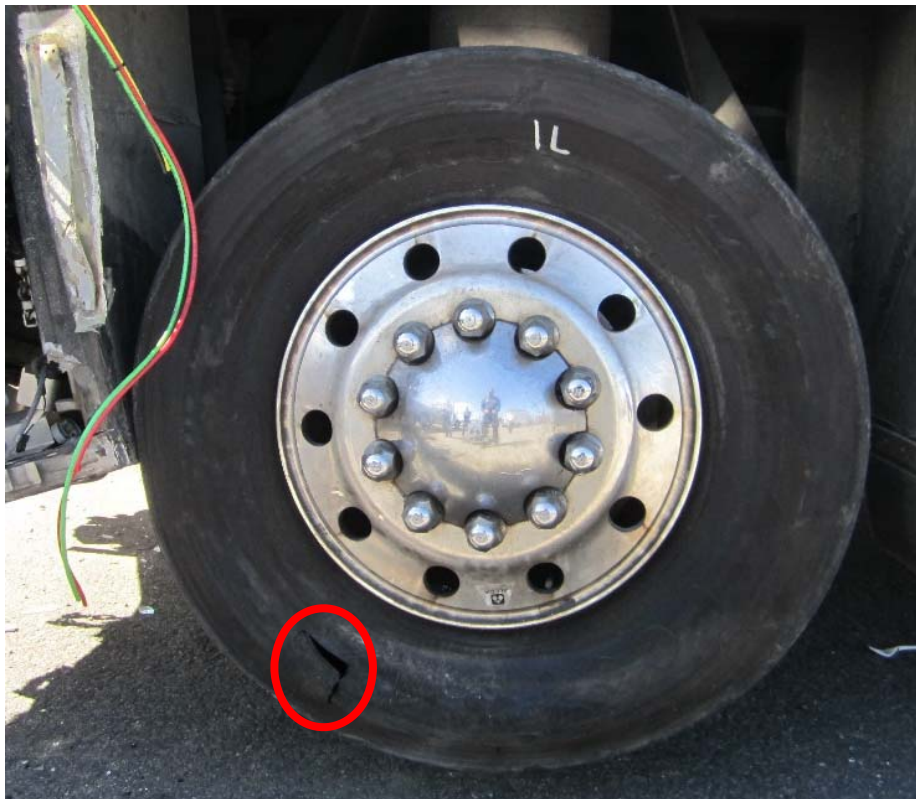
**Photograph 6:** This is a view of the left-side tire and wheel (axle 1) of the motorcoach. Since the motorcoach has already been placed on blocks in this photograph, the tire appears to be inflated, but, due to the damaged sustained to the sidewall of the tire (red oval) from the displacement of the forward wheel well opening, the tire had been punctured and was deflated.

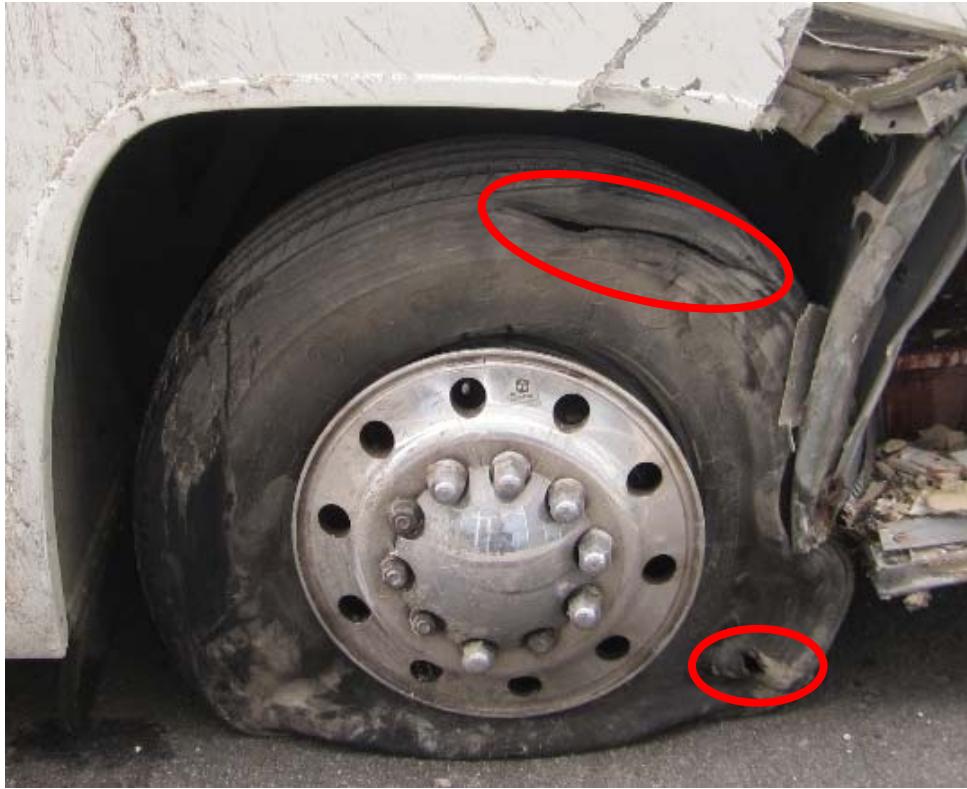
**Photograph 7:** This is a view of the right-side tire and wheel (Axle 1) of the motorcoach. Due to the crash, the tire sustained numerous cuts and abrasions. The tire sidewall had been punctured in two locations as well (red ovals).

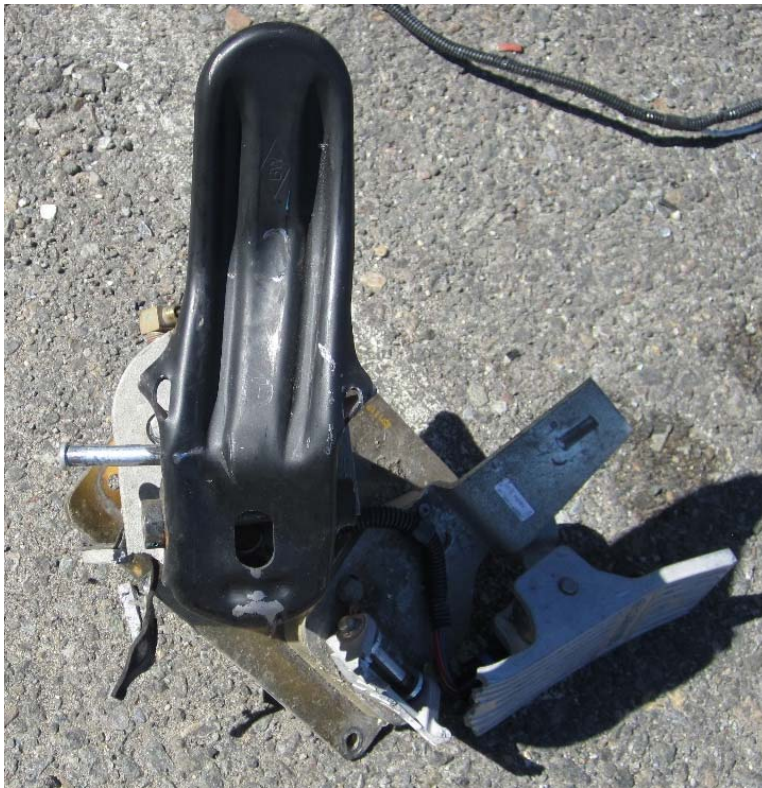
**Photograph 8:** This is a view of the brake pedal and accelerator pedal. Both the brake and accelerator pedals are deformed, and accelerator pedal is broken close to the pedal mounting pin.

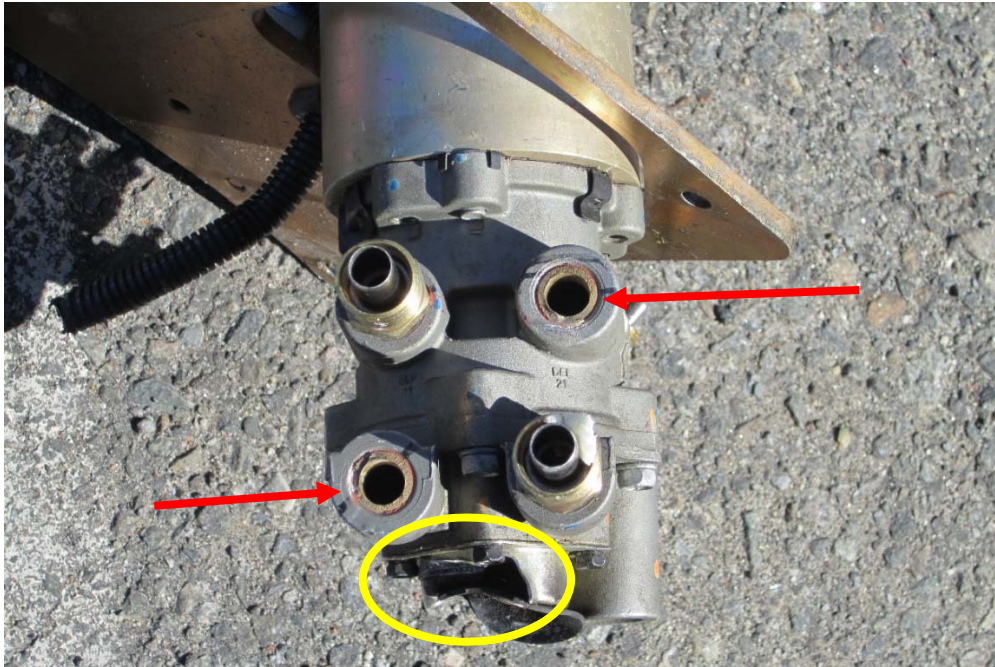
**Photograph 9:** This is a view of the treadle valve before repairs. Notice the two broken fittings that had to be removed and replaced (red arrows), and the damage to the exhaust port (yellow oval).

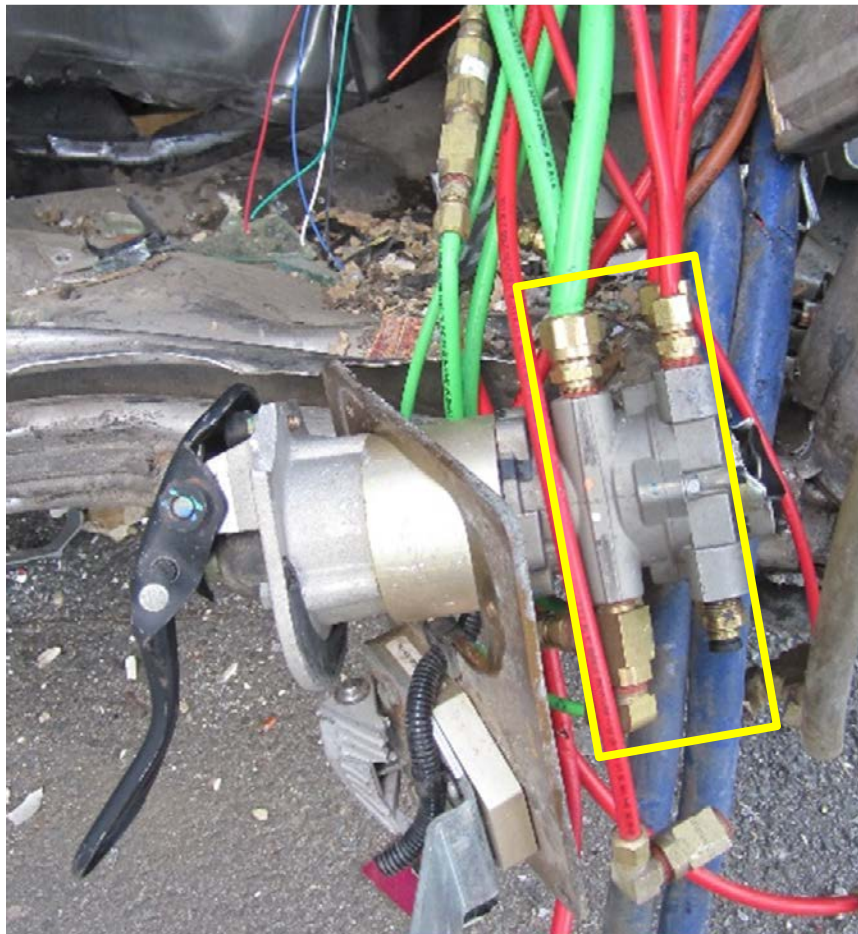
**Photograph 10:** This is a view of the brake pedal and treadle valve after the airlines, which supplied air to the vehicle brakes, had been re-attached (yellow rectangle). The port that is plugged, on the lower right of the treadle valve, was not needed for the brake application.

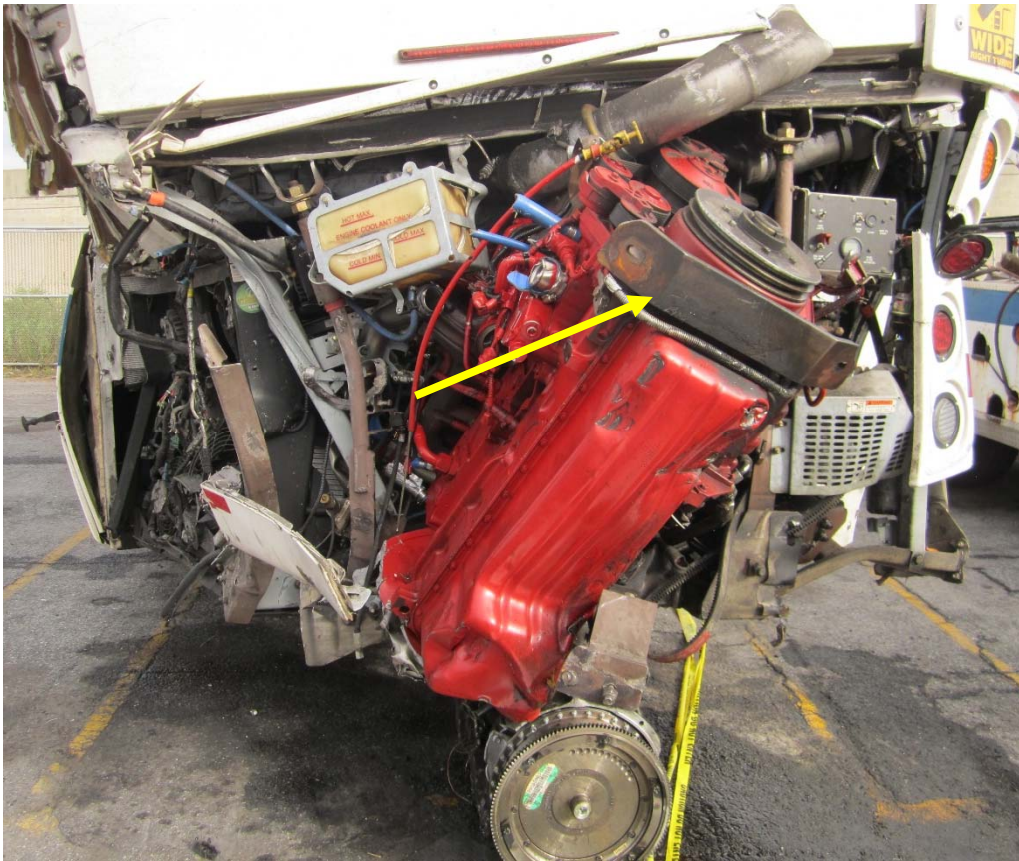
**Photograph 11:** This is a view of the engine and engine compartment of the transit bus. Most of the fluid hoses and electrical wiring had been severed. The engine cradle is still attached to the engine (yellow arrow).

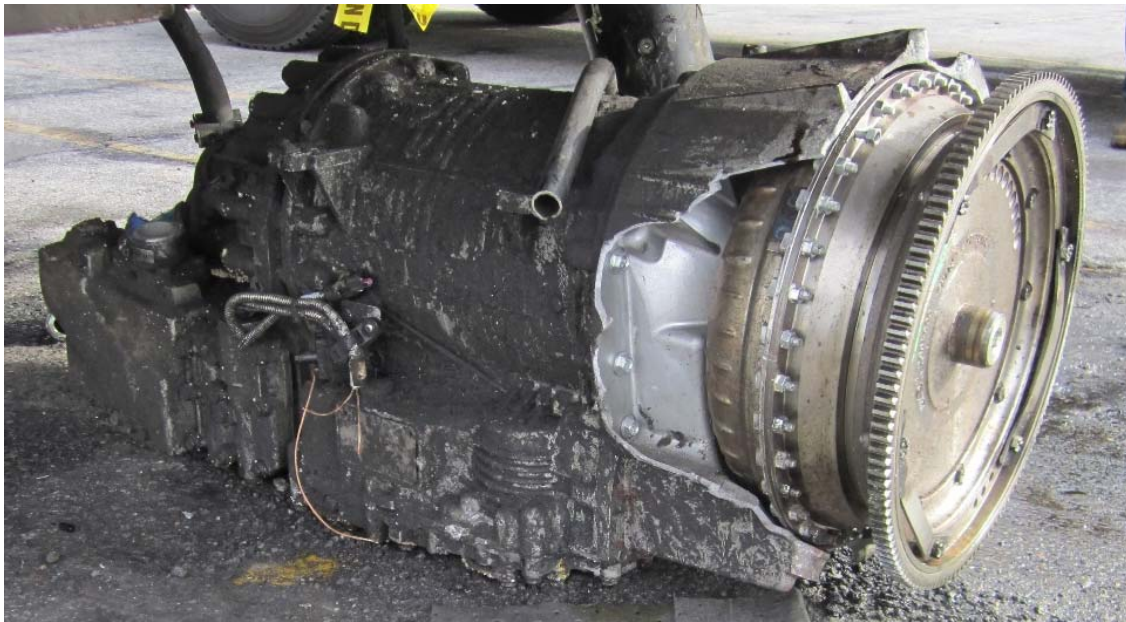
**Photograph 12:** This is a view of the damage sustained to the transmission that had been mounted on the rear of the engine.

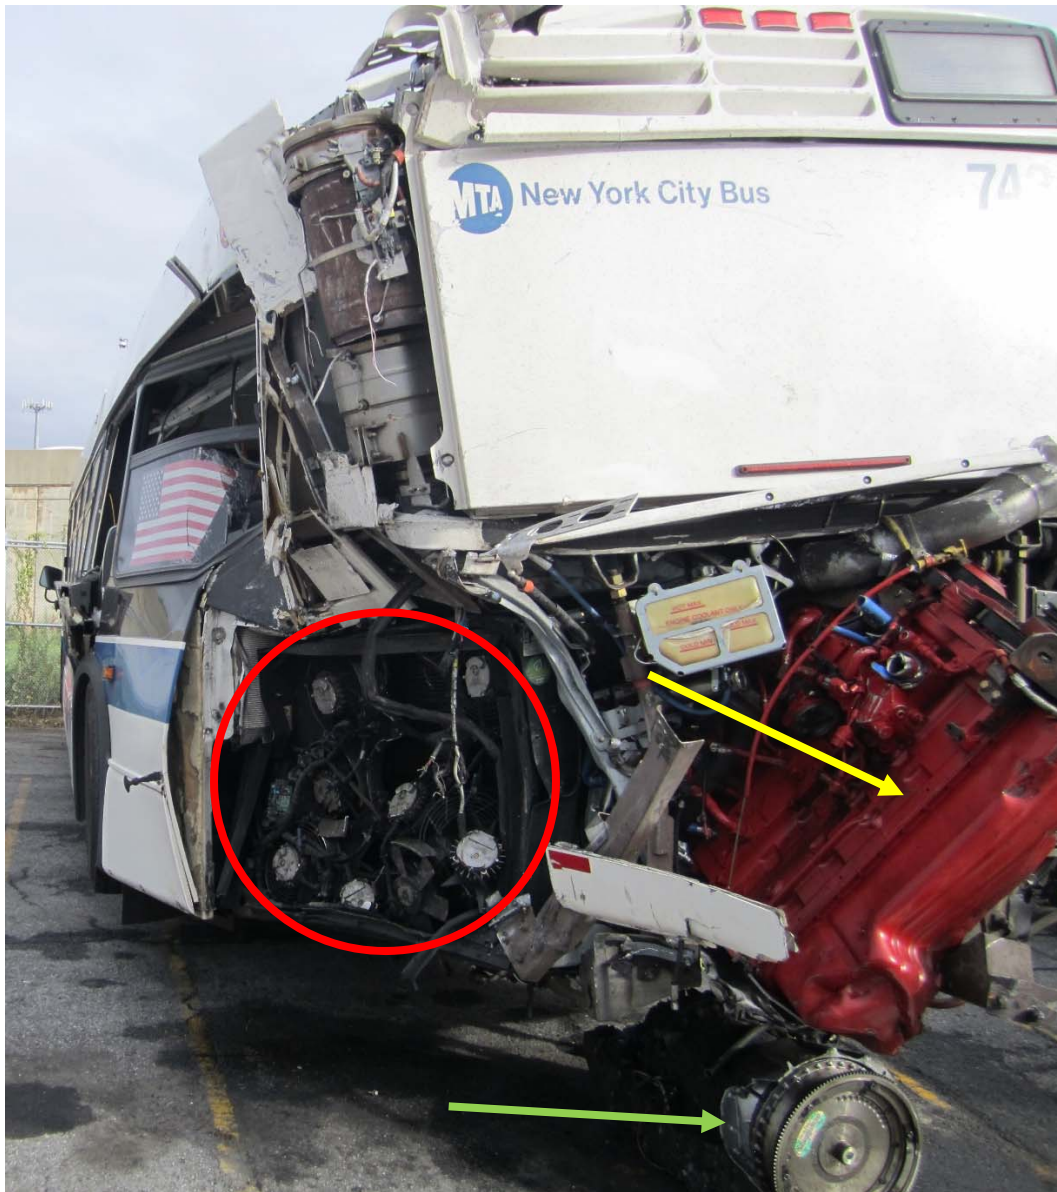
**Photograph 13:** This view is looking from the left-rear corner towards the front of the Transit Bus. This photograph depicts the damage sustained to the left-rear of the transit bus. Notice the displacement of the engine compartment to the right. You can also see the engine (yellow arrow) and transmission (green arrow) have sustained major damage and are no longer connected. The rear windows are either shattered or missing and the engine cooling fans have been crushed (red circle).

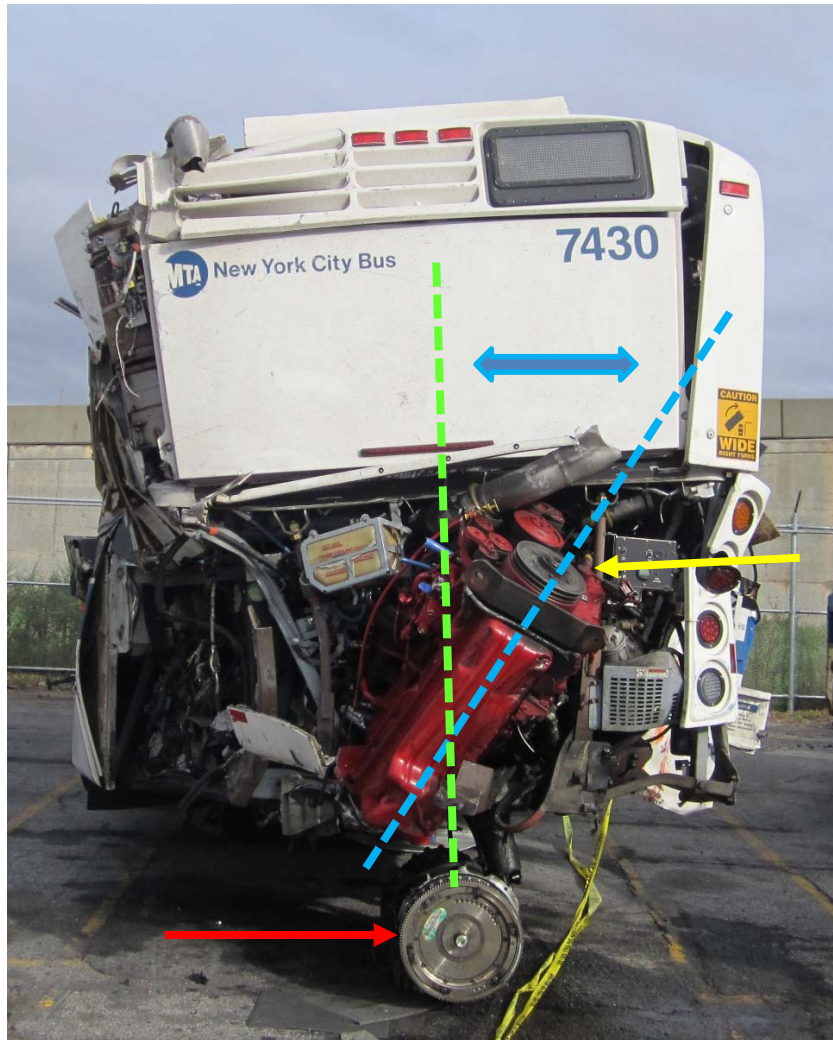
**Photograph 14:** This is a view looking towards the rear of the transit bus. The left corner shows evidence of an impact which resulted in substantial damage. There is obvious displacement of the engine compartment components to the right. The engine is displaced rearward from the engine compartment, and the front of the engine is pointing up to the sky (yellow arrow). The engine is also rotated to the right (broken blue line). The broken green line indicates approximately where the front of the engine should be located. Below the engine is the transmission (red arrow) which became separated from the engine during the crash.

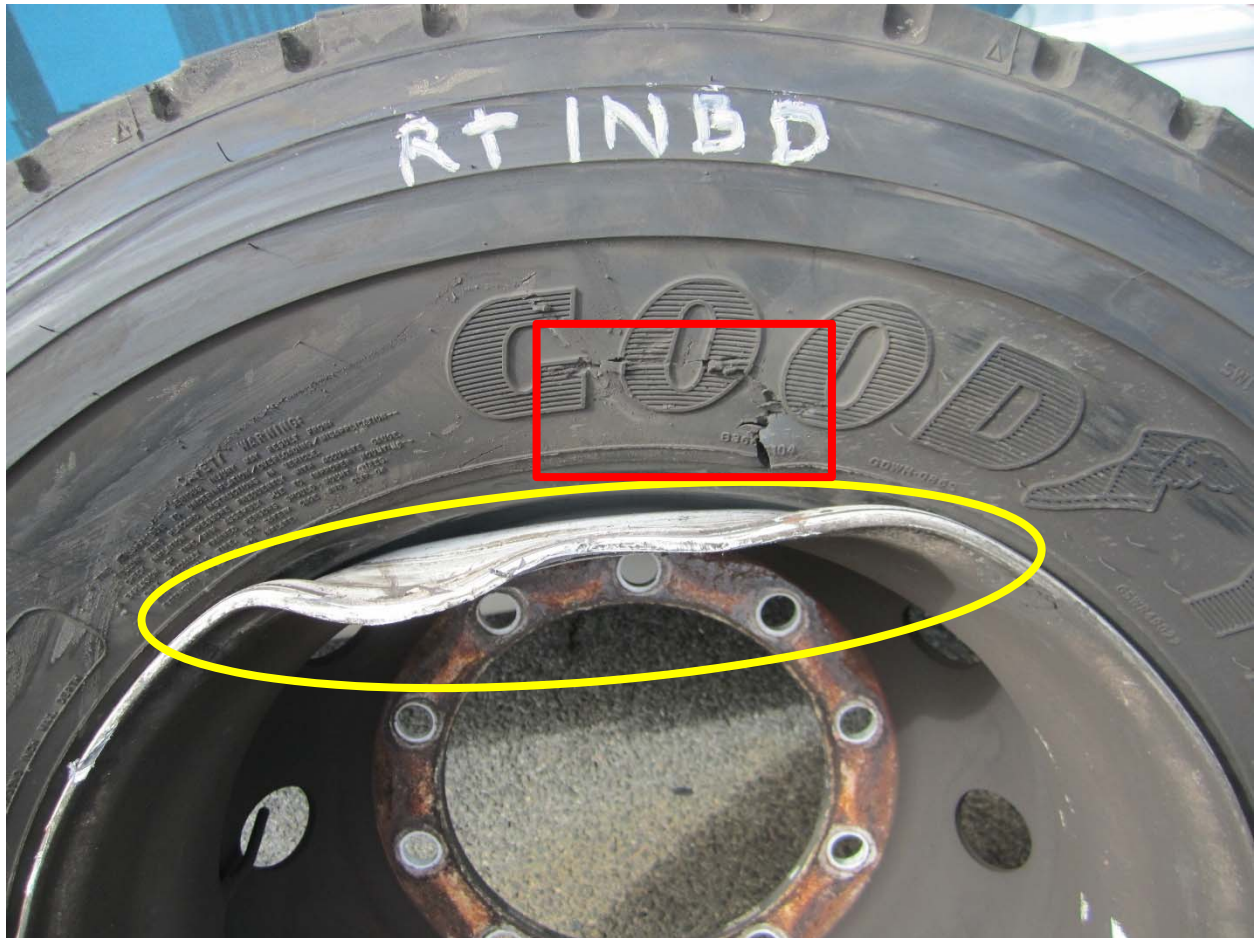
**Photograph 15:** This is a view of the tire and wheel that was mounted on the right-side of axle 2 – at the inside position. Axle 2 had dual tires and wheels mounted to each axle end. The yellow oval shows the radial collapse of the wheel. The red rectangle on the tire sidewall shows the location of the L-shaped puncture.
