NATIONAL TRANSPORTATION SAFETY BOARD
Office of Aviation Safety
Washington, D.C. 20594

Vehicle Recovery Group Factual Report

DCA-15-MA-019

Operator: Scaled Composites, LLC
Location: near Koehn Dry Lake, CA
Date: October 31, 2014
Time: 1007 Pacific Daylight Time
Vehicle: Scaled Composites SpaceShipTwo reusable suborbital rocket, N339SS

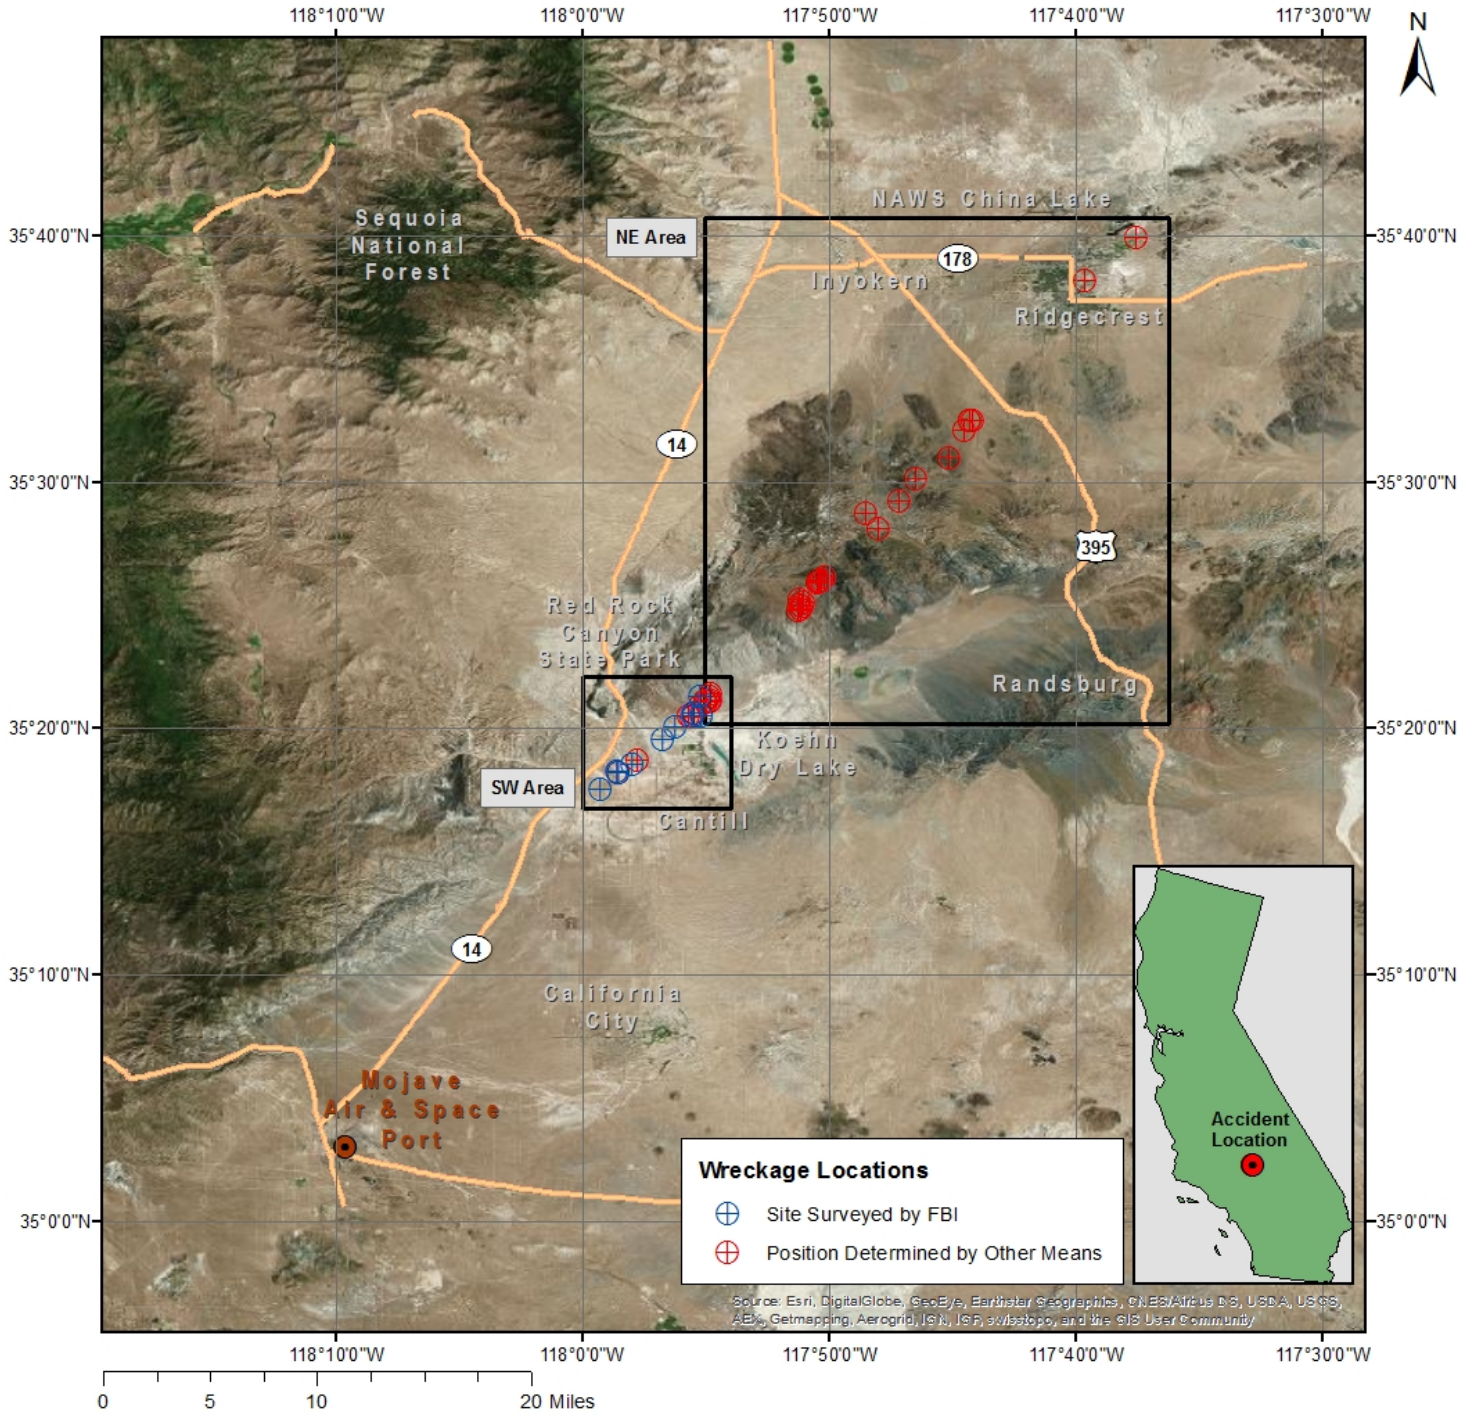
Figure 1
Overall map of the wreckage locations

The positions of all of the recovered wreckage (when the impact positions were available) are shown in figure 1. In addition to this figure, two additional wreckage maps were developed showing the points in the southwest (SW) area of the total wreckage distribution and the points in the northeast (NE) area of the total wreckage field. These maps are shown in figures 2 and 3. In these figures, the wreckage locations where FBI ERT survey data was used are shown in blue, while the remainder of the wreckage

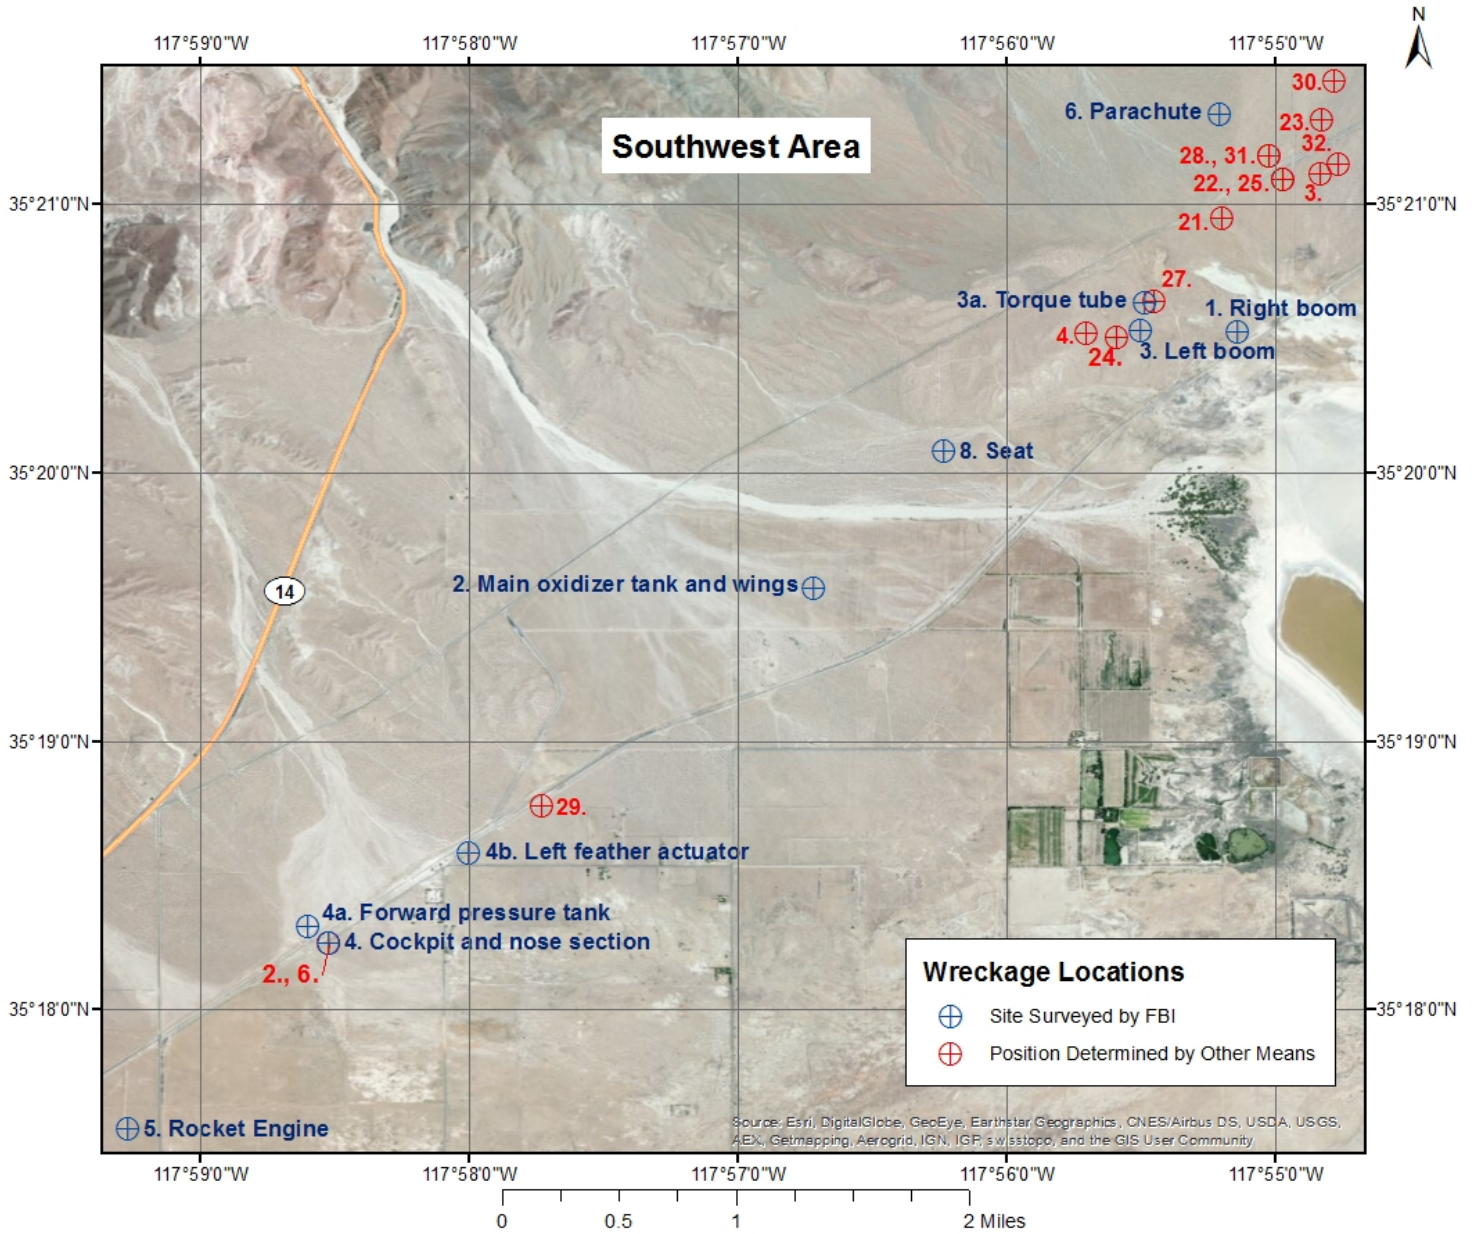
Figure 2
Wreckage locations from the southwest portion of the wreckage field

locations are shown in red (the numbers adjacent to the red symbols in figures 2 and 3 correspond to an item number in Appendix A).

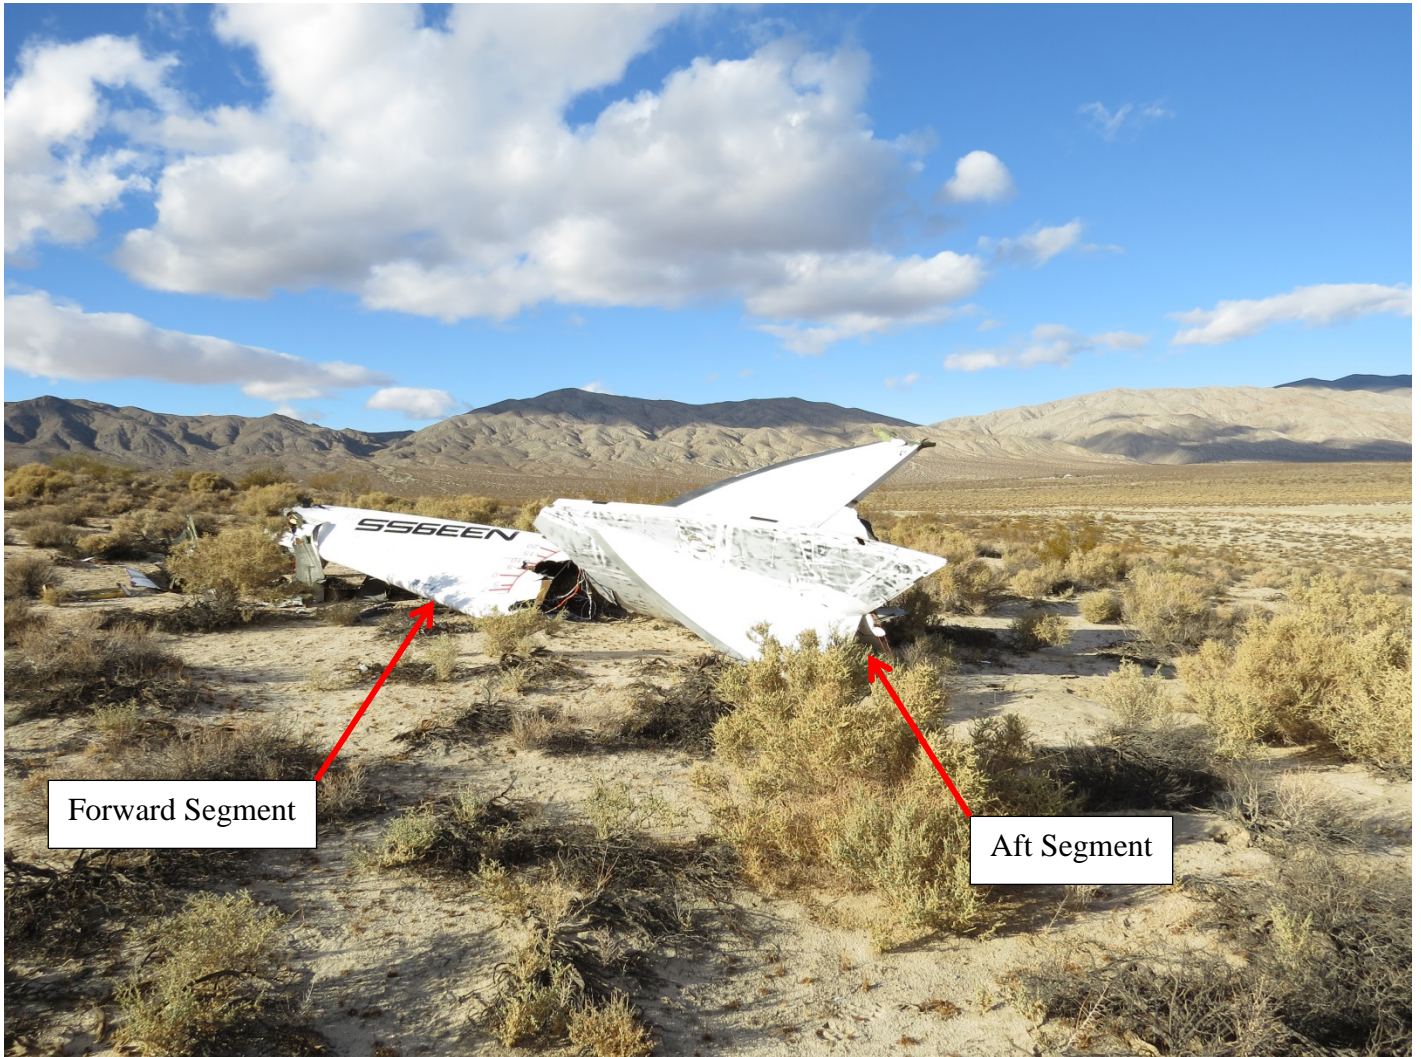
Figure 4
Right boom – Overall view

The main portion of the right boom was found fractured into two pieces at the horizontal stabilizer actuator attach rib and lying on its inboard side (see figure 4).

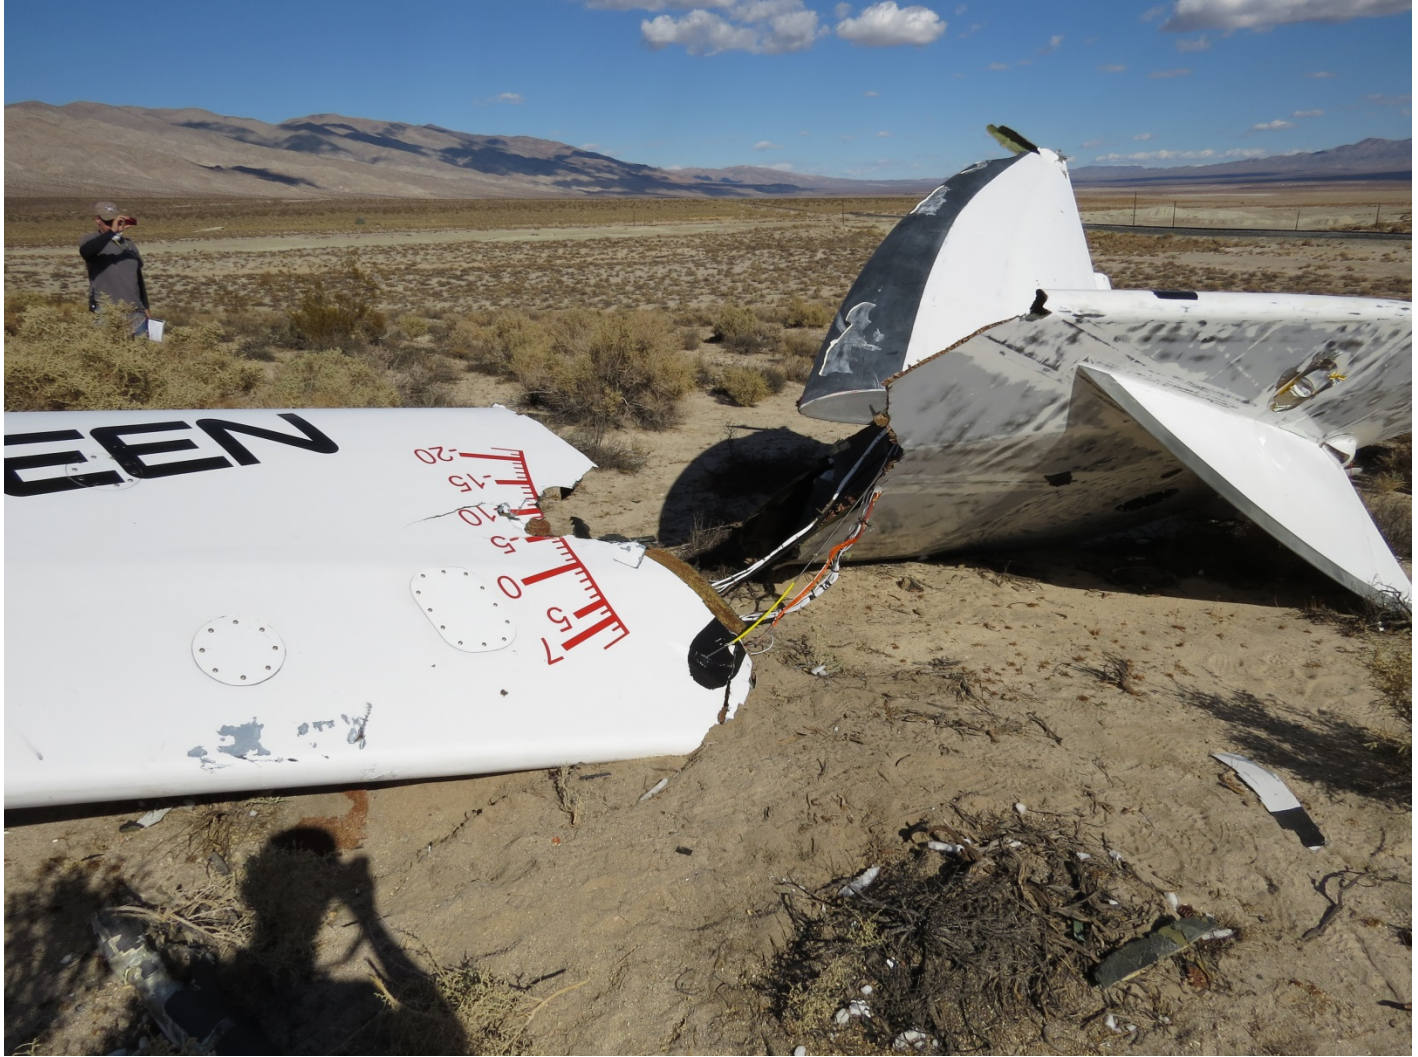
Figure 7

A witness mark was observed on the horizontal stabilizer position scale consistent with a horizontal stabilizer position between -6 and -9 deg (see figure 7).

Right boom – view showing split between forward and aft segment

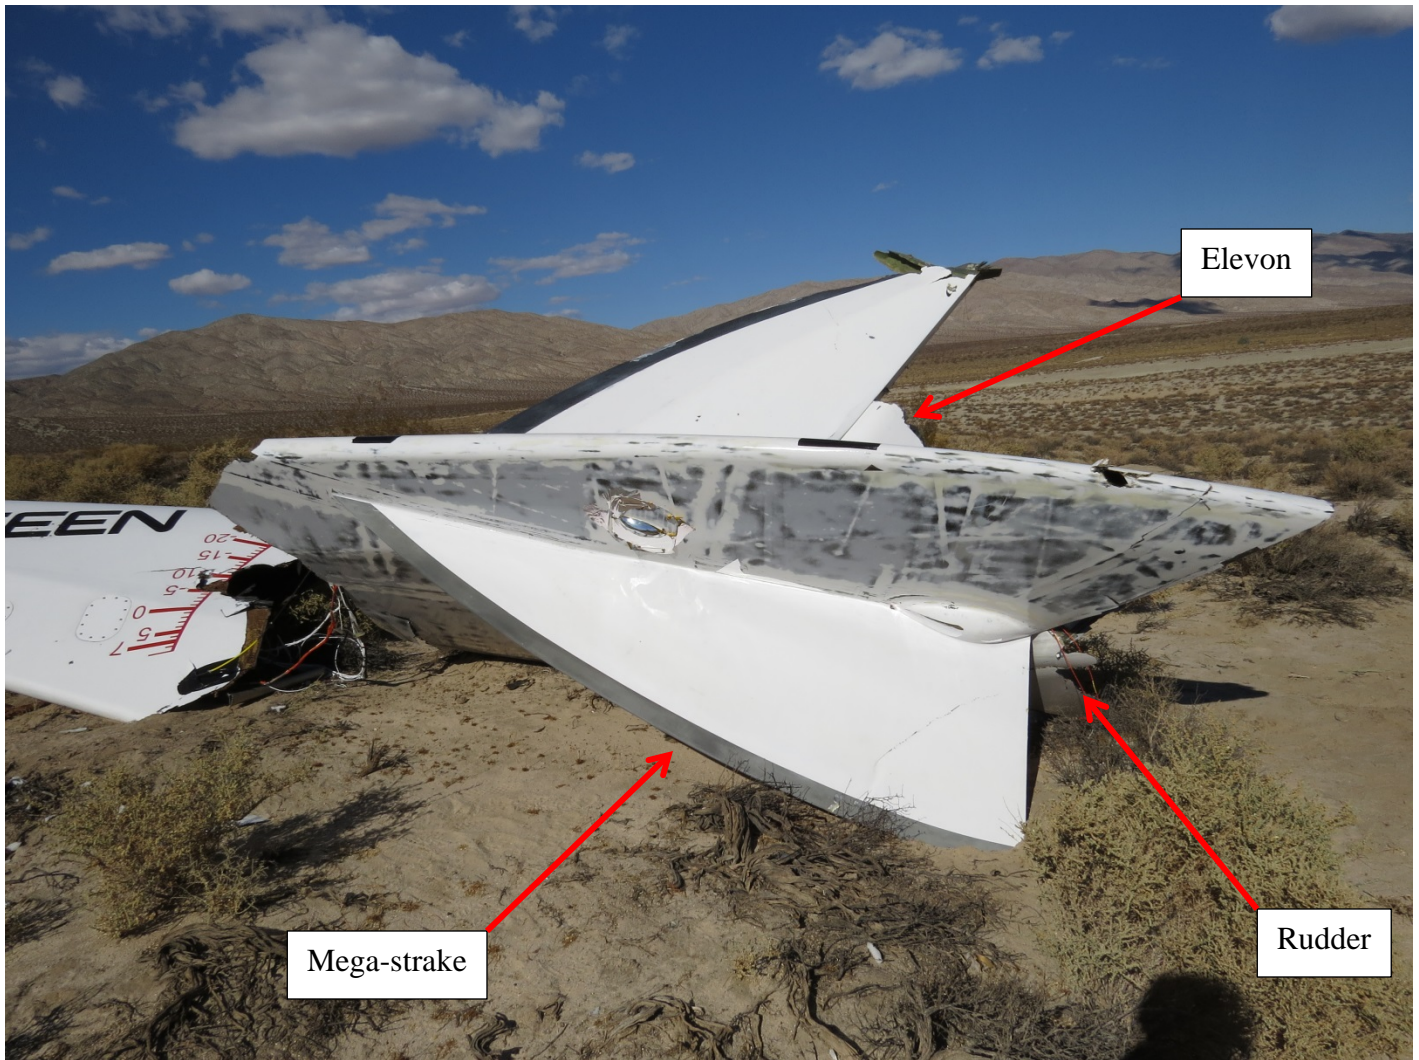
Figure 8

The Kapton reflective tape was missing from the inboard surface of the boom. That surface was noted to have a sticky residue remaining (see figure 8).

Right boom – aft segment showing mega-strake and remaining elevon and rudder surface sections

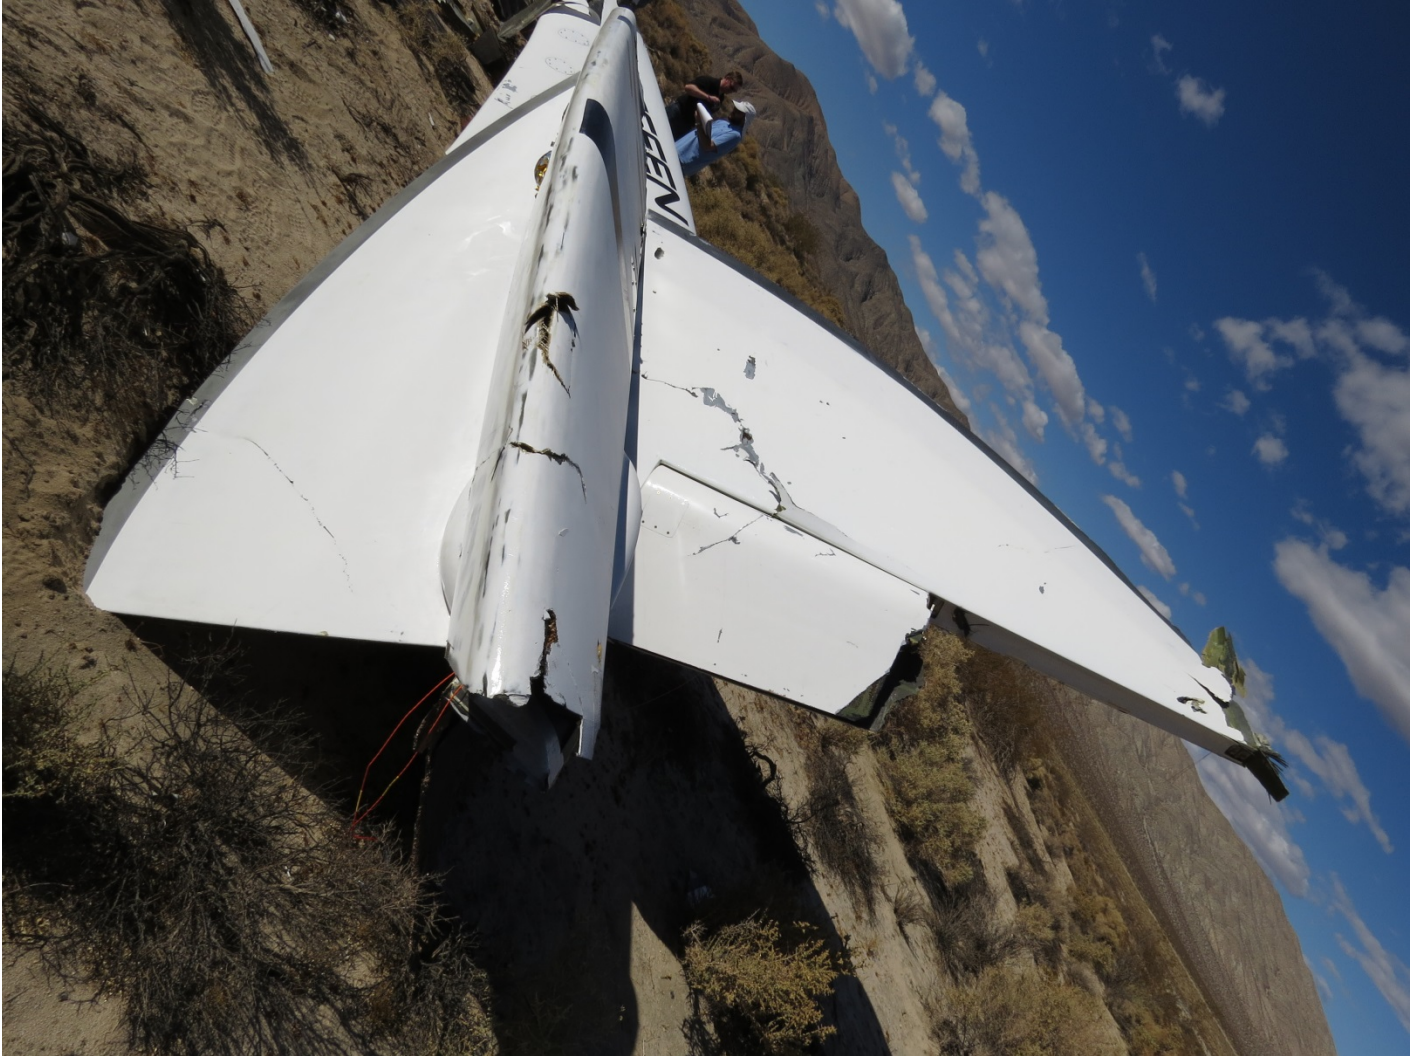
Figure 9

The inboard portion of the elevon was present on the boom (see figure 9). The length of the trailing edge of this piece of elevon control surface was measured to be 36 inches. The length of the leading edge of the same piece was measured to be 38 ¼ inches.

Right boom – aft end showing elevon section remaining

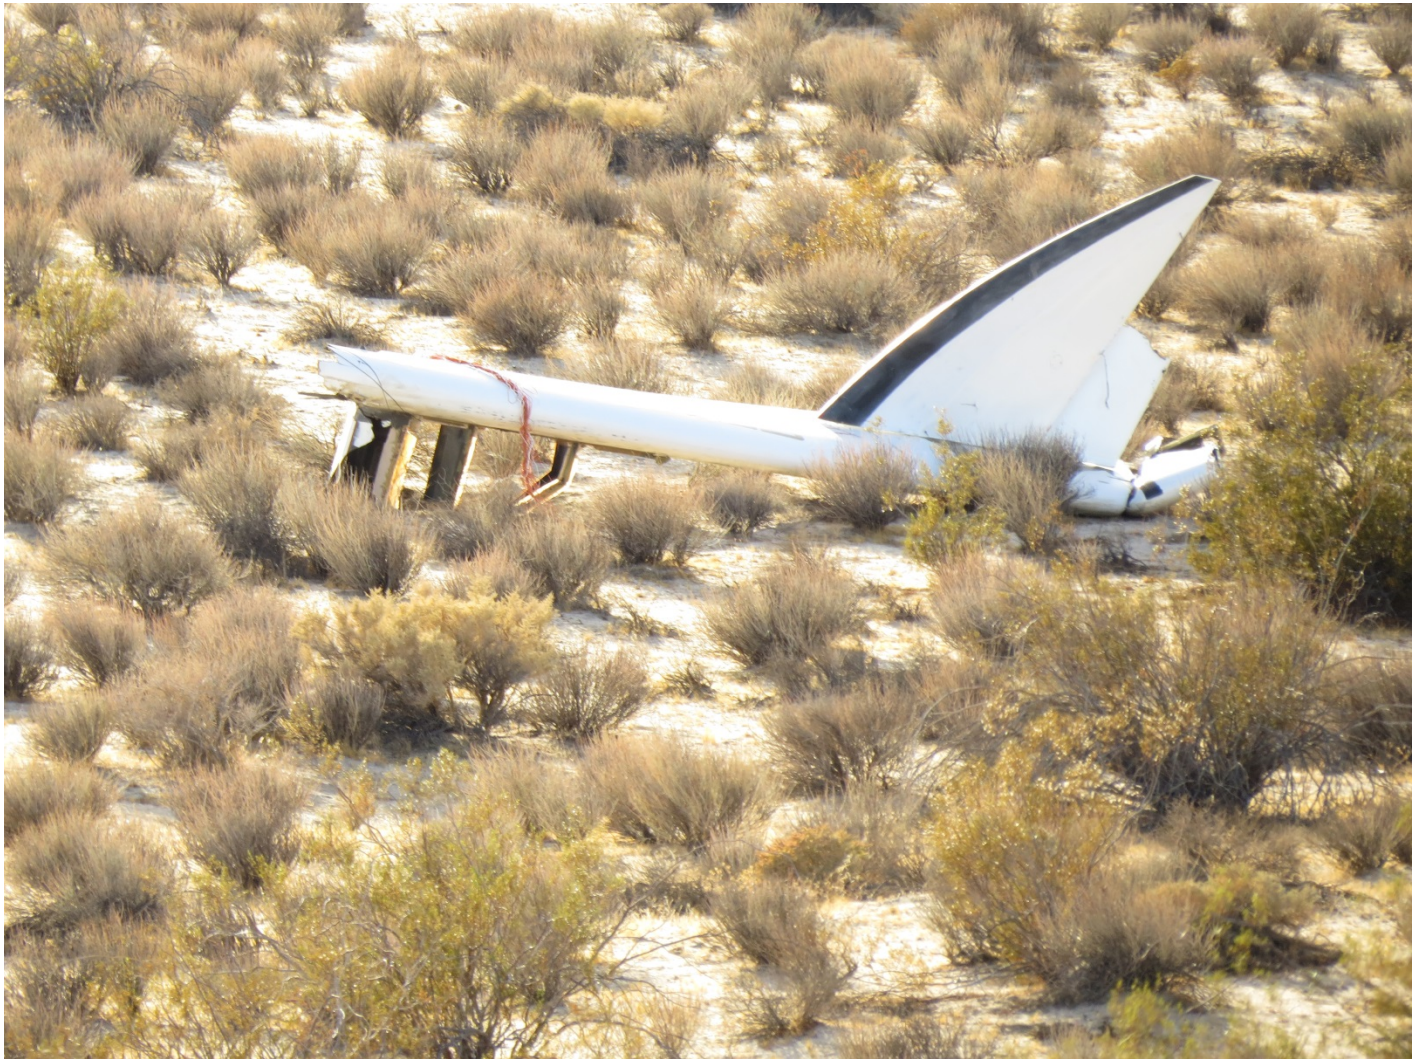
Figure 10
Left boom – overall view

The main portion of the left boom was found in one piece and laying on its inboard side resting in front on the forward torque tube which was broken at an approximate 45 deg angle (see figure 10).

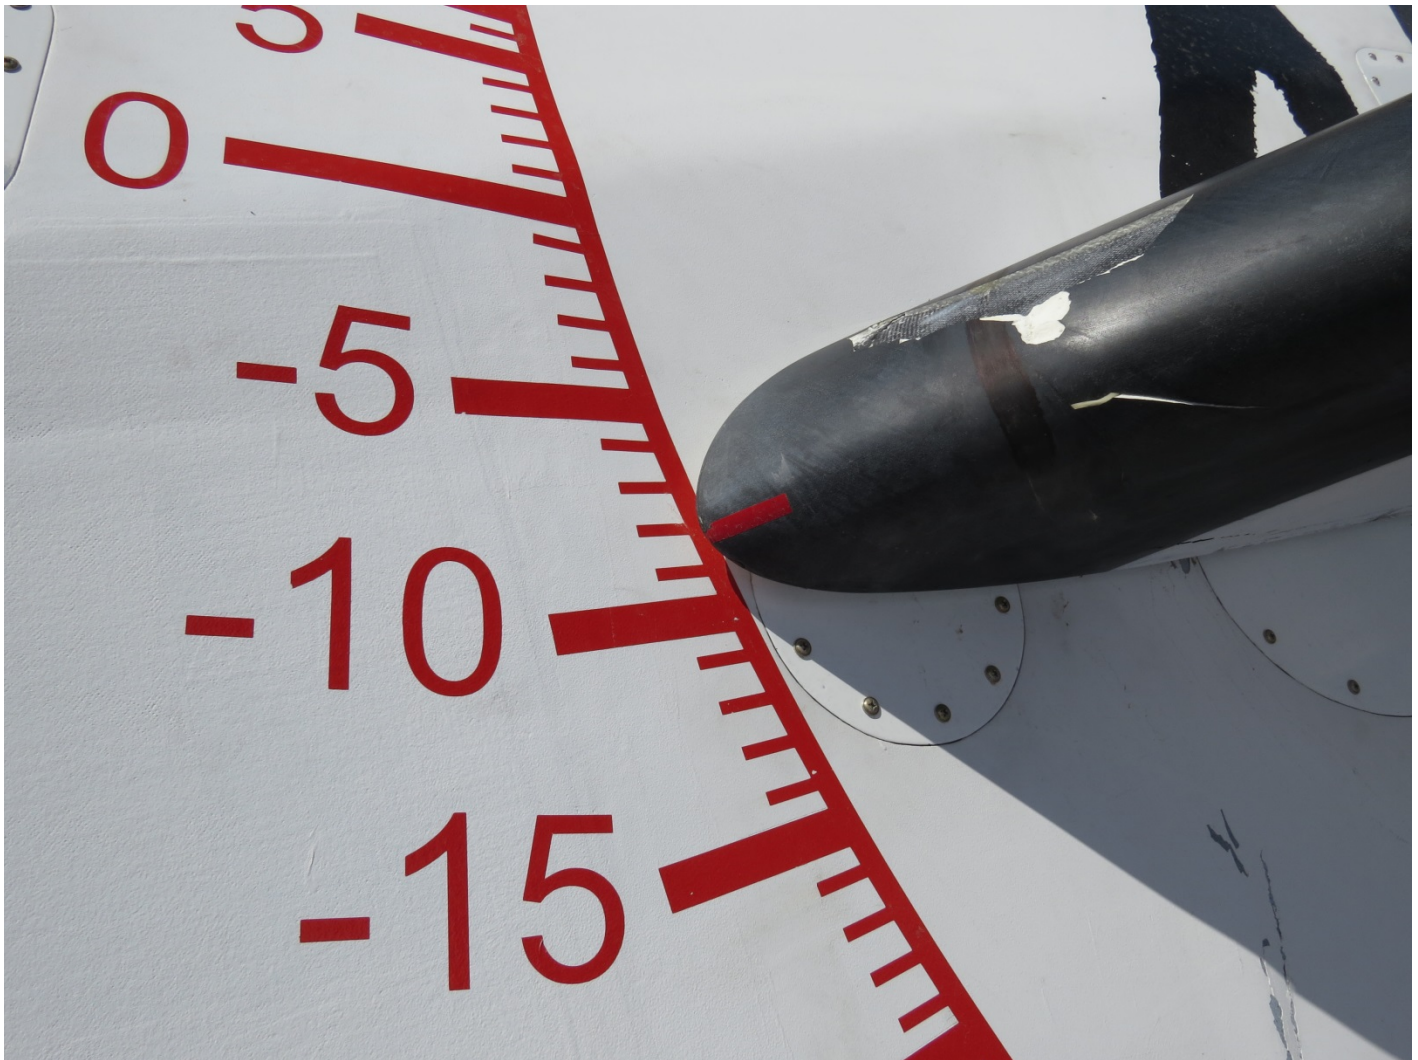
Figure 13
Left boom – horizontal stabilizer reading of -8.5 deg

The indicator mark on the horizontal stabilizer was aligned with markings on the horizontal stabilizer position scale consistent with a horizontal stabilizer position of -8 ½ deg (see figure 13).

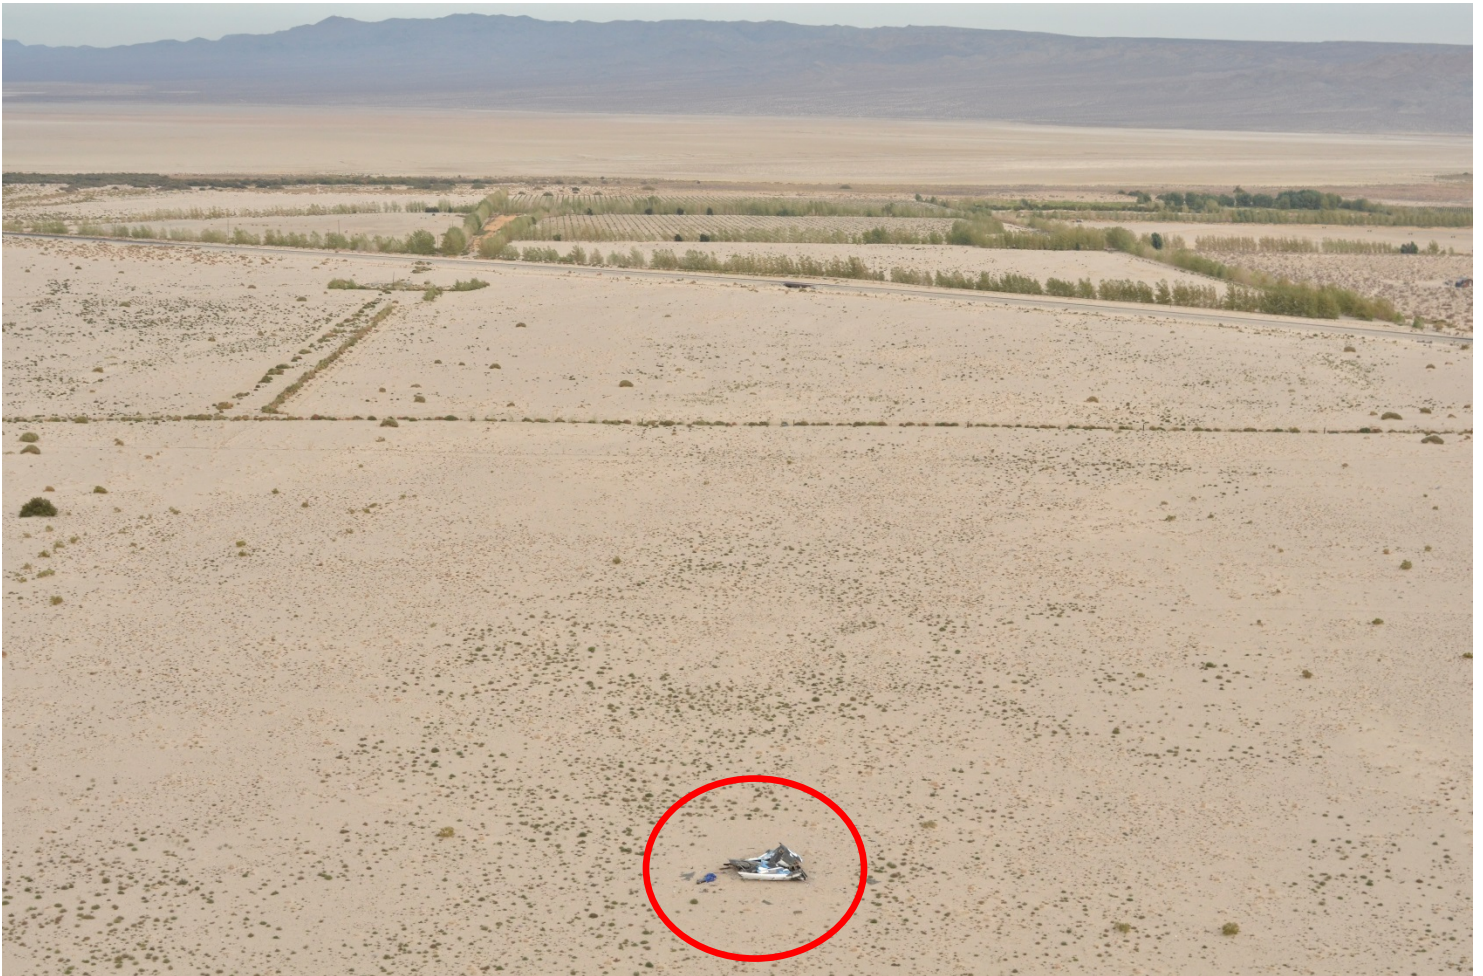
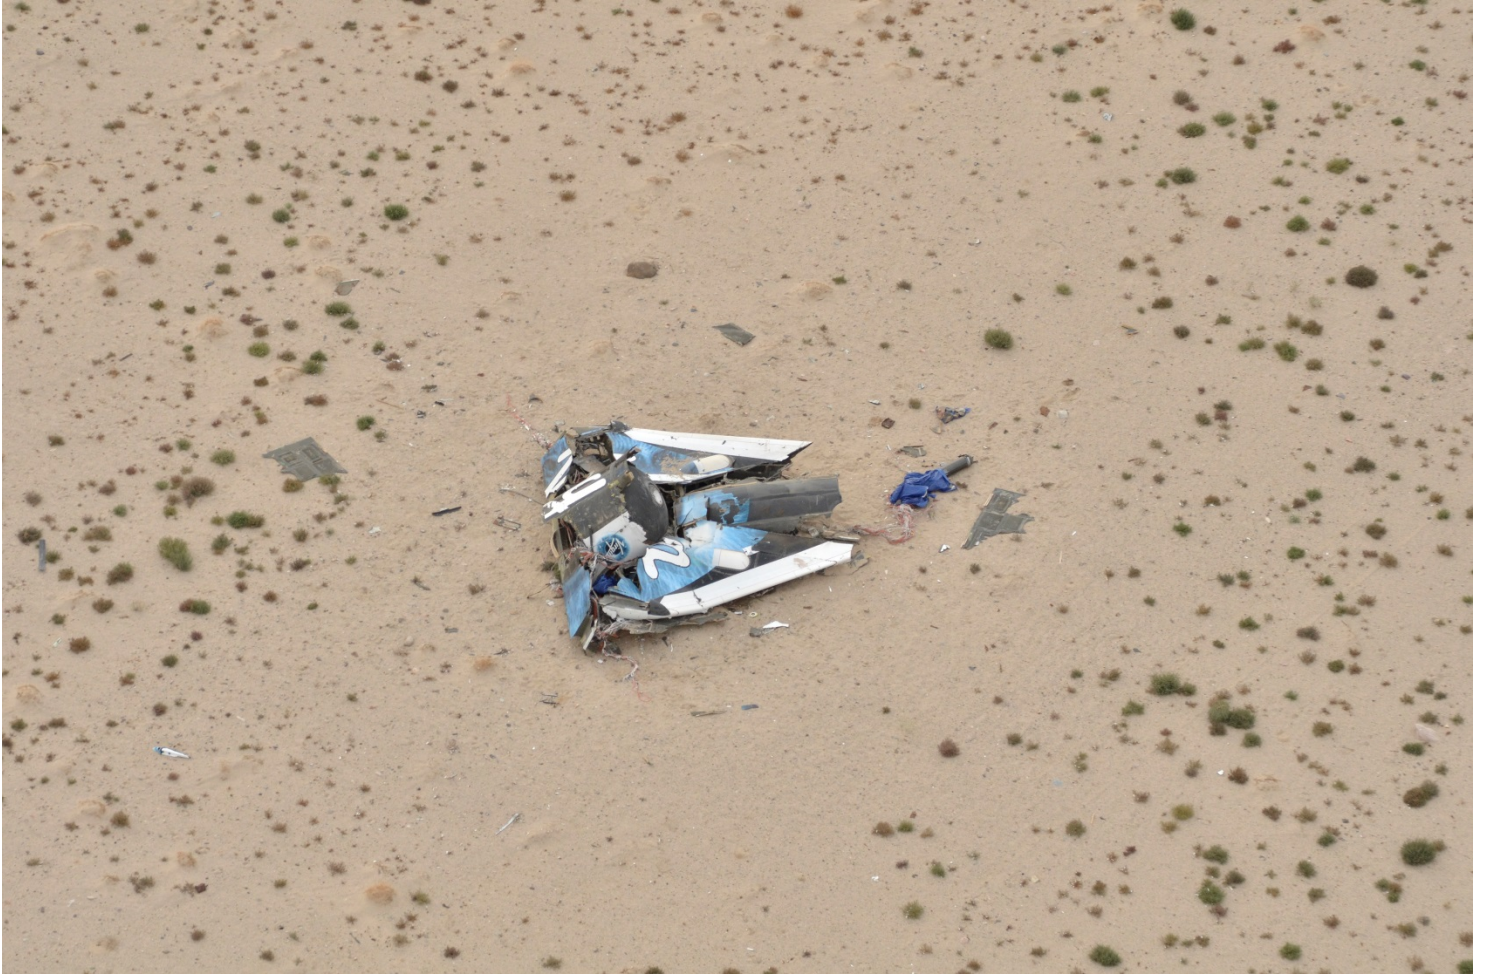
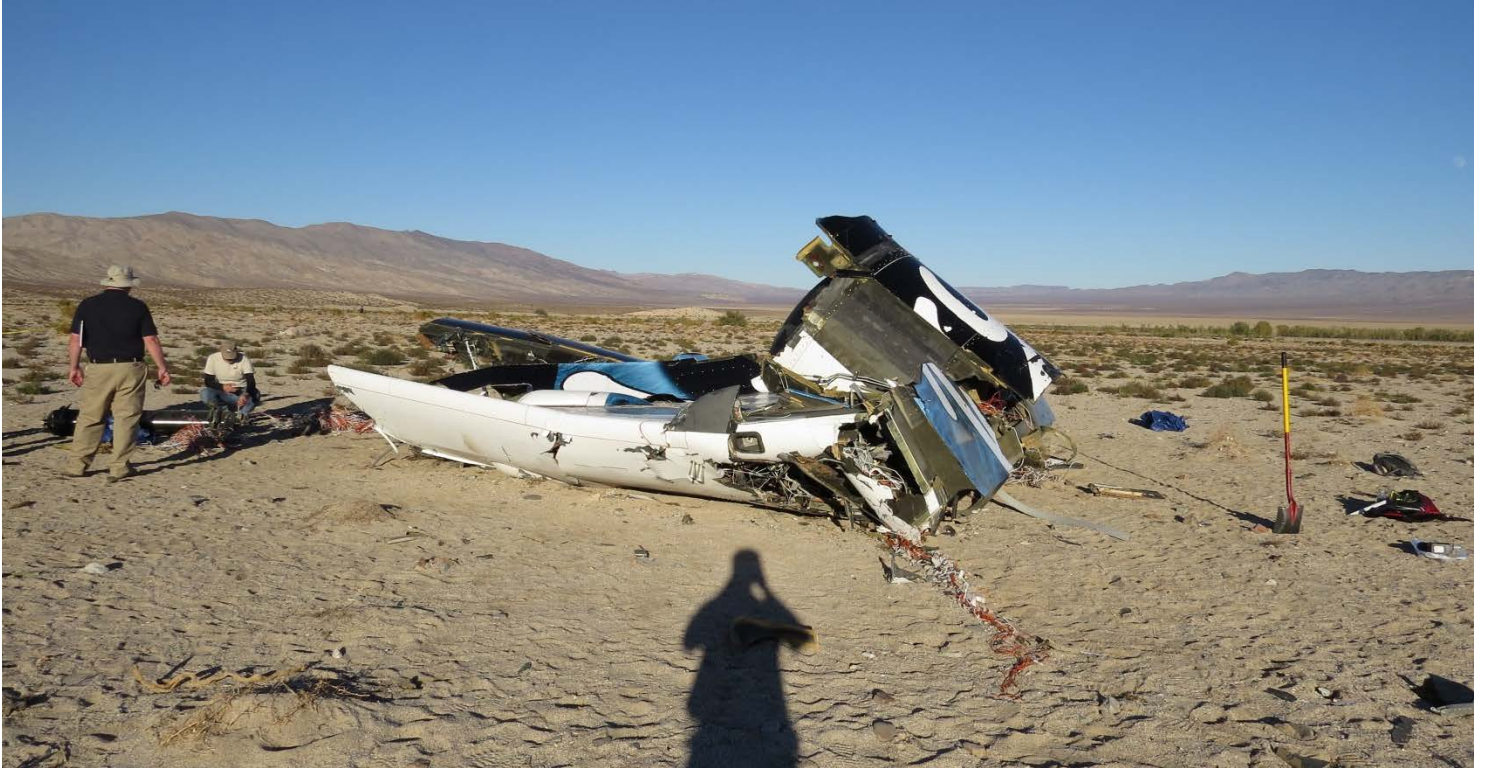
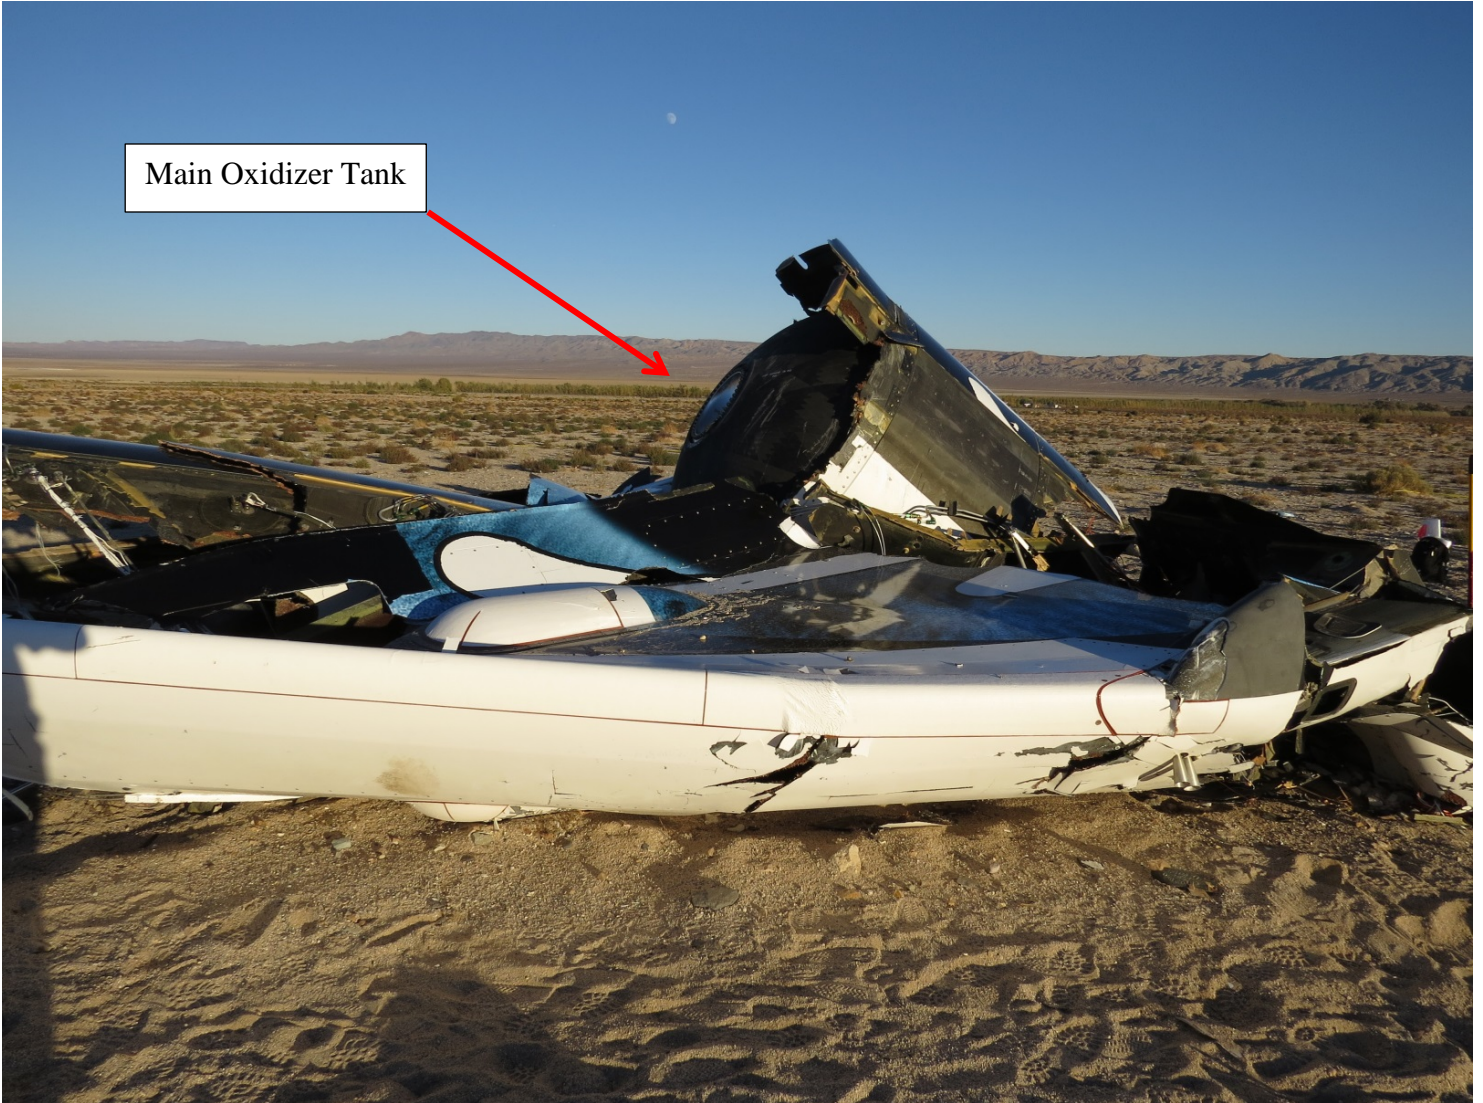
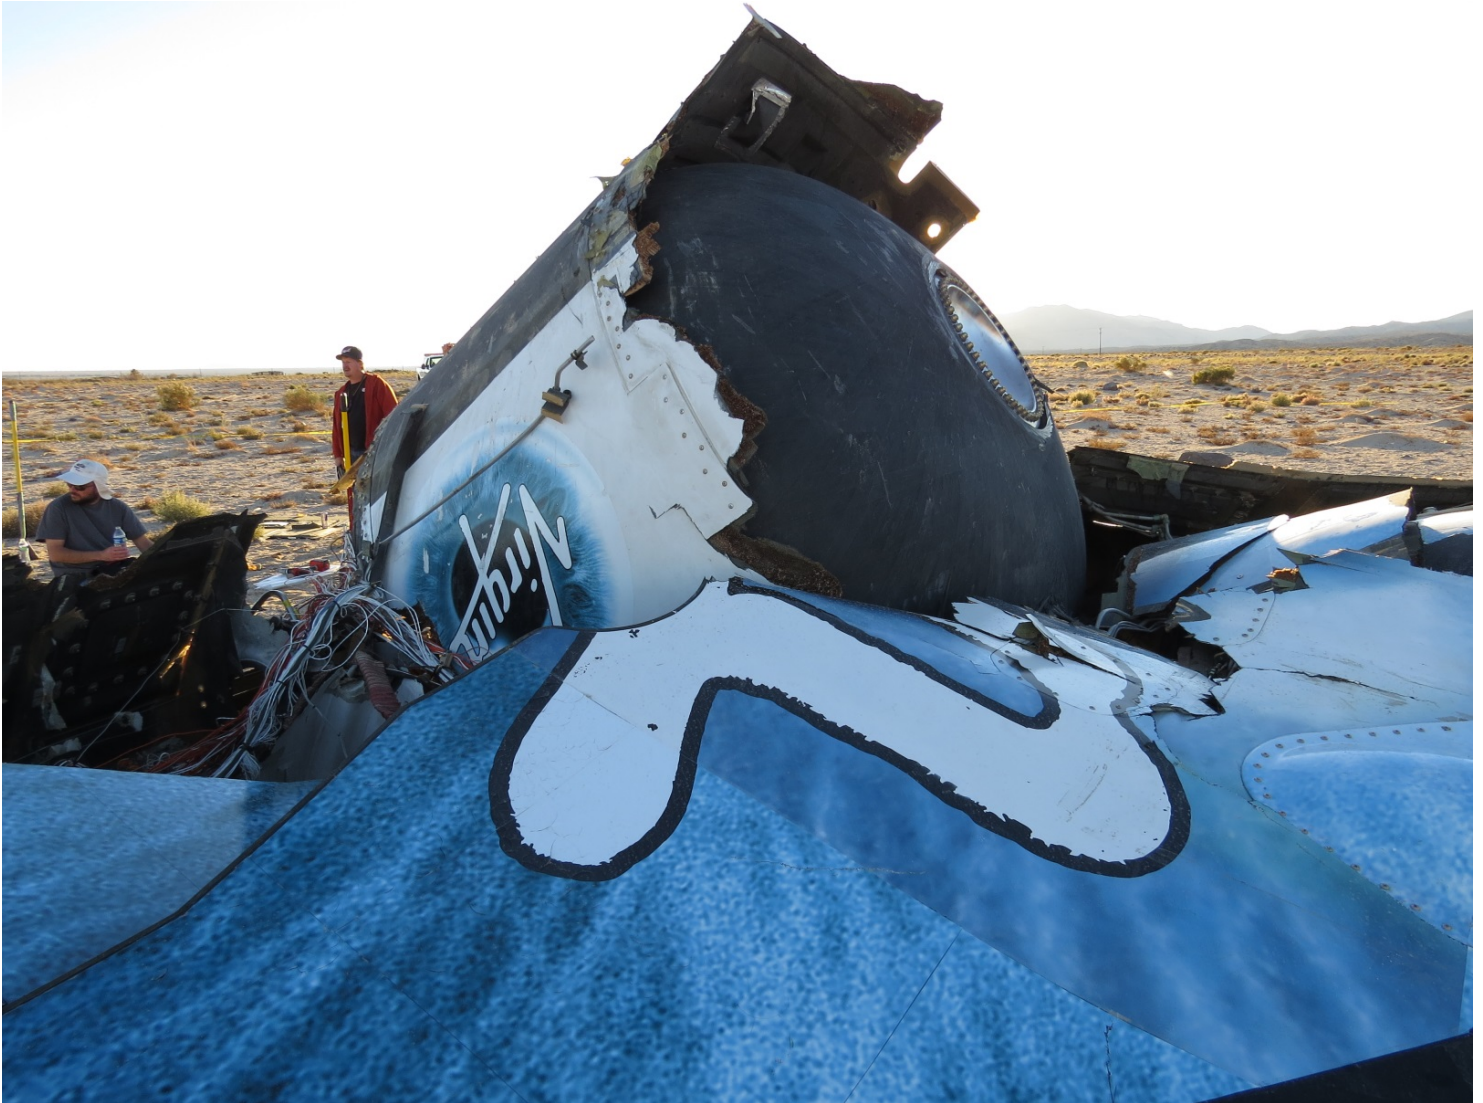
The main fuselage section was found resting inverted with the main oxidizer tank (MOT) displaced from its normal position. The main oxidizer valve was displaced but still attached to the MOT. The MOT was ruptured on the mid-forward face of the tank, and the portion of the MOT that was resting on the ground displayed damage consistent with crush damage (see figures 15-19).

Figure 15
Main fuselage – aerial view

Figure 16
Main fuselage – aerial view – close up

Figure 17
Main fuselage – overall view

Figure 18
Main fuselage – view of right side

Figure 19
Main fuselage – view of left side
