NATIONAL TRANSPORTATION SAFETY BOARD
Office of Aviation Safety
Washington, D.C. 20594

Vehicle Recovery Group Factual Report

DCA-15-MA-019

Operator: Scaled Composites, LLC
Location: near Koehn Dry Lake, CA
Date: October 31, 2014
Time: 1007 Pacific Daylight Time
Vehicle: Scaled Composites SpaceShipTwo reusable suborbital rocket, N339SS

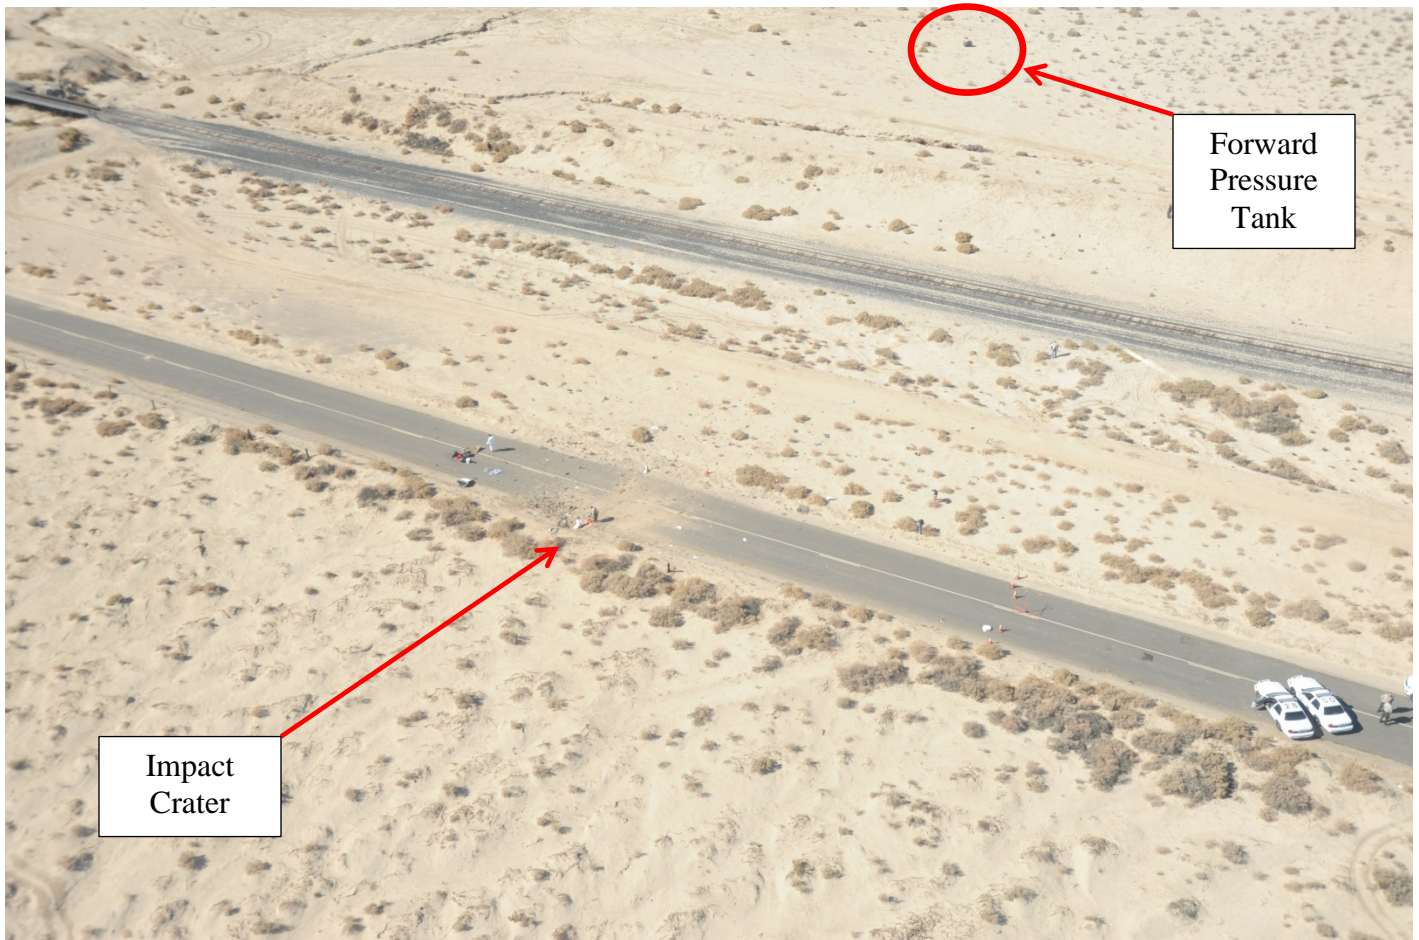
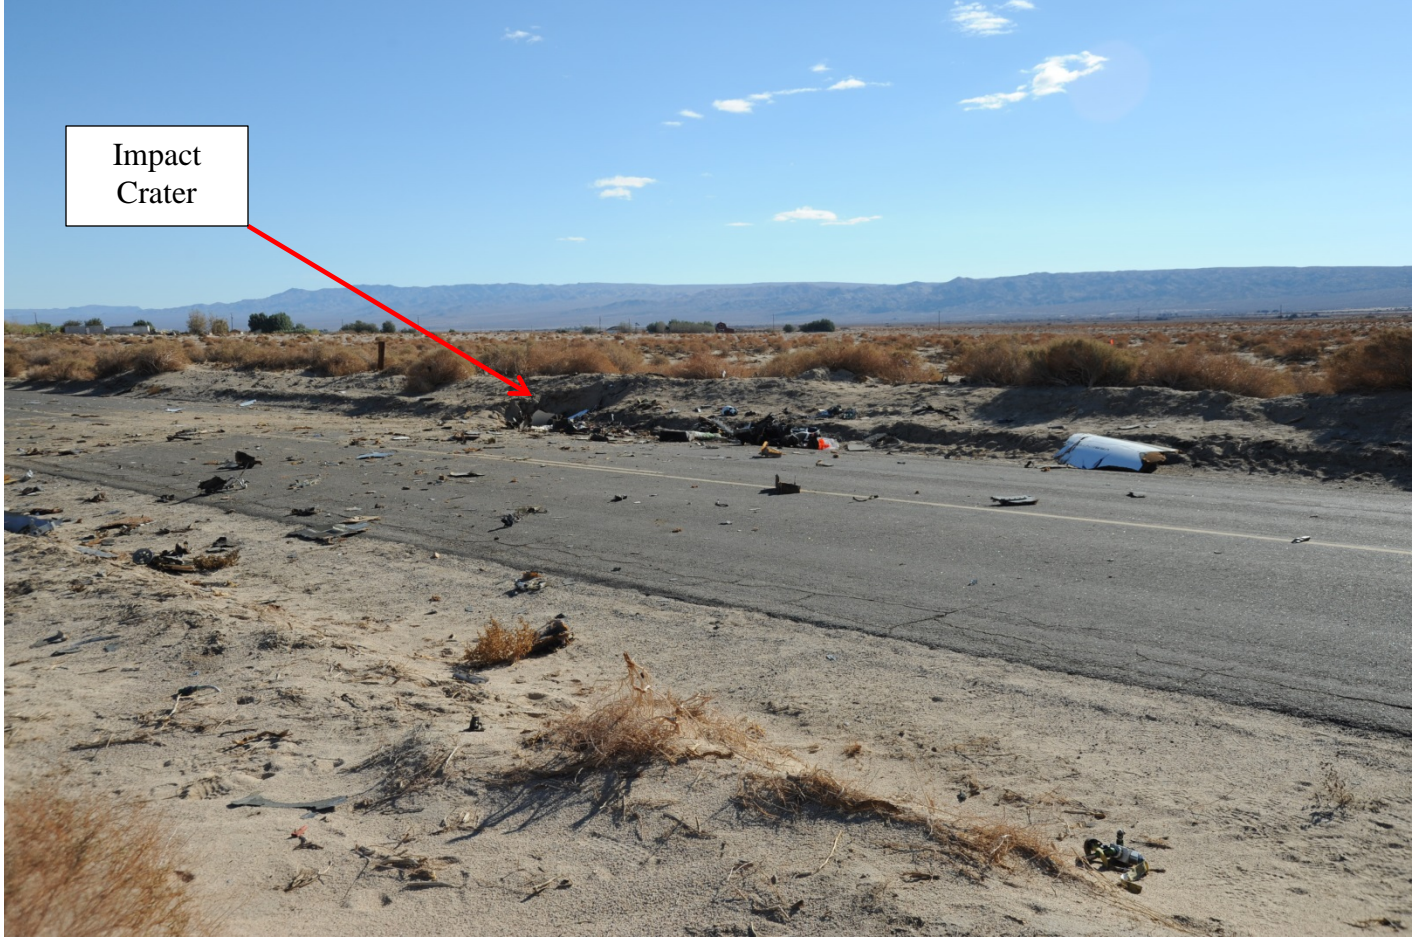
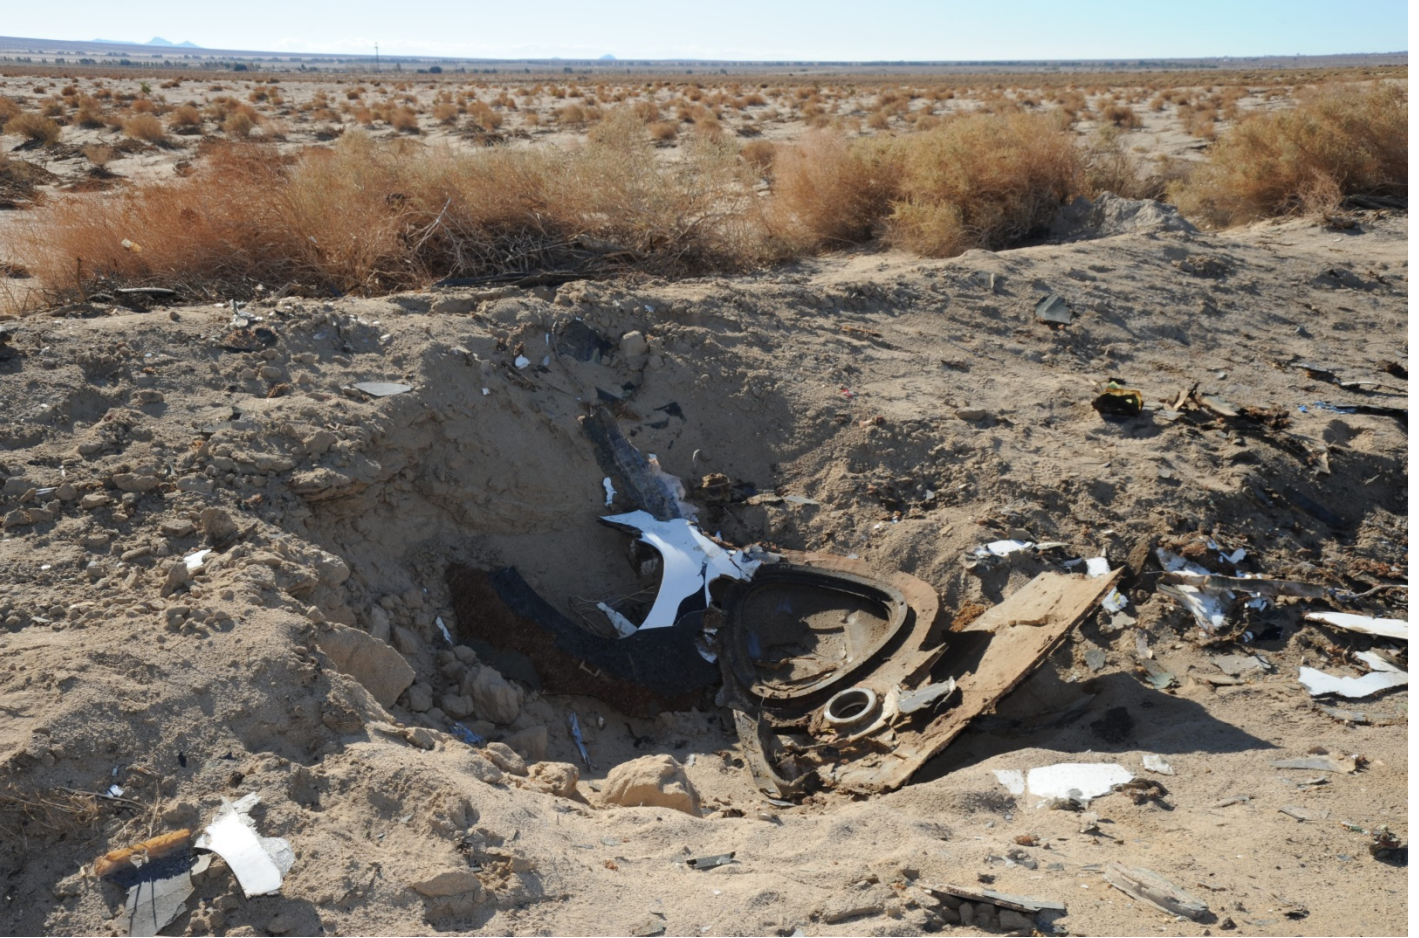
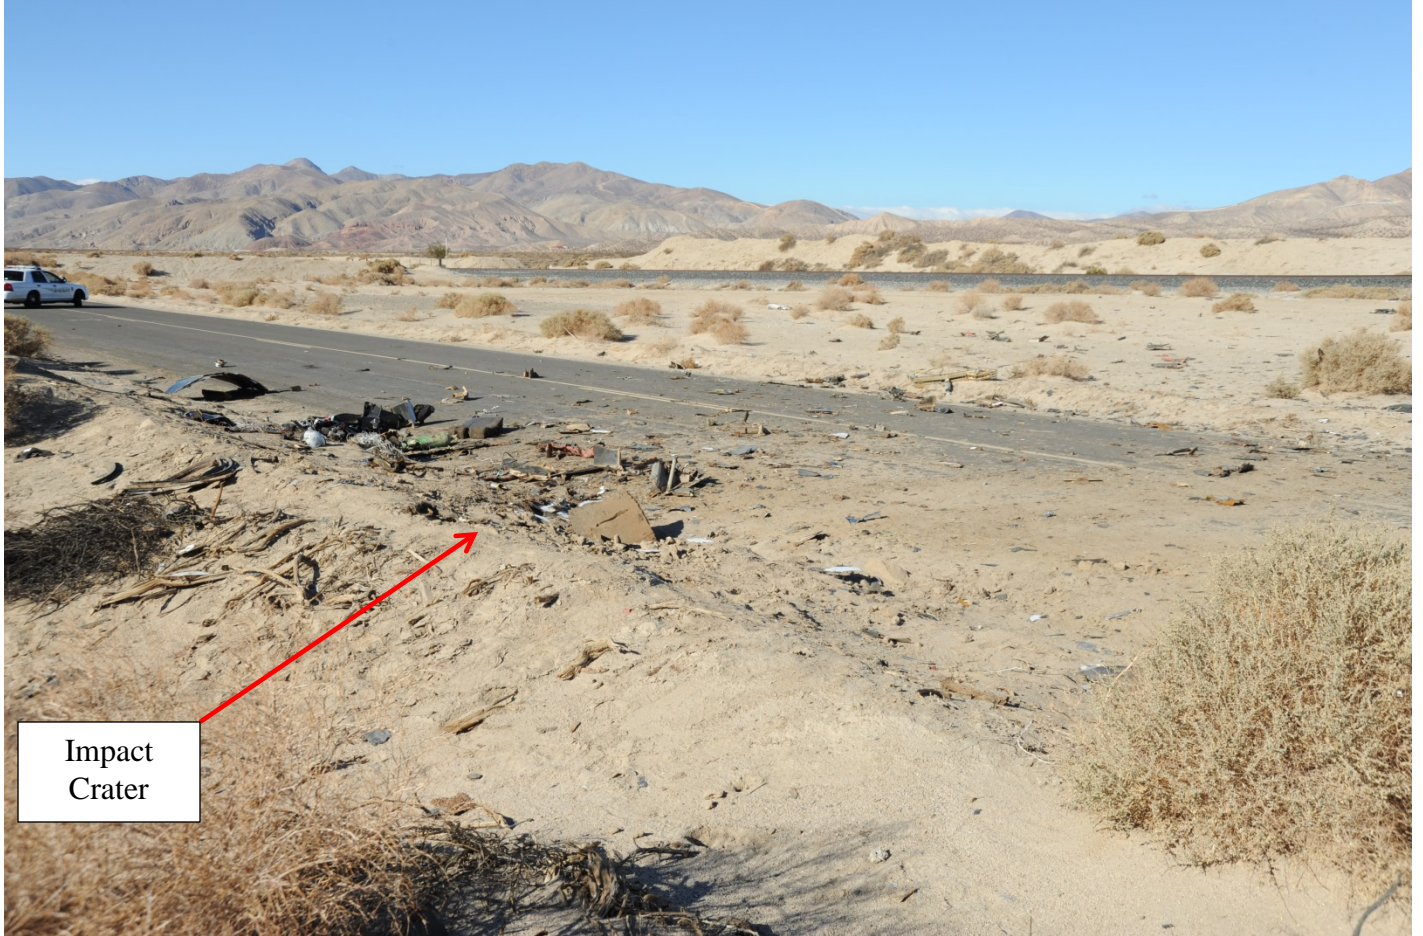
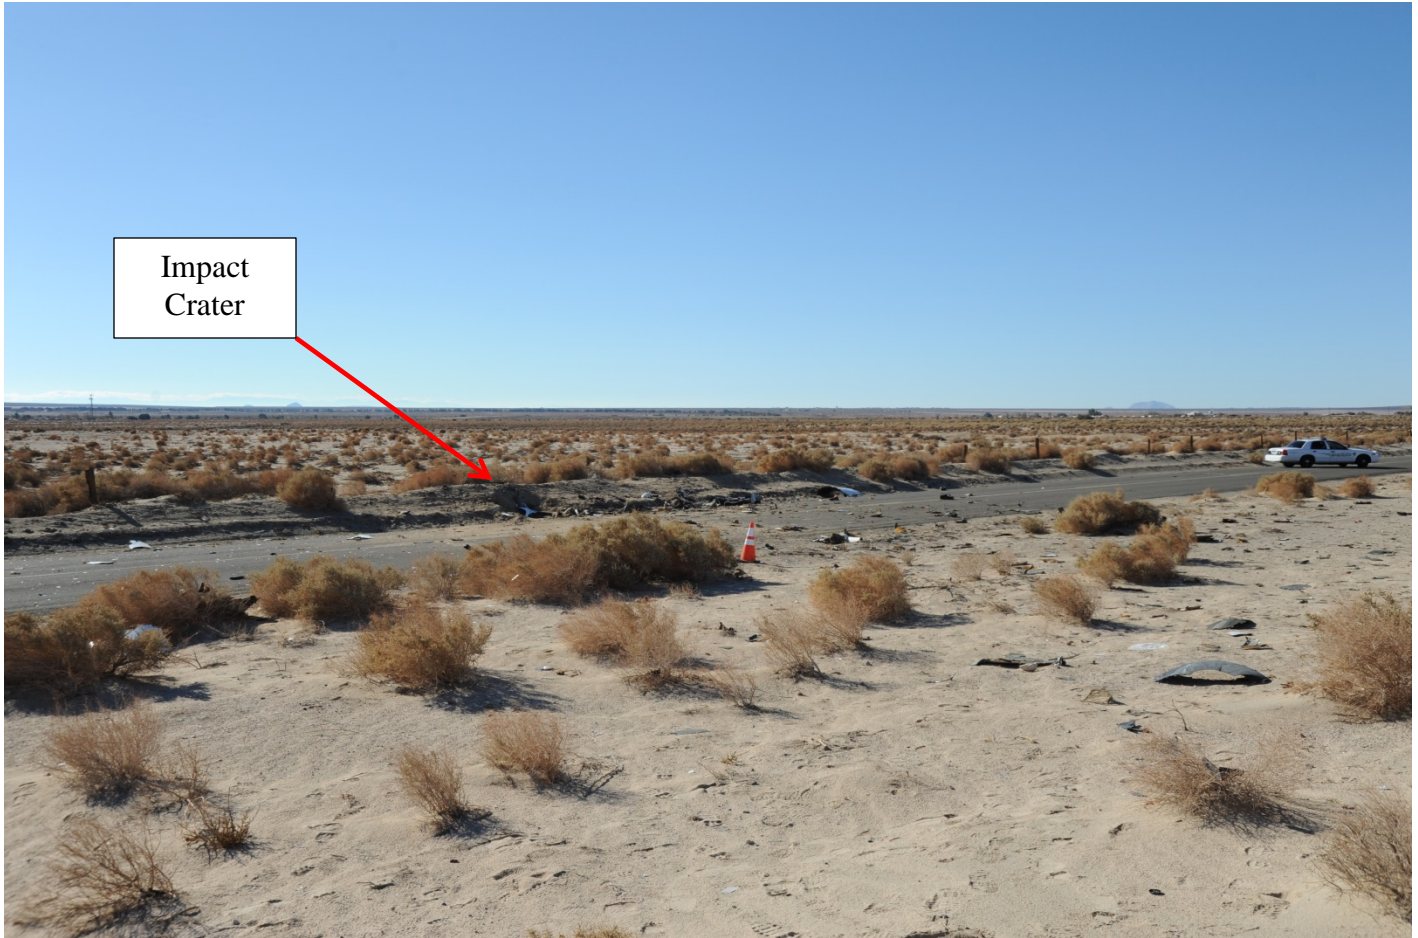
The forward pressure tank was found approximately 530 feet away from the impact crater (see figures 20-24).

Figure 20
Cockpit section – aerial view of impact crater and forward pressure tank

Figure 21
Cockpit section – impact crater and debris

Figure 22
Cockpit section – impact crater - close up

Figure 23
Cockpit section – impact crater and debris field

Figure 24
Cockpit section – impact crater and debris field

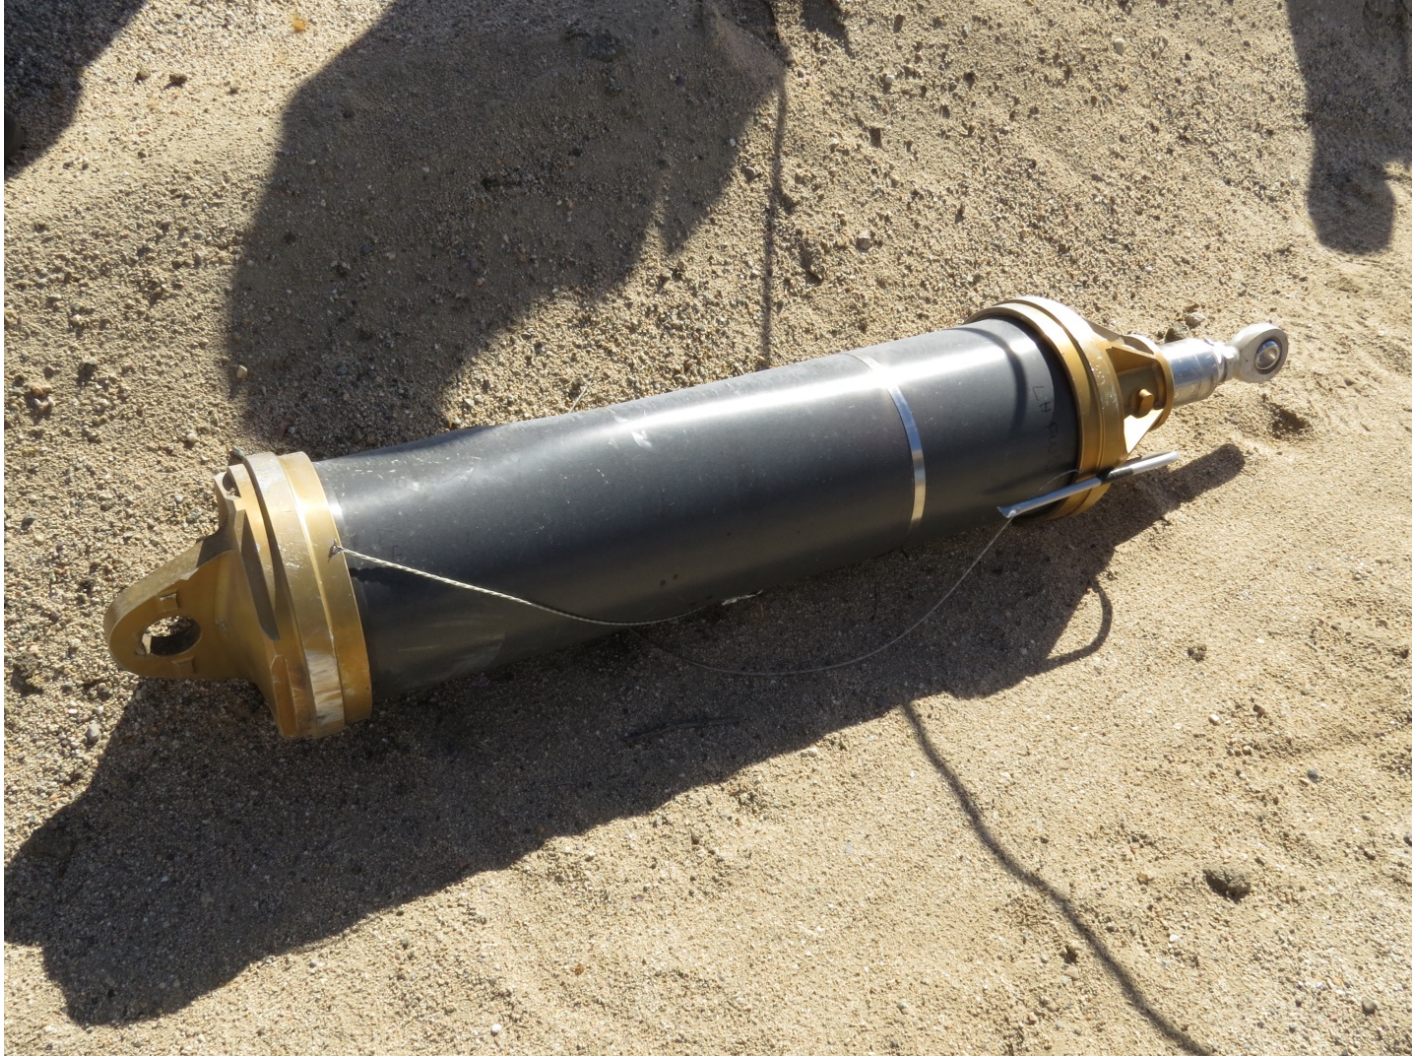
Figure 26
Left feather actuator

The left feather actuator was found approximately 0.6 miles from the impact crater in site 4 (see figure 26). No deformation was noted on either attachment end of the actuator. The forward rod end was intact, but the attachment pin was missing. The aft spherical bearing was missing. There was a crack in the outer wall of the actuator at a location consistent with the position of the piston head. The length of exposed chrome was measured to be $3 \frac{7}{8}$ inches.

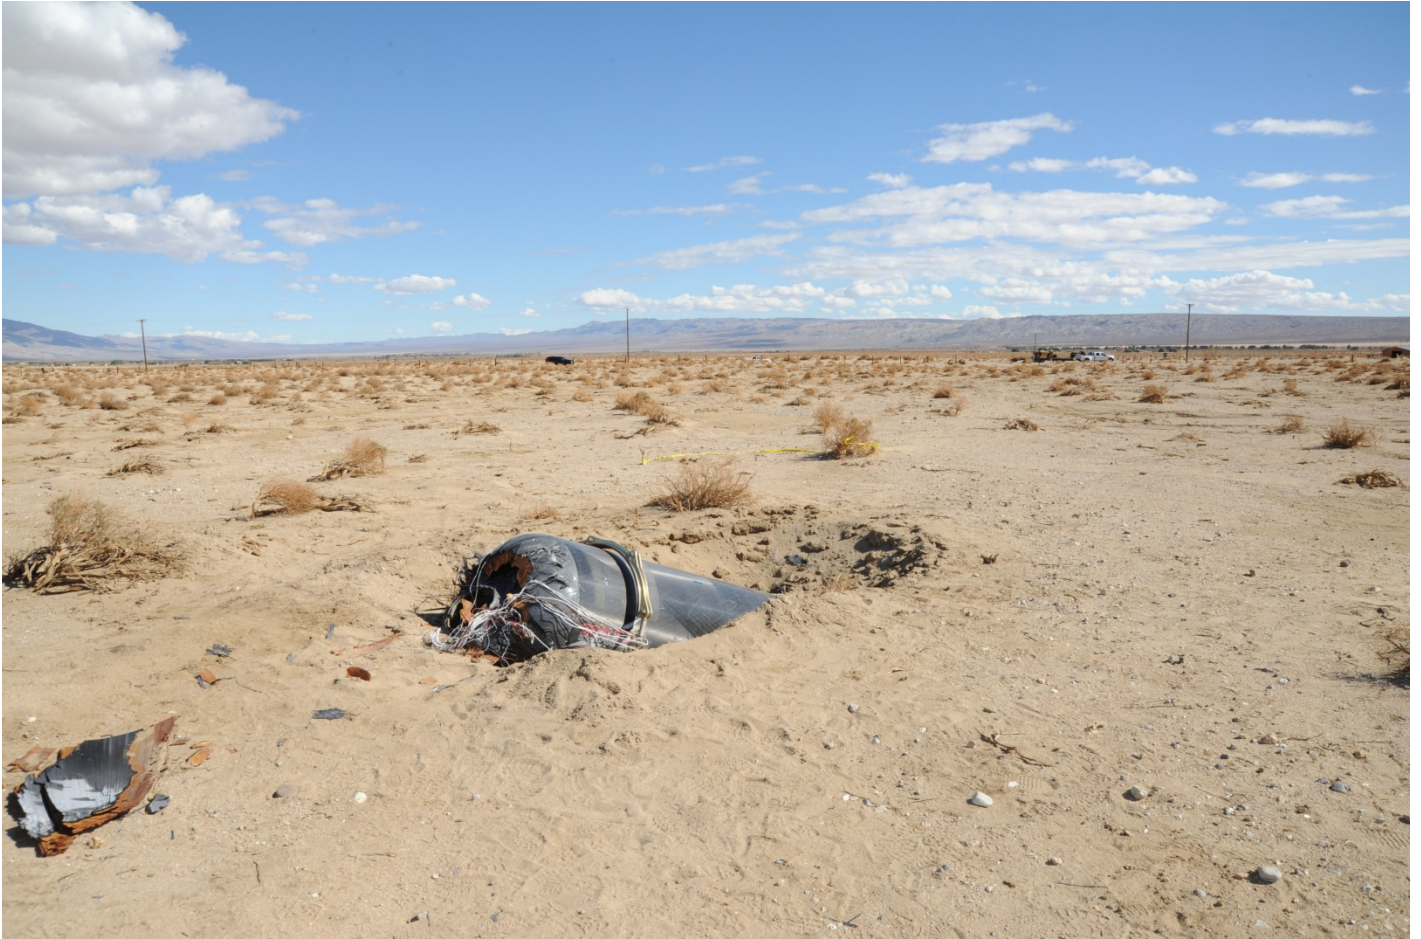
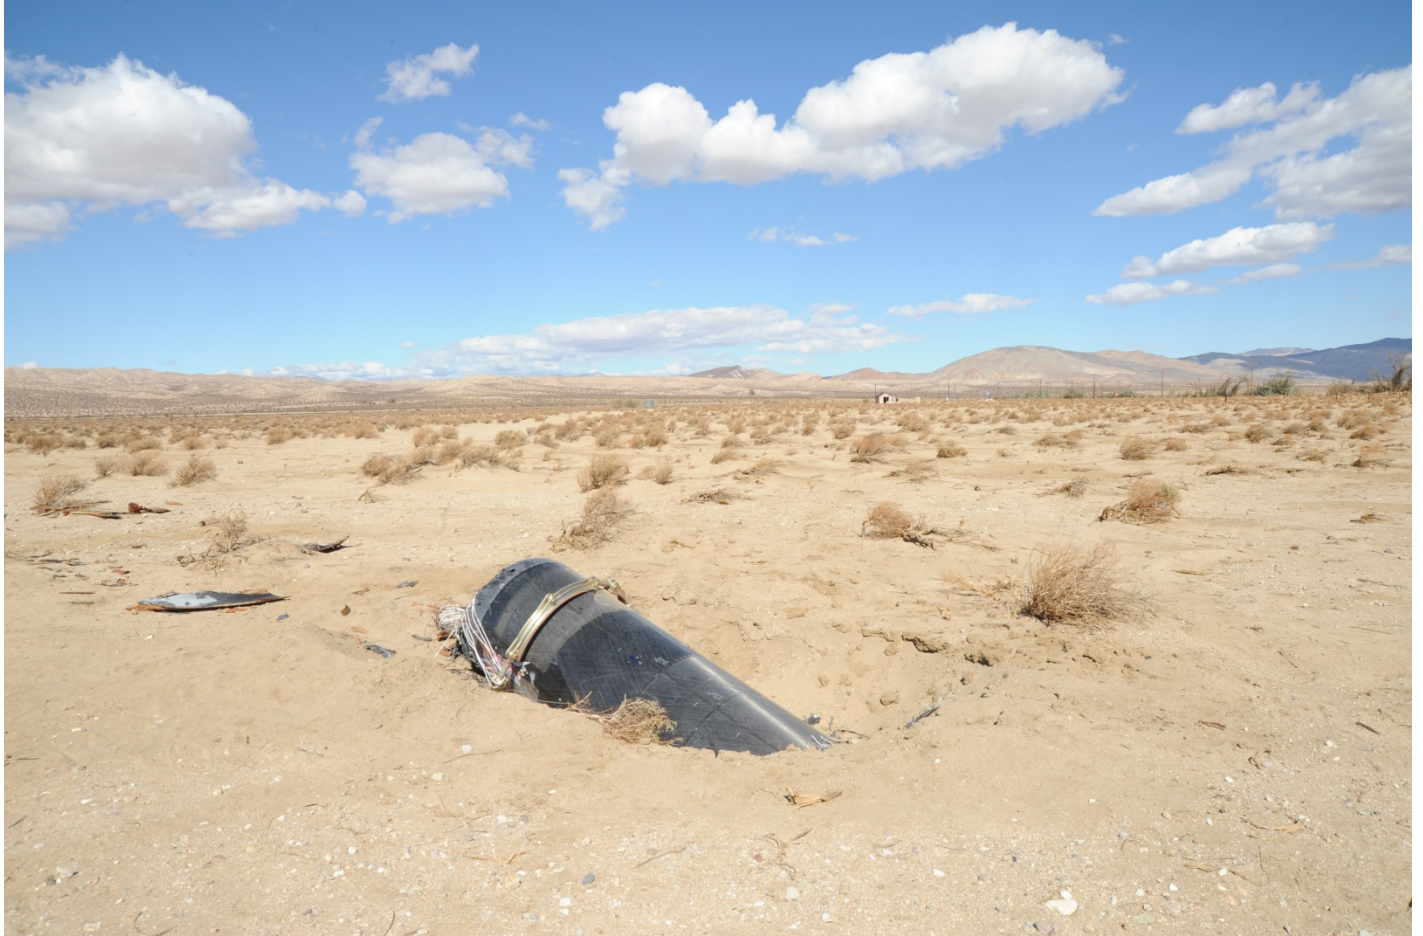
1.1.6 Site 5 – Rocket motor (see figures 27 and 28)

Figure 27
Rocket motor – overall view

Figure 28
Rocket motor – overall view

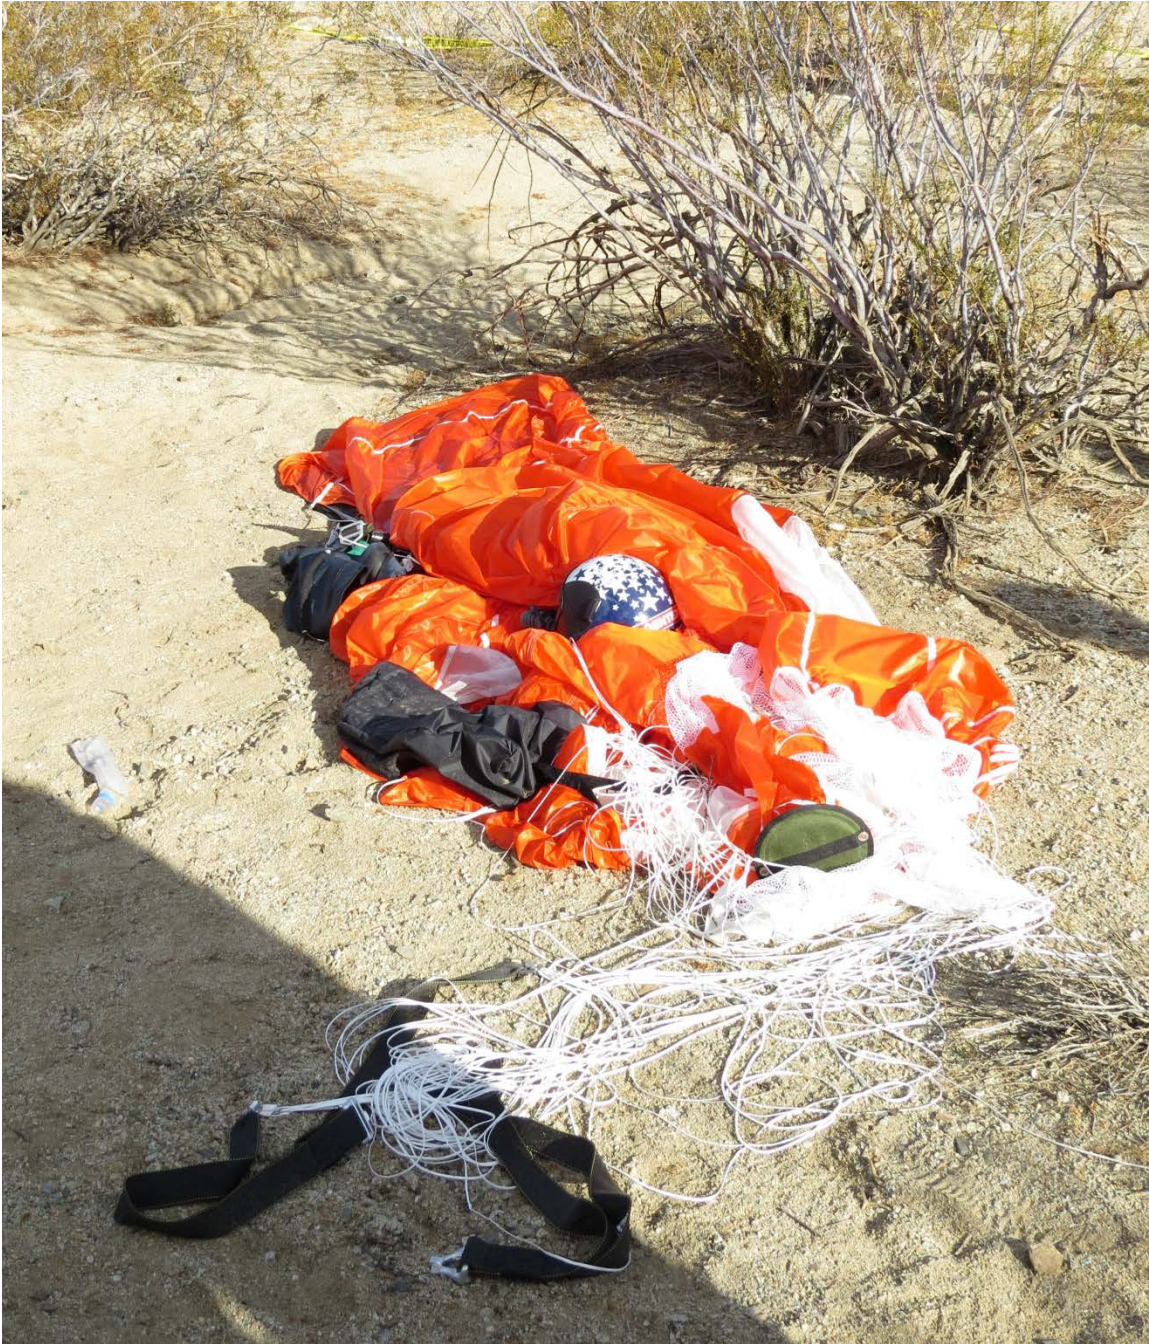
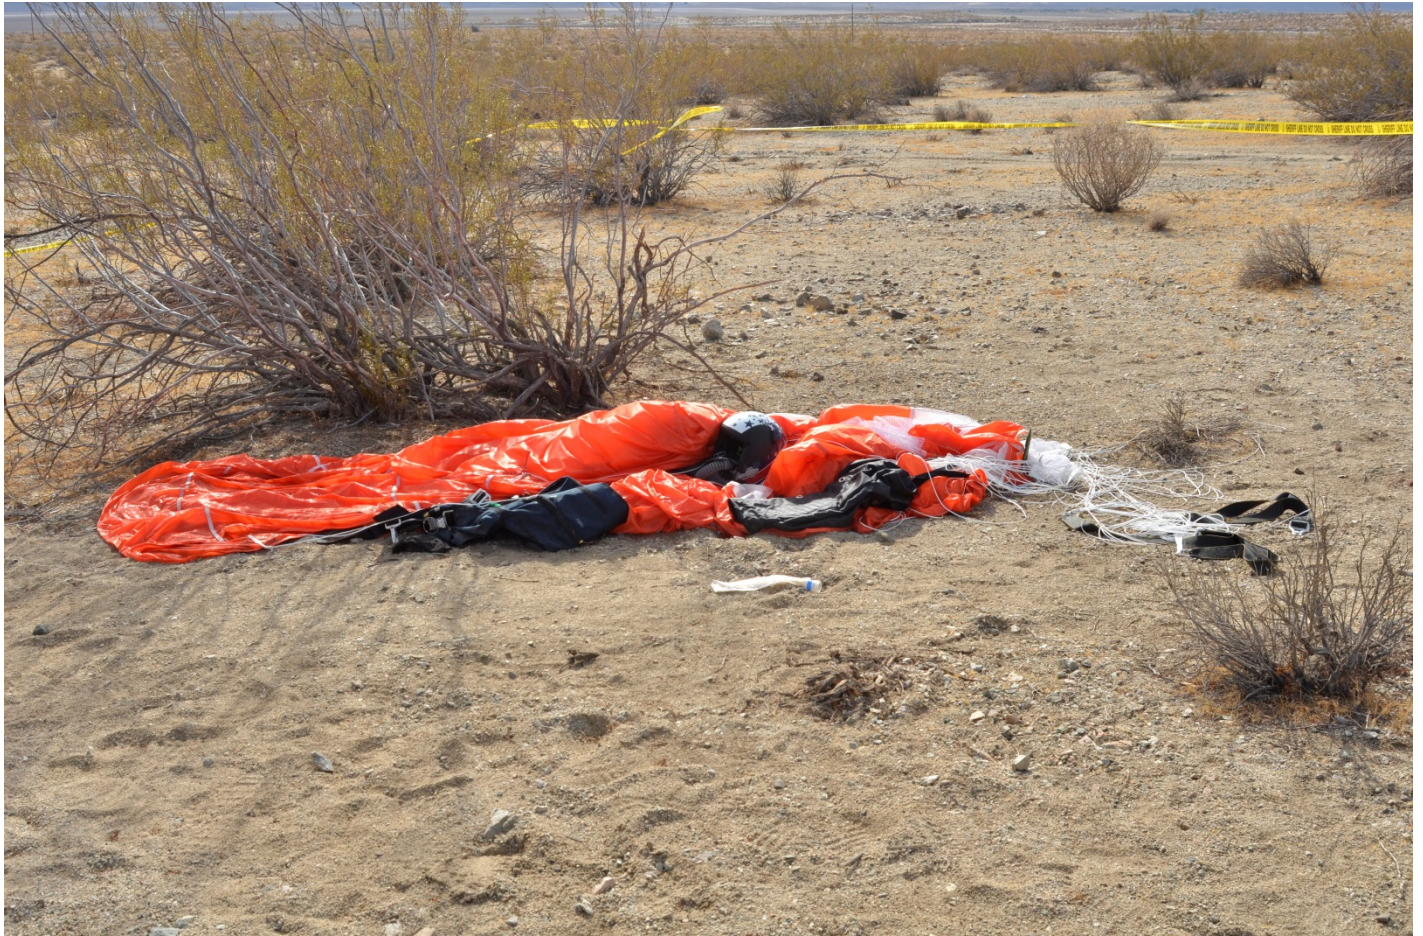
1.1.7 Site 6 – Pilot’s parachute (see figures 29-30)

The pilot's parachute along with the pilot's helmet and other flight gear was recovered from site 6. Further documentation of this gear was conducted by the survival factors group.

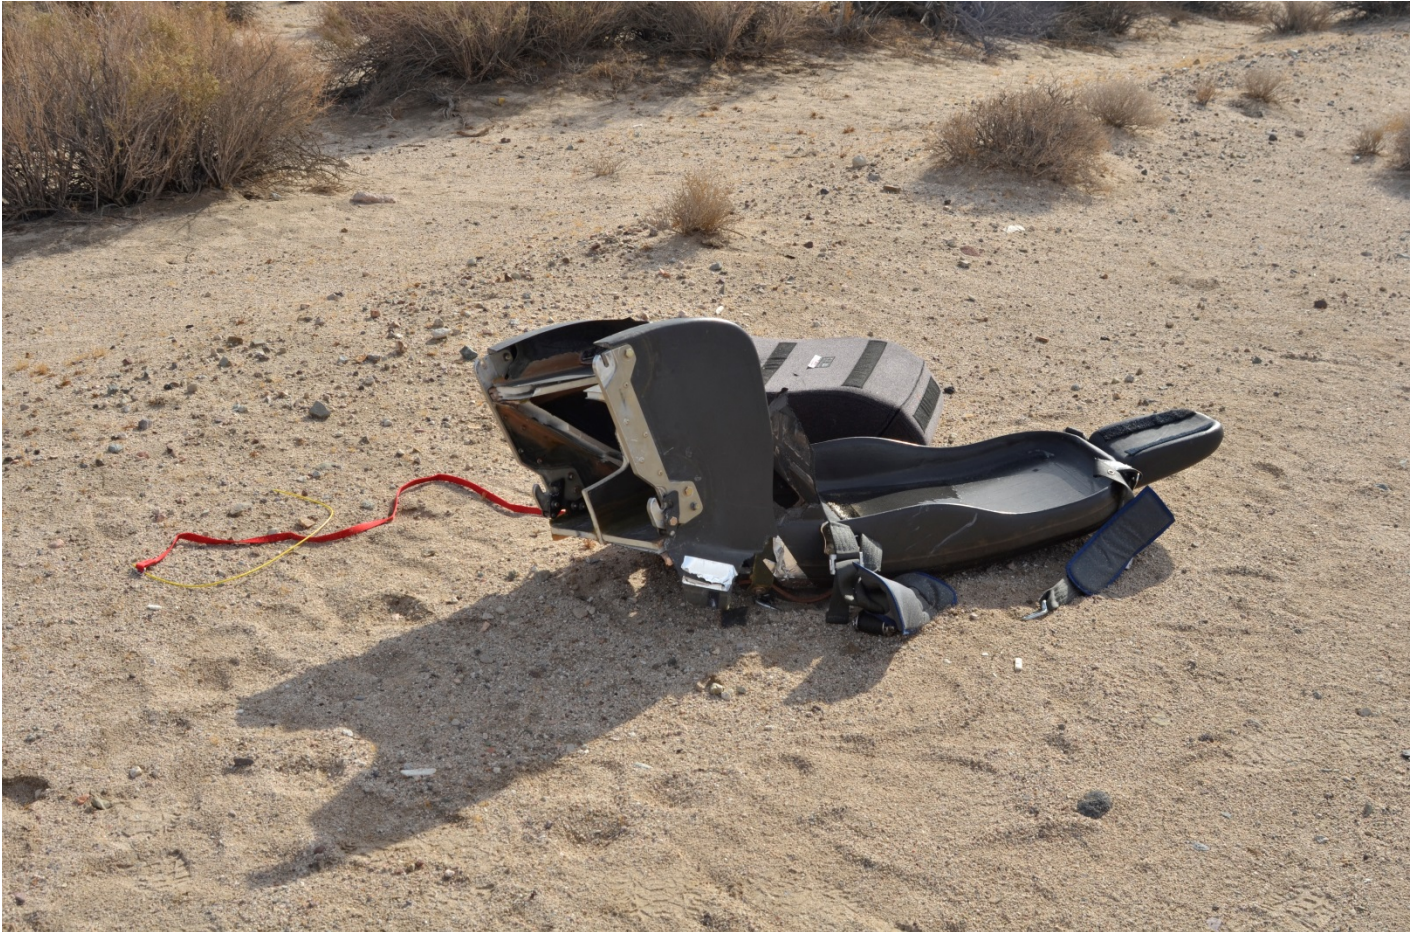
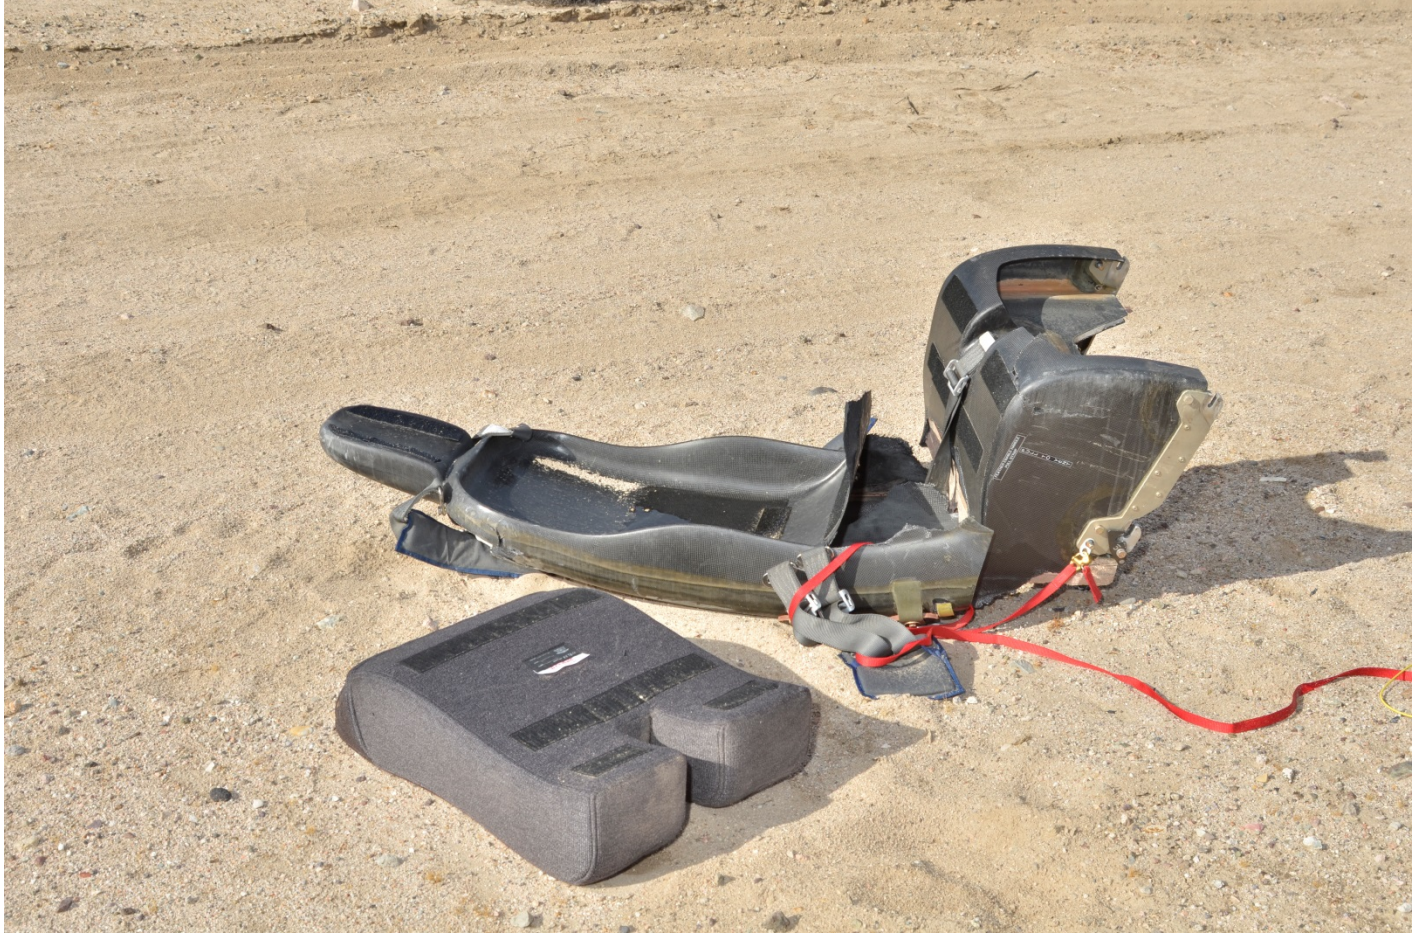
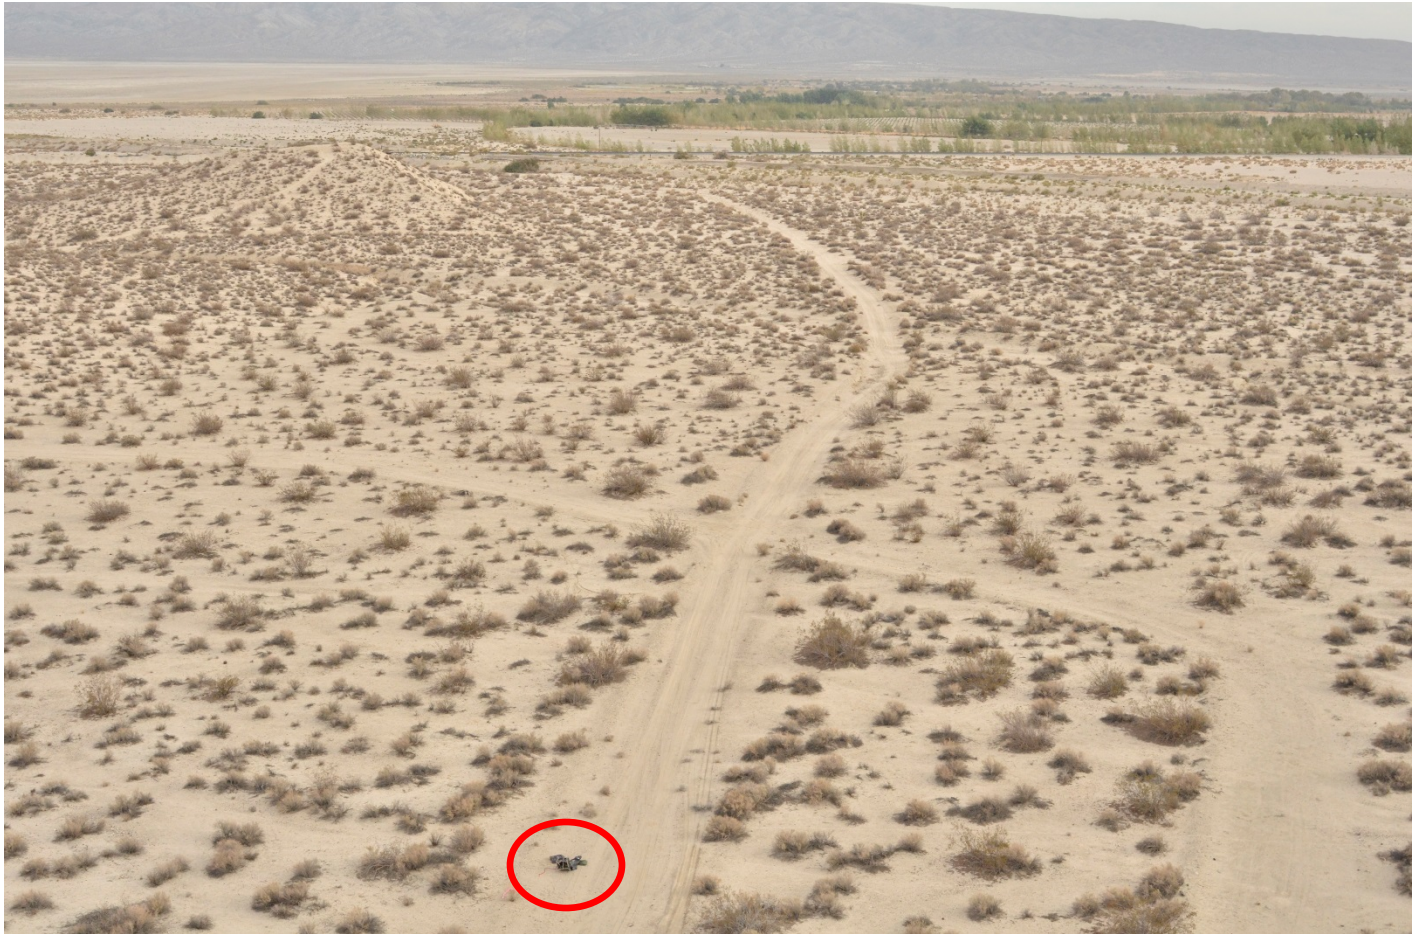
The pilot’s seat was recovered from site 8 (see figures 31-33). The seat was fractured at the hip point. The harness was intact. The static line was attached to the seat. The seat rail release mechanism was damaged. Further documentation of the seat and other survival gear was conducted by the survival factors group.

Figure 31
Pilot's seat – left side

Figure 32
Pilot's seat – right side

Figure 33
Pilot's seat – aerial view
