Vehicle Attachment 1  
Arizona DPS Vehicle Inspection Reports

Dolan Springs, AZ  
HWY-09-MH-09

### MECHANICAL INSPECTION REPORT

**Vehicle inspected:** Model: Starcraft 29 Passenger Shuttle bus

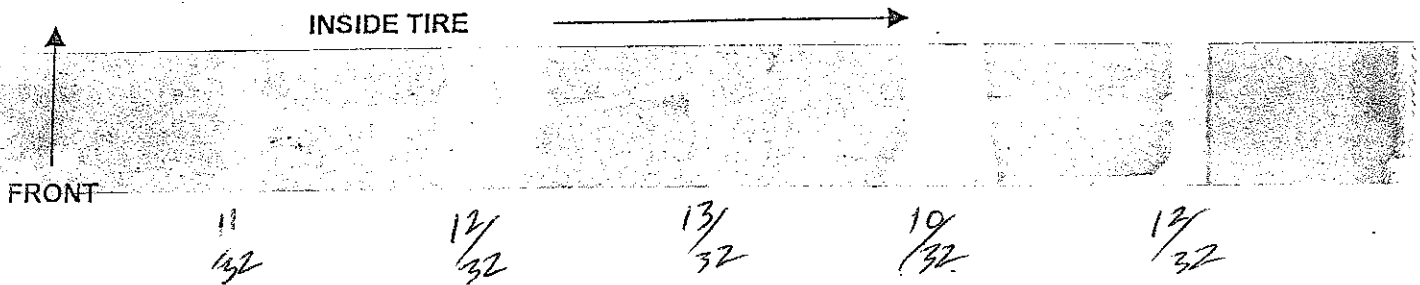
# LEFT FRONT TIRE AND RIM FAILURE ANALYSIS

Left front tire, Goodyear G647, 225/70R19.5. Air pressure measured at (80)psi. Manufacture's recommended pressure max load (95)psi. Tread depth measured at 11/32in.

AIR PRESSURE 80 PSI COLD

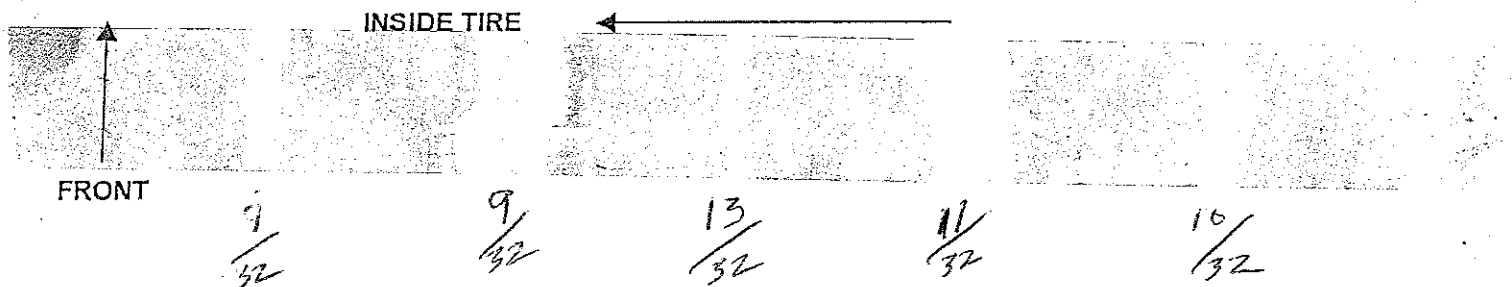
# RIGHT FRONT TIRE AND RIM FAILURE ANALYSIS

Right front tire, Goodyear G647, 225/70/19.5. Air pressure measured at (0) psi. Tire flat accident induced. Manufacture's recommended pressure max load (95)psi. tread depth measured at 10/32in.

AIR PRESSURE FIAT ~~95~~ PSI COLD

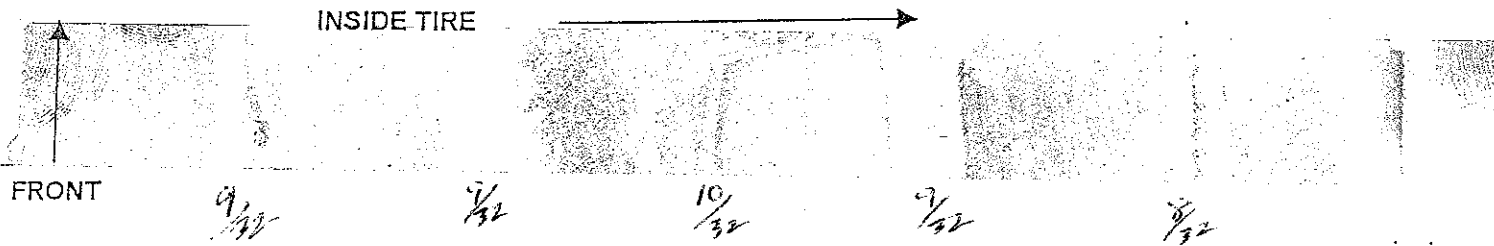
# LEFT REAR TIRE AND RIM FAILURE ANALYSIS

Left rear outside dual, Goodyear G647, 225/70/19.5. Air pressure measured at (0)psi. Tire flat accident induced. Manufacture's recommended pressure max load (95)psi. Tread depth measured at 9/32in.

Left rear inside dual, Goodyear G647, 225/70/19.5. air pressure measured at (57)psi. Manufacture's recommended pressure max load (95)psi. Tread depth measured at 9/32in.

AIR PRESSURE 30.57  
0/0 FLAT PSI COLD

7/32 11/32 9/32 7/32 8/32

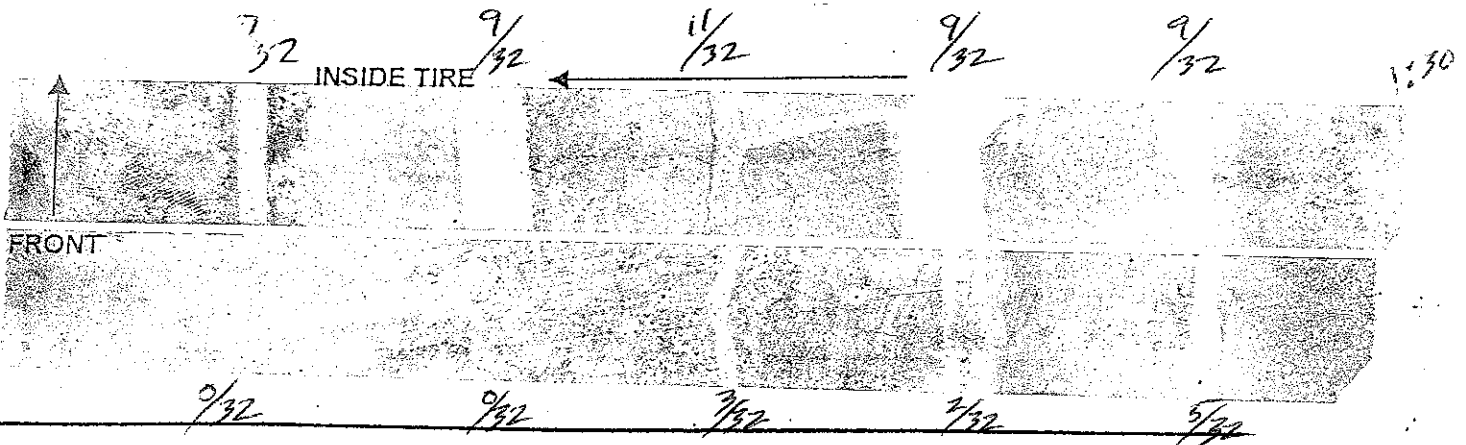
# RIGHT REAR TIRE AND RIM FAILURE ANALYSIS

Right rear outside dual, Goodyear G647, 225/70/19.5. Air pressure measured at (0)psi. Tire flat accident induced. Manufacture's recommended pressure max load (95)psi. Tread depth measured at 9/32in. One nail was found in tire. Tire was demounted and checked for nail penetration into casing. None found.

Right rear inside dual, Goodyear G647, 225/70/19.5. Air pressure measured at (0)psi. Tire flat accident induced. Manufacture's recommended pressure max load (95)psi. Tread depth measured at 9/32in. Two nails were found in tire. Tire was aired to 95 psi and checked for leaks. None found.

0/0 FLAT  
1/0 FLAT COLD

O/D ① NAIL - TIRE WAS DEGRADED - NAIL DID NOT PENETRATE EATING DUAL

I/R ② NAILS - TIRE WAS AIRED UP ON 02/03 NO LEAKS
