**VEHICLE GROUP CHAIRMAN'S**

**Attachment H**  
**Bridgestone Tire Examination**  
**(19 Pages)**

**TIRE ANALYSIS REPORT**

**Description:** Motorcoach Run Off Roadway Bridge and Rollover  
**Location:** U.S. Highway 75, Sherman, Texas  
**Date of Accident:** August 8, 2008  
**NTSB Case No:** HWY-08-MH-022

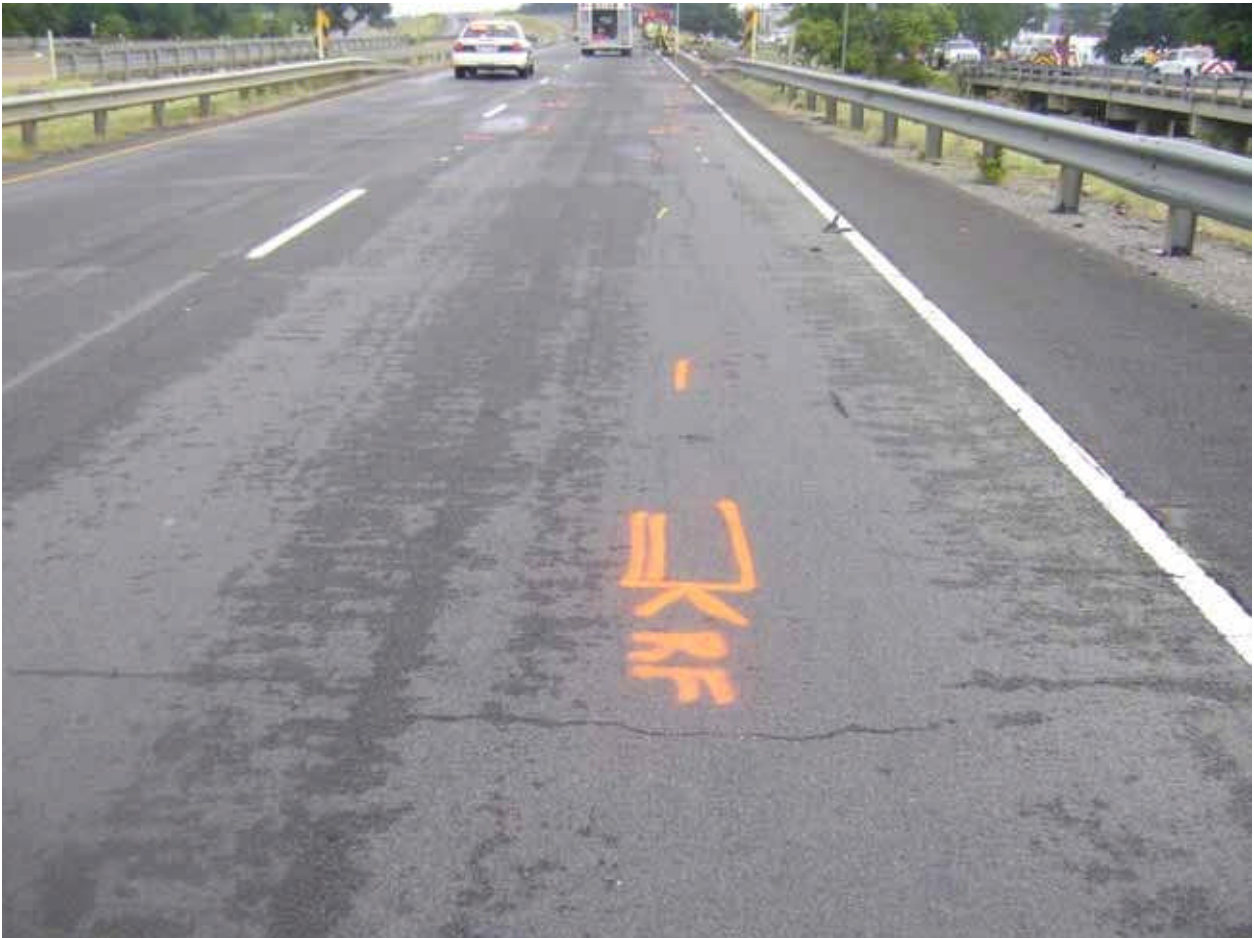
The tire failure was initiated by steel belt separation, leading to belt edge lift, shoulder rubber tearing, and a detachment of the belts and tread within 600 feet of the bridge. During the detachment sequence, the casing ruptured and a rapid inflation pressure loss resulted. Flat tire marks on the highway start at approximately 85 feet from the bridge as shown in Figure 1. The marks extend approximately 130 feet and indicate a path of the motorcoach to the right until the point of impact with the concrete curb of the bridge, Figure 2. The right front tire

Figure 1: Northbound View; Rapid Air Loss Initiation Location  
DSC01363.JPG (Sherman PD)

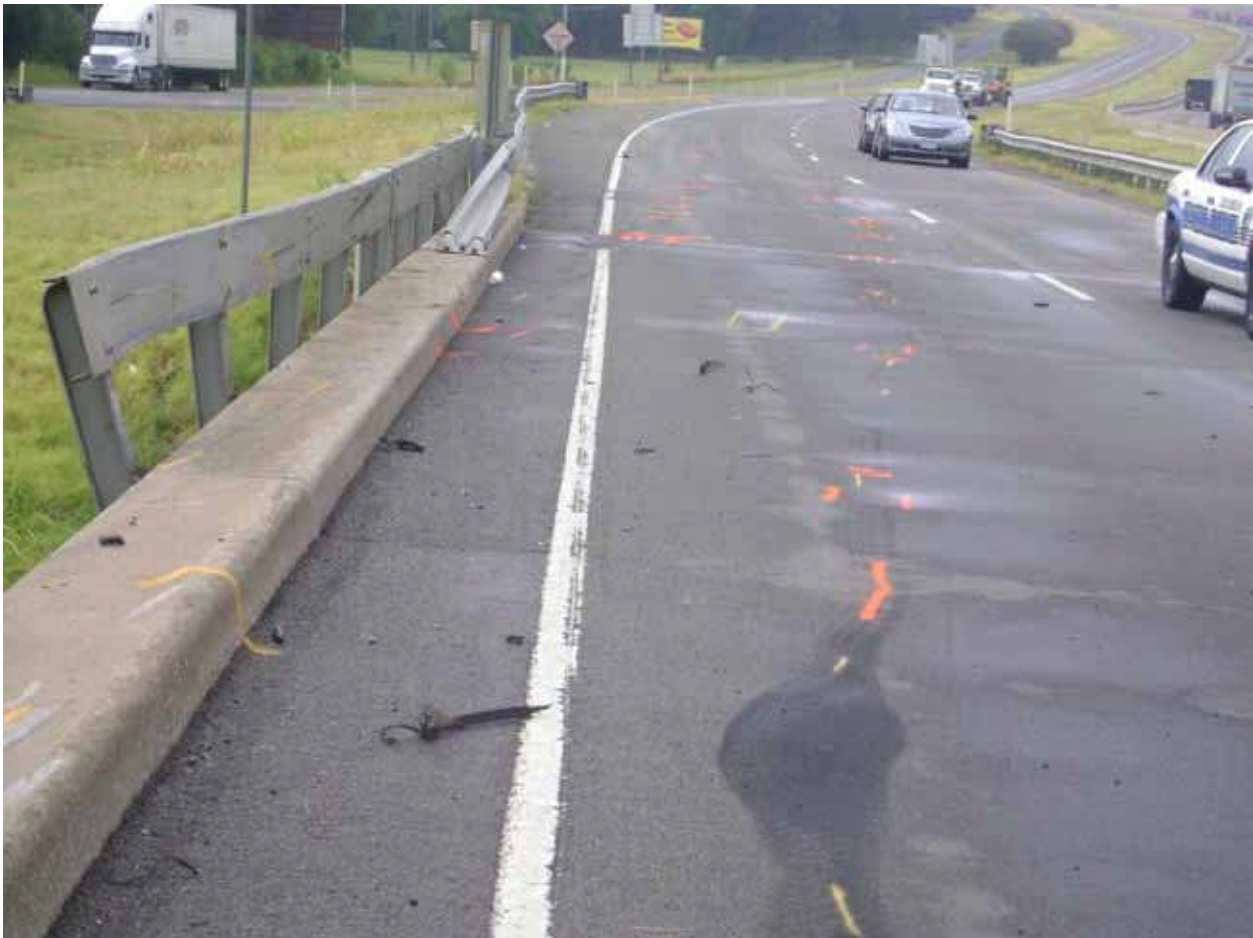
Figure 2: Southbound View; Impact Location  
DSC01353.JPG (Sherman PD)

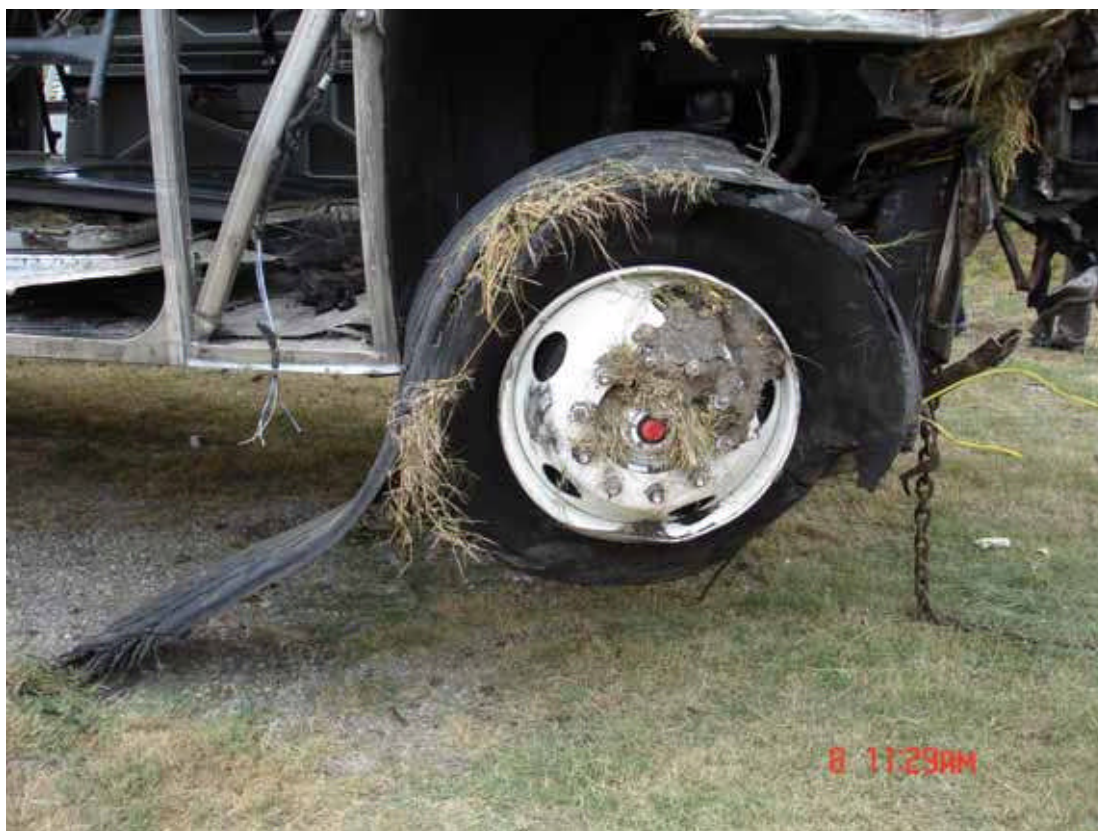
Appearance of the right front tire/wheel after the accident, prior to removal from the vehicle, is shown in Figure 3. The remaining tires ("companion tires") from the motorcoach are shown in Figure 4.

Figure 3: Right Front Tire/Wheel Prior to Removal from Motorcoach  
dsc00595.jpg (Sherman PD)

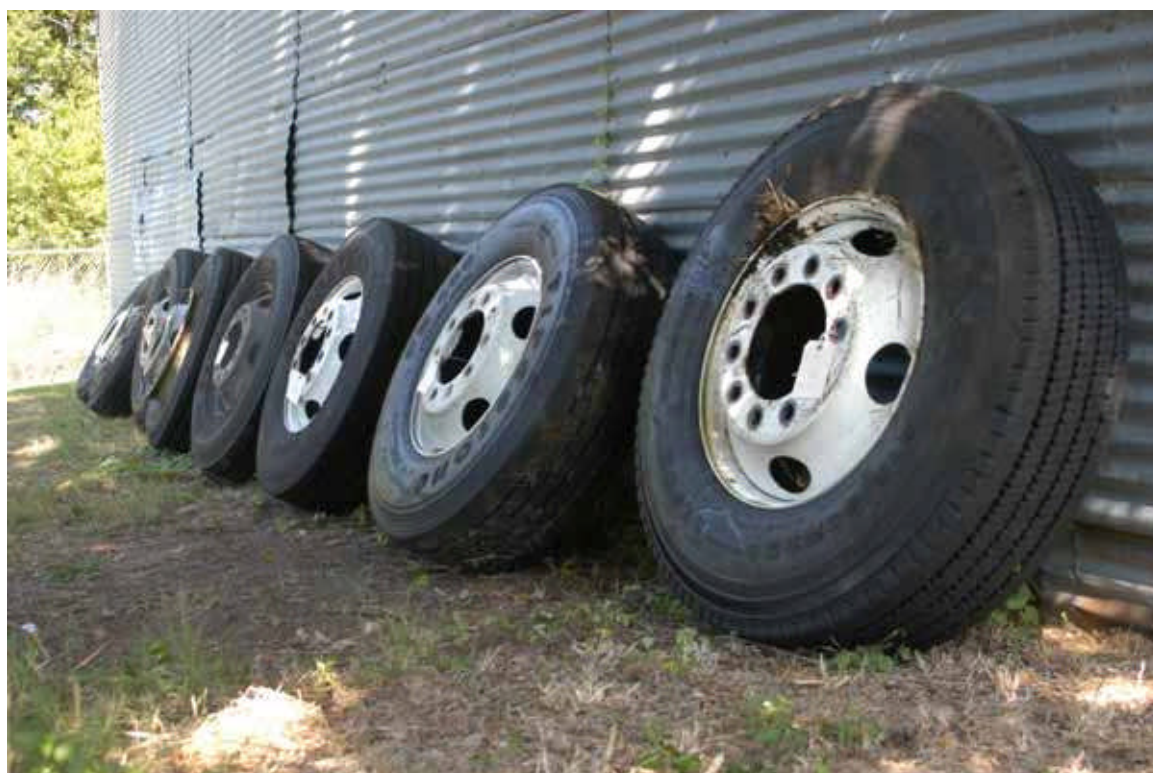
Figure 4: Companion Tires (NTSB 081408 Sherman-B001.jpg)

6. In addition to the tires on the tag axle being mounted to improper wheels for their application, inflation pressure measurements taken after the accident indicate that the tires on this axle were approximately 30 psi underinflated. (Inflation pressure measurements of the left and right tires on the tag axle were 88 psi and 89 psi respectively; see NTSB Vehicle Group On-Scene Information.) Thus, each tire was potentially overloaded by approximately 1,580 lbs., or 19%.

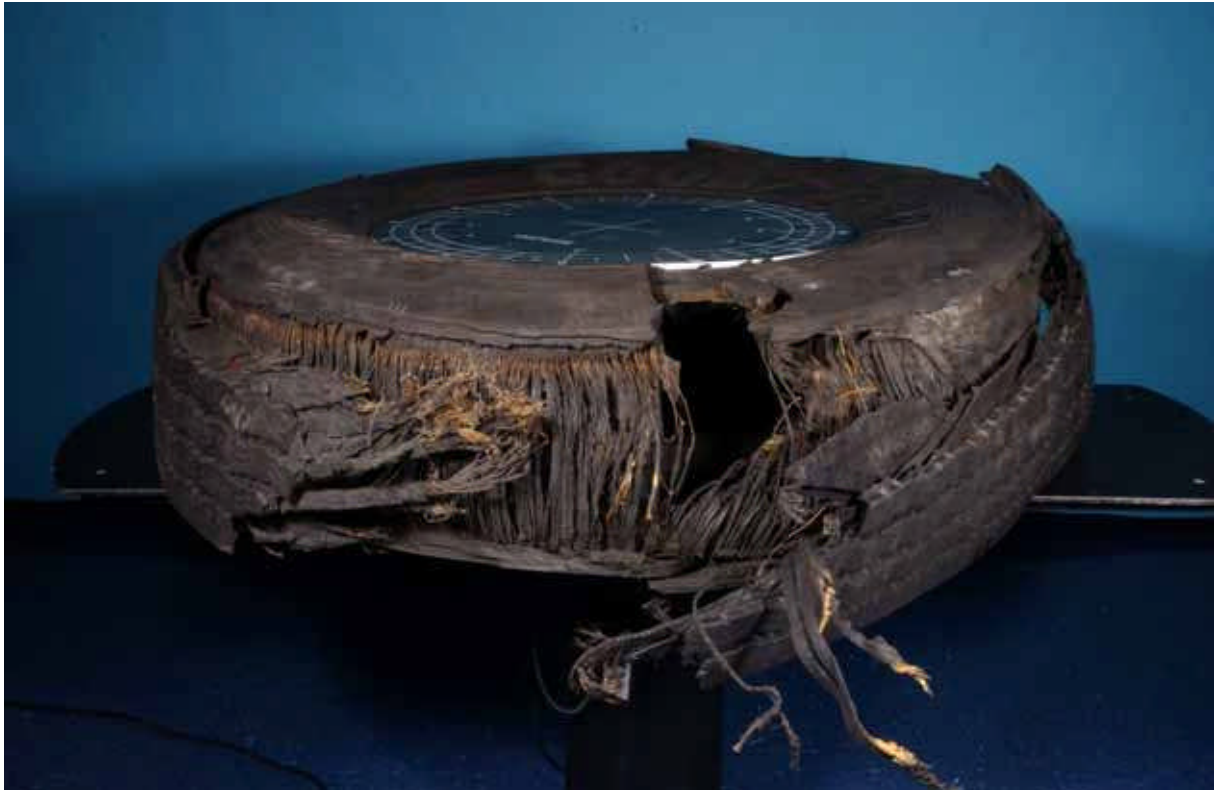
The subject tire failure initiated and propagated within the original casing. Separation began between the 2<sup>nd</sup> and 3<sup>rd</sup> steel belt plies and is most pronounced in the area between 8:30 clockwise to about 11:30, peaking at about 10:30. (Note regarding clock position protocol: All circumferential locations on the tire are referenced to the "DOT" symbol as 12:00, considering the serial side of the tire to be a clockface.) Belt edge lift and shoulder rubber tearing occurred along the serial side (outboard facing) shoulder as the tread/belt detachment initiated in this area due to the centrifugal force of highway speed tire rotation. The detachment occurred predominantly between the 2<sup>nd</sup> and 3<sup>rd</sup> steel belt plies and between the radial body ply and the 1<sup>st</sup> steel belt ply as it progressed. Before a full detachment of the belts and tread could occur, the casing ruptured at about 10:00 and the tire rapidly deflated (at location on the highway shown in Figure 1). Continued operation of the tire while flat and the subsequent impact with the bridge curb and guard rail resulted in additional damage to the tire, which is shown in Figure 6.

Figure 6: Subject Right Front Tire, View Centered about 10:30, Serial Side Up  
(08AA330-B104.jpg)

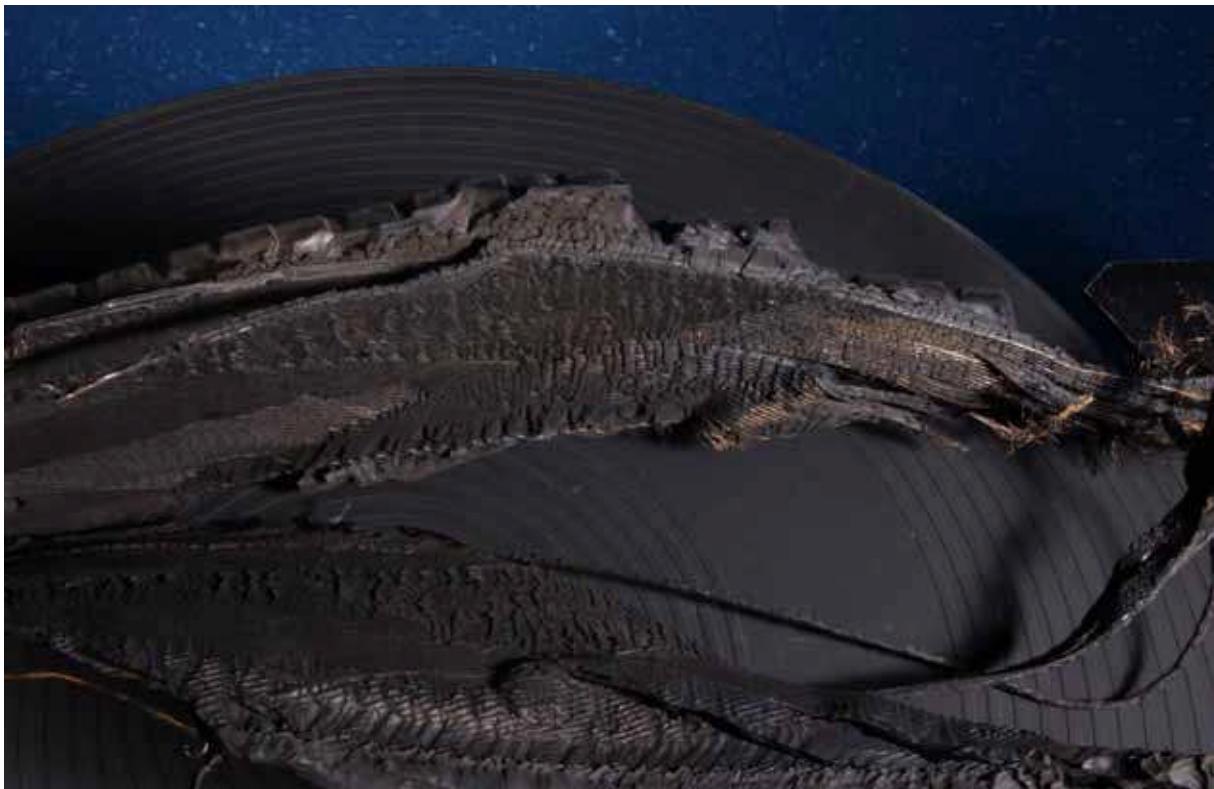
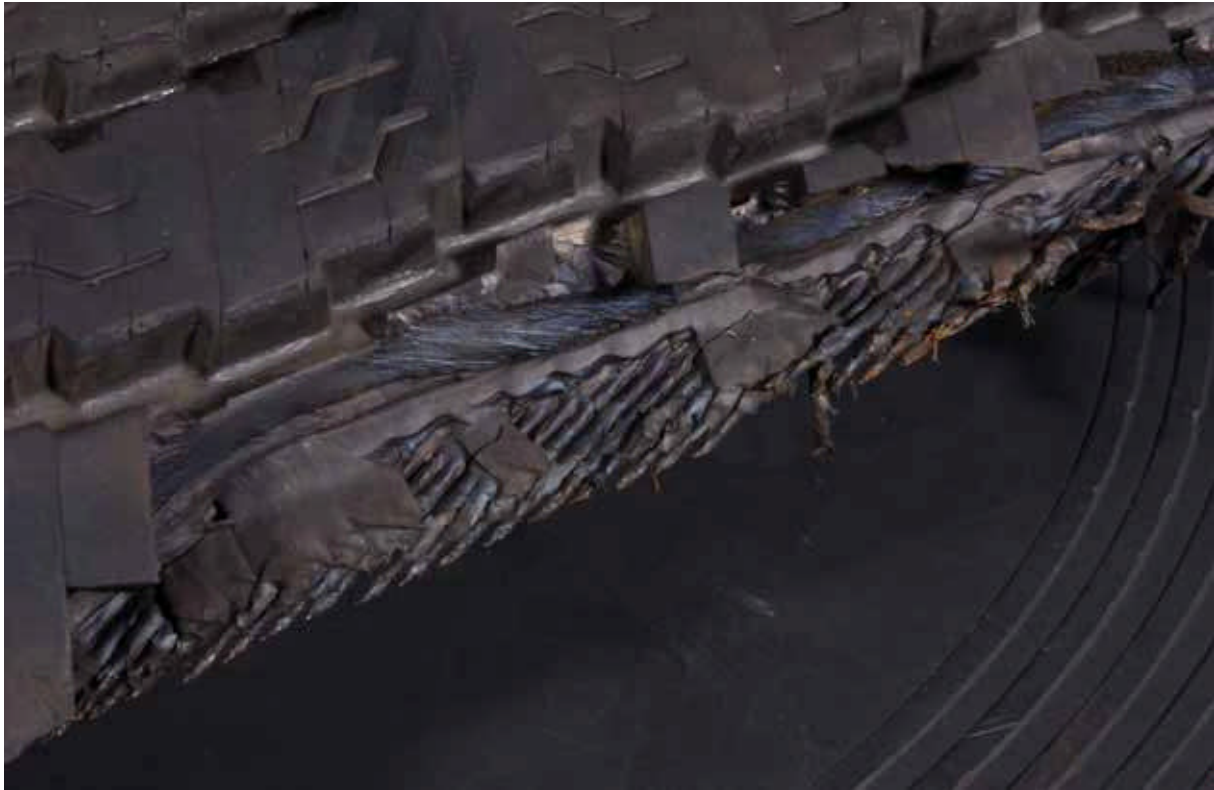
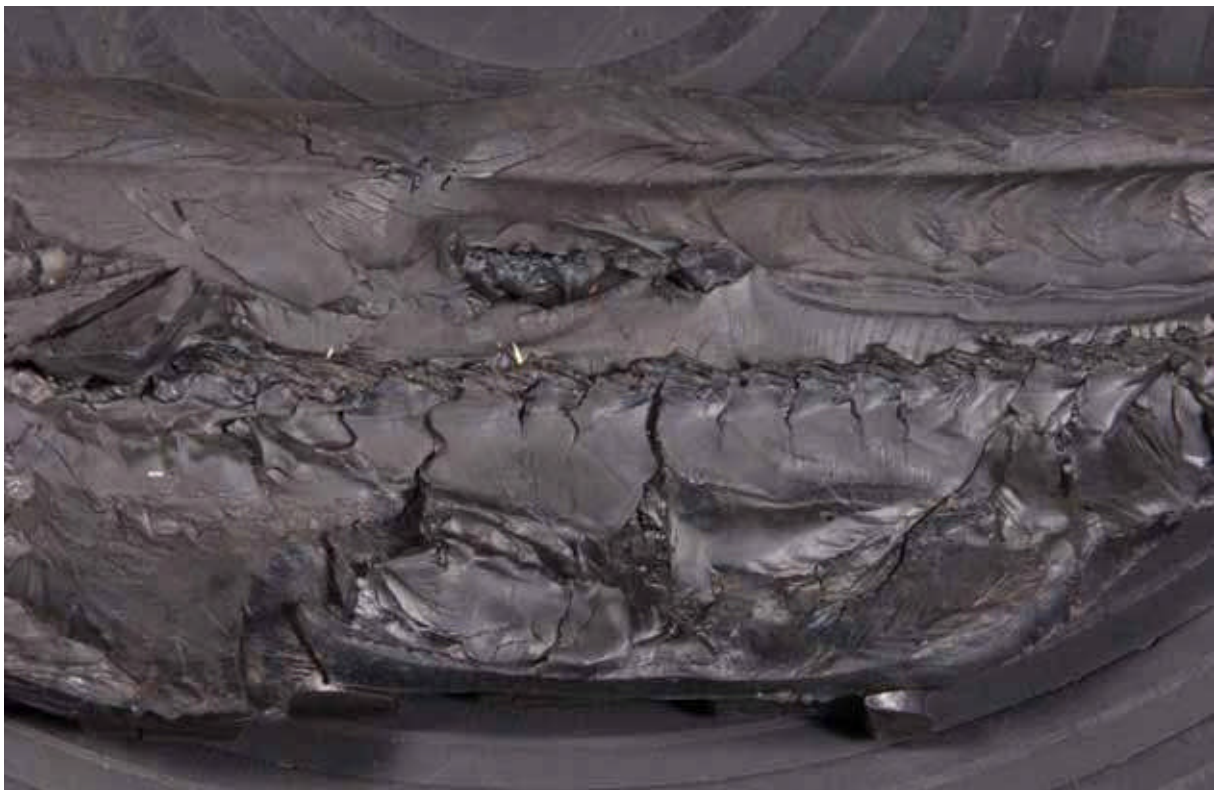
Examination of the separated and detached tread, belt, and casing surfaces reveals multiplane tear patterns, evidence of adequate adhesion and properties of fatigue, crack propagation, and tear resistance. Such an appearance is typical of a properly designed and manufactured tire that has sustained a tread/belt separation and/or detachment caused by damage or other external factors during use. In addition, numerous exposed rubber surfaces exhibit a blue-tint appearance, indicative of excessive heat generation during operation. Examples of multiplane tearing and blue-tint rubber appearance are shown in Figures 7 through 9.

Figure 7: Torn Appearance Between 2<sup>nd</sup> and 3<sup>rd</sup> Belts, ~9:00 Clockwise to 11:00  
(08AA330-B146.jpg)

Figure 8: Torn Appearance of 3<sup>rd</sup> Belt Edge, Serial Side, about 7:00  
(08AA330-B142.jpg)

Figure 9: Torn Appearance of Shoulder Rubber, Serial Side, about 12:00  
(08AA330-B185.jpg)

The tread/belt tear patterns, heat discoloration, lower sidewall/bead fatigue, and rim compression grooves are indicative of tire operation in an over-deflected condition. Over-deflection is caused by underinflation, overloading, or a combination of the two. In this case, the most probable cause of over-deflection is underinflation due to an un-repaired puncture to the tire which lead to inflation pressure loss and damaging stress/strain and heat build-up. The puncture is located at 4:00 in the serial side shoulder, shown in Figure 12. The unknown puncturing object gouged and tore the tread surface (Figure 13) and the bulk of the rubber, but did not fully pass through the tire. However, with each deformation and compression of the tread in the contact patch as the tire rotated, the object was penetrated deep enough into the tire to create numerous tears through the innerliner (Figures 14 and 15), causing a gradual loss of inflation pressure. The puncturing object most likely ejected from the tire during the tread/belt detachment process.

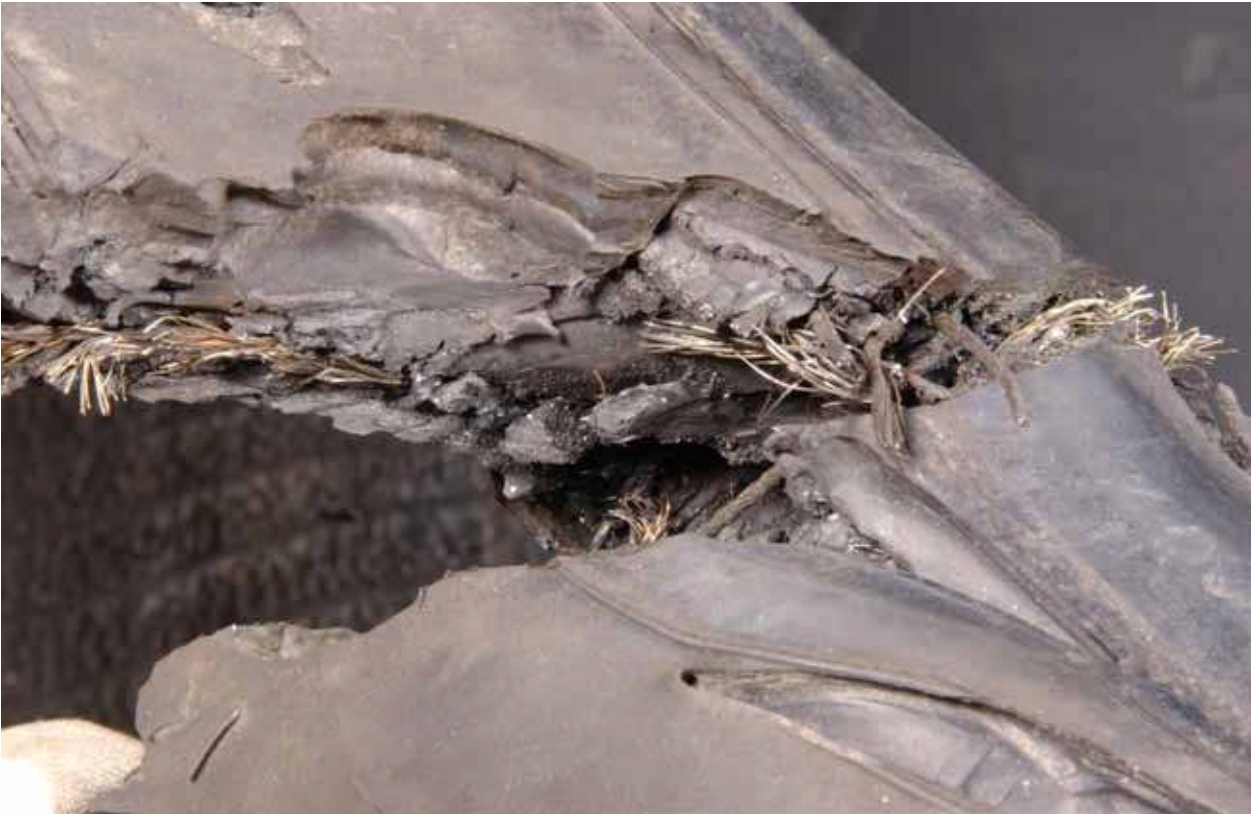
Examination of torn lower sidewall and bead areas reveals additional casing fatigue and heat-related damage. In Figure 10, incipient separation of the steel bead reinforcement ply, steel body ply, and fabric chafer is exposed. The beads also exhibit undulating deformations and compression grooving from the rim flange, an example shown in Figure 11.

Figure 10: Exposed Components of Lower Sidewall, Serial Side, about 10:00  
(08AA330-B126.jpg)

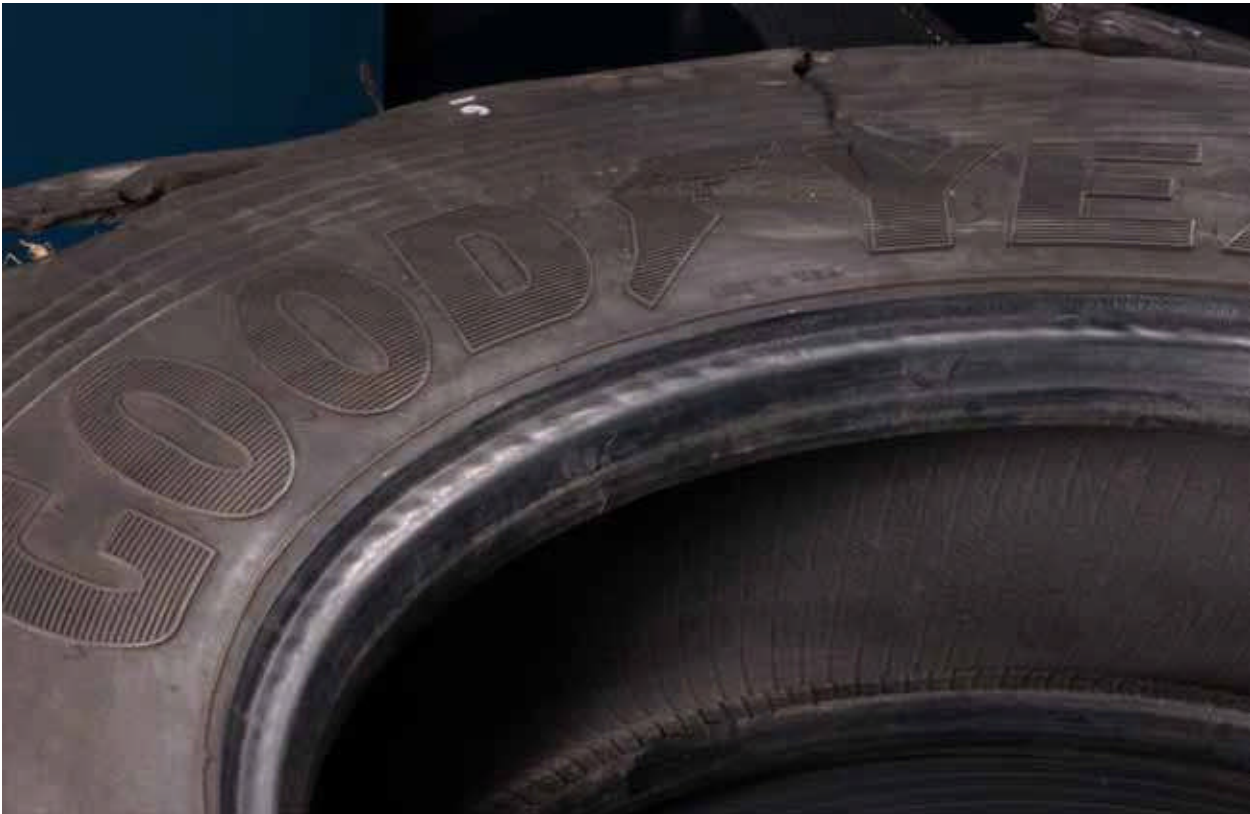
Figure 11: Rim Flange Compression Grooving, Serial Side  
(08AA330-B134.jpg)

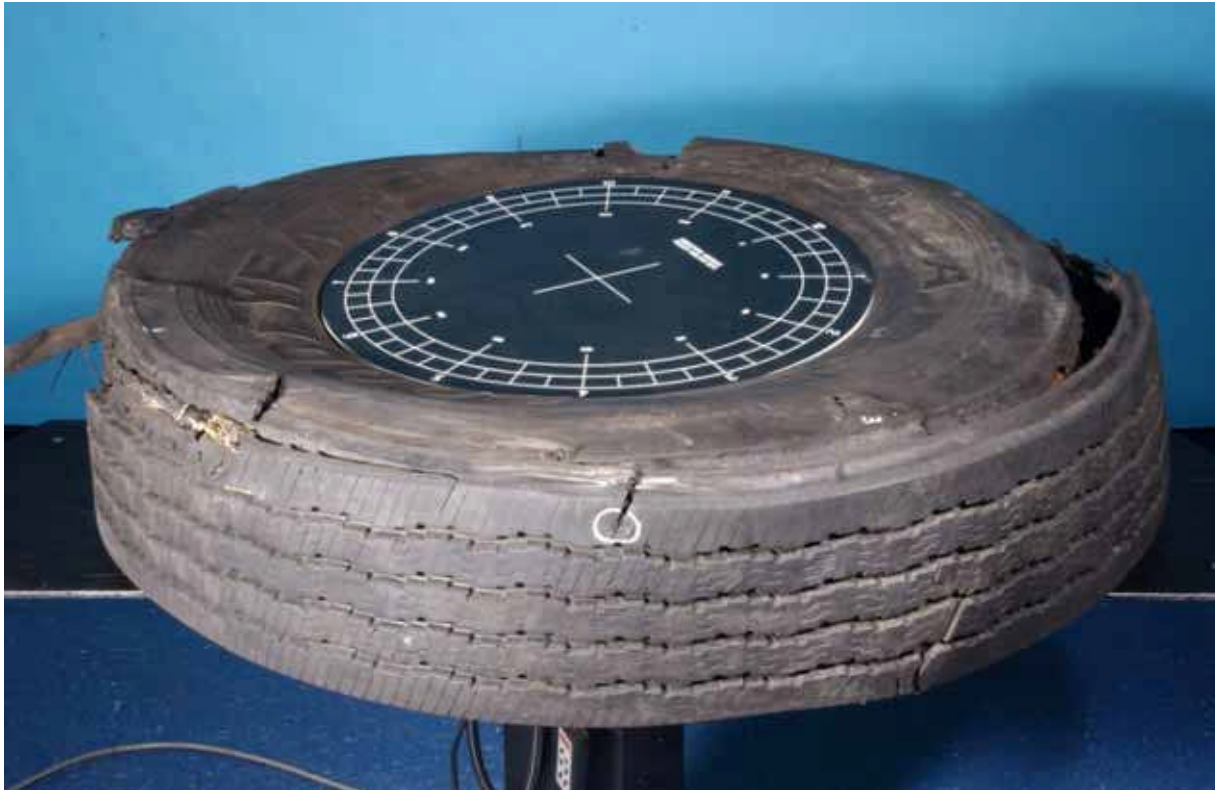
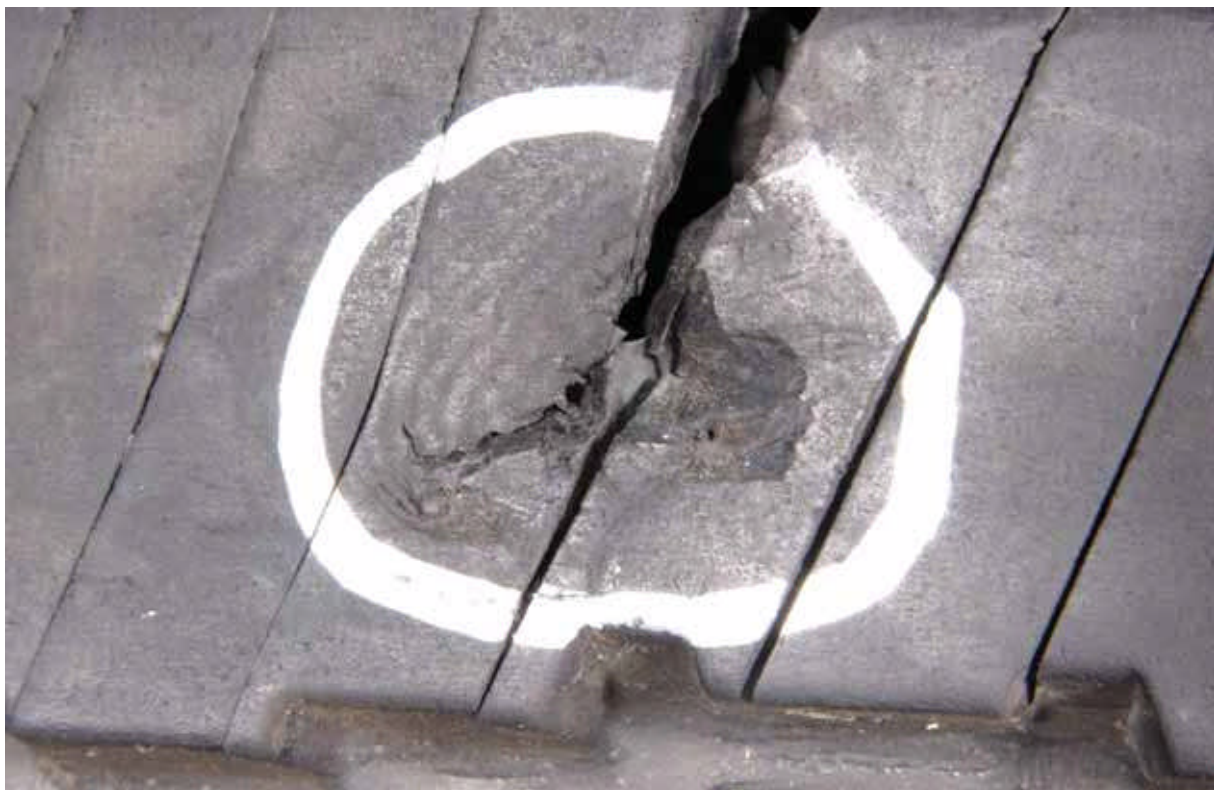
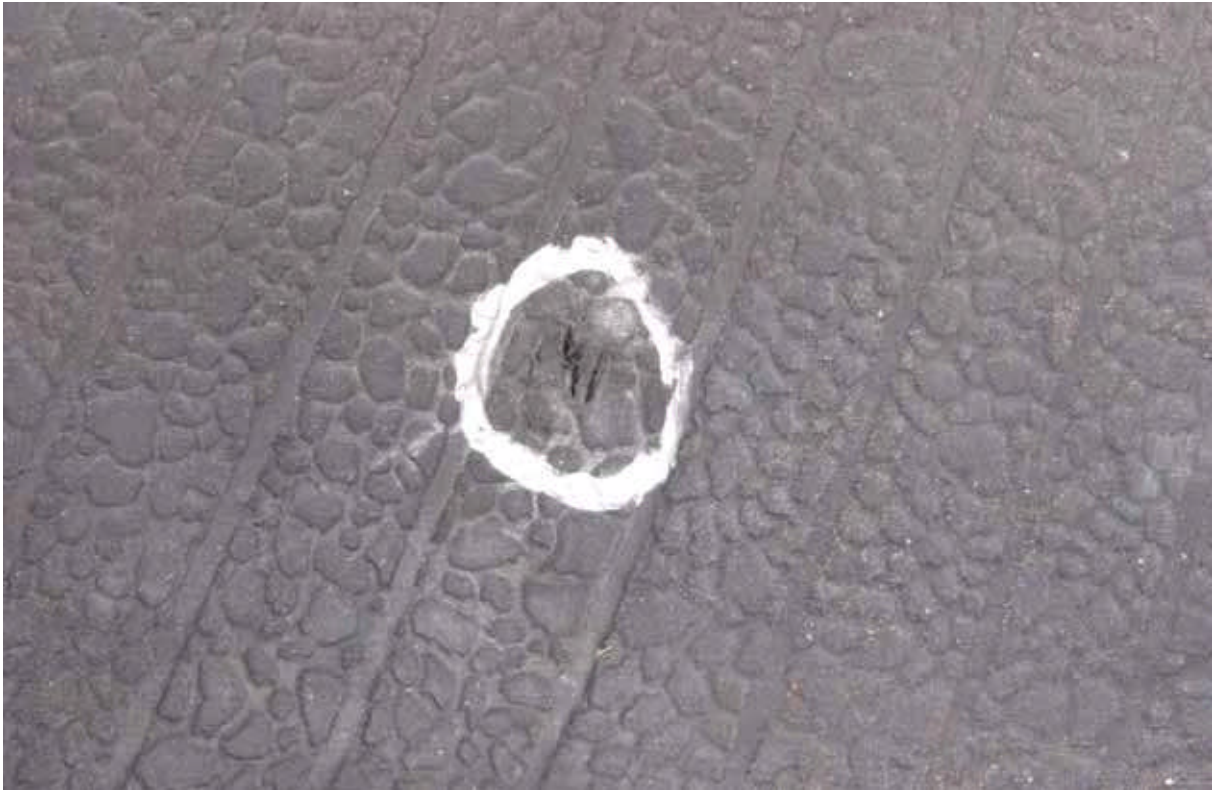
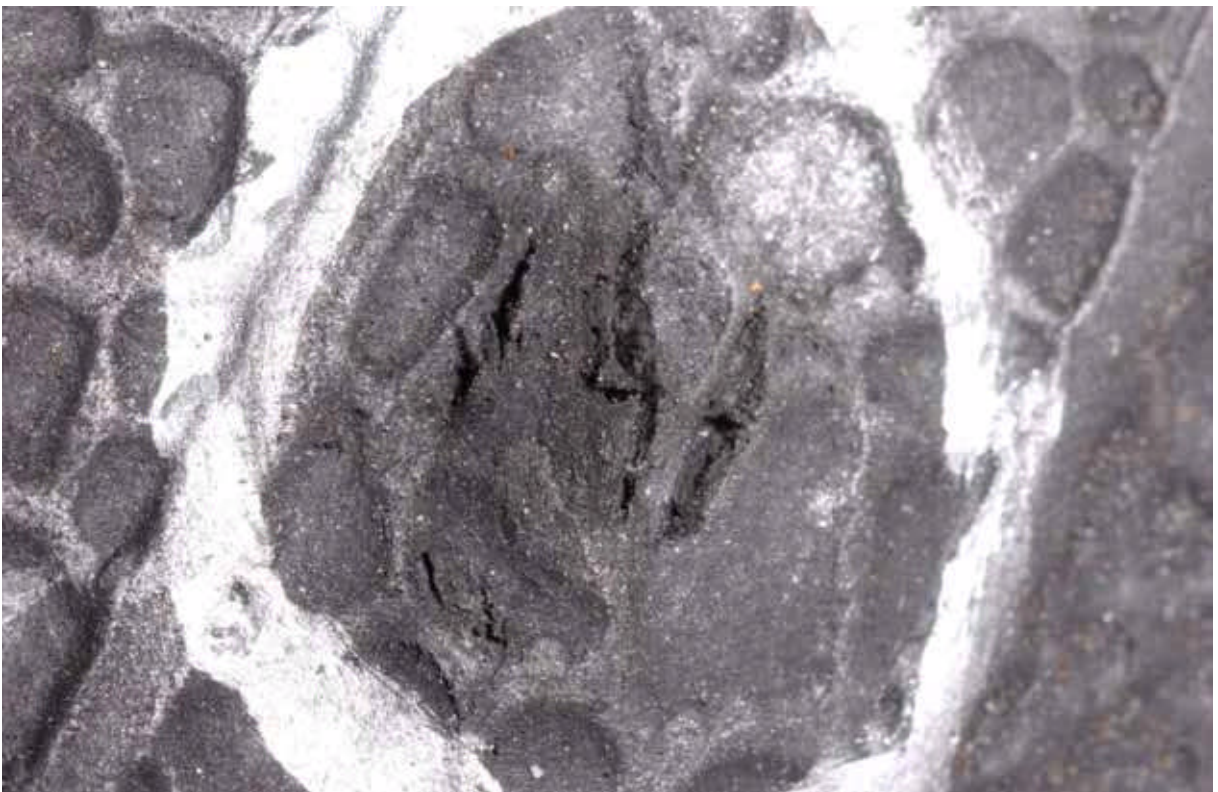
Figure 12: Puncture Location, about 4:00, Serial Side Shoulder Rib  
(08AA330-B244.jpg)

Figure 13: Close View of Puncture Location, about 4:00, Serial Side Shoulder Rib  
(08AA330-B255.jpg)

Figure 14: Penetration Tears to Innerliner, about 4:00, Serial Side Shoulder  
(08AA330-B257.jpg)

Figure 15: Close View of Penetration Tears to Innerliner  
(08AA330-B259.jpg)

2. The tread/belt detachment of the right front tire occurred as a result of damage caused by over-deflected operation. In this case, the most probable cause of over-deflection is underinflation due to an un-repaired puncture to the tire which lead to inflation pressure loss and damaging stress/strain and heat build-up. The puncture which lead to the failure occurred after the tire was retreaded and put back into service.

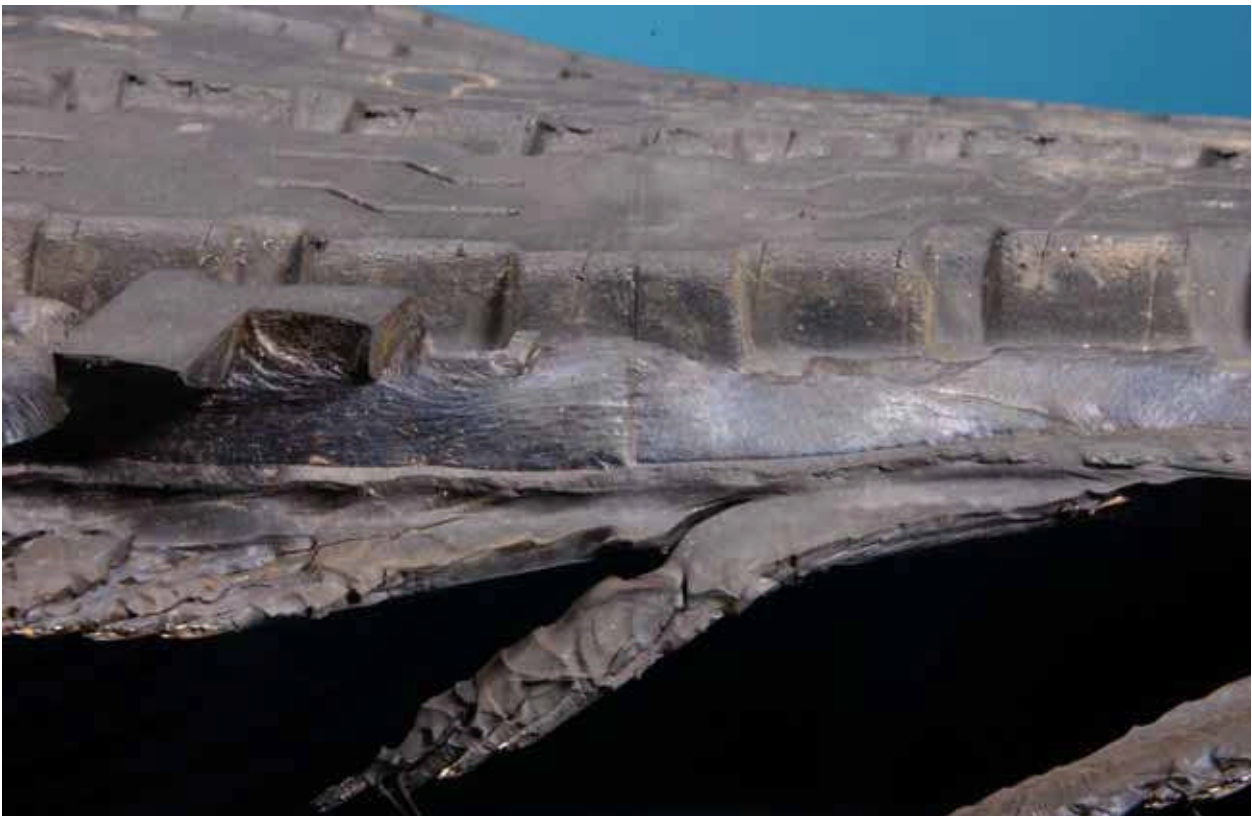
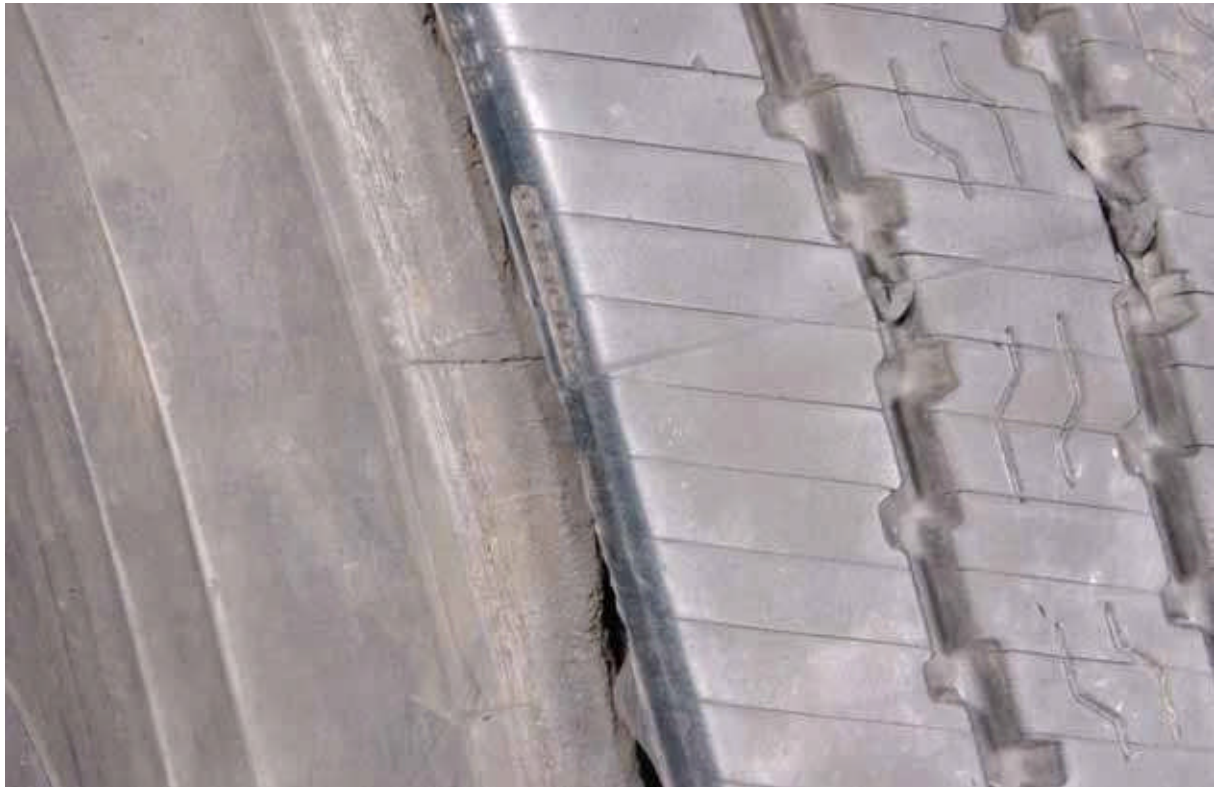
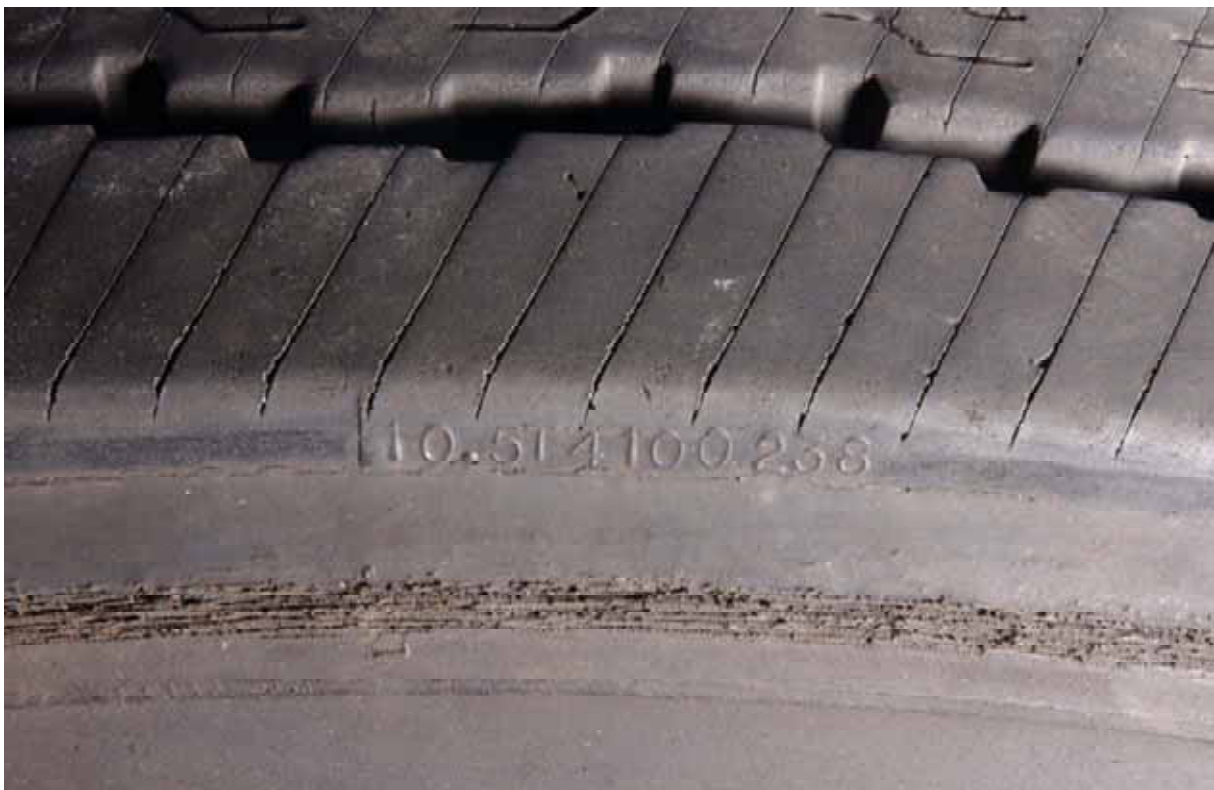
The subject tire exhibits proper retread manufacture and there is no indication of separation or detachment of retread material at the splice or along any surface of the casing buffed during retreading. There are no evident repairs. Tearing of the serial side shoulder through the tread splice at 8:30 as shown in Figure 16 reveals fully intact splice interfaces. Proper tread alignment and curing envelope venting at the splice is indicated in Figure 17. Both shoulders exhibit uniform and concentric application of the tread and cushion rubber as exemplified in Figure 18.

Figure 16: Exposed Tread Splice Due to Tearing, Serial Side Shoulder at 8:30  
(08AA330-B162.jpg)

Figure 17: Tread Splice Alignment, Opposite Serial Side Shoulder at 8:30  
(08AA330-B208.jpg)

Figure 18: Tread and Cushion, Opposite Serial Side Shoulder at 5:00  
(08AA330-B243.jpg)
