NATIONAL TRANSPORTATION SAFETY BOARD

Video/Image Factual Report

DCA06MA010

Location:	Miami, FL
Date:	December 19, 2005
Time:	1439 Eastern Daylight Time
Aircraft:	Grumman G-73T Turbo Mallard, registration: N2969
Operator:	Flying Boats, Inc.

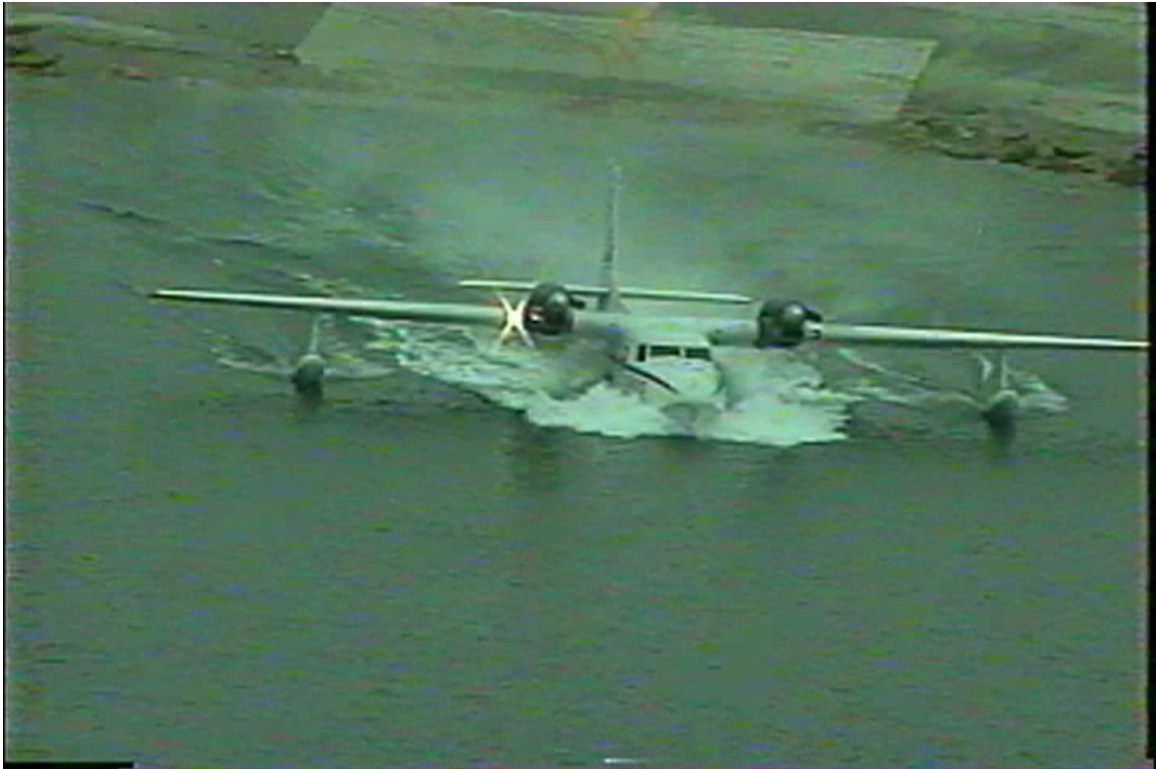
Figure 2 - Accident airplane departing Watson Island Seaplane Base

crossing from right to left, to move a ladder. The airplane starts to roll forward at approximately 40 seconds ET. It proceeds down the ramp and the nose gear enters the water at 55 seconds ET. The airplane travels away from the ramp and towards the camera [Reference Figure 2]. The outboard pontoons can be seen lightly skimming the water surface. The airplane is seen bearing slightly to the left as the recording is interrupted again at 1 minute and 21 seconds ET.

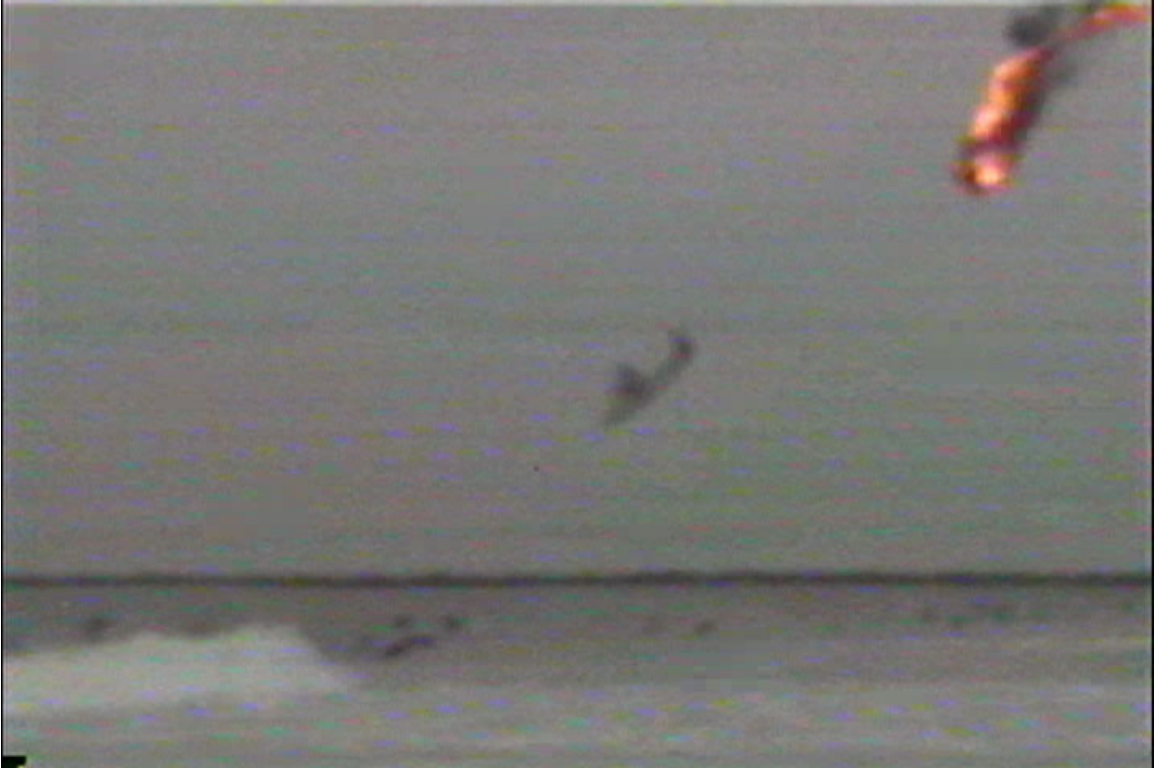
Figure 3 – First Video Frame of Accident Airplane, Time 8.5 seconds ET

The recording begins with a still image of four surfers in the ocean. The camera location appears to be a beach and the sky is overcast. At 7 seconds ET, the still image becomes 'unfrozen' and motion begins. The surfers are moving in the water. At 8.5 seconds ET the recording is interrupted, and the new view shows the accident airplane in the center of the view in an approximately 35 – 45 degree nose down attitude [Reference Figure 3].

There is no obvious smoke or debris coming directly from the airplane; but, trailing behind the airplane, in the upper right hand corner of the view, is a cloud of fire and black smoke. In the foreground, a beach, water with numerous swimmers, and a jetty can be seen. Both the airplane and cloud of fire and smoke follow a similar trajectory and impact the water, behind the jetty. The airplane impacts at 9.16 seconds ET [Reference Figure 4] and the cloud of fire and smoke impacts at 10.2 seconds ET [Reference Figure 5]. The cloud lands at a location slightly behind the airplane's impact point.

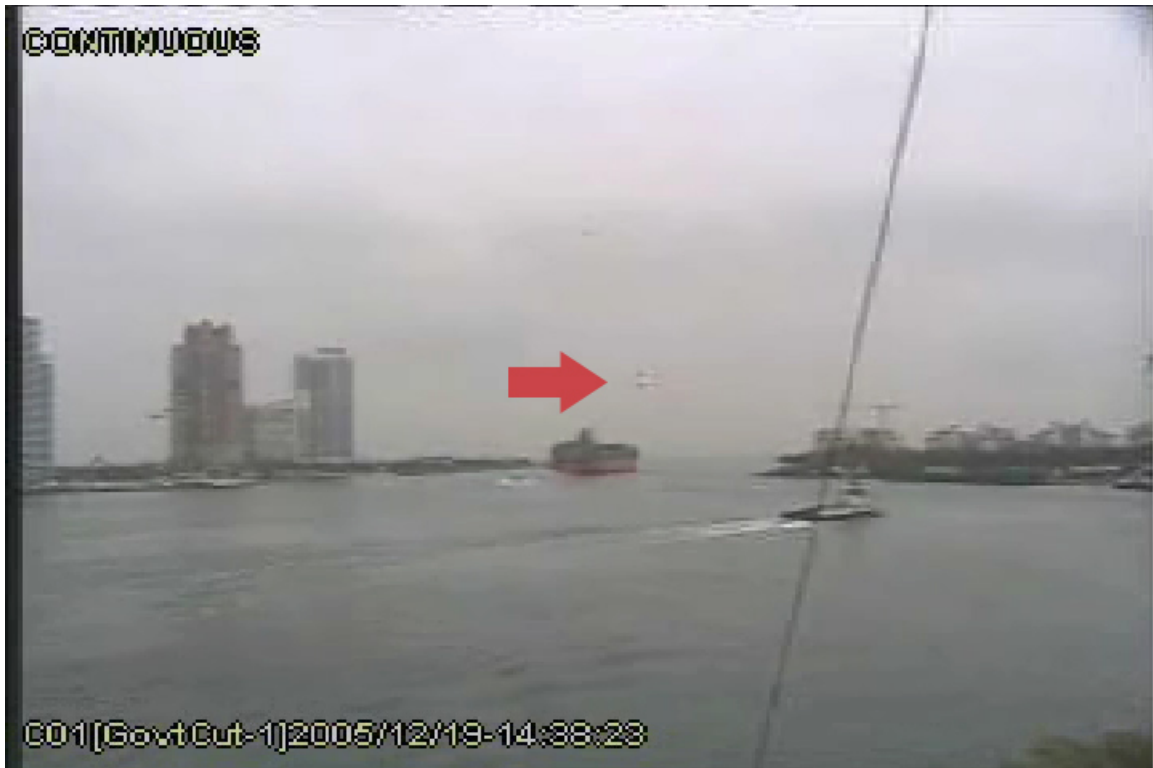
Figure 6 – Flash Marked by Arrow

The accident airplane enters the view from the left at approximately 1 second ET and travels away from the camera at an angle. The airplane is too far away to be seen at 11 seconds ET, about the time it reaches the center of the view. At about 20 seconds ET a flash is seen in the area that the airplane was last seen [Reference Figure 6], directly above the waterway.

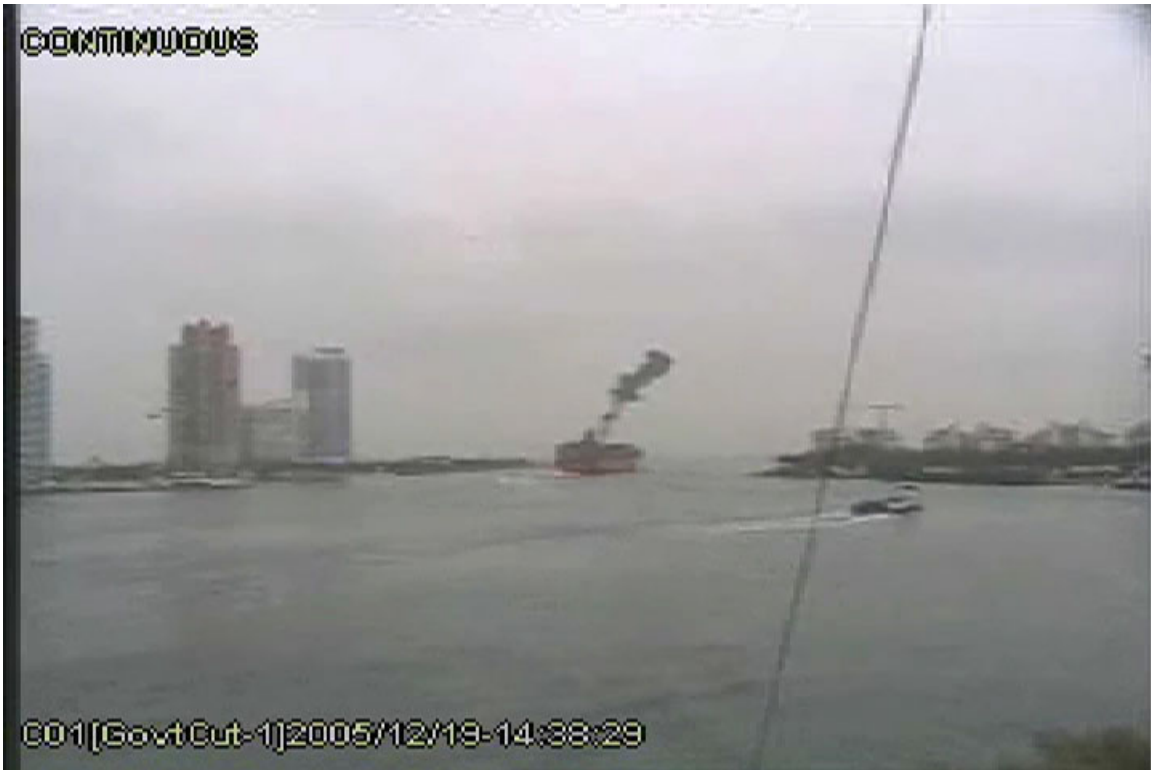
Figure 7 – Smoke Trail

At 21 seconds ET black smoke begins coming from the flash and the smoke trail falls towards the water over the next few seconds. The smoke trail disappears behind a ship located in the Channel, 4 seconds later [Reference Figure 7]. The smoke continues to billow up from the impact site until the recording ends after approximately 39 seconds of recorded video.

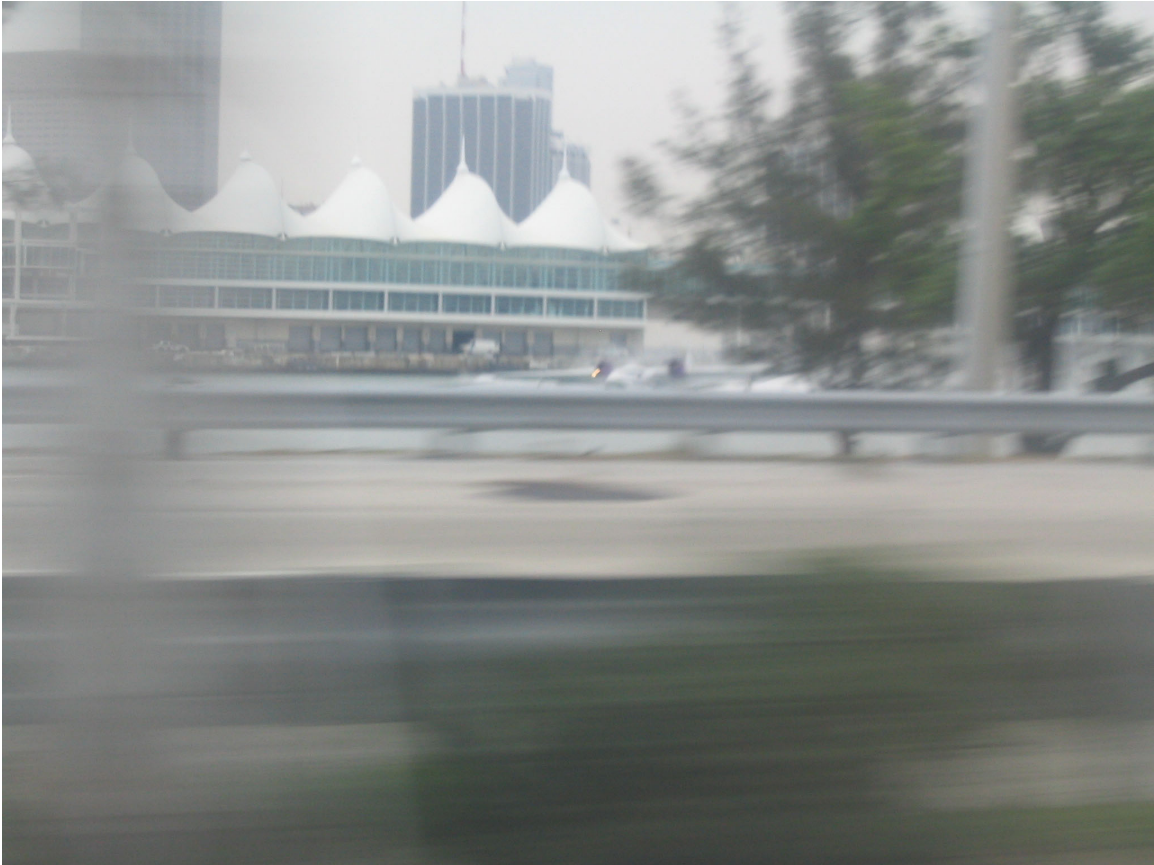
The NTSB received a digital still image [Reference Figures 8 and 9] from an observer, via email. The observer was traveling in an automobile on the MacArthur Causeway and captured the accident airplane while it was in the water prior to takeoff. According to the photographer, the photo was taken at 2:34 pm.

In the image, the accident airplane can be seen in the Main Channel between the MacArthur Causeway and the cruise ship dock. Comparing the background and foreground of the photo with satellite imagery confirms that the airplane is in close proximity to the seaplane base. Both propellers appear to be in motion. A bright streak located near the right engine is observed and is likely

the flashing light located outboard of the right engine, as in the video recording (in Figure 2). In the foreground trees, a guardrail, and a road can be seen. In the background, the cruise ship terminal and several high-rise buildings are seen.

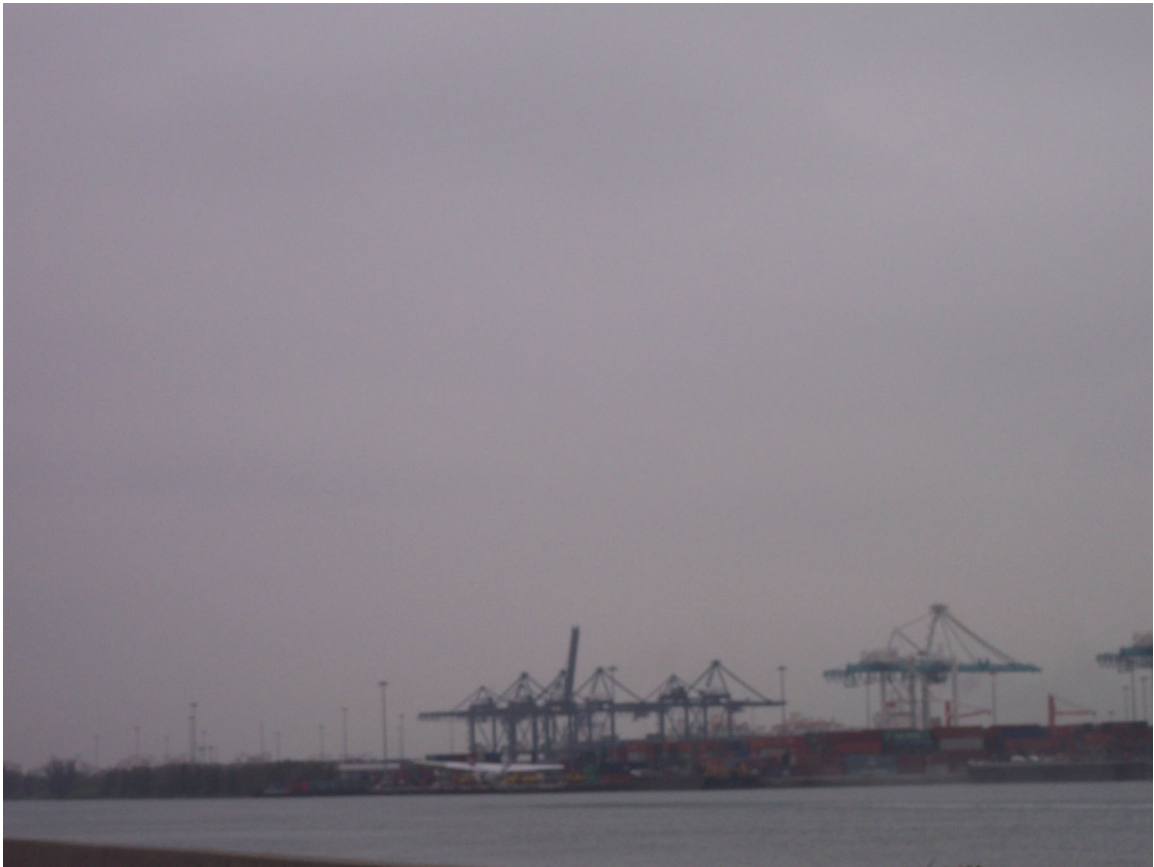
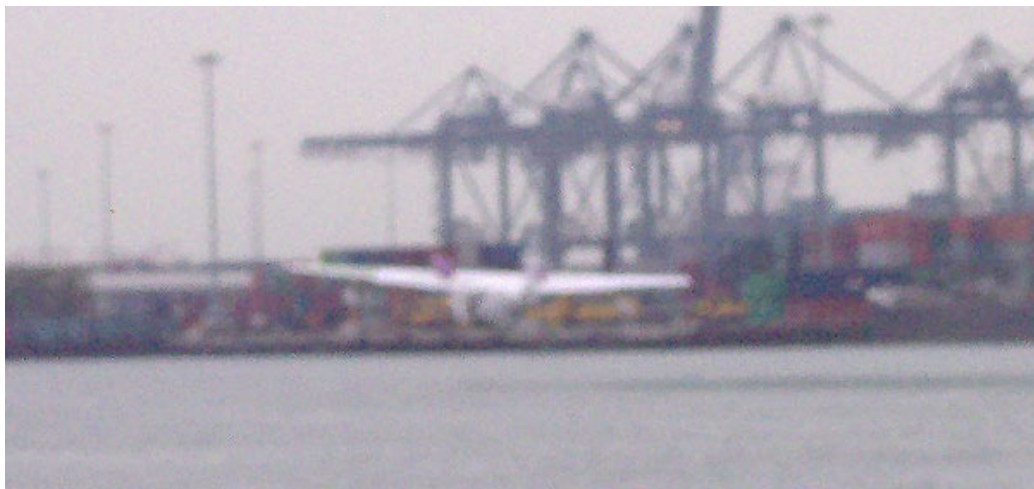
The NTSB received a digital still image [Reference Figure 10] from an observer, via email. She was also traveling in an automobile on the MacArthur Causeway and captured the accident airplane just above the water. According to the photographer, the photo was taken at approximately 2:30 pm. The type of camera is unknown.

In the image, the airplane can be seen traveling above the water of the Main Channel just after liftoff. In the background are the docks of the Port of Miami. Numerous cargo containers and heavy lift cranes are observed. The sky is overcast.

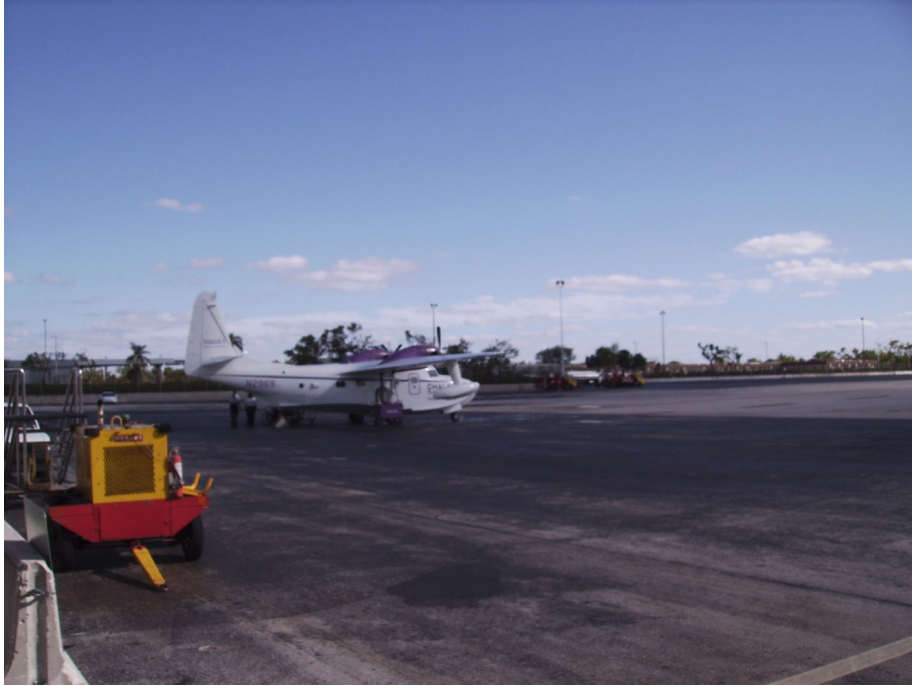
Figure 12 – Still Image 3

Still Image 3 [Reference Figure 12] captures the accident airplane parked on the apron at an unspecified location. The right side of the airplane is seen. The engines are not running. Two people can be seen on the left side of the aircraft near the rear door. A ladder is in position next to the airplane and a small cart is under the right wing. In the immediate foreground, a ladder and a cart are seen to the left. In the background trees and a car can be seen. It is during the day and the sky is clear with a few clouds.

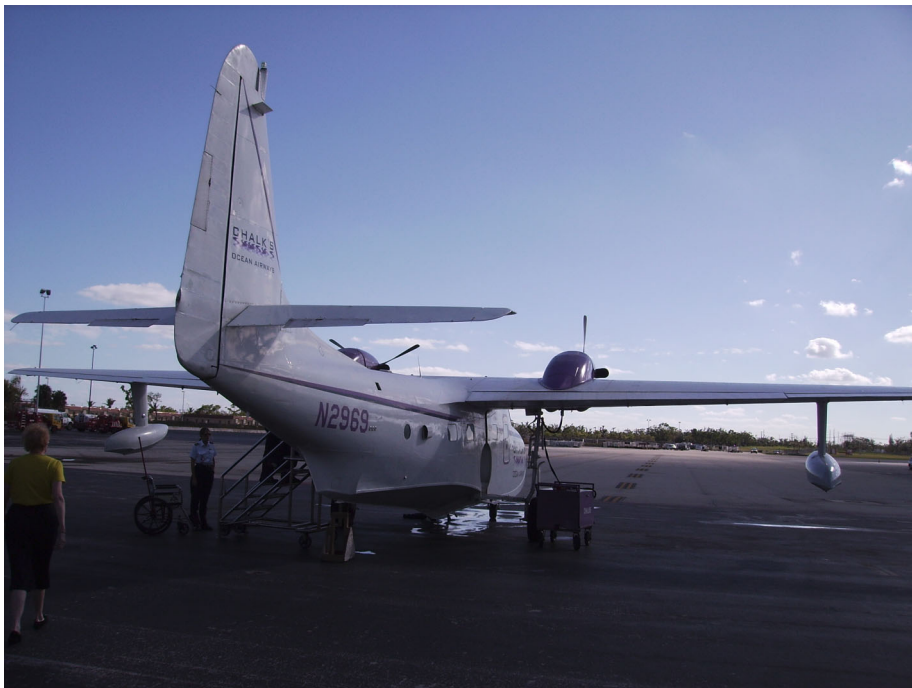
Figure 13 – Still Image 4

Still Image 4 [Reference Figure 13] also captures the airplane on the apron at an unspecified location. The right-rear of the airplane can be seen. There is one person in a pilot's uniform standing next to a ladder on the left side of the airplane. A woman is seen walking towards the airplane. A wheelchair is next to the ladder and a cart is under the right wing. It is daytime and the sky appears clear.

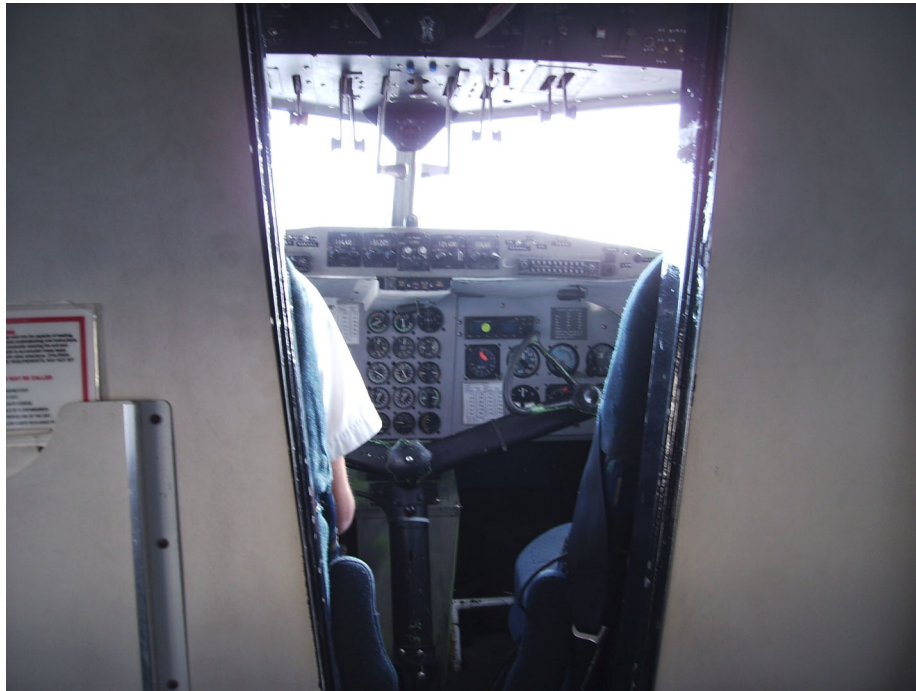
Figure 14 – Still Image 5

Still Image 5 [Reference Figure 14] is a view of the cockpit taken from the cabin. The left seat is occupied and the right seat is unoccupied. The visible gauges indicate both engines are running.

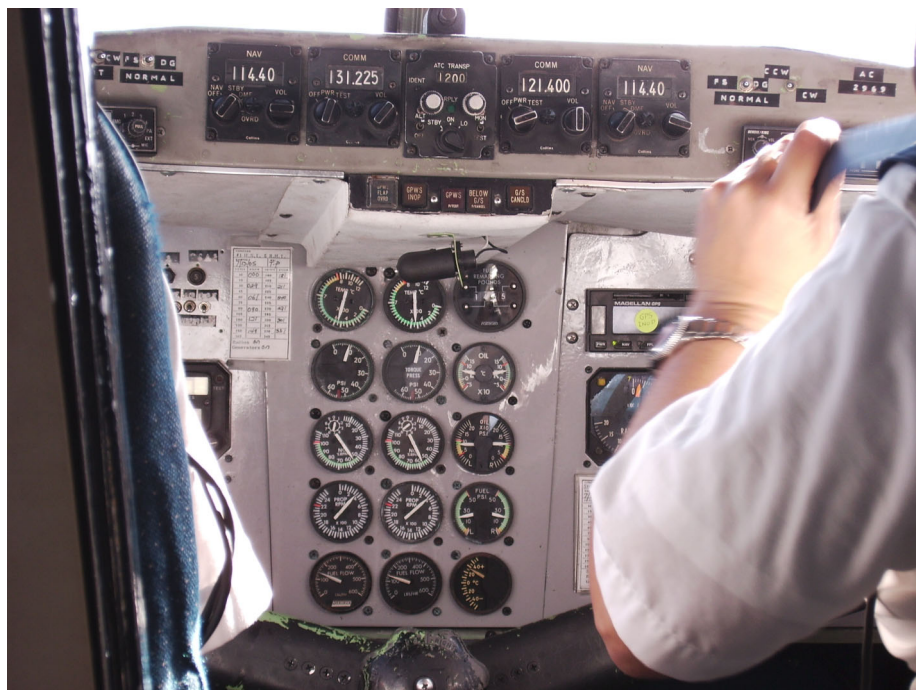
Figure 15 – Still Image 6

Still Image 6 [Reference Figure 15] is another view of the cockpit taken from the cabin. Both seats are occupied and the gauges indicate the engines are running.

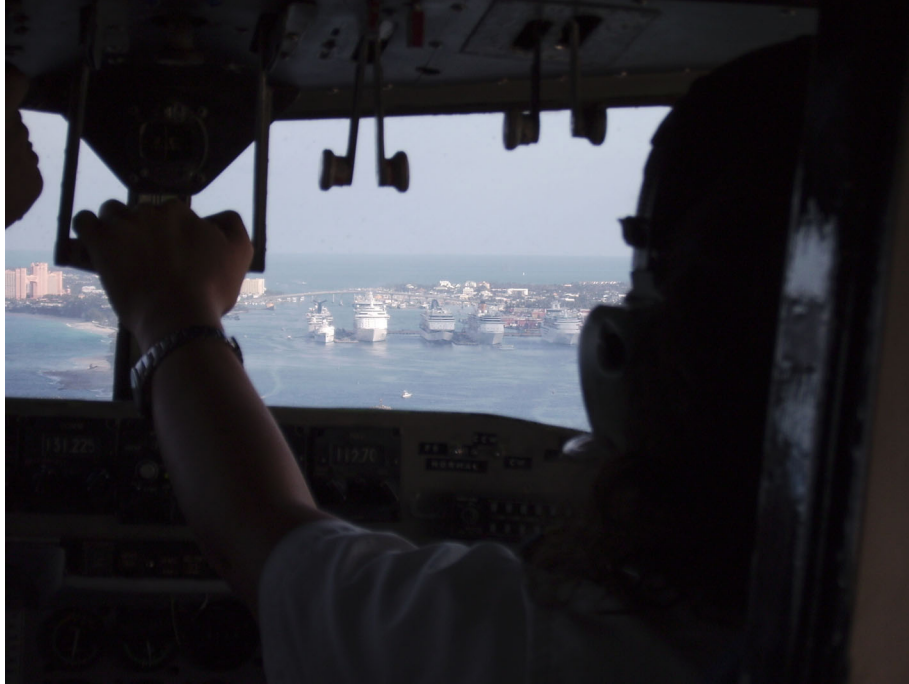
Figure 16 – Still Image 7

Still Image 7 [Reference Figure 16] is a view out of the front windscreen, through the cockpit, from the cabin. The right seat is occupied and the left seat is out of view. The pilot in the right seat has his or her hand on a lever that is mounted on the ceiling. Outside of the airplane, a large resort, a bridge, and cruise ship docks with six cruise ships can be seen. The airplane appears to be airborne.

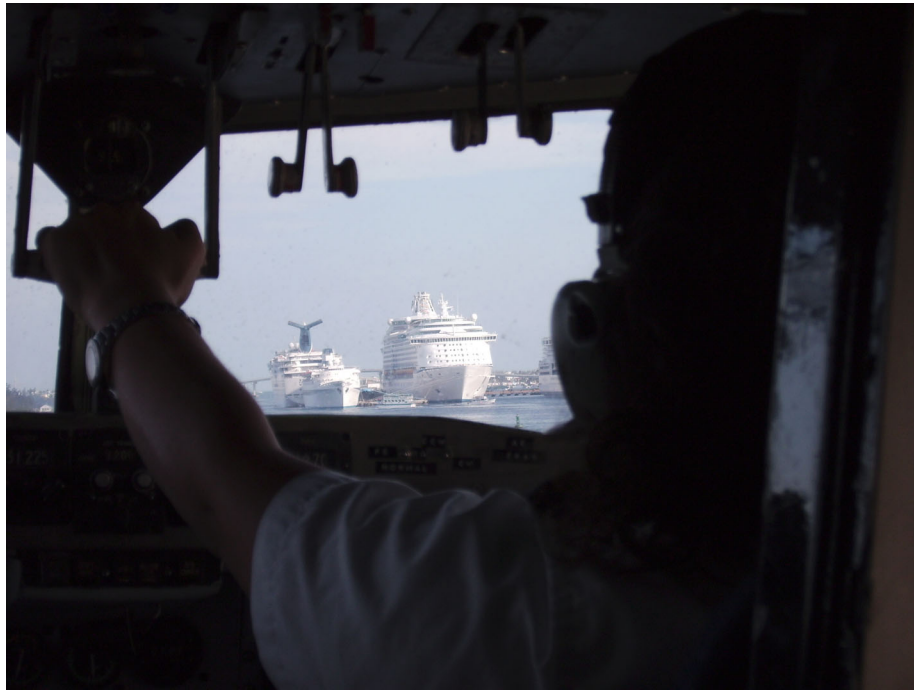
Figure 17 – Still Image 8

Still Image 8 [Reference Figure 17] is also a view out of the front windscreen similar to Still Image 7. The cruise ship docks and four cruise ships are seen. A water taxi is also present. The location of the airplane is lower than in Still Image 7, and could be on or near the water surface.
