**NATIONAL TRANSPORTATION SAFETY BOARD**

**Video/Image Study**

**CHI06FA210**

Location: Sullivan, MO  
Date: July 29, 2006  
Time: 1345 Central Daylight Time  
Aircraft: de Havilland DHC-6-100, registration N203E

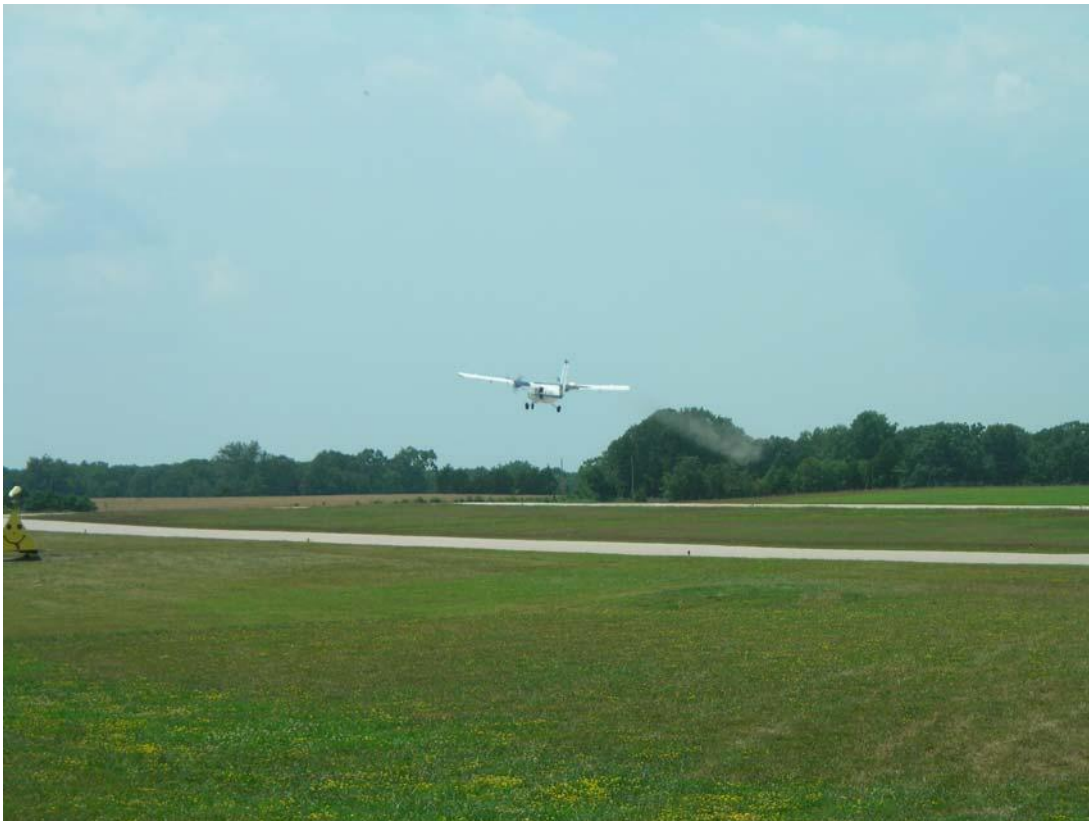
**Figure 1 - Photograph taken from ground**

The digital still photograph was taken from the ground, viewing the airplane as it departed near the end of runway 24.

The photograph shows smoke trailing from the airplane, the right propeller rotating at a slower speed than the left propeller, and a bright yellow/orange area near the right engine. Metadata<sup>1</sup> retrieved from the original image files indicate that the picture was taken on July 29 at 19:57:29 (according to the camera's internal clock) with a shutter speed of 1/336 second, and an aperture of F5.3. The image was imported into a computer drafting program to measure the "smearing" of the propeller blade, caused by motion blur.

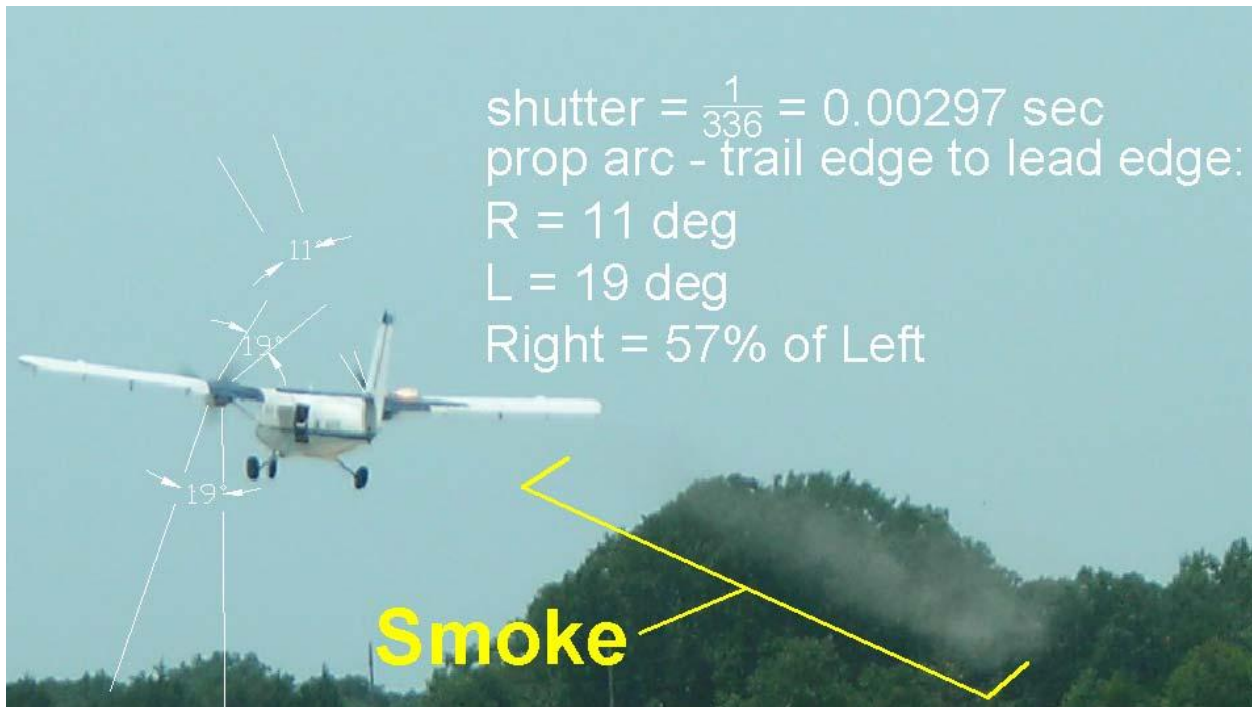
**Figure 2 - Enlarged area of photograph**

The "smearing" of one propeller blade on the left engine was measured to be about 19 degrees, compared to about 11 degrees on the right engine.
