NATIONAL TRANSPORTATION SAFETY BOARD

17 - Video Factual Report

**Specialist's Factual Report
by Bill Tuccio**

Location: Scottsdale, Arizona
Date: July 9, 2012
Aircraft: Mooney M20L
Registration: N137MP
Operator: Private
NTSB Number: WPR12FA297

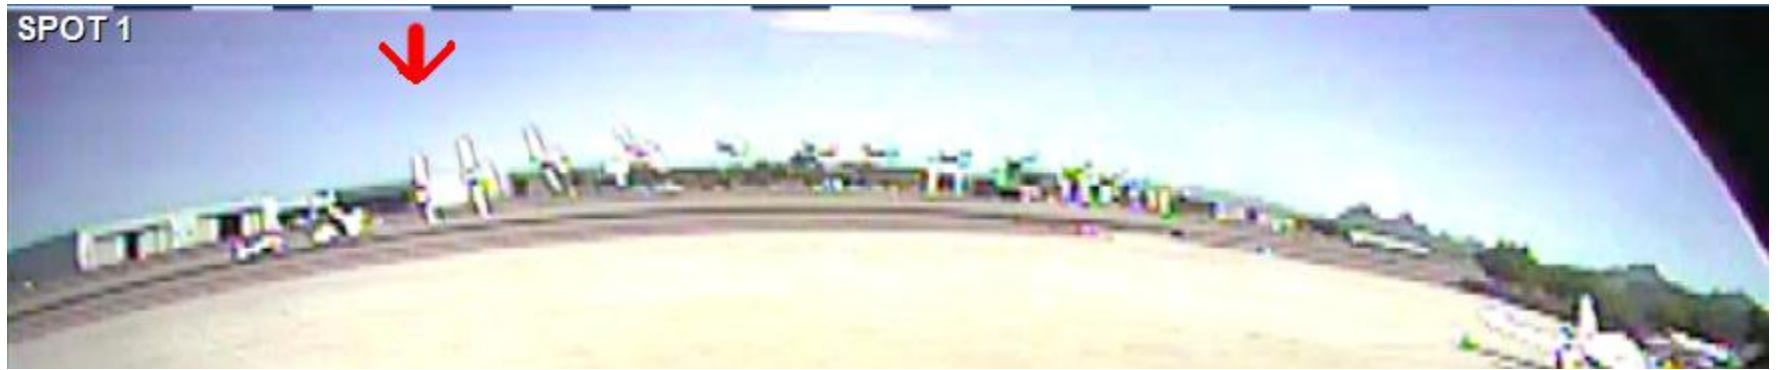
Figure 2. FBO security video - time-lapse view of accident sequence (annotated).

The time-lapse sequence shows a side view of the aircraft accident sequence in the vicinity of runway 21. The frames in Figure 2 show the aircraft moving from right to left in the time-lapse representation. As the accident sequence progresses, the aircraft bank angle progressively increases. The left wing impacts the ground at about the location shown by the arrow in Figure 2 (snapshot 48).

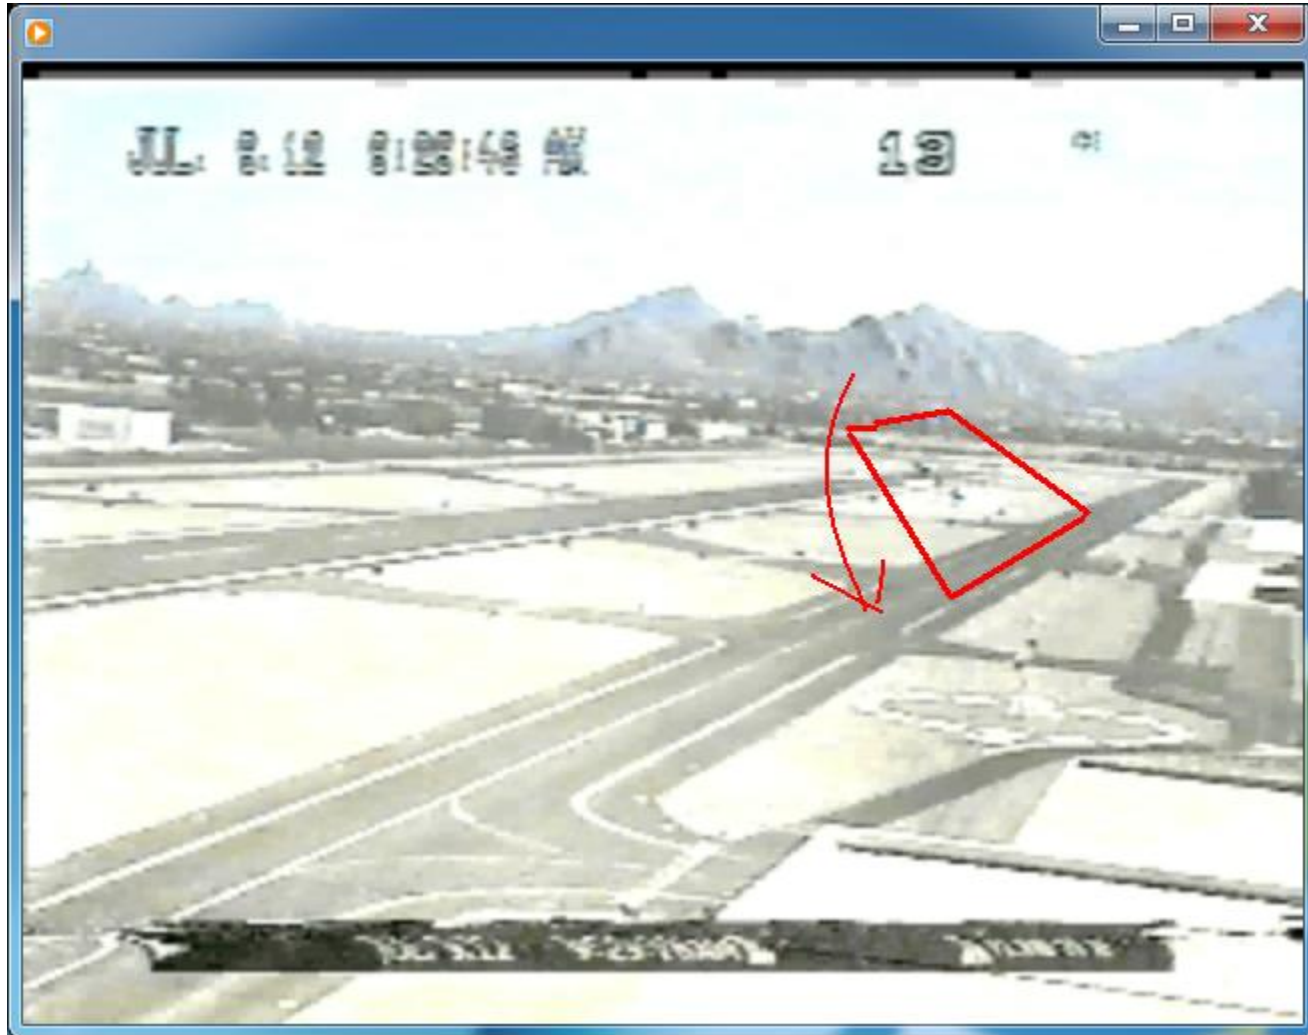
Figure 3. Tower video - time-lapse view of accident sequence (annotated).

Figure 3 shows the aircraft lateral path deviated to the left, south of the runway, during the accident sequence. The aircraft came to rest in the grass, near the taxiway paralleling the runway.
