**NATIONAL TRANSPORTATION SAFETY BOARD
Office of Research and Engineering
Vehicle Recorder Division
Washington, D.C. 20594**

GROUP CHAIRMAN'S FACTUAL REPORT OF INVESTIGATION

WPR13FA370

Location: Paradise, California
Date: August 13, 2013
Aircraft: Champion 7GCAA, N9607S
Operator: Private
NTSB Number: WPR13FA370

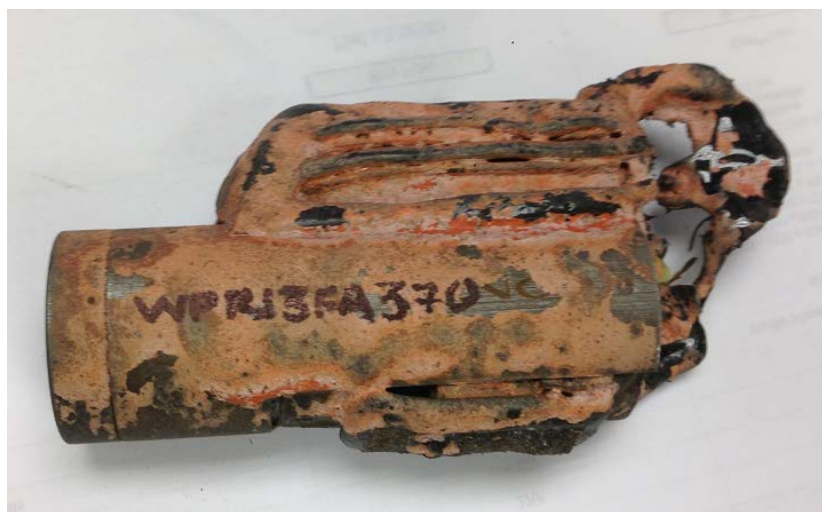
The camera suffered significant heat and structural damage, as shown in figures 1 through 3. Figure 4 shows the camera model after the damaged lens was removed. Despite the damage to the camera, the 32GB microSD card was not physically damaged and was removed from the camera without difficulty, as shown in figure 5. The mounting configuration of the camera is shown in figure 6, using an exemplar aircraft. According to the operator, the camera was typically pointed down about 45 degrees relative to the longitudinal axis of the aircraft.

Figure 1. Contour+2 camera side view.

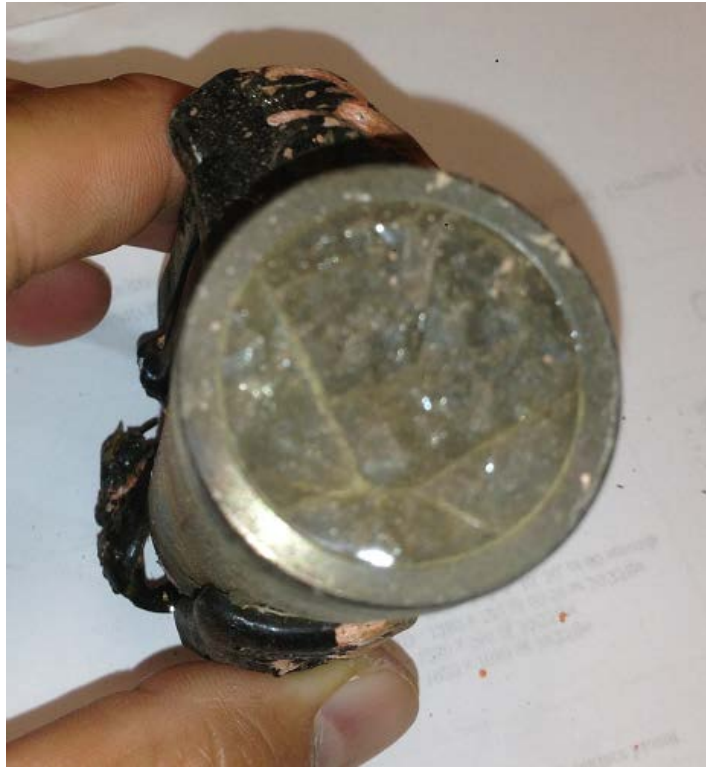
Figure 2. Contour+2 lens view.

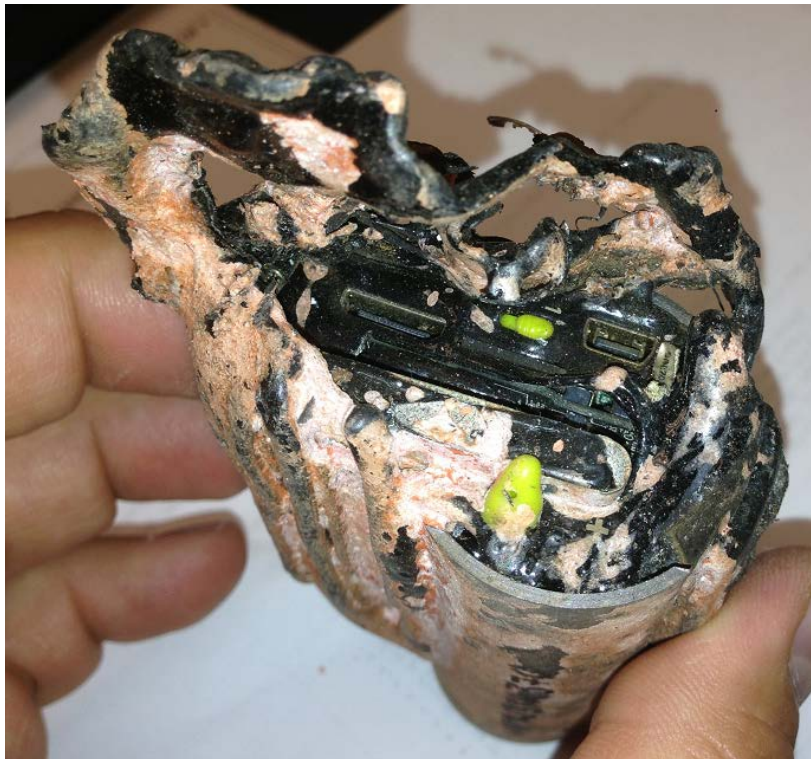
Figure 3. Contour+2 back view.

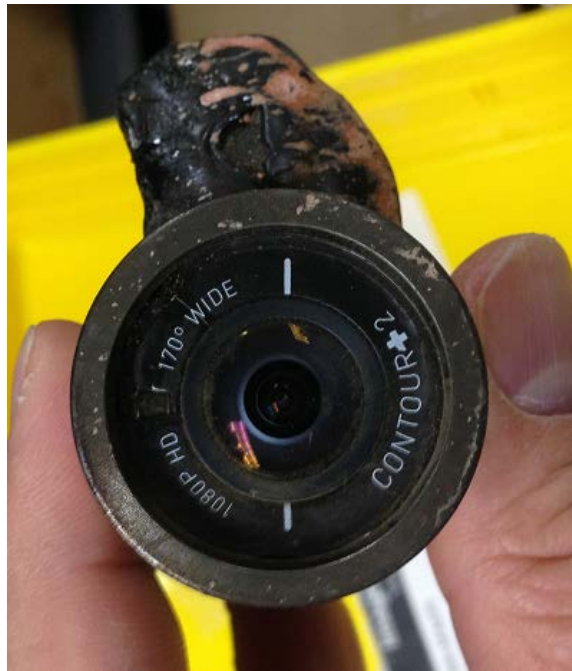
Figure 4. Contour+2 after damaged lens removed.

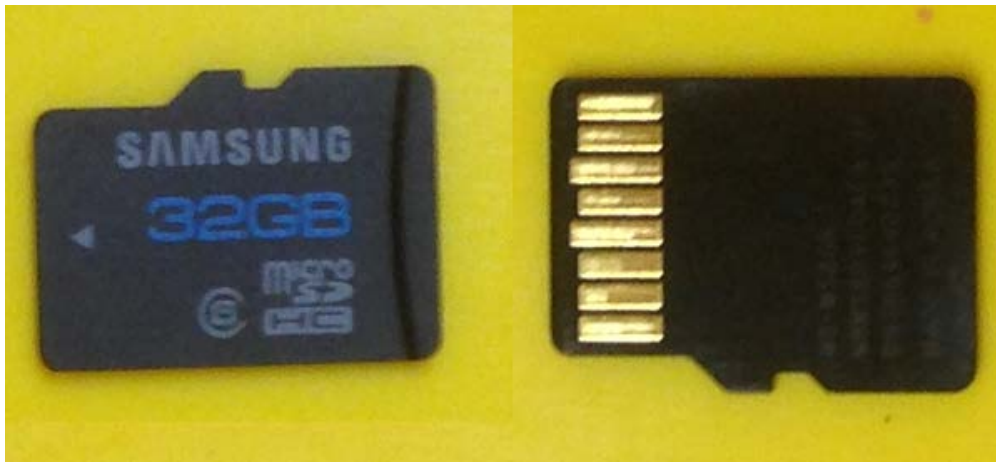
Figure 5. Contour+2 microSD card removed from camera.
