NATIONAL TRANSPORTATION SAFETY BOARD
Office of Research and Engineering
Washington, D.C. 20594

Video Study

NTSB Case Number:
WPR13FA370

Location: Paradise, California
Date: August 13, 2013
Time: 11:30 AM
Airplane: Champion 7GCAA, N9607S

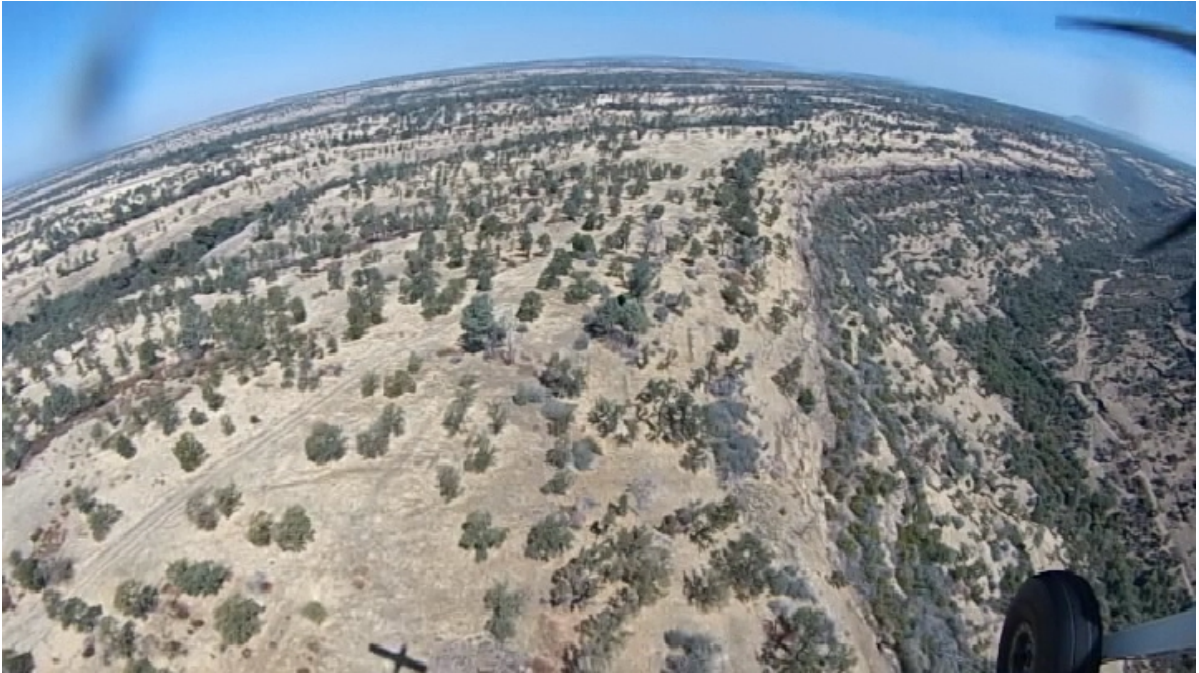
The airplane had a Contour+2 camera mounted on it. The camera was pointed forward and was pitched down relative to the horizontal plane. It recorded continuous video with resolution of 1280x720 and frame rate of 30 frames per second. The camera used a wide-angle lens that severely distorted the images. Figure 1 shows a typical frame from the video that illustrates the distortion.

Figure 1 Distorted Frame from Video

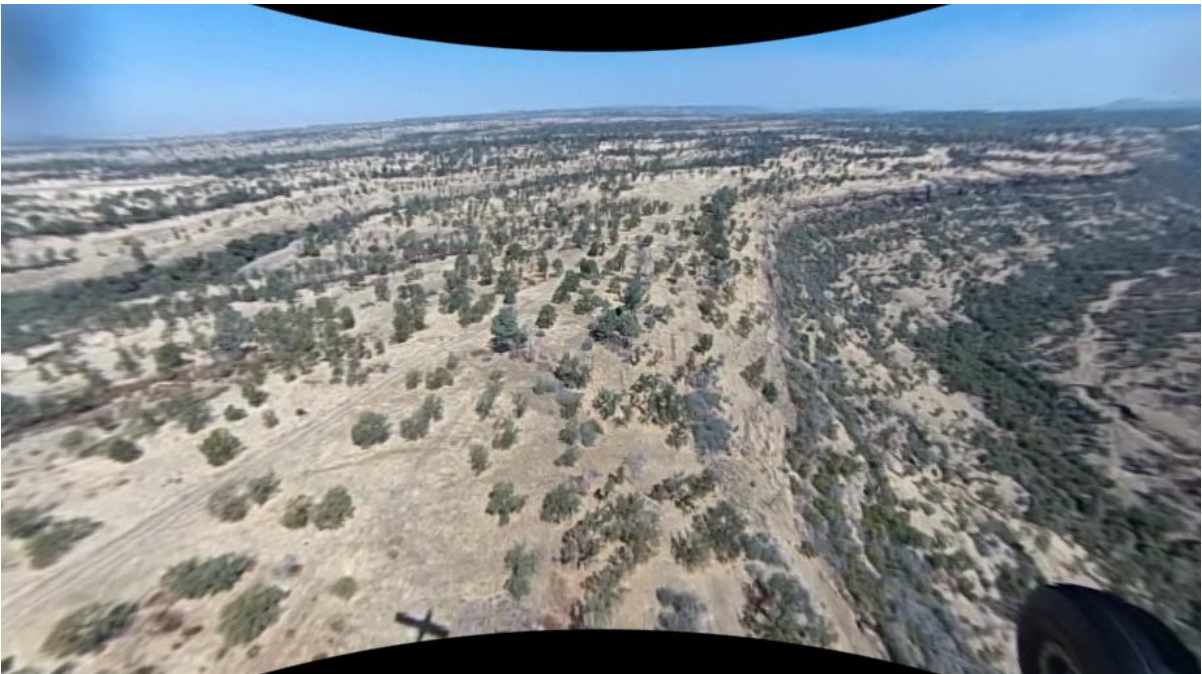
Figure 2 Corrected Frame from Video

The distortion was corrected mathematically to generate a video that had only small residual distortion. Figure 2 shows a corrected version of the distorted video frame from Figure 1. The black areas in the corrected video frame correspond to areas that were outside of the distorted frame. The distortion correction is most accurate near the center of the frame. It is least accurate near the corners of the image where it did not matter because the analysis described below did not rely on information near the corners.

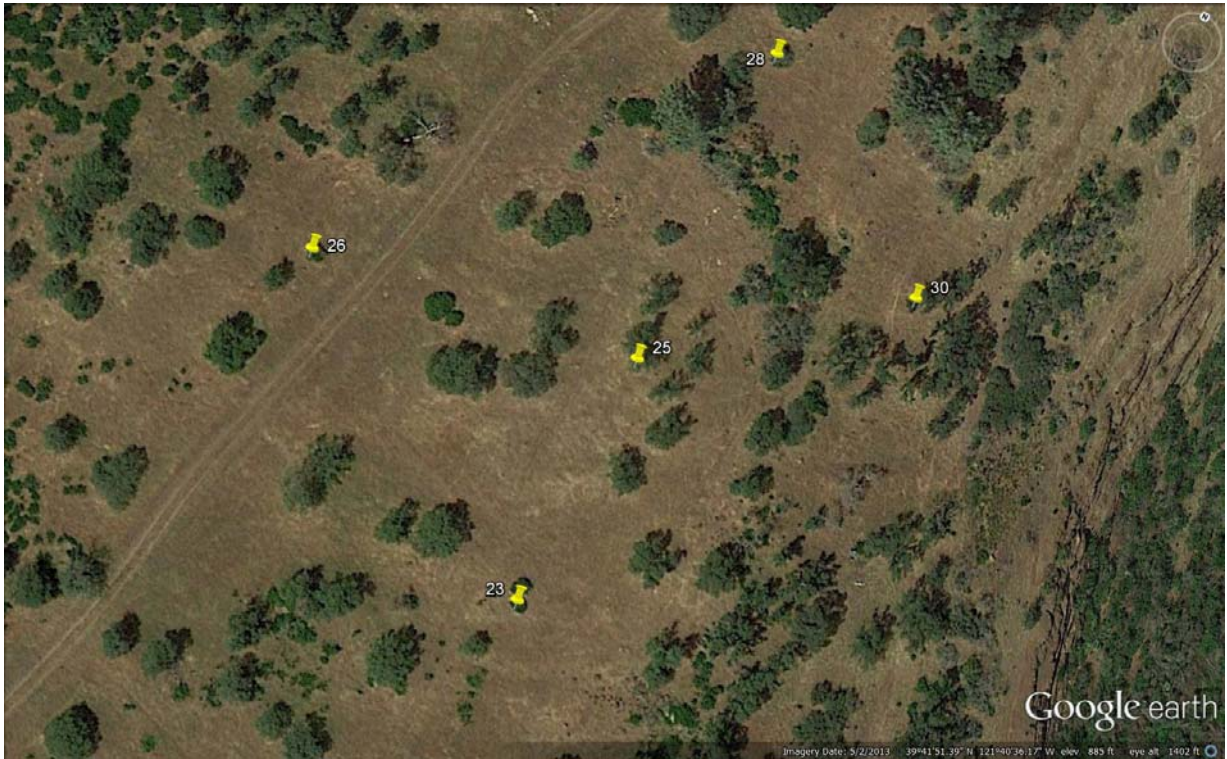
Figure 3 Aerial Image from Google Earth with Five Marked Reference Points

The first step toward location and orientation estimation was identification of reference points on the ground in Google Earth and correlating them with their images in the video. Google Earth imagery at the accident location was acquired in May of 2013, less than five months before the accident. Consequently, the images of bushes and trees in the video and in Google Earth were similar and the use of bushes and trees as reference points was feasible. Figure 3 shows five reference points marked on an aerial image from Google Earth. Figure 4 shows these points as seen in a video frame.

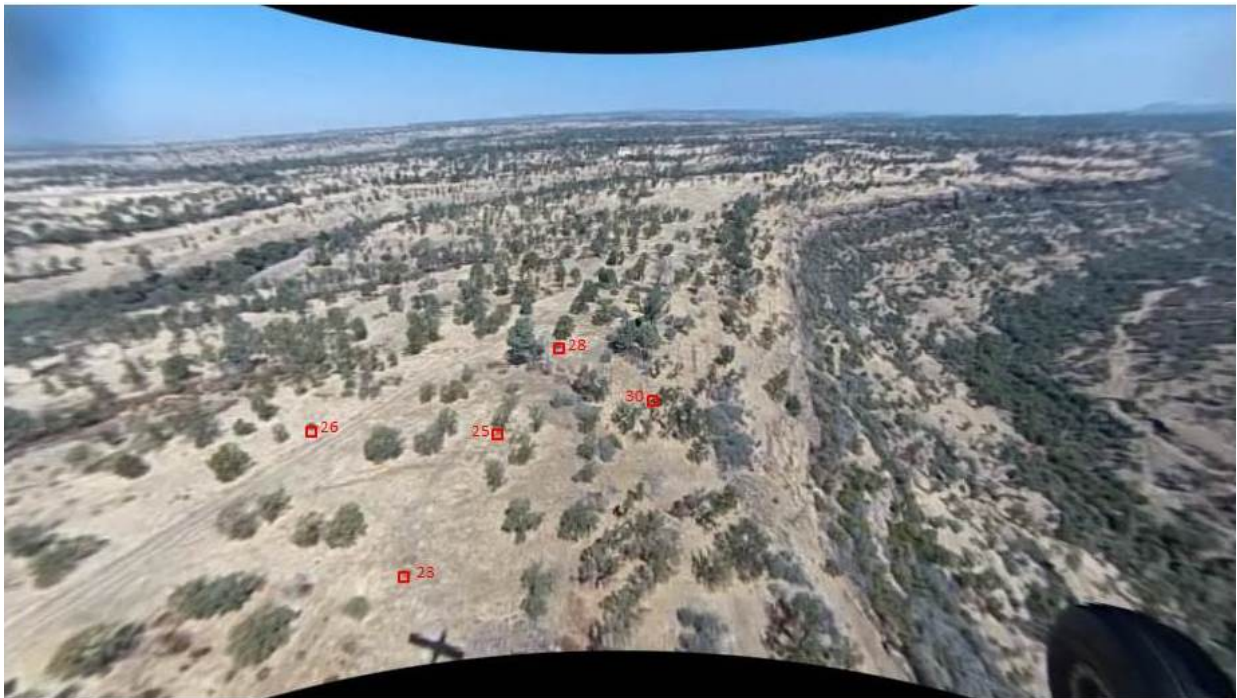
Figure 4 Video Frame Showing the Five Reference Points Seen in Figure 3

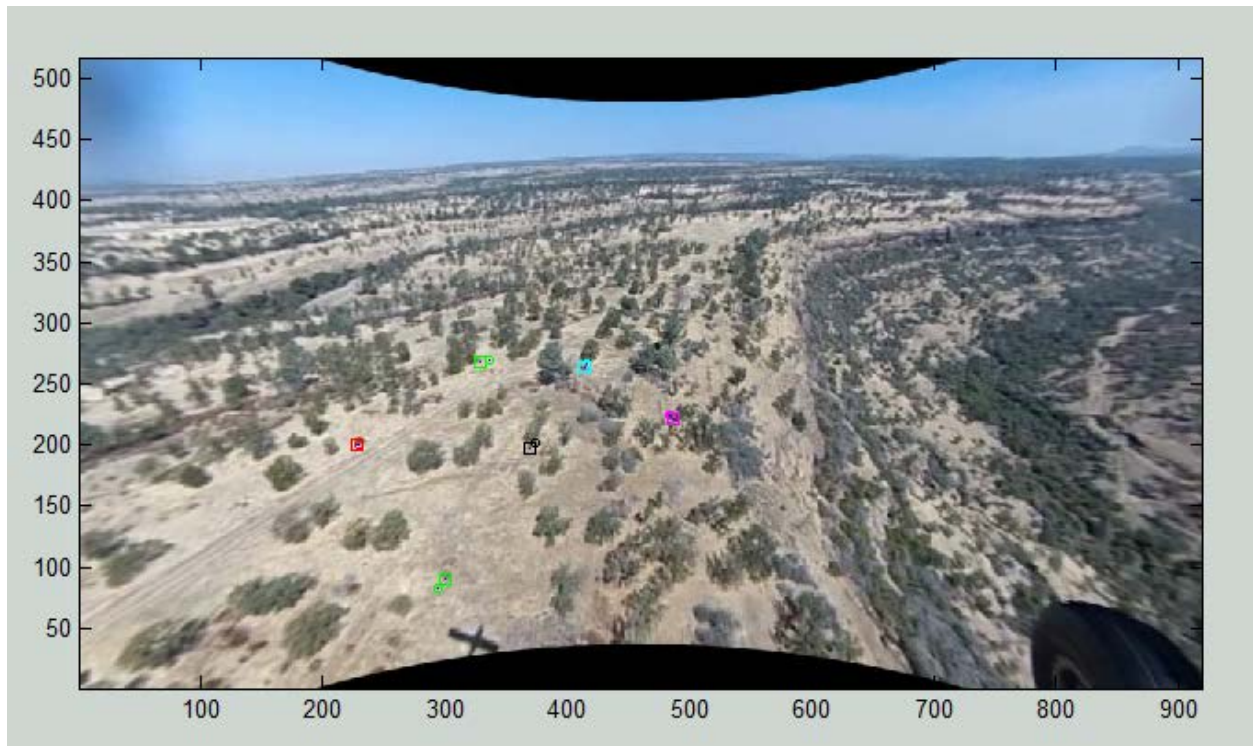
The third step was an iterative process in which a user moved and rotated the simulated camera until synthesized reference points mapped onto a video frame were aligned with the images of these reference points in the frame. Figure 5 shows a video frame with six reference points marked on it (squares) and six mapped synthesized points (circles) after alignment.

Figure 5 Reference Points (squares) and Mapped Reference Points (circles)

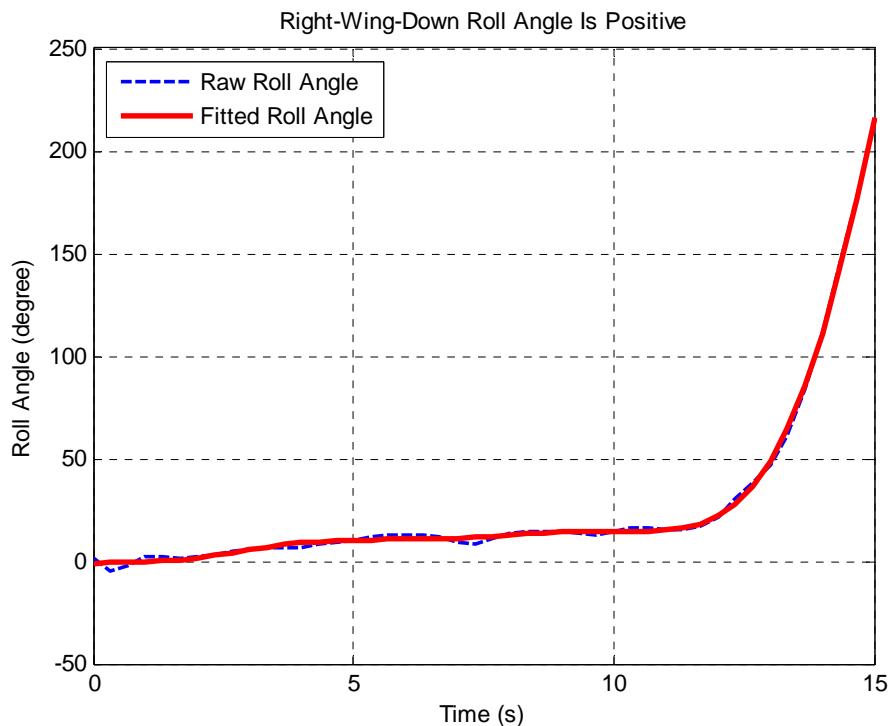
Over the next 2.7 seconds, the roll angle increased from 15° to 180° , corresponding to an average roll rate of 61 degrees/second. When the roll angle was 180° and the airplane was flying upside down, the roll rate was approximately 105

The roll angle and the roll rate are shown in Figures 6 and 7, respectively. Time zero seconds in these figures is set at 20 seconds before ground impact. Roll rate was computed by differentiating the roll angle signal. Differentiation is sensitive to measurement noise and when the raw roll angle estimate was differentiated, the raw roll rate signal was noisy. Therefore, a polynomial was fitted to the raw roll angle signal and differentiated analytically to get a noise-free roll rate signal estimate. Figures 6 and 7 show both the raw and the fitted signals. The fitted curve in Figure 7 is a better estimate of the roll rate than the raw roll rate curve.

Figure 6 Roll Rate Estimate (airplane hit ground at time 20 s)

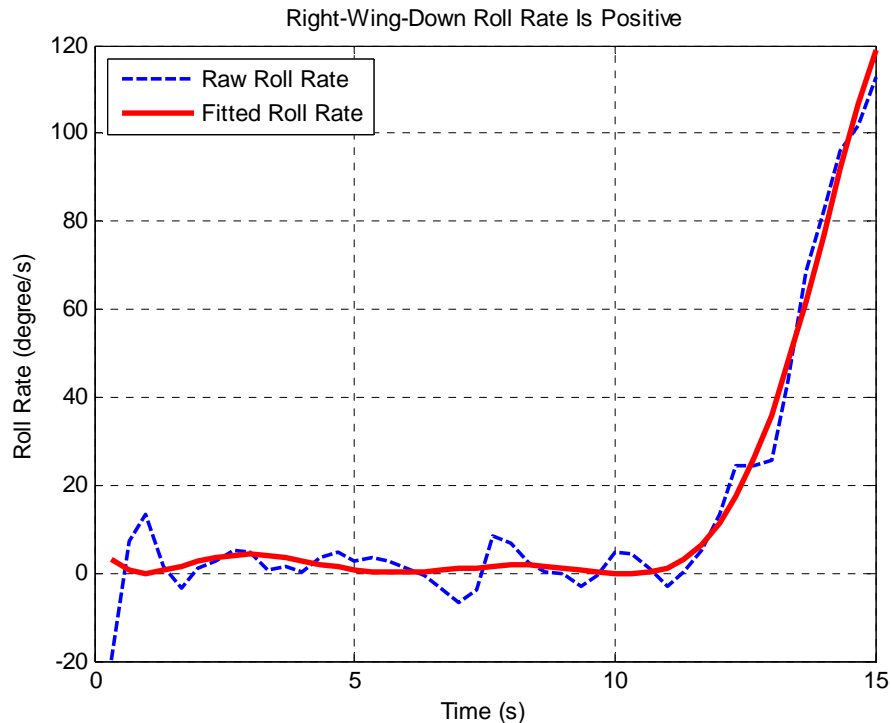
Figure 7 Roll Rate Estimate (airplane hit ground at time 20 s)
