NATIONAL TRANSPORTATION SAFETY BOARD
Office of Research and Engineering
Washington, D.C. 20594

Video Study

**NTSB Case Number:
HWY17MH005**

Location: Palm Springs, California
Date: October 23, 2016
Time: 5:16 a.m. PDT
Vehicle: 1996 MCI motorcoach

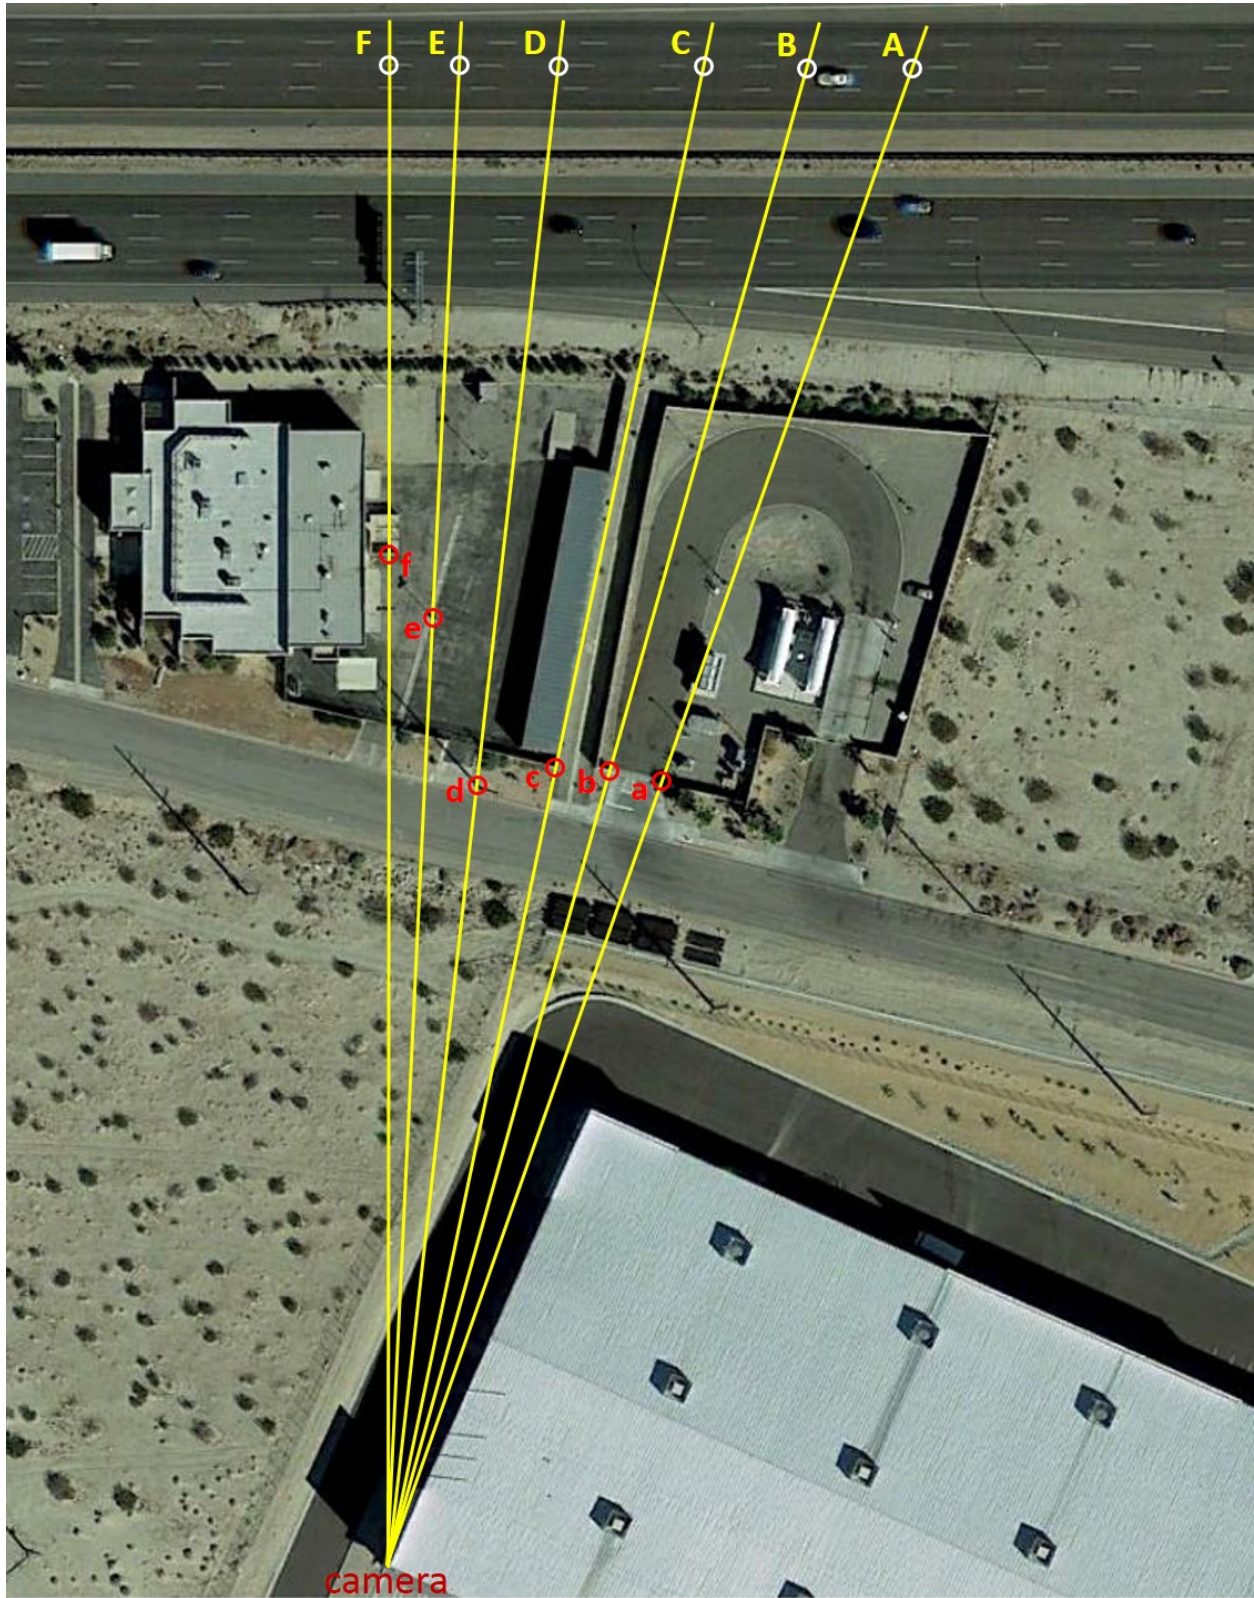
Figure 1. Aerial View of Highway Segment where Speed Was Estimated

Figure 1 shows an aerial view of the highway segment where speed estimation was performed as well the location of the West Yard South camera. The blue arrow indicates the direction of motion of the motorcoach. The seven yellow lines originating from the camera location are lines of sight passing through reference points. The reference points are marked a through f. These points included fence edges and light poles. Figure 2 shows a video frame on which reference point b is marked. It is the edge of a fence to which a metallic gate is attached. Figure 3 shows reference point b in Google Earth Street View.

The lines of sight in Figure 1 are extended through all the lanes of the highway. It is assumed that the motorcoach was traveling in the second lane when recorded by the West Yard South camera. Its left side would then be close to the lane line between the second and the third lanes. Therefore, motorcoach locations A through F are marked along this lane line.

The speed of 67.5 ± 2 mph was estimated assuming that the motorcoach was traveling in the second lane. As seen in Figure 1, the estimated distances along the highway are longest if the motorcoach is assumed to be in the first lane, resulting in the highest possible speed estimate. If the motorcoach was traveling in the first lane, the speed estimate is 68.5 ± 2 mph.

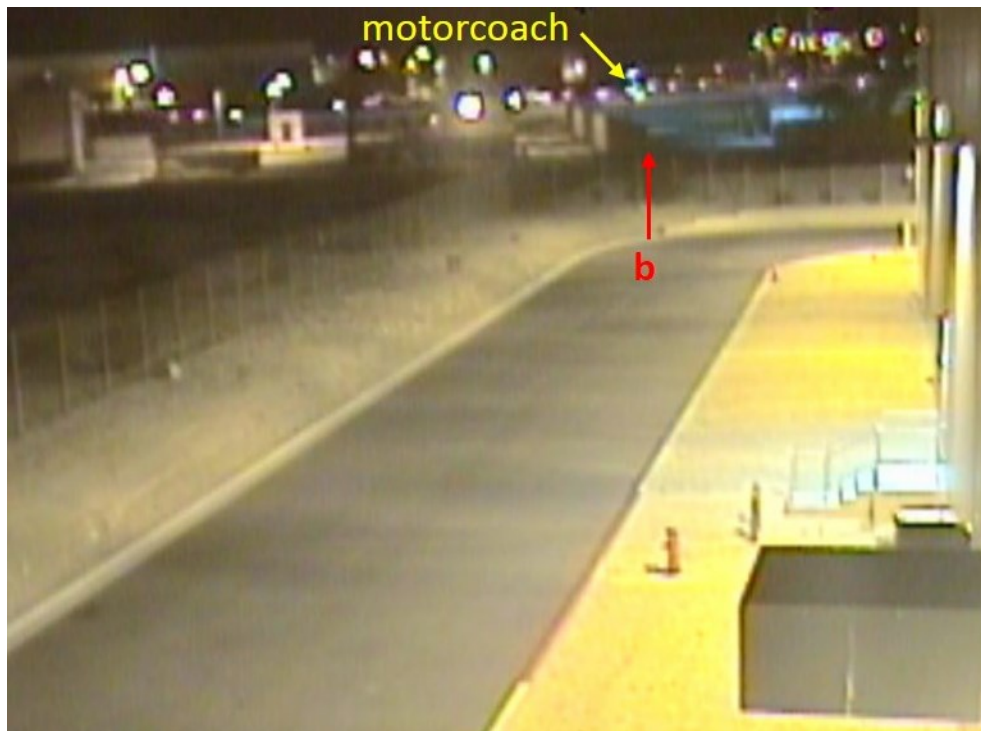
Figure 2. Video Frame Showing Reference Point b and Motorcoach Location

The times when the front of the motorcoach was at locations A through F were determined by inspecting the video frames for alignment of the front of the motorcoach with reference points a through f. Figure 2 shows a frame where the motorcoach is approximately aligned with reference point b. Because of poor visibility, the motorcoach cannot be identified in a frame just by inspecting that one frame. However, by stepping through the video one frame at a time, the moving image of the motorcoach makes its identification in video frames possible.

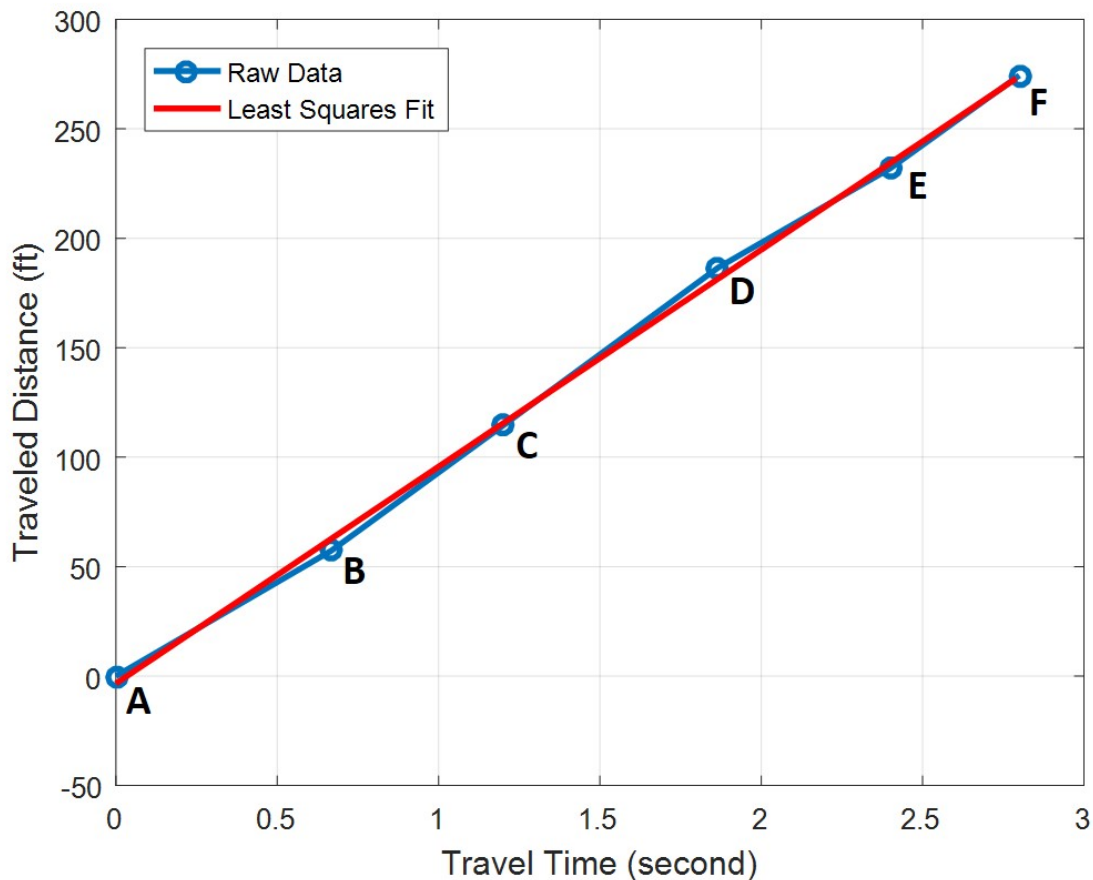
Figure 4. Distance Traveled by the Motorcoach vs. Time

Figure 4 shows a plot of the distances along the highway vs. the time when the motorcoach was at locations A through F. The distance at location A and the time at that location were both set to zero. The red line in Figure 4 is a least-squares fit to the raw data. It happens to be very close to the line connecting point A with point F. The slope of the least-squares line is 67.5 mph. To account for uncertainties involved in the speed estimation process, the estimated motorcoach speed is specified as 67.5 ± 2 mph.
