NATIONAL TRANSPORTATION SAFETY BOARD
Vehicle Recorder Division
Washington, DC 20594

Video Study

Specialist's Report By Sean Payne

Location: South Bend, Indiana
Date: March 17, 2013, 16:23 EDT
Aircraft: Hawker Beechcraft model 390, N26DK
Operator: Private
NTSB Number: CEN13FA196

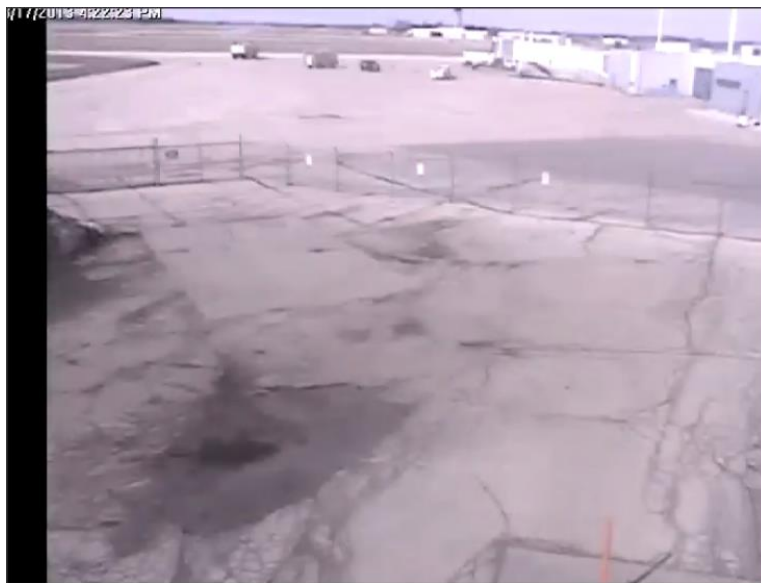
The “12 Term Maint East PTZ” security camera video primarily captured a day time view of the ramp area looking towards the north as shown in Image 4.1. The accident runway (Runway 09R/27L) can be seen at the top edge of the image.

The accident aircraft appears in the left hand portion of the frame on or near Runway 09R at 1.00 seconds elapsed recording time and crosses the image plane towards the right. The camera’s timestamp displays 3/17/2013 4:22:24 PM. The aircraft continues to cross the image plane towards the departure end of Runway 09R until the aircraft disappears behind a jetway at 4.75 seconds into the recording. Nothing else related to the accident is captured in the video and the provided recording ends at 09.125 seconds. This recording captures the aircraft’s second attempt to land based on the camera’s timestamp.

Image 4.3: A screen capture of 12 Term Maint East PTZ_3 17 2013 4 22 23 Pm (utc-04 00)-1.mp4.

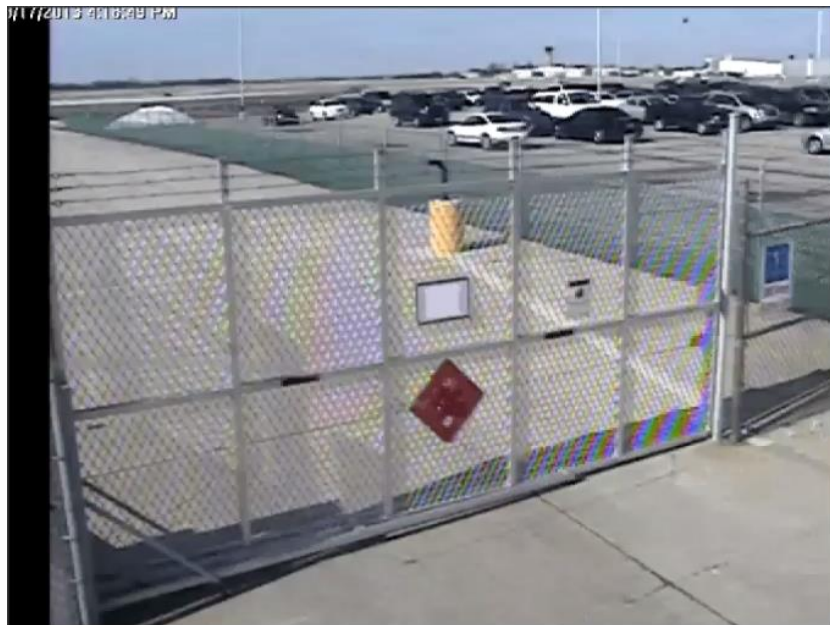
At 2.50 seconds into the recording, the accident aircraft appears in the left hand portion of the frame and is seen climbing out of the frame by 8.00 seconds. The camera's timestamp shows 3/17/2013 4:18:50 PM at the start of the recording. Approximately 03 minutes and 18.25 seconds later at 03 minutes and 26.25 seconds, the aircraft enters the frame from the left. The aircraft continues across the image plane as it moves down Runway 09R. There appears to be some change in altitude as the aircraft moves across the image plane and out of frame to the right by 03 minutes 33.25 seconds. The file captures nothing else of interest and terminates at 03 minutes and 41.00 seconds.

This recording captures both the first and second attempts of the aircraft to land at KSBN.

Image 4.5: A screen capture of “36 W. SIDA-PTZ_3 17 2013 4 18 50 Pm (utc-04 00)-1.mp4”

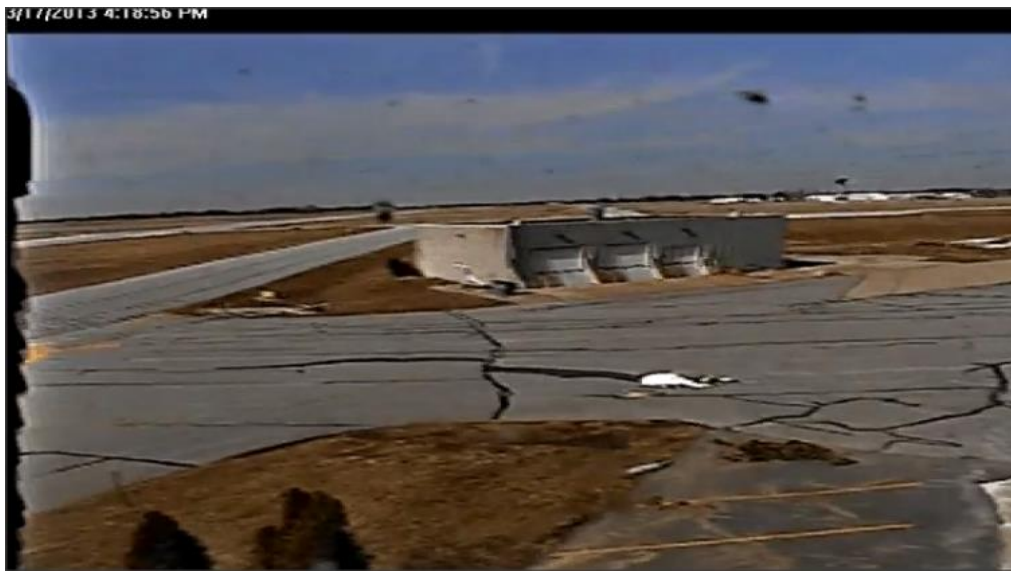
The camera shows a daytime view of primarily Taxiway N and the charted “NON-MOVE AREA” on the airport diagram along with a significant stretch of Runway 9R/27L. The control tower and runway can be seen at the upper edge of the image. The overall image is of very low quality.

At the start of the recording, the accident aircraft appears in the left hand portion of the frame and is seen moving down Runway 09R and transitioning to a climb. The timestamp displays 3/17/2013 4:18:48 PM. By 7.00 seconds elapsed time the aircraft has crossed out of the image plane to the right. Approximately 03 minutes and 16.50 seconds later at 03 minutes and 23.50 seconds, the aircraft enters the image plane from the left in a shallow descent. The aircraft continues across the image plane as it moves down Runway 09R. There appears to be a slight change in altitude (possibly a bounce) as the aircraft moves across the image plane and out of frame to the right at 03 minutes 32.50 seconds. Nothing else of interest is captured related to the accident and the file terminates at 03 minutes and 34.50 seconds.

Image 4.6: A screen capture of “46 S.W. Safety PTZ_3_17_2013 4_18_48 PM (UTC-04_00).mp4”

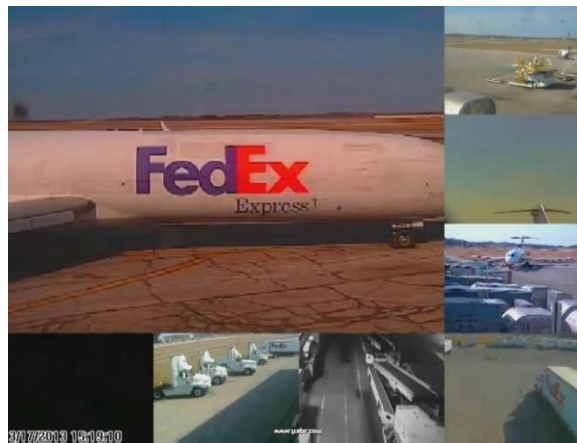
The composite feed captures the accident aircraft on three cameras. In the first file, at 00.25 seconds elapsed recording time, the accident aircraft is shown on a low approach over the threshold area of Runway 09R. The security system's timestamp displays 3/17/2013 15:19:11. The aircraft moves out of view at 04.13 seconds. At 07.26 seconds, the aircraft is shown again in the upper right feed in close proximity to Runway 09R. At 10.50 seconds, as the accident aircraft crosses out of the image plane on the upper right hand feed, it appears in the main feed moving across the runway. As the aircraft exits the camera's field of view, it is shown in a positive pitch up attitude leaving the runway. The aircraft is no longer captured by any other cameras in this file.

The second file shows the accident aircraft's second landing pass. The aircraft is shown in the same manner as the first file appearing at approximately 01 minute and 48 seconds into the new file. The security system's timestamp displays 3/17/2013 15:22:33. As the accident aircraft crosses out of view at 02 minutes and 33 seconds, the aircraft is still close to the runway and does not appear to be in a climb. The file terminates at 03 minutes and 00 seconds.

Image 4.7: A screen capture of the Fedex security camera feed which captured the aircraft from three angles. This image has been mirrored vertically from the provided file in non-linear video editing software.

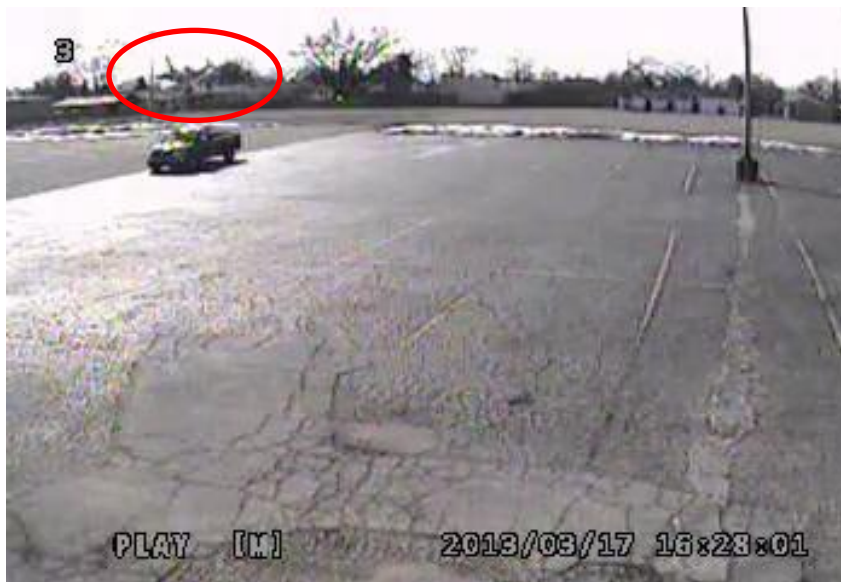
At 15.50 seconds the aircraft appears in the upper left hand corner of the image rolled steeply and approaching a housing structure. In the next frame the aircraft has begun to impact a structure. A debris cloud forms and the video ends at 43 seconds.

Image 4.8: A screen capture of "Proprietor#1_StreamCapture_000.mp4" showing the accident aircraft moments before impact.

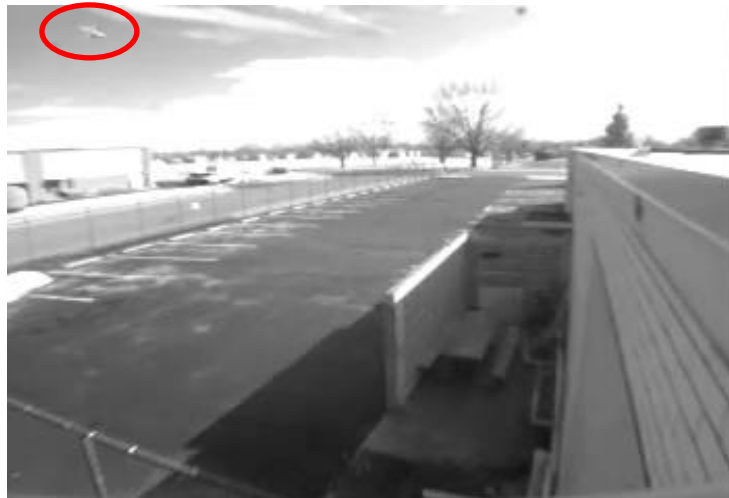
The camera captures the accident aircraft and its subsequent impact near a housing development. At 01 minute and 47.63 seconds the aircraft appears in the upper left hand corner of the image in an unknown roll attitude. The aircraft continues to appear unstable as it descends toward the treeline for 12 frames. The moment of impact is captured at 01 minute and 51.10 seconds. A debris cloud forms and the video ends at 02 minutes and 49.76 seconds.

Image 4.9: A screen capture of “PS1622_2013 03 17 16 21 00-1.mp4” showing the accident aircraft in an unknown roll condition.

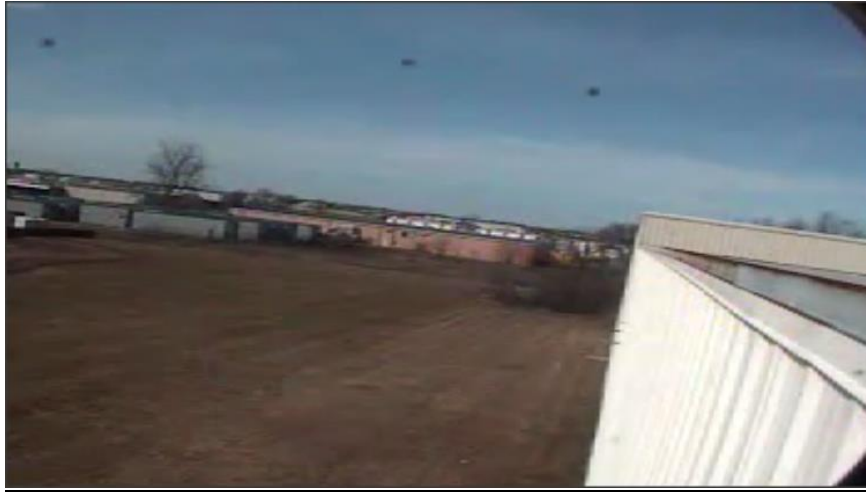
The camera captures a view of property adjacent to the business looking towards the airport. The airport does not capture the runway surface of Runway 09R/27L, however, aircraft departing Runway 09R can be seen during climb out. The camera shows the accident aircraft on the far left of the image plane leaving the Runway 09R at 01 minute and 30.86. The aircraft performs a climb until it disappears from the right of the frame at 01 minute and 38.06 seconds. The video file terminates at 02 minutes and 50 seconds without capturing any more information about the accident aircraft. There is no timestamp information.

Image 4.10: A screen capture of “PS1640_2013 03 17 16 12 00-1.mp4”

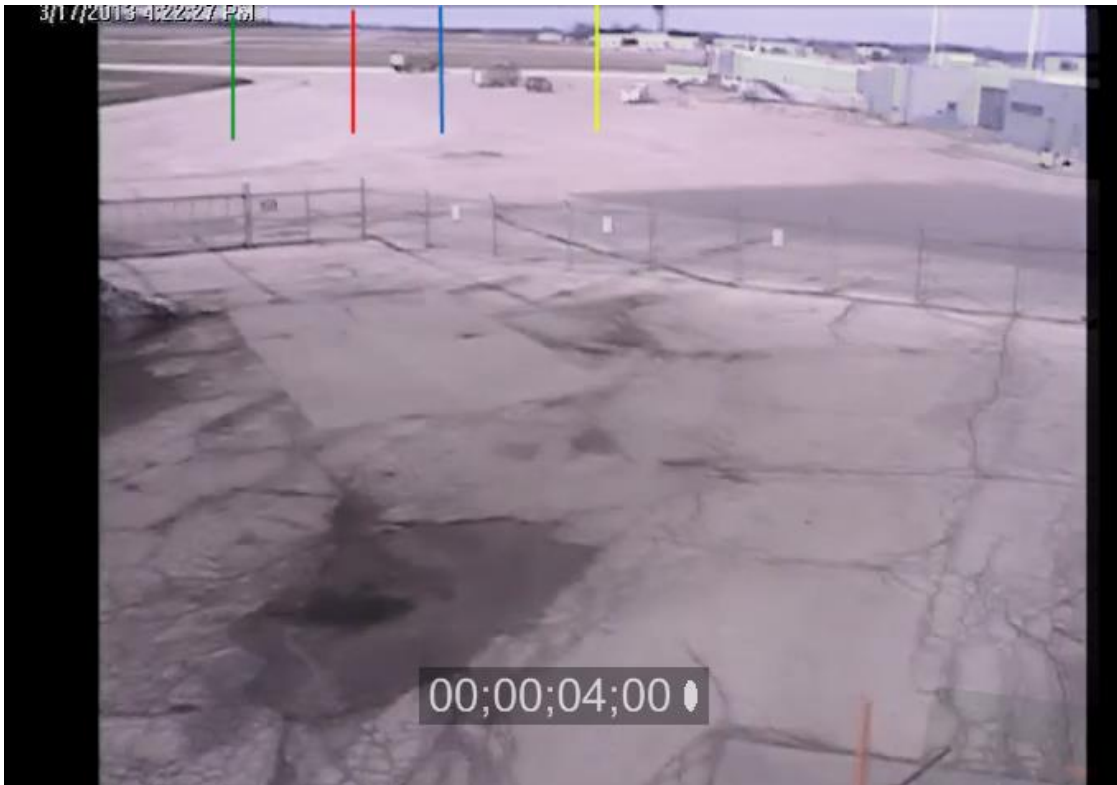
Image 4.19: Vertical lines drawn from each of the known calibration positions are used to indicate when the accident aircraft crossed each segment on the runway's centerline in reference to the security camera's perspective. In this image both the calibration recording and the accident recording are overlaid on each other with an opacity value set to 50%. A time code was added in a 30 frame per second SMPTE⁸ timecode format.

The accident aircraft is shown moving frame by frame through the image in reference to the calibration lines generated from the calibration recording. The time it takes for the aircraft's nose to move between each calibration line was then recorded. This time is displayed by the video editing software as a combination of whole seconds and a carryover frame count in a 30 frame per second timeline. The carryover frame number is an integer value which counts the number of frames from each subsequent integer second.

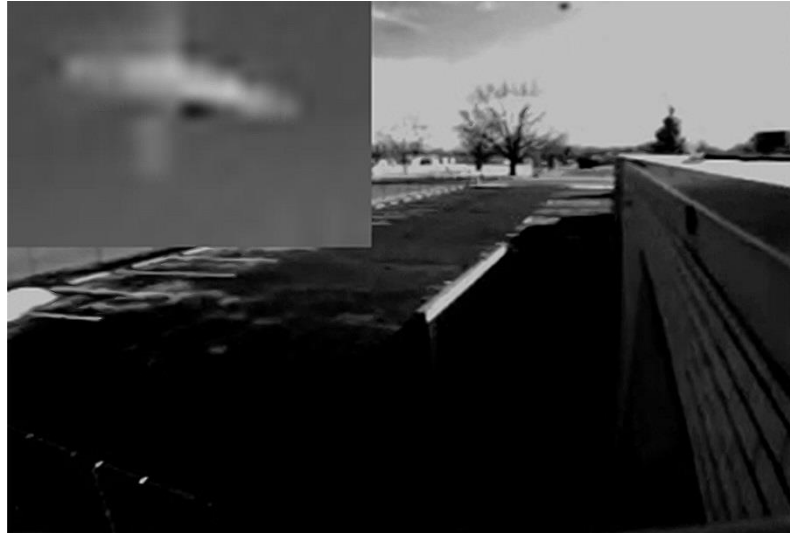
each frame at the native recording rate of 3.75 FPS. Near the departure end of Runway 09R, the aircraft is visible in an unknown roll state as it approaches the ground and impacts near a residential area.

Image 6.1: The first frame in which the aircraft is visible in the security recording. The aircraft is shown in an unknown roll upset.

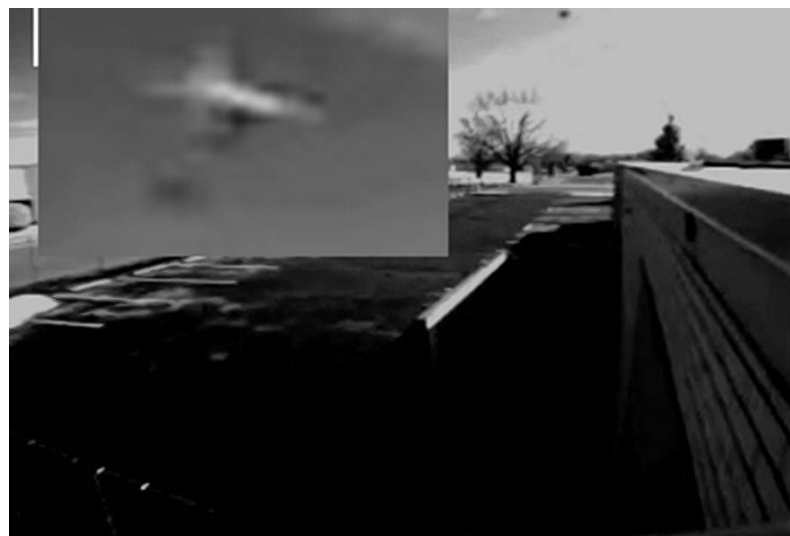
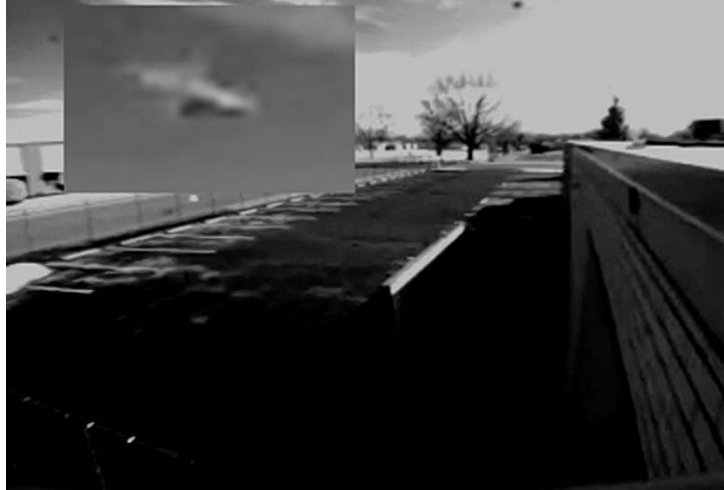
In an attempt to clarify these images, a variety of filters in a photo editing software program were used to better identify the unknown roll state. Sharpening filters were used in combination with brightness and contrast effects to achieve an improved result. In each frame, the aircraft was zoomed in on and enhanced. The results are shown in the attached images below in images 6.1 – 6.9. The particular vehicle is referred in the image description.
