**NATIONAL TRANSPORTATION SAFETY BOARD**

**Video Study Report**

**HWY07MH024**

Location: Minneapolis, MN  
Date: August 1, 2007  
Time: 1805 Central Daylight Time  
Event: Collapse of I-35W Bridge

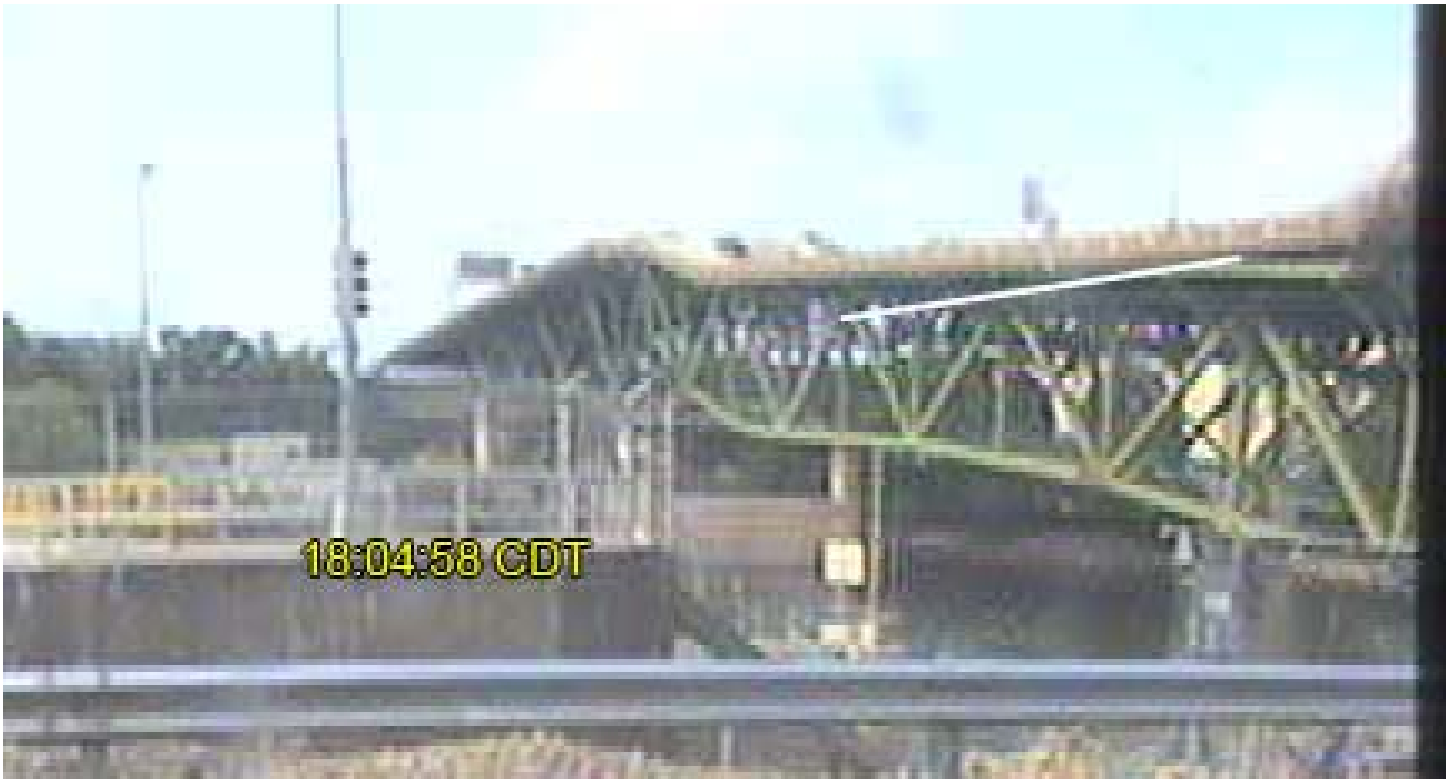
**Figure 7. North/south tilt as span 7 fell.**

Span 7 appears to have remained level about its longitudinal axis as it fell (that is, it did not tilt left or right), but did tilt north/south about its lateral axis. The north end of the span was higher than the south end as it fell. Span 7 collapsed completely into the river in slightly more than 3 seconds.

Figure 7 is the first of the three images recorded at timestamp 18:04:58. The white line represents a parallel to the horizon, at this location in the image. The white line was drawn on a precollapse image between nodes L12W and L12'W, which was assumed to represent a horizontal line in plane with the west truss, and parallel to the horizon. Figure 7 shows the difference between the outer (western) edge of the bridge deck and the white level horizontal line at 18:04:58, indicating a pitch or downward slope from north to south.

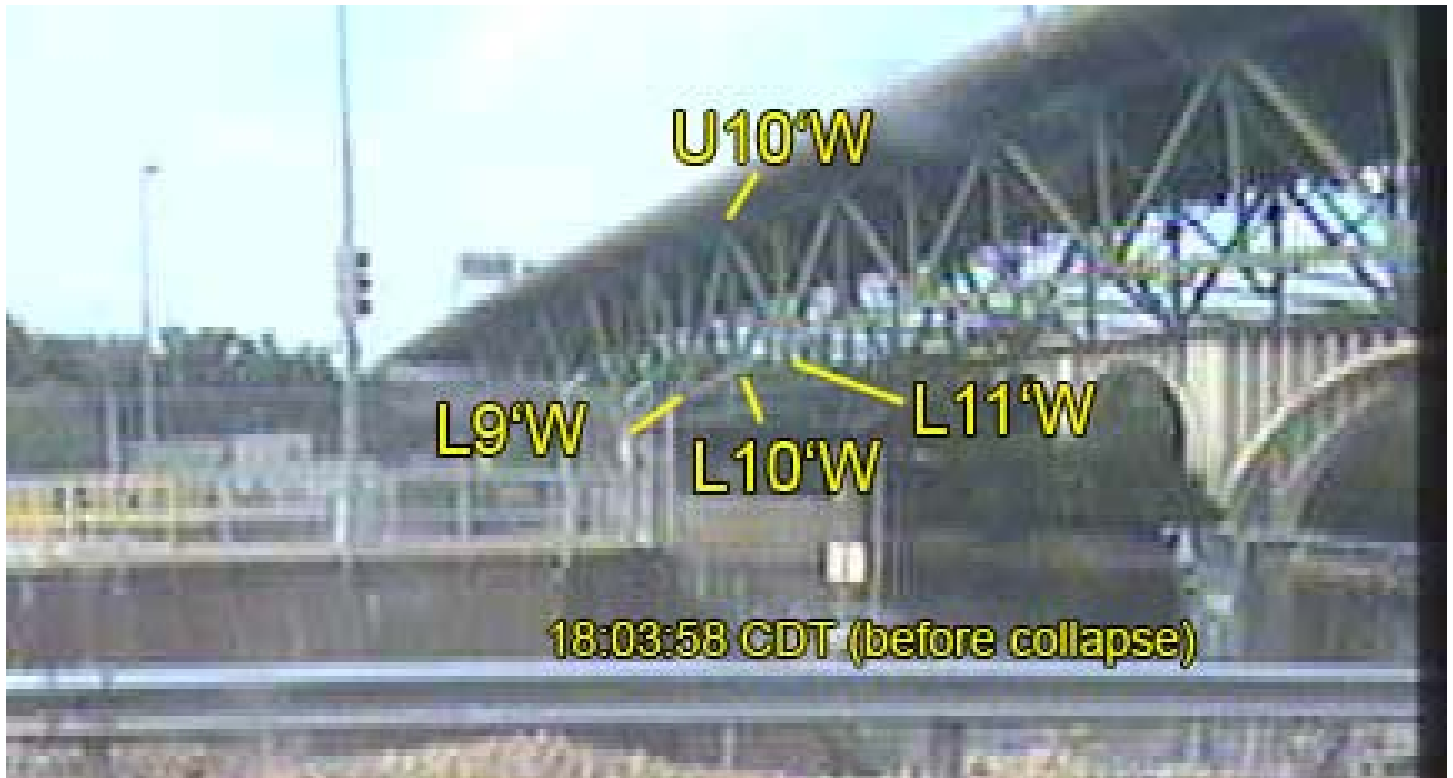
**Figure 8. Precollapse orientation of L9' / L11'W beam section.**

In the first image of the collapse (at 18:04:57), a localized displacement can be seen in beam section L9' / L11'W, at or just north of node L10'W. Figure 8 shows this area of the bridge before the collapse began.

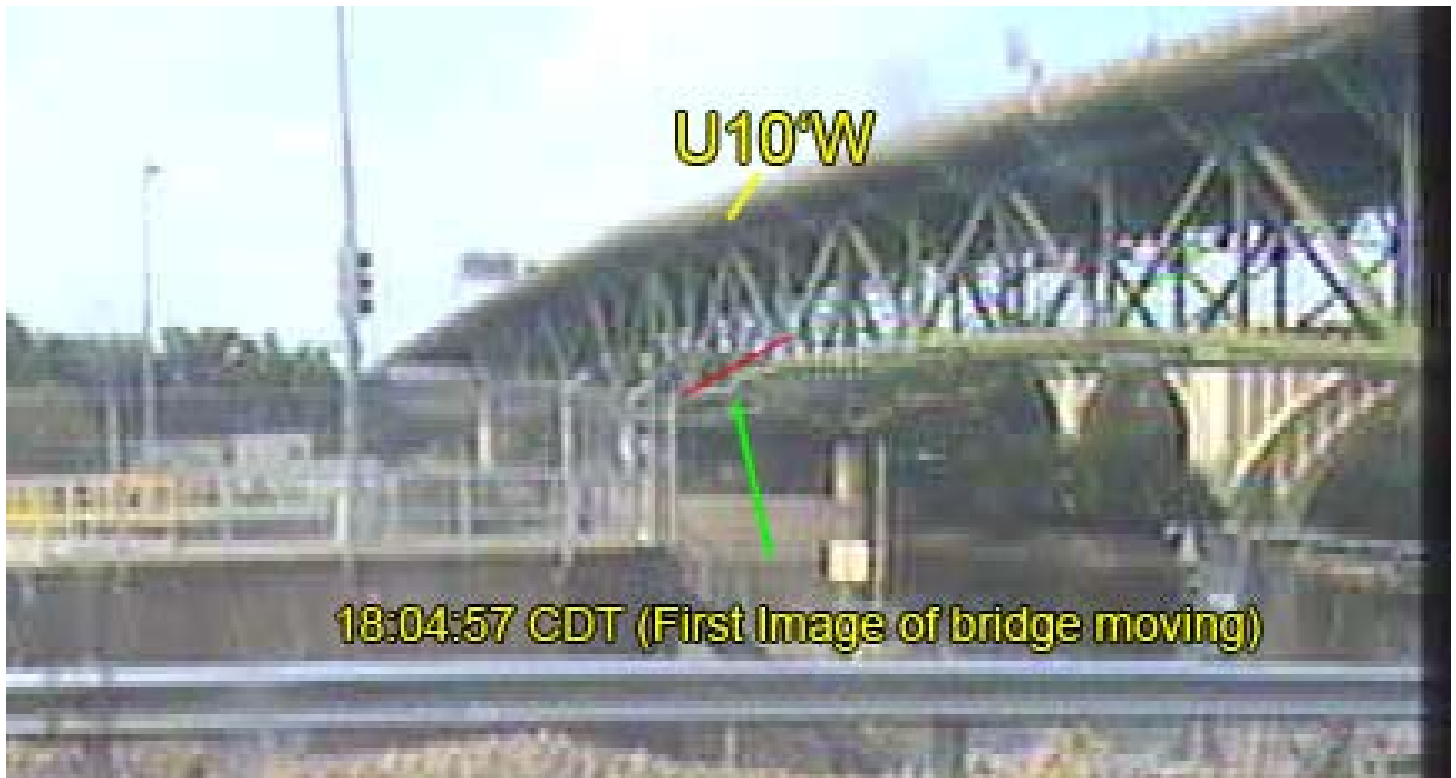
**Figure 9. Discontinuity in L9' / L11'W beam section at node L10'W.**

- A “bend” or discontinuity in beam L9' / L11' West (W)<sup>1</sup> at node L10' W.
- A separation of deck stringer 14, the westernmost stringer, from the deck at node U11W.

Figure 9 shows the first recorded image of the bridge moving. The red line shows the precollapse location/orientation of the entire beam section between nodes L9'W and L11'W. The green arrow points to the localized displacement that occurred after the bridge started moving, at or just north of node L10'W.

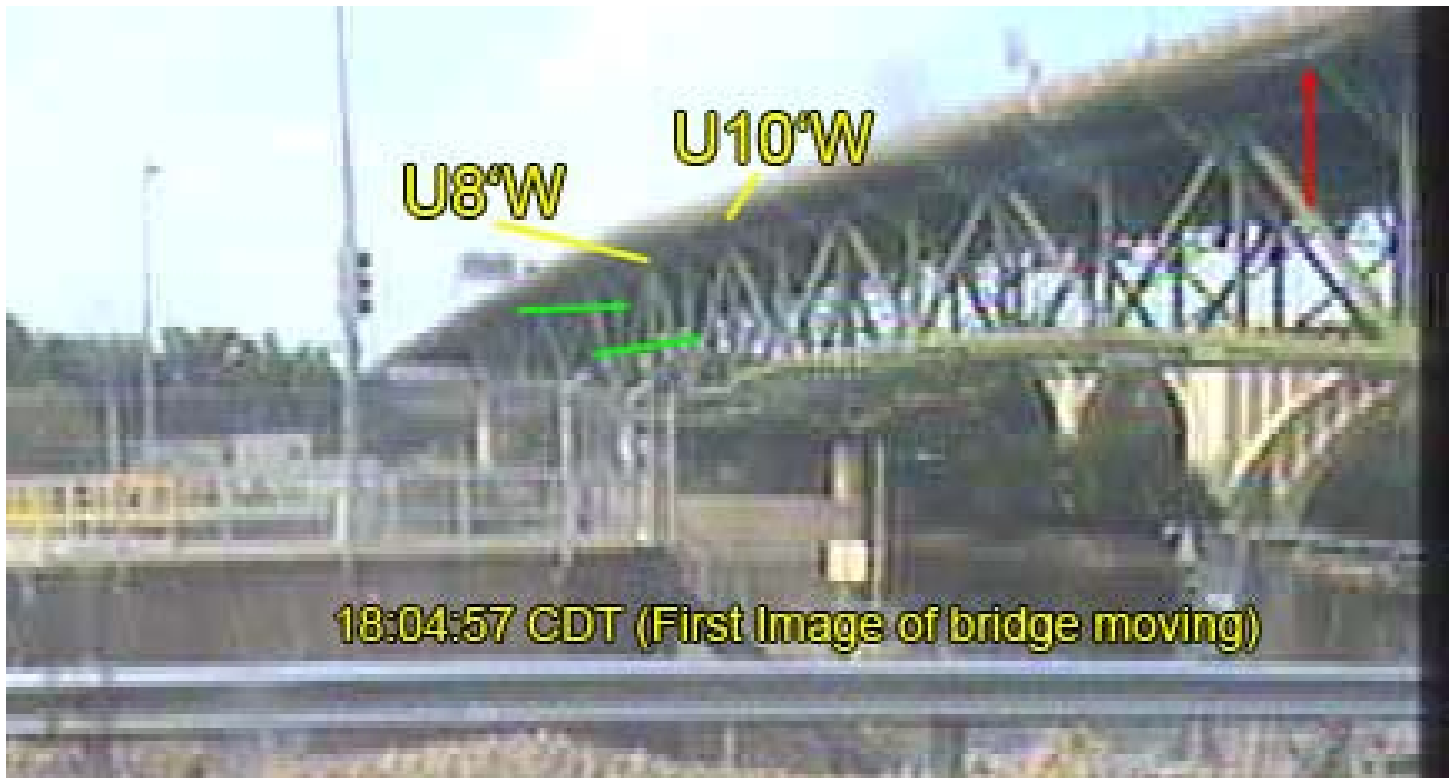
**Figure 10. First image of bridge moving at 18:04:57 CDT.**

In the first image of the bridge moving, the upper portion of beam L7' / U8'W appears to have bent slightly, and the top end near U8'W seems to have moved slightly southward. (See the upper green arrow in Figure 10.) Similarly, beam L9' / U10'W appears to have bent southward near the center (or slightly below the center) (lower green arrow in Figure 10).

Both of these apparent displacements can be seen when the 18:04:57 image is compared with the precollapse images. However, the motion seen at these locations may have been caused by artifacts introduced in the imaging process, such as distortion introduced during image acquisition or compression.<sup>6</sup>

The westernmost deck stringer (stringer 14) appears to have separated from the bridge deck, where the cantilever diagonal met stringer 14 outboard of U11W (red arrow in Figure 10).

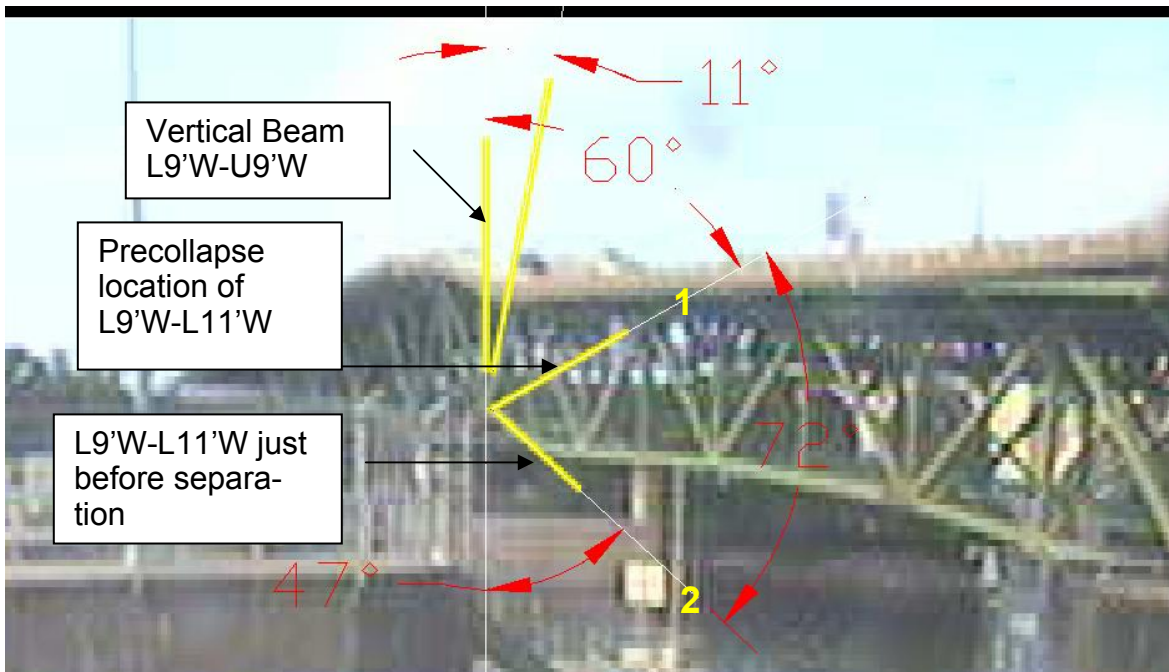
Figure 11. Perceived angles measured directly on the image.

As the main portion of span 7 fell, some bending occurred at two locations in the L9' / L11' W beam. One bend occurred at L10'W, at or near the location of the discontinuity noted above in Figure 9. The other was at node L9'W where the beam bent downward, approximately 22 degrees before it fell away from node L9'W.

The *perceived* angle between vertical beam L9' / U9' W and beam L9' / L11'W, before the collapse, measured 60 degrees as noted in Figure 11 (yellow line 1 shows the precollapse location of L9' / L11 W).

After the collapse began (at 18:04:58 CDT, just before the beam separated from node L9'W, indicated by yellow line 2), the *perceived* angle between the L9' / L11'W beam and the extended centerline of vertical beam L9' / U9' W, measured 47 degrees.

$$180 - 81.5 - 76.4 = 22.1 \text{ degrees}$$

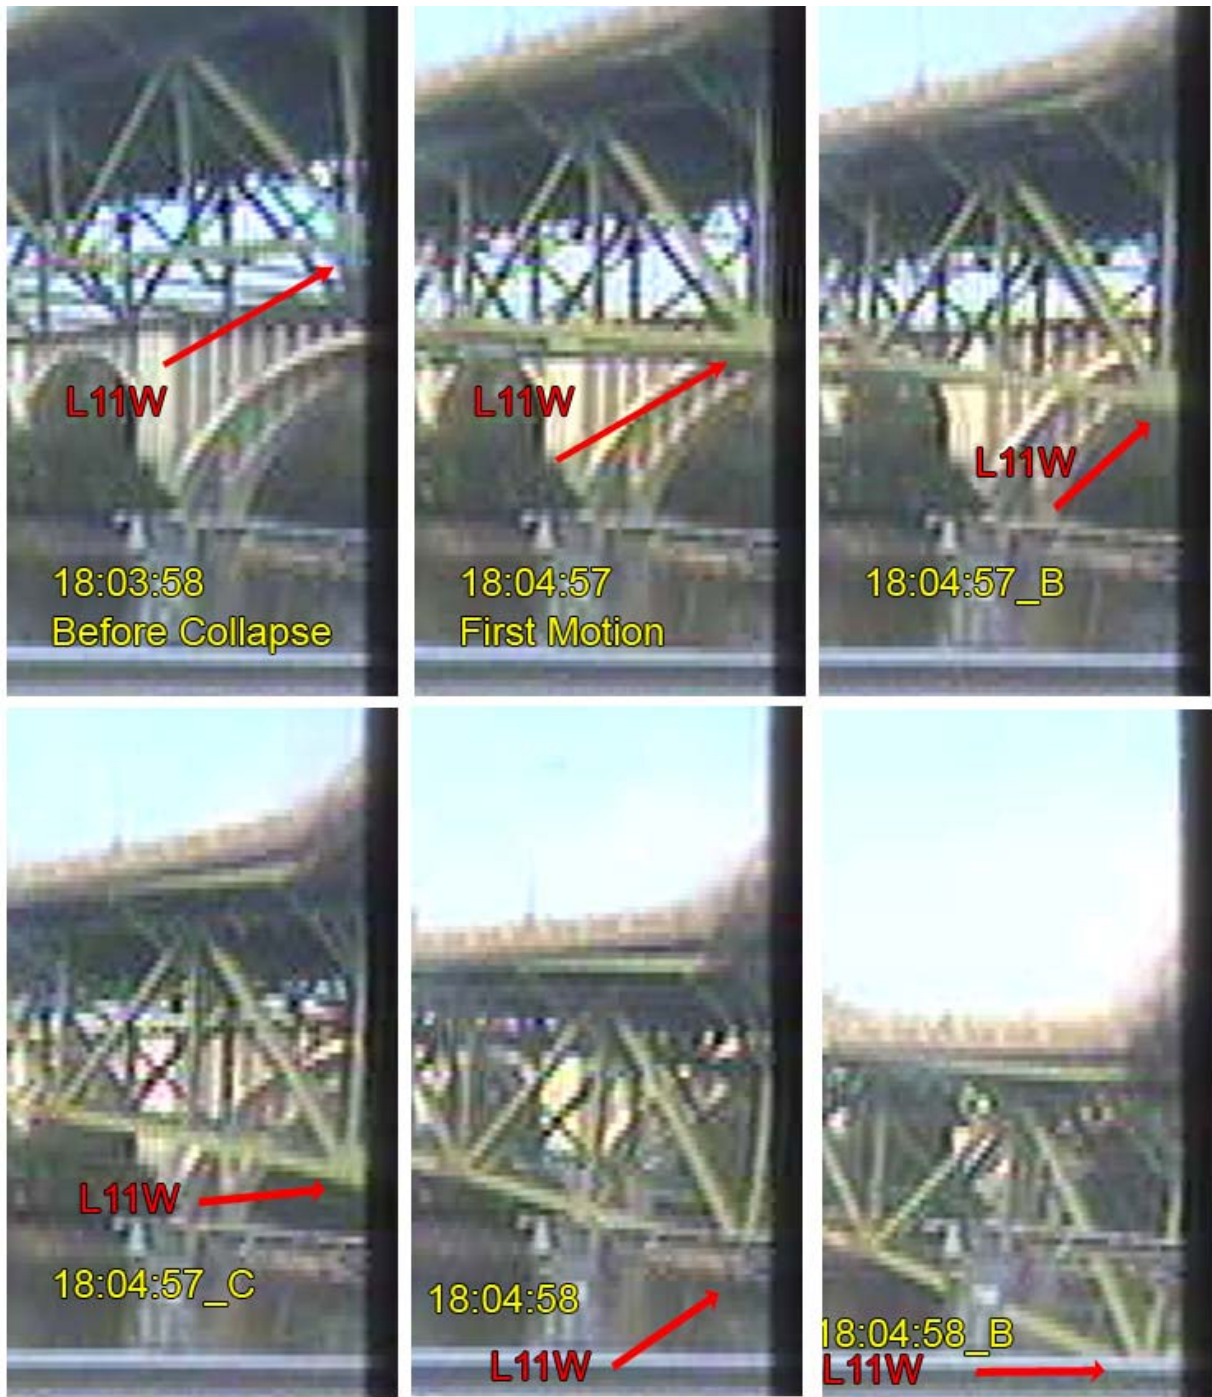
Figure 12. Sequential images of region surrounding node L11W.

As the bridge fell, the L11 W node and all visible beam sections entering it appear to have remained intact, and to have maintained their positions relative to one another. Staff verified these positions by overlaying reference lines along the visible beams that meet at L11 W in a precollapse image, and transposing those lines (in the same orientation) to each of the images recorded during the collapse. The reference lines indicated that all three visible beams at L11W

maintained the same orientation. Also, these elements appear to have fallen together as one contiguous unit along with the truss section northward of L11W as described below. The L11/U11 beam appears to be bowed in the image recorded at 18:04:58. Figure 12 shows several sequential images (enlarged 200% and cropped) that show the area around L11W during the collapse. After time 18:04:57\_C, the node is obscured by items in the foreground of the view.

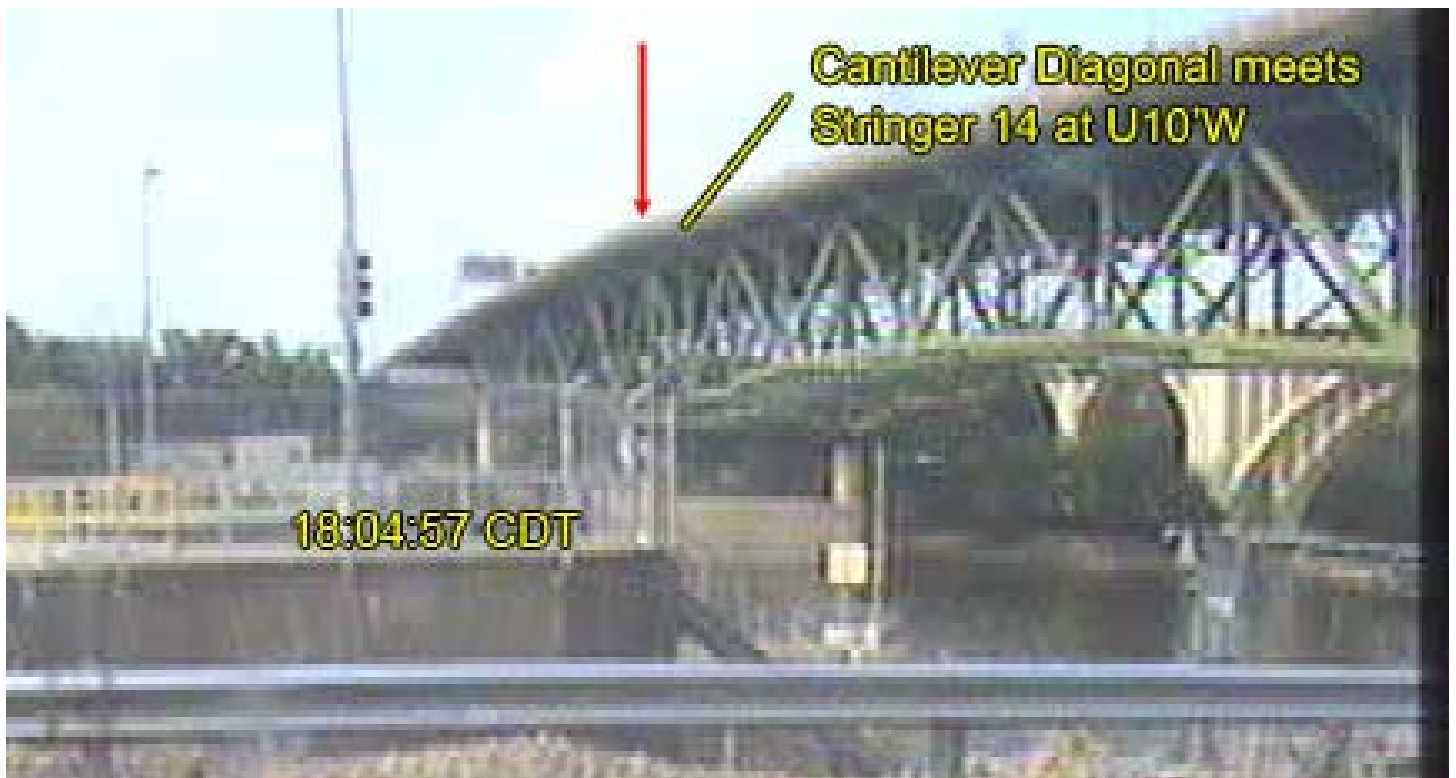
Figure 13. "Bend" in deckline north of U10'W.

The first discontinuity or bend in the deck line can be seen in the first image of the collapse (18:04:57), just north of where the cantilever diagonal intersected stringer 14, outboard of node U10'W. The bend occurred at the red arrow in Figure 13.

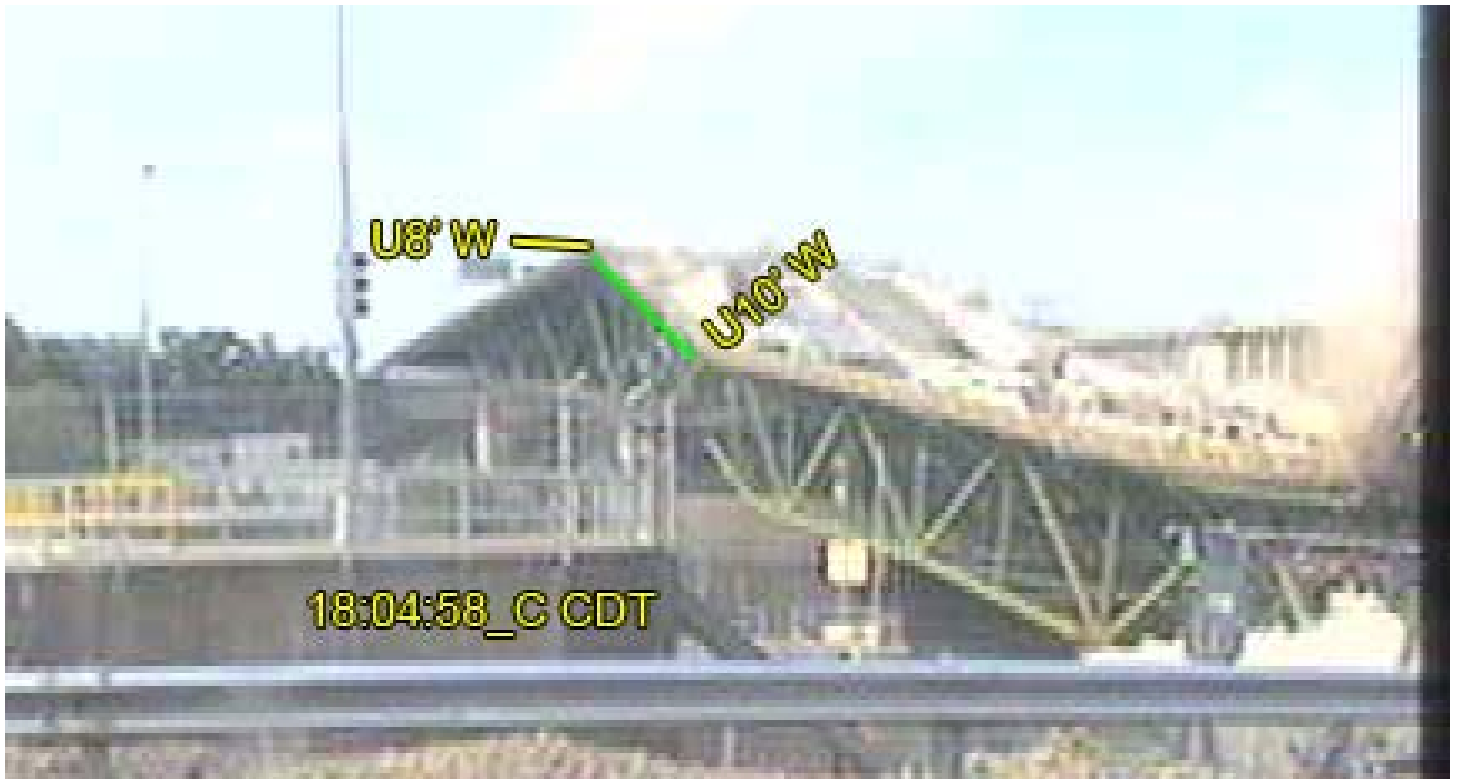
Figure 14. Bridge deck between U8'W and U10'W.

As the collapse progressed, a break in the deck line at U8'W occurred, creating a deck region that appears to have moved as a rigid body between U8'W and U10'W. See Figure 14.

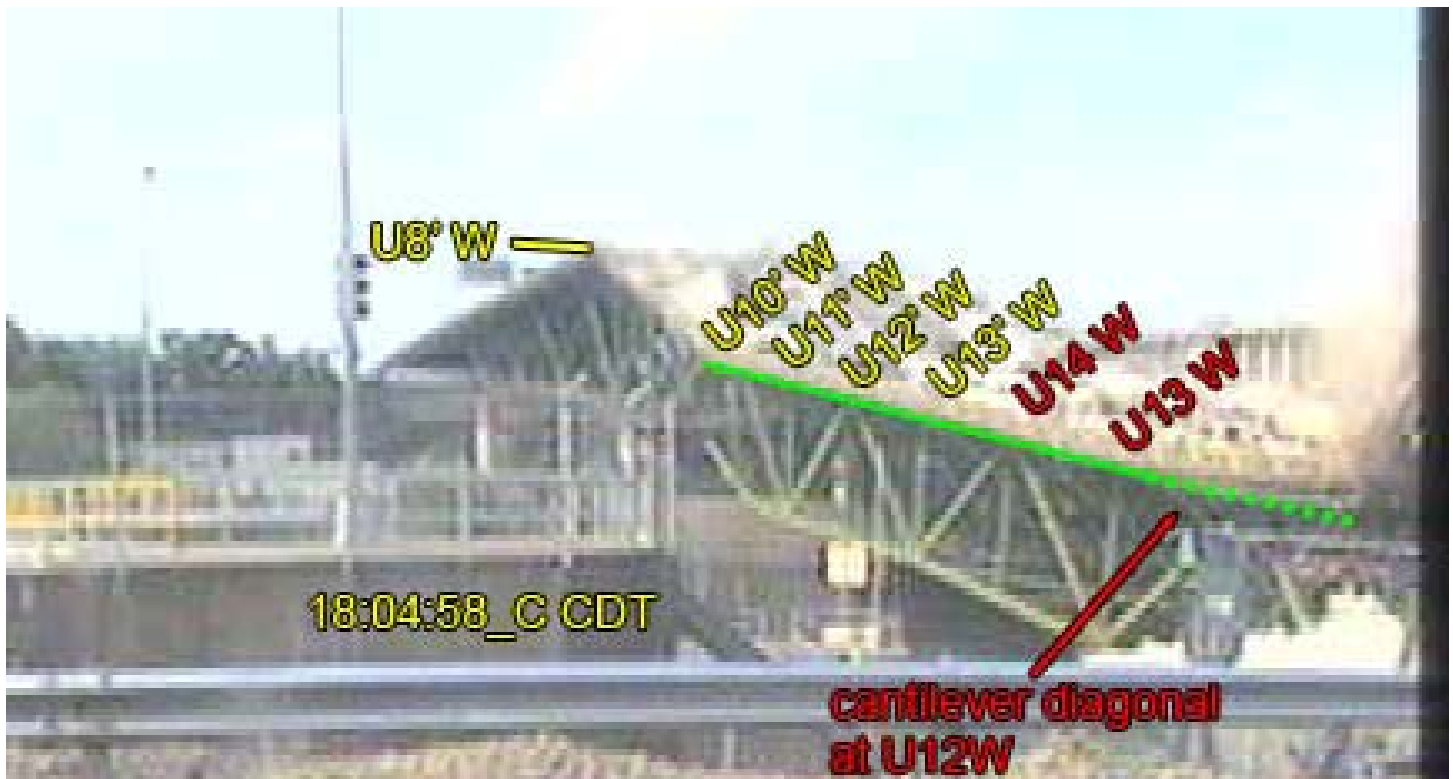
Figure 15 - Bridge deck between U10'W and U12W

The solid green line in Figure 15 outlines the bridge deck from U10'W to U12W.<sup>8</sup> U12W is the southernmost longitudinal visual reference that can be positively identified along the deck-line at the time of this image.

The large portion of span 7 that appears to have fallen as one contiguous segment (at the deck level) extended from U10'W (left end of solid green line) to the south beyond U12W, ending at the right end of the *dotted* green line. The precise location of the right end of the dotted green line (southernmost end of the contiguous deck section) could not be determined. However, it appears to have been just south of U11W.

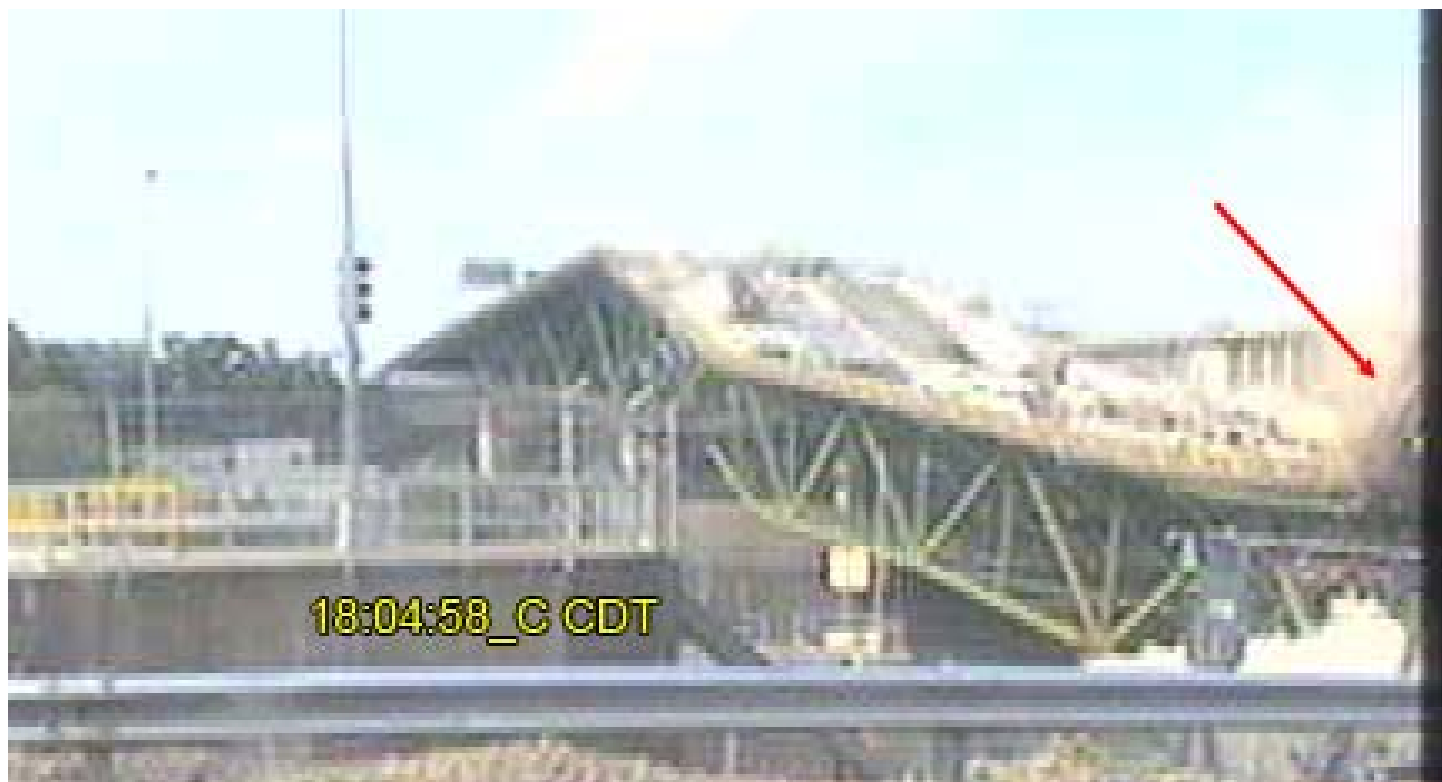
Figure 16. Bridge deck south of node U11W.

The red arrow in Figure 16 shows the portion of bridge deck south of node U11W, angling downward. Dust and debris partially obscure the view of the deck.

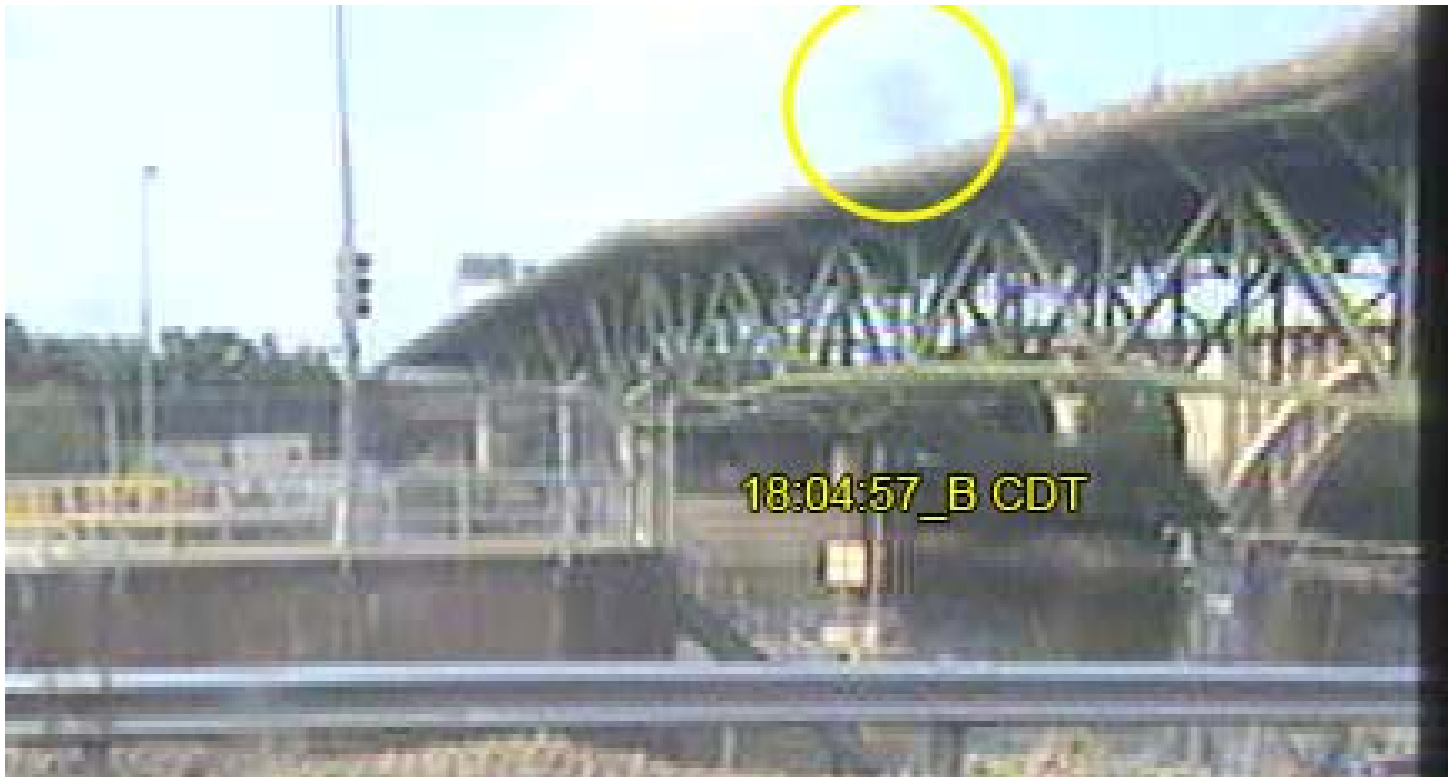
Figure 17. Imaging system artifact.

In the first few frames showing the collapse, a dark region can be seen above the bridge deckline. This artifact gives an illusion that dust or smoke might have been rising from the bridge deck in the early stages of the collapse. However, this artifact was actually fixed with respect to the camera view (it did not move), and was present throughout the recording (both before and after the collapse). This artifact is consistent with some type of contamination on the lens, the camera housing, or elsewhere in the imaging system. See Figure 17.

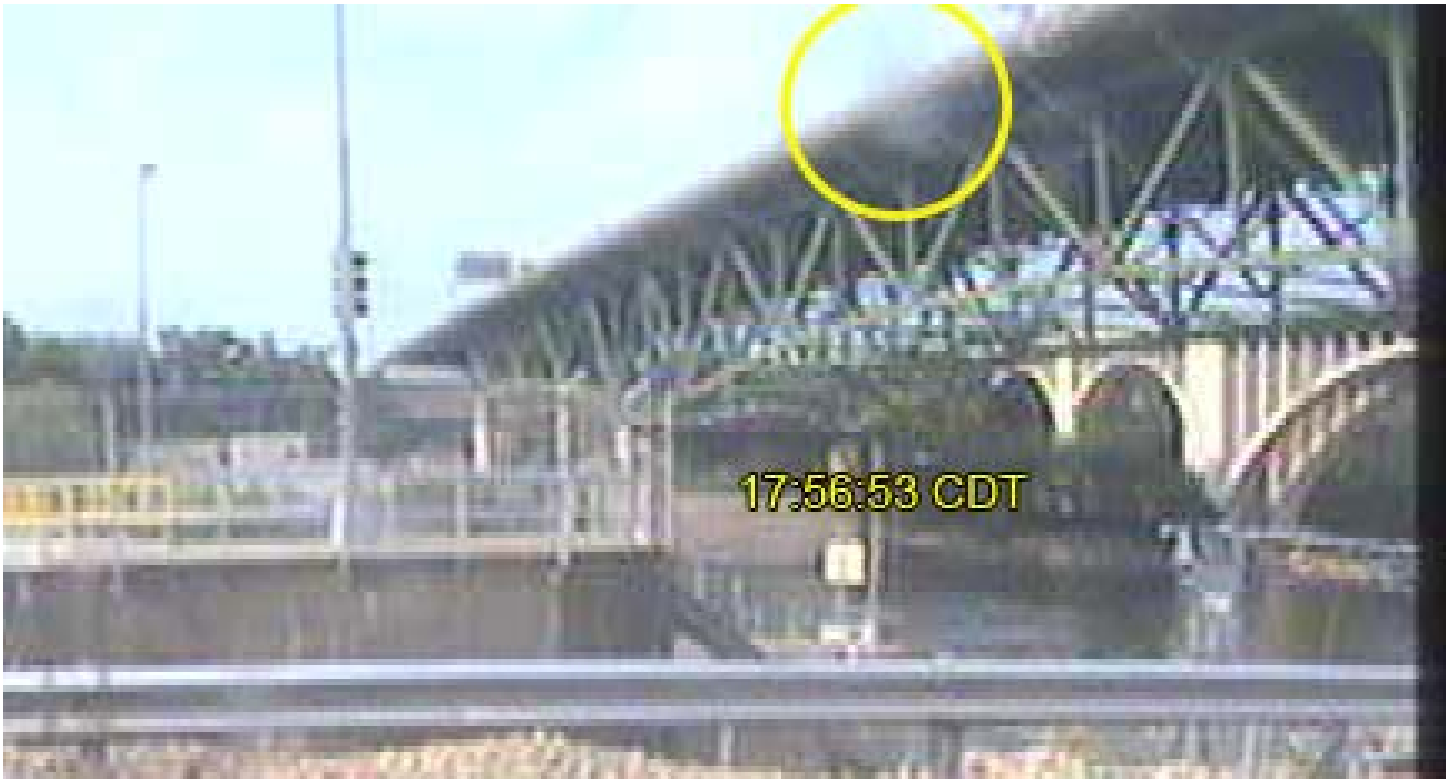
**Figure 18. Imaging system artifact.**

In Figure 18 (about 8 minutes before the collapse), this artifact is in exactly the same location as it was in Figure 17. The artifact appears lighter in color where the background is the dark bridge deck, and darker in color where the background is the lighter colored sky. After the bridge moves downward, the entire artifact appears dark in contrast with the sky.

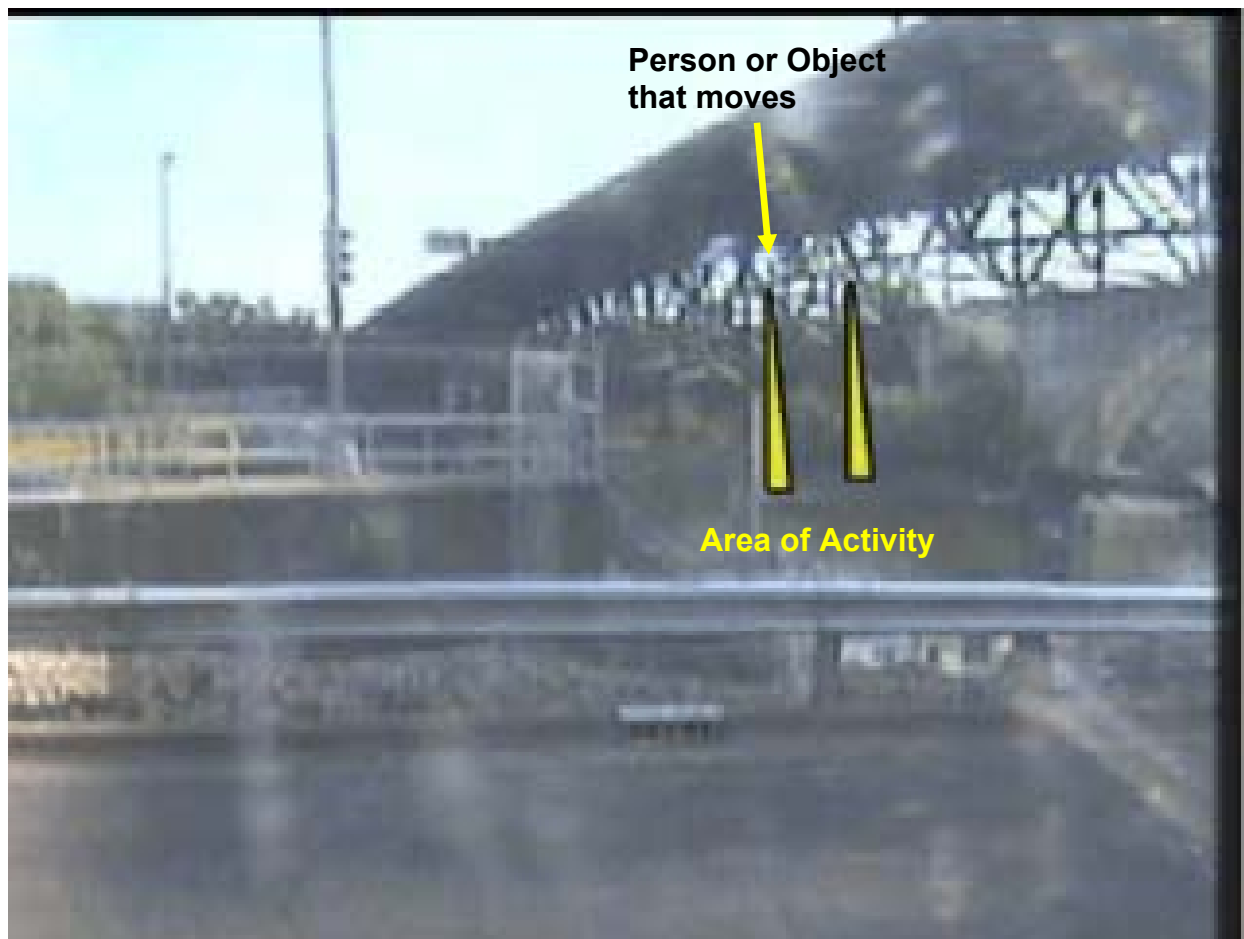
**Figure 19. Location of activity between 09:00 and 09:20 on 8/1/2008.**

Due to the distance from the camera, the activity is difficult to discern in a single still image. Figure 19 shows the area of the activity, and one of the persons or (objects) appears to be moving along the lower members of the west truss.
