NATIONAL TRANSPORTATION SAFETY BOARD

Video Study

Specialist's Report
by Sean Payne

Location: Bagram Air Base, Bagram, Afghanistan
Date: April 29, 2013
Aircraft: Boeing 747-400
Registration: N949CA
Operator: National Airlines
NTSB Number: DCA13MA081

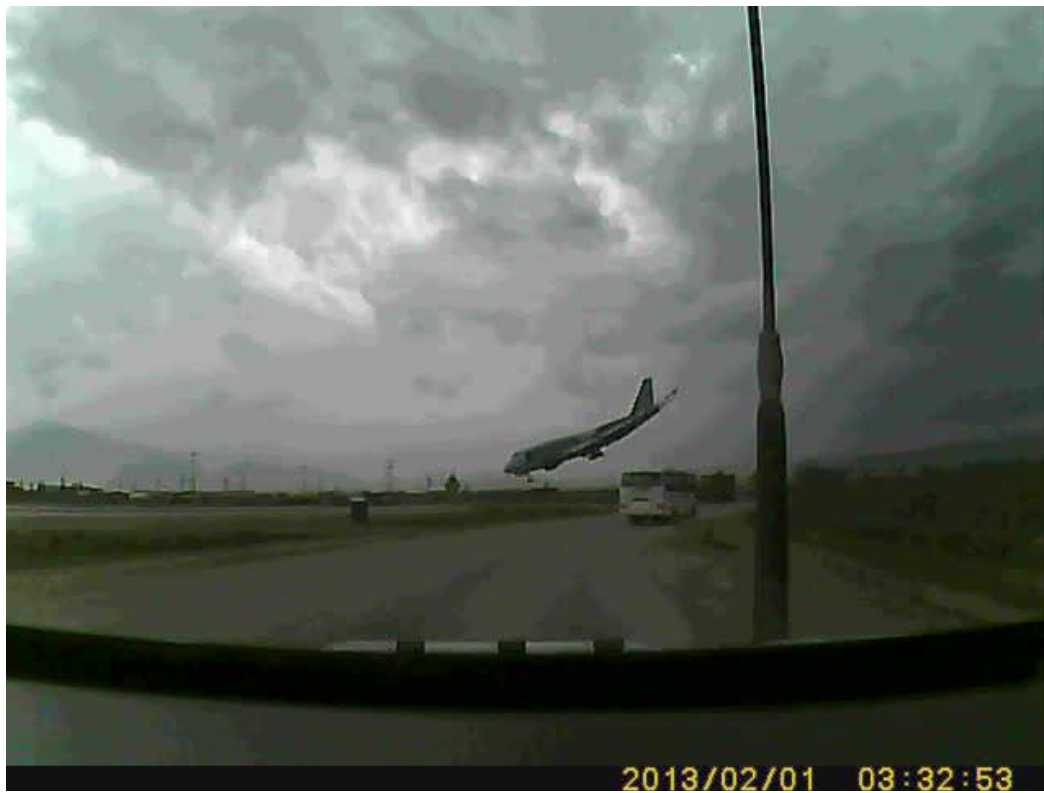
Figure 6. Frame # 538 from the Dashboard Camera without alteration.

Frame 538 shows a view almost normal to the left side of the aircraft (Figure 6). The wireframe model was aligned to the aircraft in Frame 538 and a screen capture of Softimage was taken (Figure 7). The 3D model was rendered as a textured object and compared to a cropped image of the accident aircraft in frame 538 (Figure 8). This shows the right main wing landing gear bogies in the retracted position as compared to the model.

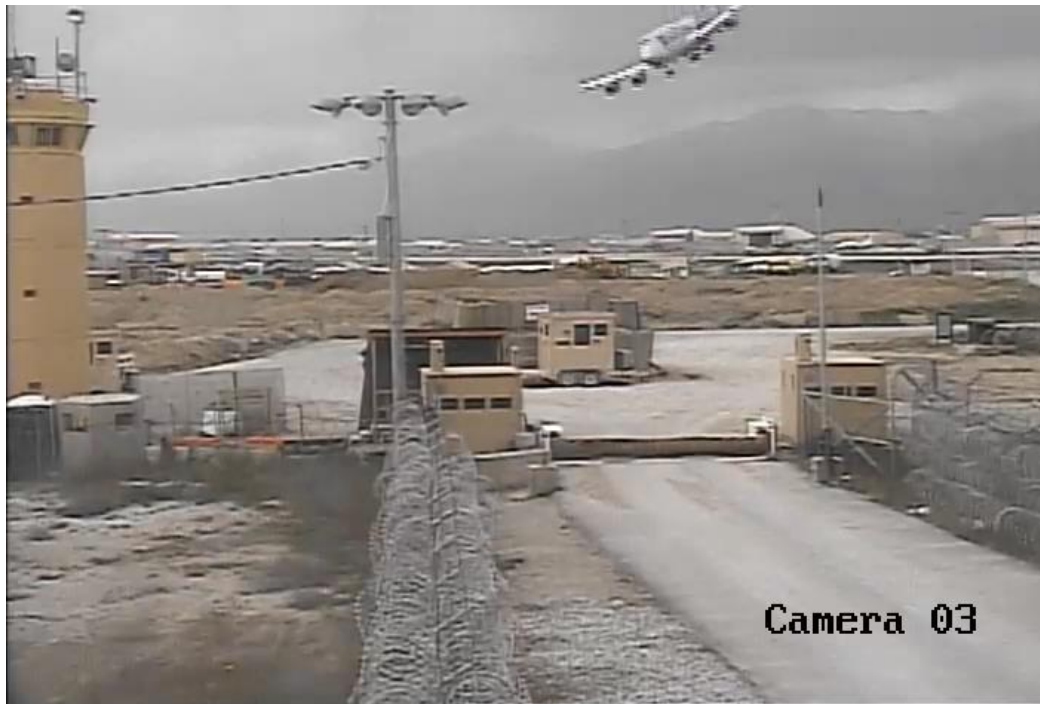
Figure 9. Frame 06 from the Tower 34 camera without alterations.

Frame 06 shows a front left $\frac{3}{4}$ view of the accident aircraft (Figure 9). The wireframe model was aligned to the aircraft in frame 06 and a screen capture of Softimage was taken (Figure 10). The 3D model was rendered as a textured object and compared to a cropped image of the accident aircraft in frame 06 (Figure 11). This shows the left wing landing gear bogies in the retracted position as compared to the model. There is some evidence of the right wing landing gear bogie being in the retracted position, although this is inconclusive as the 3D rendered model shows the nose gear would be blocking most of the camera's view of the right wing landing gear bogie in this orientation.

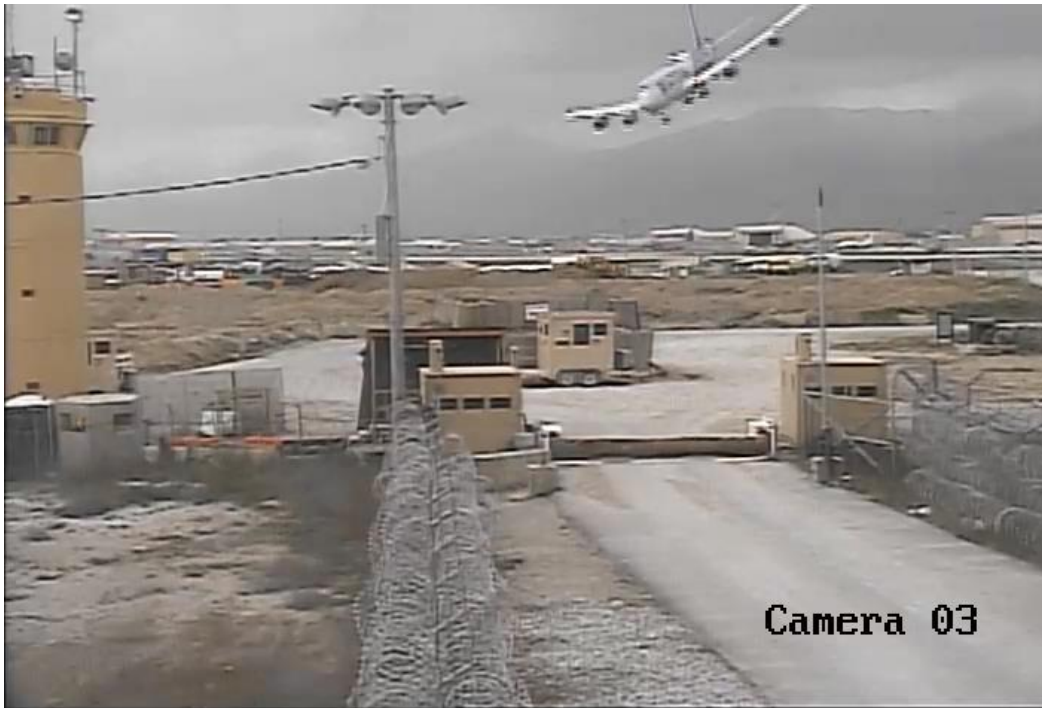
Figure 12. Frame 08 from the Tower 34 camera without alterations.

Frame 08 shows a second front left $\frac{3}{4}$ view of the accident aircraft in a more nose-down orientation (Figure 12). The wireframe model was aligned to the aircraft in frame 08 and a screen capture of Softimage was taken (Figure 13). The 3D model was rendered as a textured object and compared to a cropped image of the accident aircraft in frame 08 (Figure 14). This provides additional evidence of the left wing landing gear bogie in the retracted position. The position of the right wing landing gear bogie is uncertain due to the camera's orientation to the aircraft.

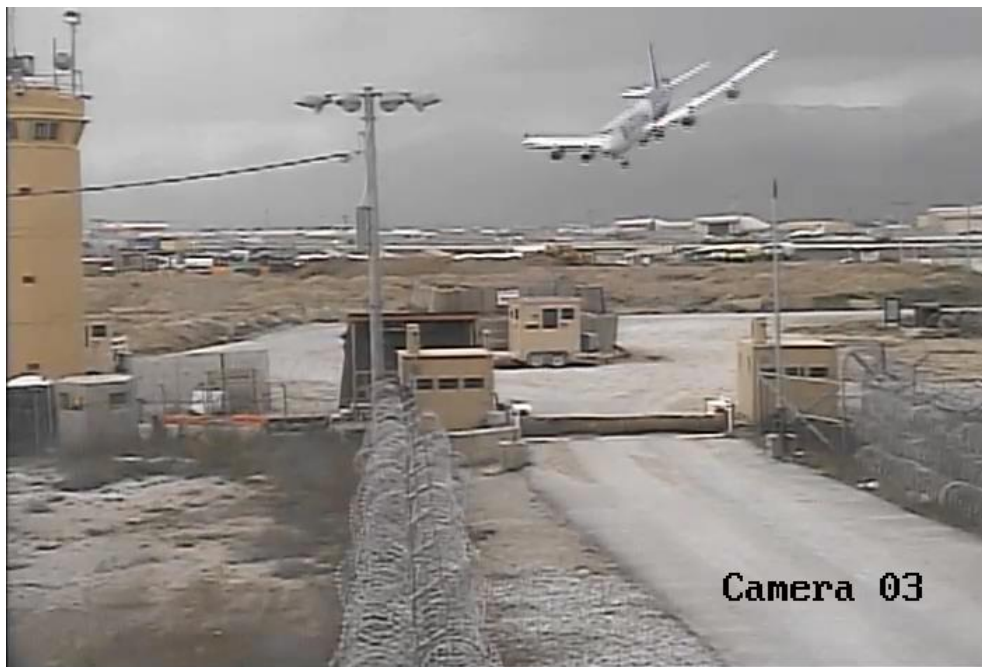
Figure 15. Frame 10 from the Tower 34 camera without alterations.

Frame 10 shows a third front left $\frac{3}{4}$ view of the accident aircraft in a nose-down orientation moments before impact (Figure 15). The wireframe model was aligned to the aircraft in frame 10 and a screen capture of Softimage was taken (Figure 16). The 3D model was rendered as a textured object and compared to a cropped image of the accident aircraft in frame 10 (Figure 17). This provides additional evidence of the left wing landing gear bogie in the retracted position. The position of the right wing landing gear bogie is uncertain due to the camera's orientation to the aircraft. Figure 18 is a frame from the video with arrows identifying the aircraft's landing gear.

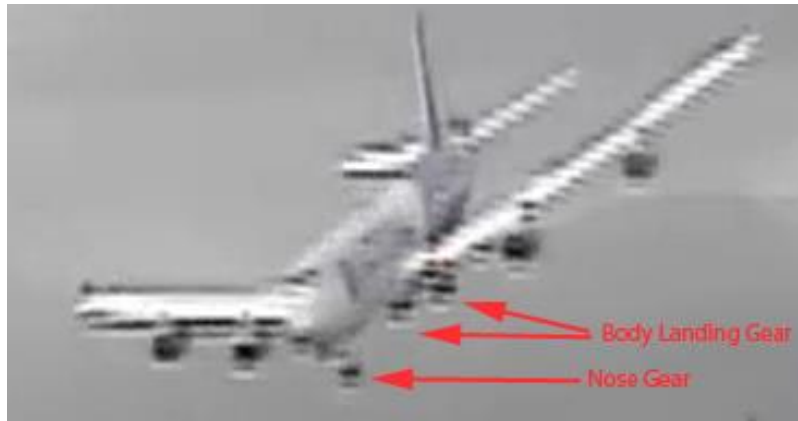
Figure 18. Identification of landing gear.

Both the Dashboard camera and the security video from file ECP10 camera show an unusual object protruding just forward of the nose landing gear. This unusual object can be seen in Figure 18 just forward and above the nose gear. After image enhancement and discussion, this unusual cluster of pixels was determined to be the nose landing gear door. Under normal operation, the gear lever is selected to the “retracted” position by the flight crew and the landing gear begins to cycle to the “retracted” or “up” position. During this operation, the nose landing gear door is opened to allow the nose gear to retract inside the aircraft’s body. Once the nose landing gear has retracted inside the aircraft’s body, the nose landing gear door is closed to reduce drag. The condition shown in both video files is unusual as the nose landing gear door is fully open while the nose landing gear appears to be in the fully down/extended position. Under normal operation, the nose and body gear door openings would be the first event(s) in the retraction sequence and then the gear would begin to retract. The *Dashboard Camera* and the video from the ECP10 camera also show the nose gear door open and the nose gear in the down position throughout the accident sequence.
