NATIONAL TRANSPORTATION SAFETY BOARD
Office of Research and Engineering
Washington, D.C. 20594

Video Study

**NTSB Case Number:
CEN15FA034**

Location: Wichita, Kansas
Date: October 30, 2014
Time: 0949 CST
Airplane: Raytheon King Air B200

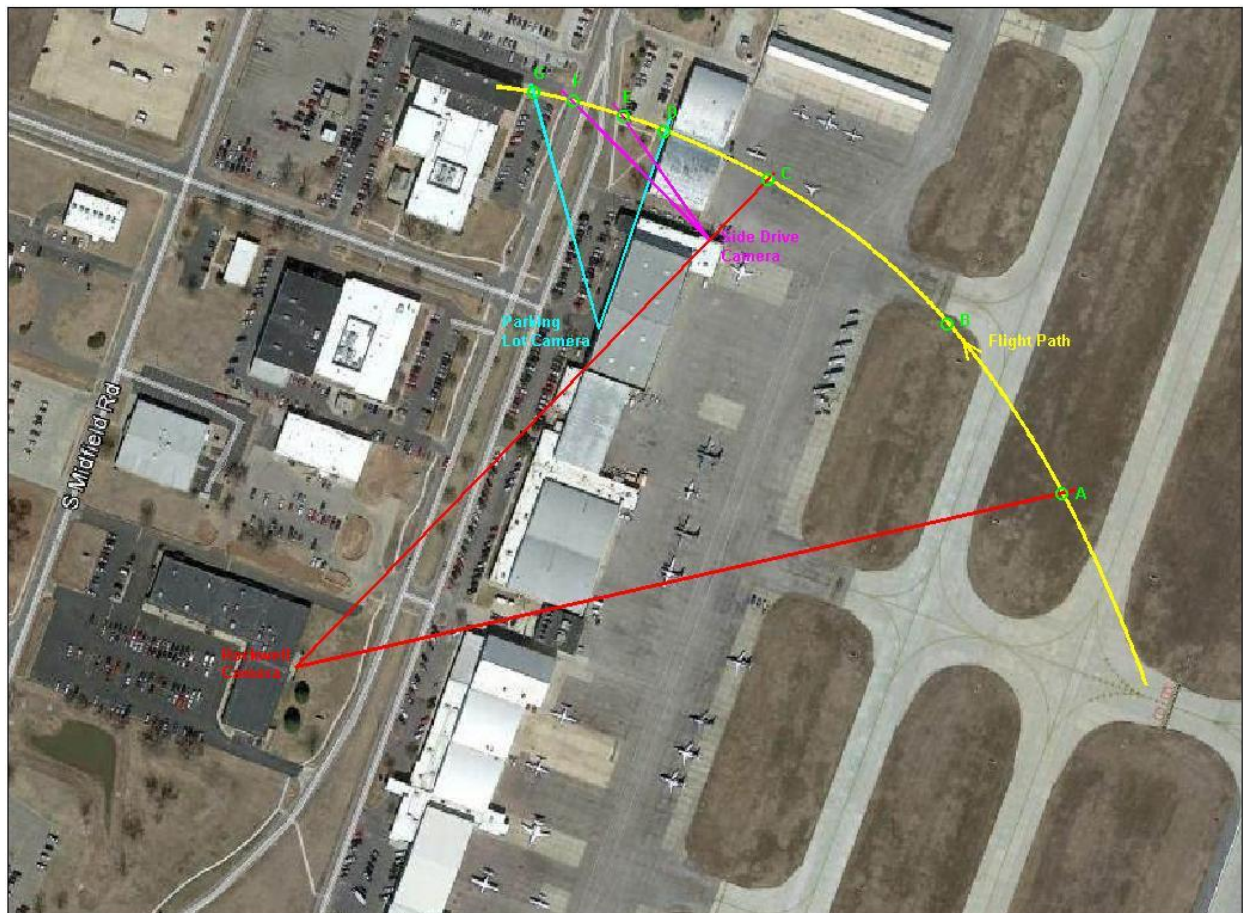
Figure 1 Camera Locations and Analysis Segments

Figure 1 is a Google Earth view of the accident area. It shows the locations of the three cameras and the angular segments in which the airplane was visible from each camera. These segments are less than the optical horizontal fields of view of the cameras. The Rockwell camera segment was restricted on the left side by poor visibility. While the airplane was still in the field of view of the camera, it was not visible in the video. The distance of the airplane from this camera was over 1200 ft and the

camera resolution was relatively low. The segment of the Side Drive camera was restricted on the right side by the vertical field of view of the camera and on the left side by a tree. The segment of the Parking Lot camera was restricted on the right side by a building and on the left side by poor visibility.

As seen in Figure 1, the analysis segment of the Side Drive camera is within the analysis segment of the Parking Lot camera. Therefore, the analyses of these two camera videos were merged to generate one estimate covering the segment of the Parking Lot camera. As also seen in Figure 1 is a gap between the segments of the Rockwell camera and the Parking Lot camera. Interpolation was used to estimate airplane locations in this segment.

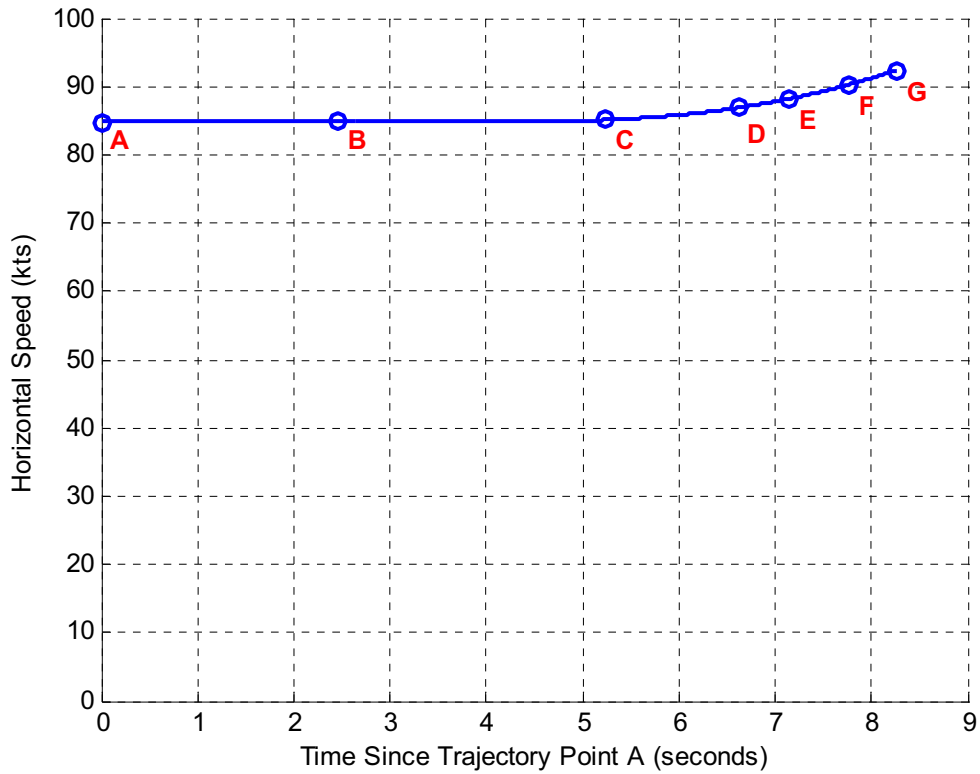
Figure 2 Estimated Horizontal Ground Speed of the Airplane

With the XYZ locations of the airplane known at video frame times, it was possible to estimate the speed of the airplane. Figure 2 shows the estimated horizontal ground speed of the airplane. It is shown over the analyzed period of approximately 8.3 seconds. The trajectory in Figure 1 marked the end points of the camera segments with letters A, B, C, D, E, F and G. These points were superimposed on the speed estimate in Figure 2 to allow correlation between speed, location and time.

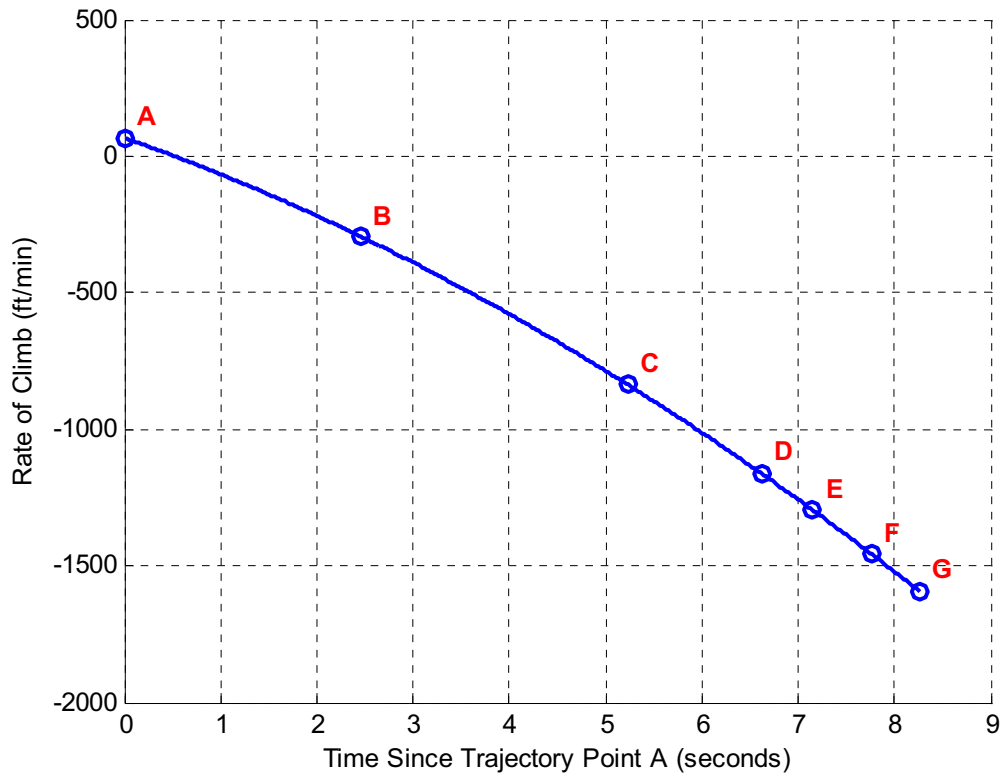
Figure 3 Estimated Rate of Climb (negative values indicate rate of descent)

Figure 3 shows the estimated rate of climb. Note that after approximately 0.5 seconds, the rate is negative because the airplane is descending.

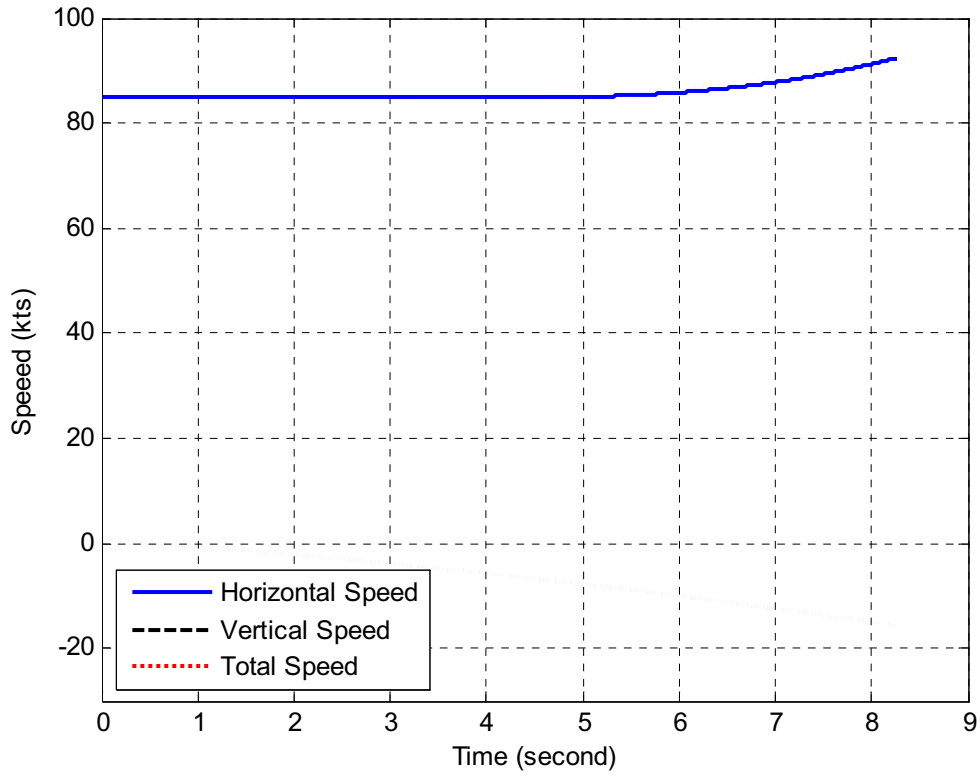
Figure 4 Estimated Horizontal, Vertical and Total Ground Speeds of the Airplane

Figure 4 shows the estimated horizontal, vertical and total ground speeds. The total speed, defined as the vector sum of the horizontal and vertical speeds, is very close to the horizontal speed estimate because the vertical speed magnitude is relatively low.

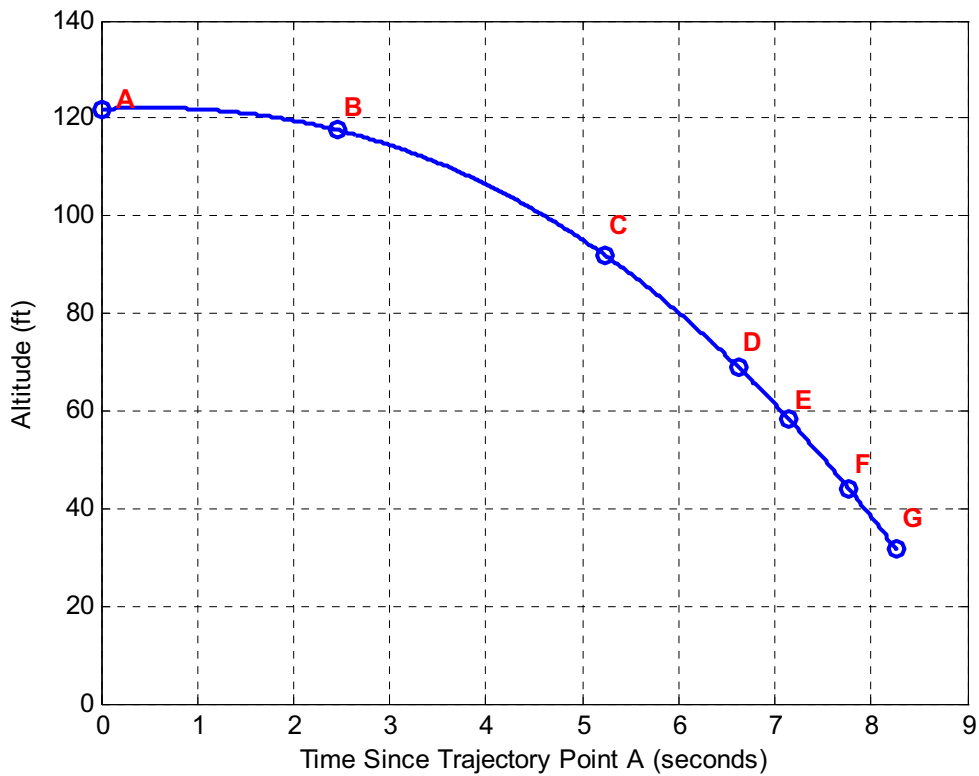
Figure 5 Estimated AGL Altitude of the Airplane

Figure 5 shows the estimated altitude of the airplane. Trajectory points A, B, C, D, E, F and G were superimposed on the altitude estimate to allow correlation between altitude, location and time.
