NATIONAL TRANSPORTATION SAFETY BOARD
Vehicle Recorder Division
Washington, DC 20594

Video Study

Specialist's Study By Sean Payne

Location: Santa Monica, California
Date: September 29, 2013 18:20 Pacific daylight time (PDT)
Aircraft: Cessna 525A, N194SJ
Operator: Private
NTSB Number: WPR13FA430

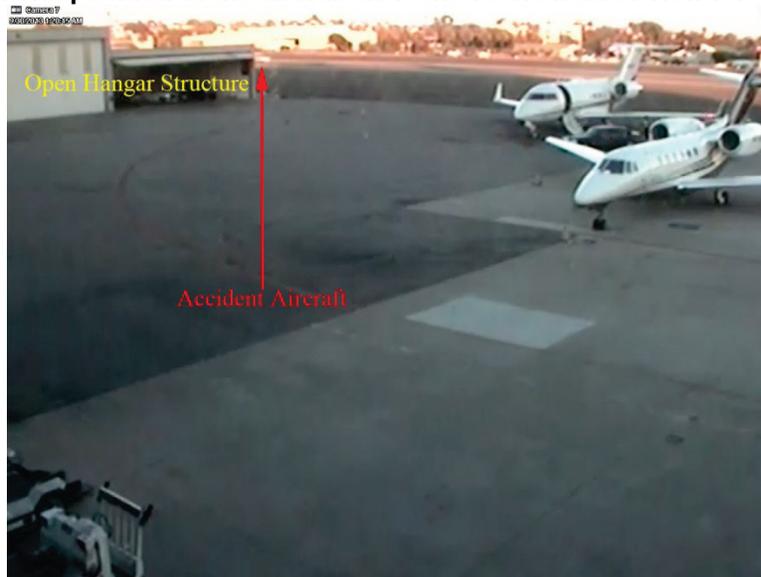
Figure 3. The position of the aircraft as it enters the field of view for Camera 7.

The aircraft first appears in the upper left corner of the frame as the cockpit area of the fuselage is shown behind an open hangar structure. Figure 3 shows the aircraft in this position at a recorded timestamp of 6:20:45 AM and two carryover frames (45.50 seconds). The amount of adjusted fuselage length was established as $\frac{1}{4}$ or approximately 11 feet.

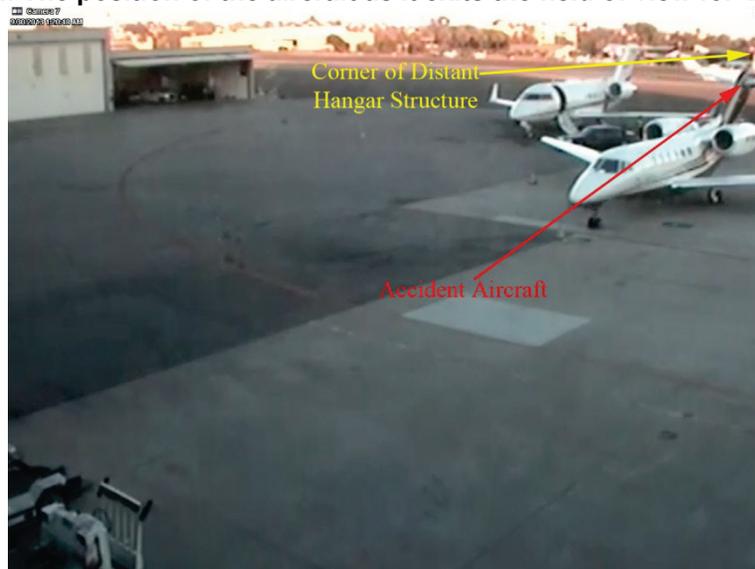
Figure 4. The position of the aircraft as it exits the field of view for Camera 7.

Shortly after, the cockpit area of the accident aircraft becomes aligned with the corner of a hangar structure on the far side of Runway 03/21. Figure 4 shows the accident aircraft in this position. The timestamp reads 6:20:48 and zero carryover frames (48.00 seconds). The adjusted fuselage length was estimated as zero.

The time calculated between the aircraft's position in Figure 3 and Figure 4. Using the equation in Section 4.3., was 2.50 seconds

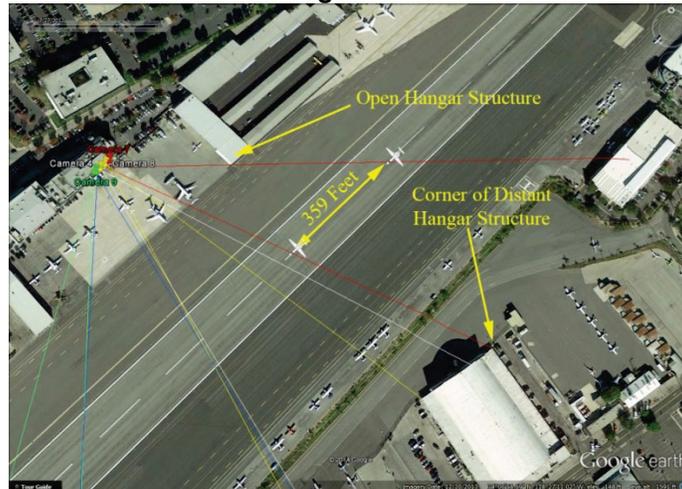
Figure 5. The distance between the aircraft's position in Figure 3 and 4 as measured on Google Earth.

Figure 5 shows the two positions of the aircraft in Figure 3 and 4 represented on Google Earth. Assuming the aircraft was on the centerline of Runway 03/21, a distance of 359 feet was measured. The adjusted fuselage length was subtracted in the amount of 11 feet. The total distance traveled was calculated to be 348 feet.

Using the equation for average groundspeed in the beginning of this section, an average groundspeed of 82.5 knots was obtained for this segment.

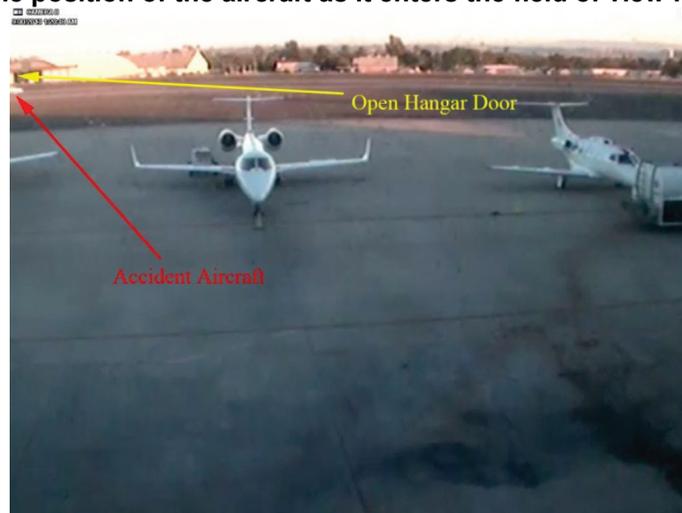
Figure 6. The position of the aircraft as it enters the field of view for Camera 8.

The aircraft first appears in the upper left corner of the frame as the cockpit area of the fuselage is shown in front of an open hangar door on the far side of Runway 03/21. Figure 6 shows the aircraft in this position at a recorded timestamp of 1:20:48 AM, likely a glitch representing 6:20:48 PM. One carryover frame was counted at this position resulting in a total time of 48.25 seconds. The camera perspective line was able to be established at this position shown in Figure 6 so no adjusted fuselage length was utilized.

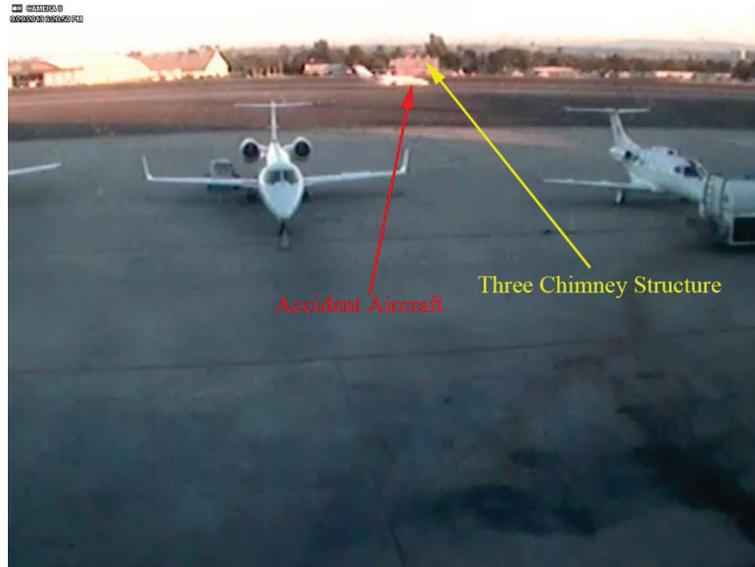
Figure 7. The position of the aircraft as it aligns with the center of a three chimney structure in the field of view for Camera 8.

Shortly after, the cockpit area of the accident aircraft becomes aligned with a vented structure on the far side of Runway 03/21. Figure 7 shows the accident aircraft in this position. The timestamp reads 1:20:50 AM and 1 carryover frame (50.25 seconds). The amount of adjusted fuselage length was established as $\frac{1}{4}$ or 11 feet.

Using the equation in Section 4.3., this time was calculated to be 2.0 seconds.

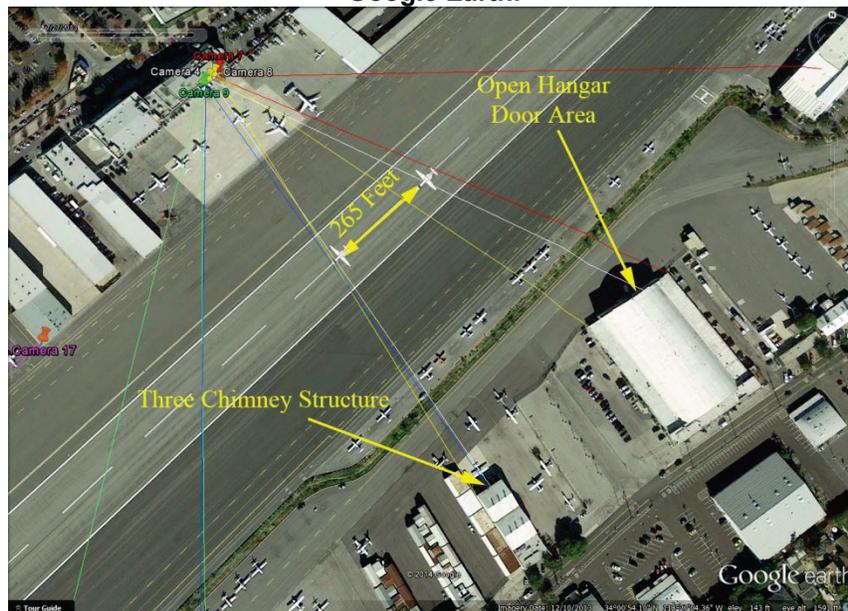
Figure 8. The distance between the aircraft's position in Figure 6 and 7 as measured on Google Earth.

Figure 8 shows the two positions of the aircraft in Figure 6 and 7 represented on Google Earth. Assuming the aircraft was on the centerline of Runway 03/21, a distance of 265 feet was measured. The adjusted fuselage length was subtracted in the amount of 11 feet. The total distance traveled was calculated to be 254 feet.

Using the equation for average groundspeed in the beginning of this section, an average groundspeed of 75.2 knots was obtained for this segment.

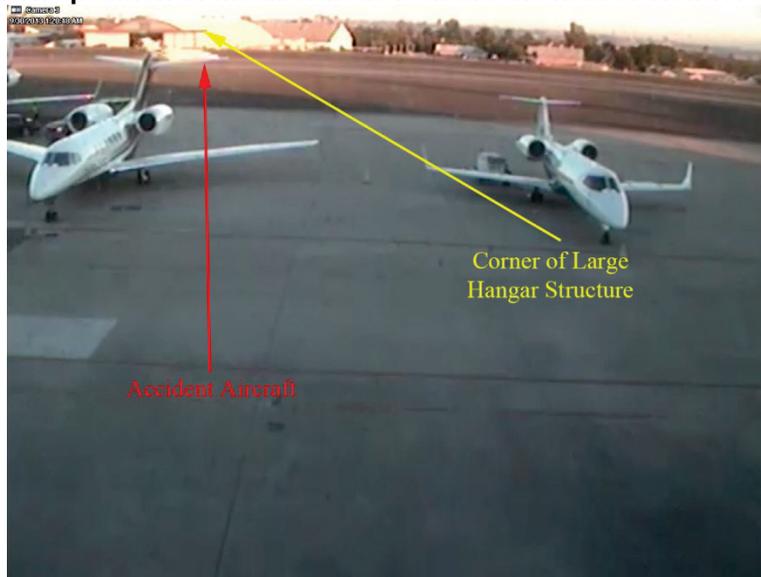
Figure 9. The position of the aircraft as it enters the field of view for Camera 3.

The aircraft first appears in the upper left corner of the frame as the cockpit area of the fuselage is shown in front of the corner of a large hangar structure on the far side of Runway 03/21. Figure 9 shows the aircraft in this position at a recorded timestamp of 1:20:48 AM and two carryover frames (48.50 seconds). The amount of adjusted fuselage length at this position was established as $\frac{1}{4}$ or 11 feet.

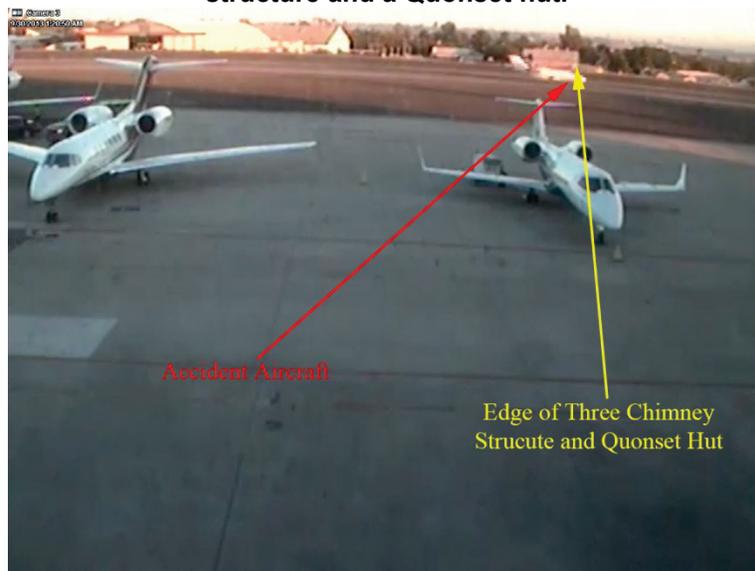
Figure 10. The position of the aircraft as it aligns with the edge of a three chimney structure and a Quonset hut.

Shortly after, the cockpit area of the accident aircraft becomes aligned with the edge of a vented structure and a small Quonset hut on the far side of Runway 03/21. Figure 10 shows the accident aircraft in this position. The timestamp reads 1:20:50 and one carryover frame (50.25 seconds). No adjustment was made for fuselage length at this position.

Using the equation in Section 4.3., this time was calculated to be 1.75 seconds.

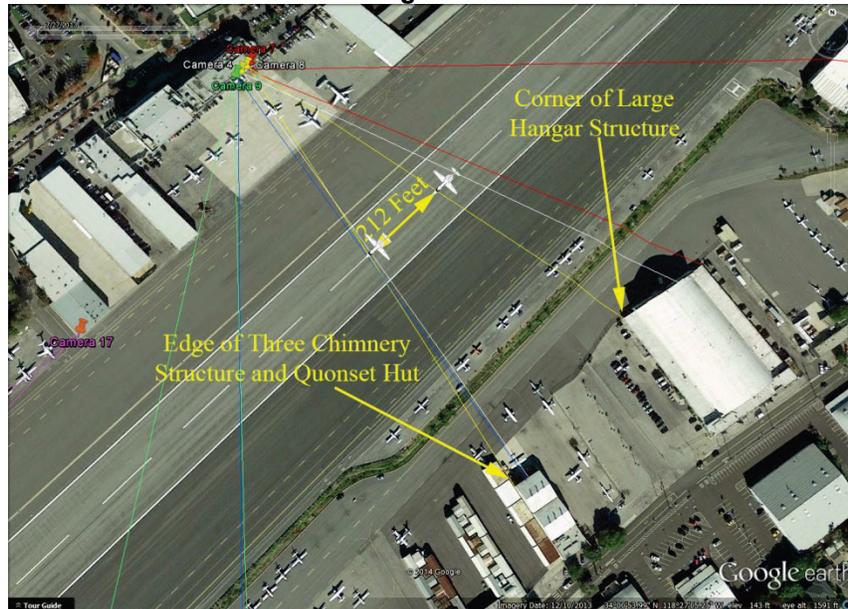
Figure 11. The distance between the aircraft's position in Figure 9 and 10 as measured on Google Earth.

Figure 11 shows the two positions of the aircraft in Figure 9 and 10 represented on Google Earth. Assuming the aircraft was on the centerline of Runway 03/21, and the amount of adjusted fuselage length was subtracted (11

feet) from a measured distance of 212 feet. 201 feet was calculated for this segment.

Using the equation for average groundspeed in the beginning of this section, an average groundspeed of 68.1 knots was obtained for this segment.

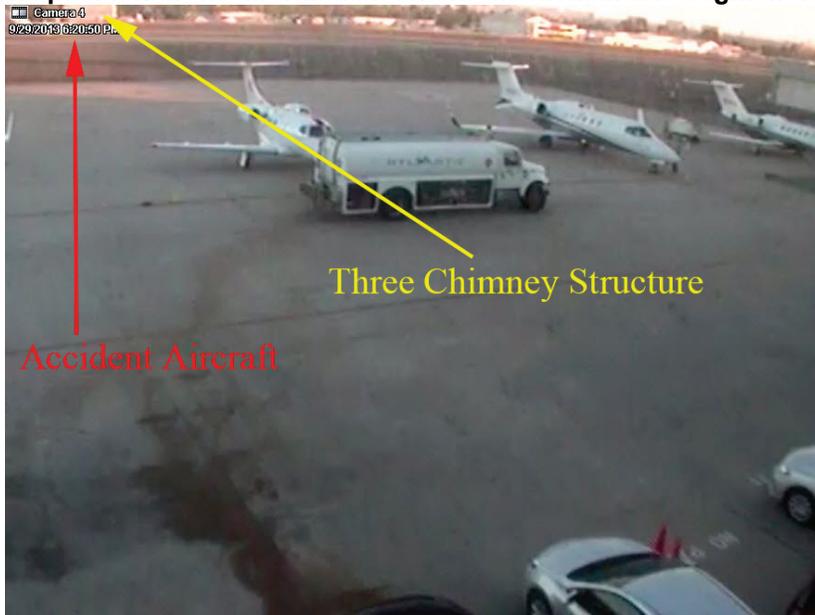
Figure 12. The position of the aircraft as it enters the measurable segment for Camera 4.

The aircraft first appears in the upper left corner of the frame as the cockpit area of the fuselage is shown in front of the three chimney structure on the far side of Runway 03/21. Figure 12 shows the aircraft in this position at a recorded timestamp of 1:20:50 PM and one carryover frames (50.25 seconds). No adjusted fuselage length was made at this position.

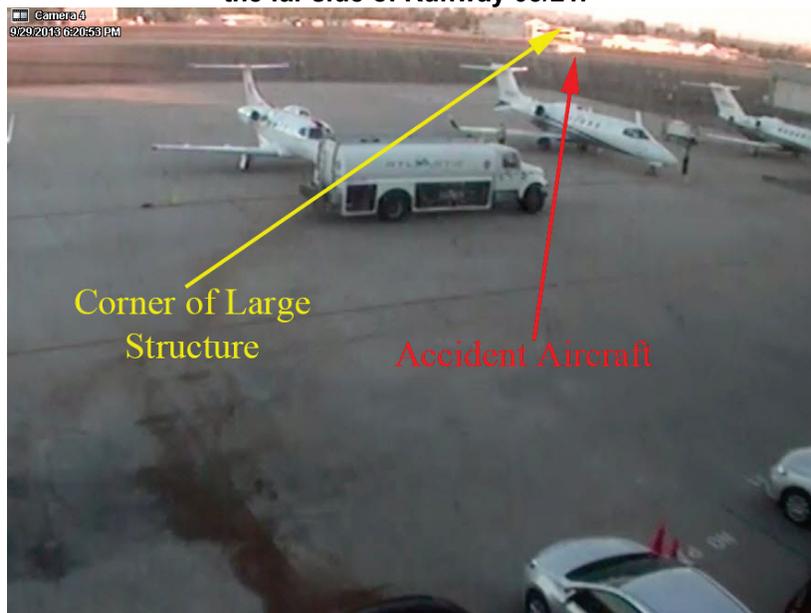
Figure 13. The position of the aircraft as it aligns with the far corner of a large structure on the far side of Runway 03/21.

Shortly after, the cockpit area of the accident aircraft became aligned with the far corner of a large structure on the far side of Runway 03/21 at a timestamp of 1:20:53 and no carryover frames (53.00 seconds). Figure 13 shows the accident aircraft in this position. No adjustment for fuselage length was made at this position.

Using the equation in Section 4.3., this time was calculated to be 2.75 seconds.

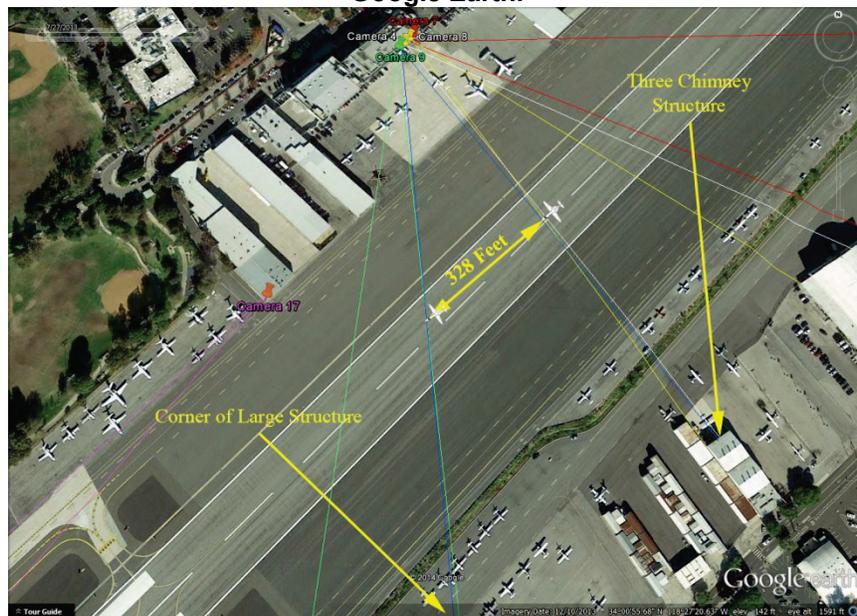
Figure 14. The distance between the aircraft's position in Figure 12 and 13 as measured on Google Earth.

Figure 14 shows the two positions of the aircraft in Figure 12 and 13 represented on Google Earth. Evidence collected on scene suggests that the accident aircraft was not on centerline at this time. Using information provided by the Investigator-in-Charge (IIC) and Figure 20 and 21, an estimate of the aircraft's path was made. When plotted on Google Earth this measurement was established as 328 feet.

Using the equation for average groundspeed in the beginning of this section, an average groundspeed of 70.7 knots was obtained for this segment.

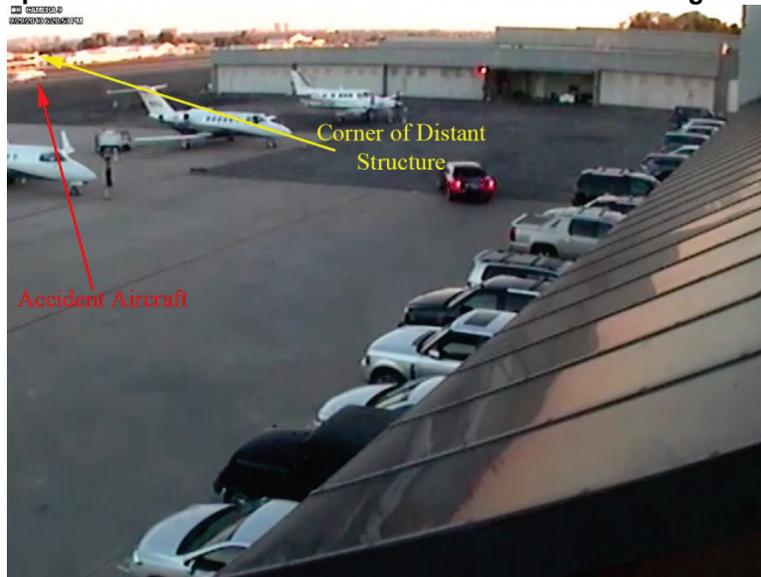
Figure 15. The position of the aircraft as it enters the measurable segment for Camera 9.

The aircraft first appears in the upper left hand corner of the recording as the fuselage is shown traveling down Runway 03/21. The aircraft fuselage appears to be aligned with the corner of a large structure on the other side of Runway 03/21. Figure 15 shows the aircraft in this position at a recorded timestamp of 1:20:53AM and zero carryover frames (53.00 seconds). No adjustment for fuselage length was made at this position.

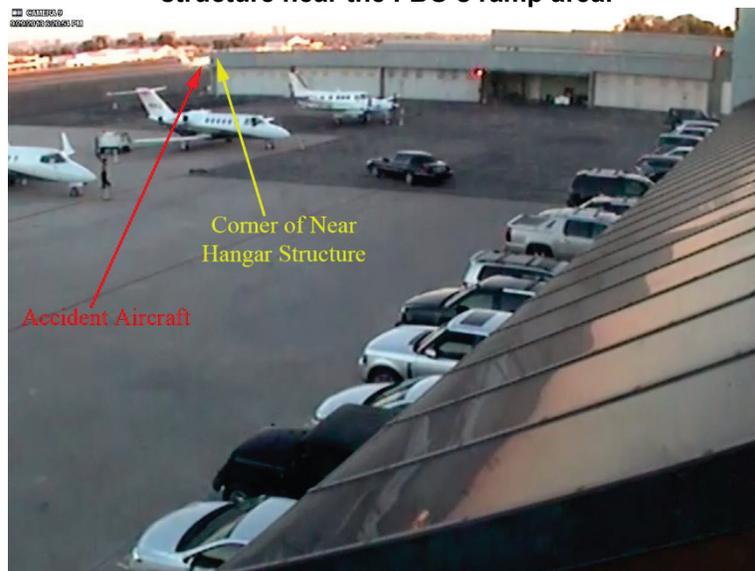
Figure 16. The position of the aircraft as the cockpit it aligns with the corner of a hangar structure near the FBO's ramp area.

Shortly after, the cockpit area of the accident aircraft becomes aligned with the corner of a hangar structure near the FBO's ramp as it crosses out of view of the camera's image. Figure 16 shows the accident aircraft in this position. The timestamp reads 6:20:54 PM¹¹ and two carryover frames (54.50 seconds). An adjusted fuselage length of $\frac{1}{2}$ (22 feet) was noted at this position.

Using the equation in Section 4.3., this time was calculated to be 1.50 seconds.

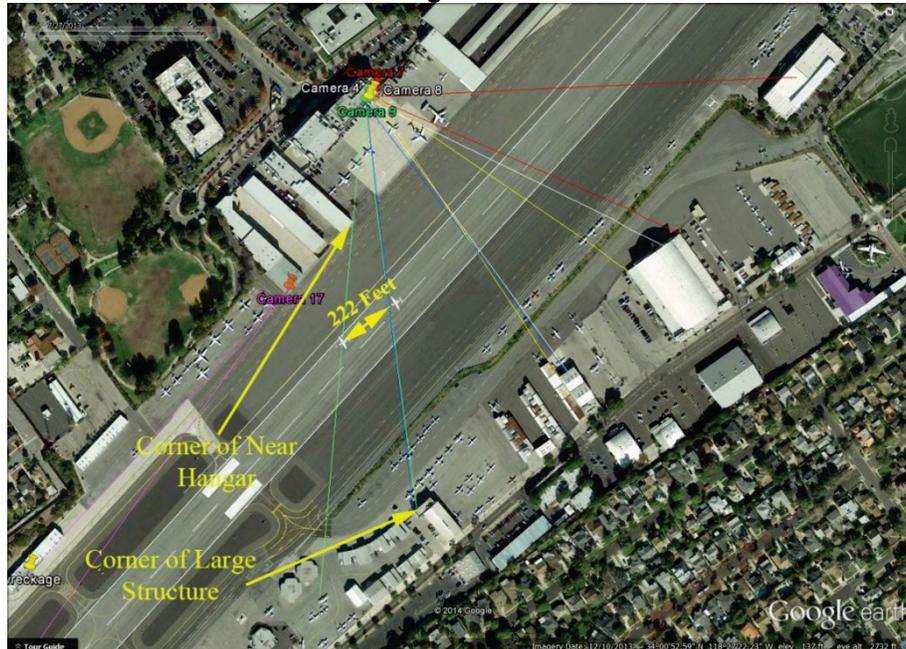
Figure 17. The distance between the aircraft's position in Figure 12 and 13 as measured on Google Earth.

Figure 17 shows the two positions of the aircraft in Figure 15 and 16 represented on Google Earth. Evidence collected on scene suggests that the accident aircraft was not on centerline at this time. Using information provided by the Investigator-in-Charge and Figure 20 and 21, an estimate of the aircraft's path was made. When plotted on Google Earth this measurement was established as 222 feet. When the adjusted fuselage length is accounted for this measurement becomes 200 feet.

Using the equation for average groundspeed in the beginning of this section, an average groundspeed of 79.0 knots was obtained for this segment.

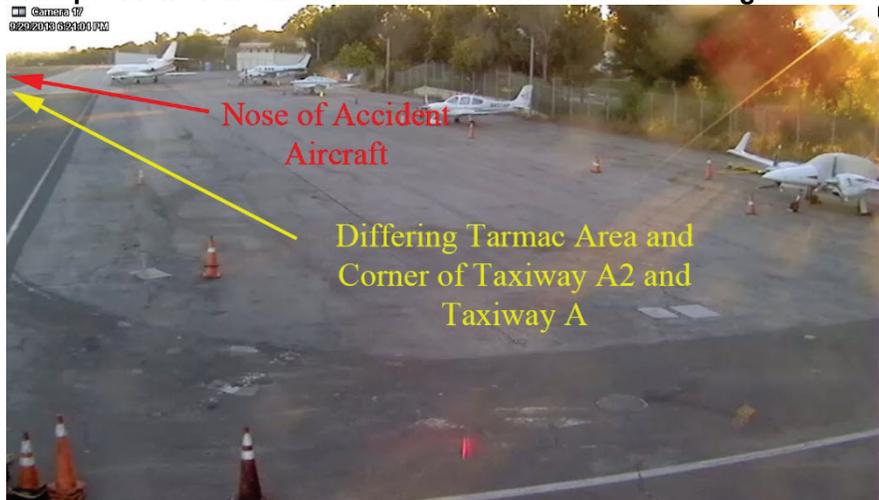
Figure 18. The position of the aircraft as it enters the measurable segment for Camera 17.

The aircraft first appears in the upper left hand corner of the recording as the nose of the aircraft is shown veering towards a tarmac area between Runway 03/21 and the intersection of Taxiway A1 and Taxiway A. There are limited background landmark features to align the aircraft at this moment. The closest fit was a line drawn from the camera location to the intersection of two different color tarmac surfaces near the area of Taxiway A2 and Taxiway A. Figure 18 shows the aircraft in this position at a recorded timestamp of 6:21:04 PM and one carryover frame (4.25 seconds). A trajectory was estimated using photographs from the on-scene portion of the investigation which showed witness marks from the aircraft's tires as it moved toward the impact location. This trajectory was used to calculate the overall distance the aircraft traveled through the measureable segment. No adjustment for fuselage length was made at this frame.

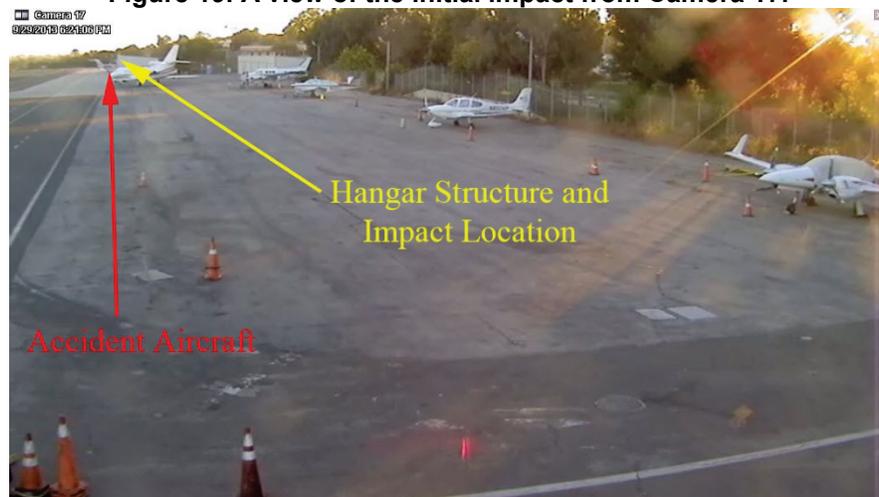
Figure 19. A view of the initial impact from Camera 17.

The cockpit area of the accident aircraft is then shown impacting a hangar structure near the edge of Taxiway A. Figure 19 shows the accident aircraft during first portion of impact with the hangar structure. At this moment, approximately half the fuselage appears to be inside the hangar (approximately 22 feet). The timestamp reads 1:21:06 AM and three carryover frames (6.75 seconds).

Using the equation in Section 4.3., this time was calculated to be 2.5 seconds.

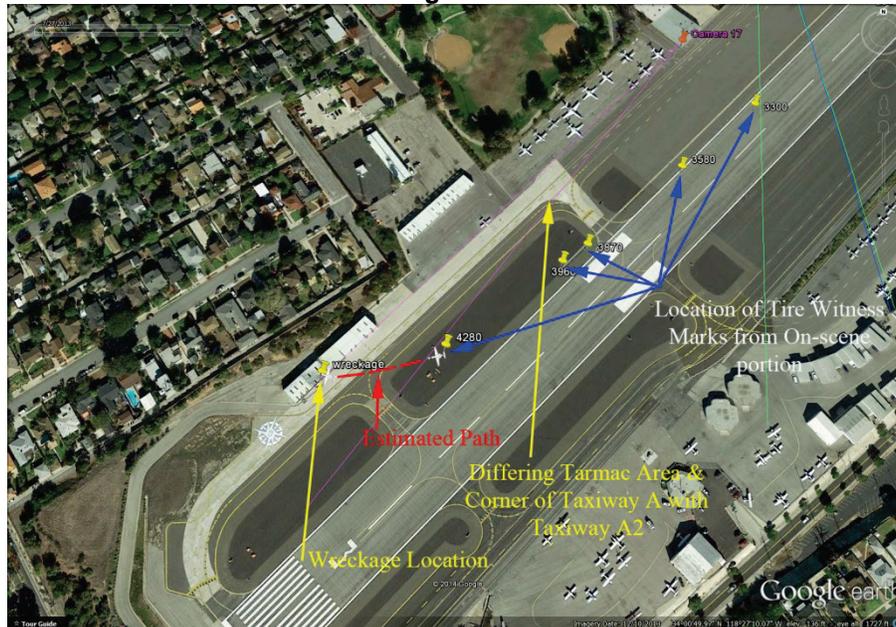
Figure 20. The distance between the aircraft's position in Figure 18 and 19 as measured on Google Earth.

Figure 20 shows the two positions of the aircraft in Figure 18 and 19 represented on Google Earth. A distance of 235 feet was calculated as an approximation based on the aircraft's trajectory across the ground provided by tire mark evidence collected on scene. Additionally, the frame at time of impact shows roughly have the aircraft impacting the structure during the 2.5 second measured time interval. Due to this, half the length of the aircraft (22 feet) was

subtracted. The resultant total distance traveled along the estimated path becomes 213 feet.

Using the equation for average groundspeed in the beginning of this section, an average groundspeed of 50.5 knots was obtained for this segment.

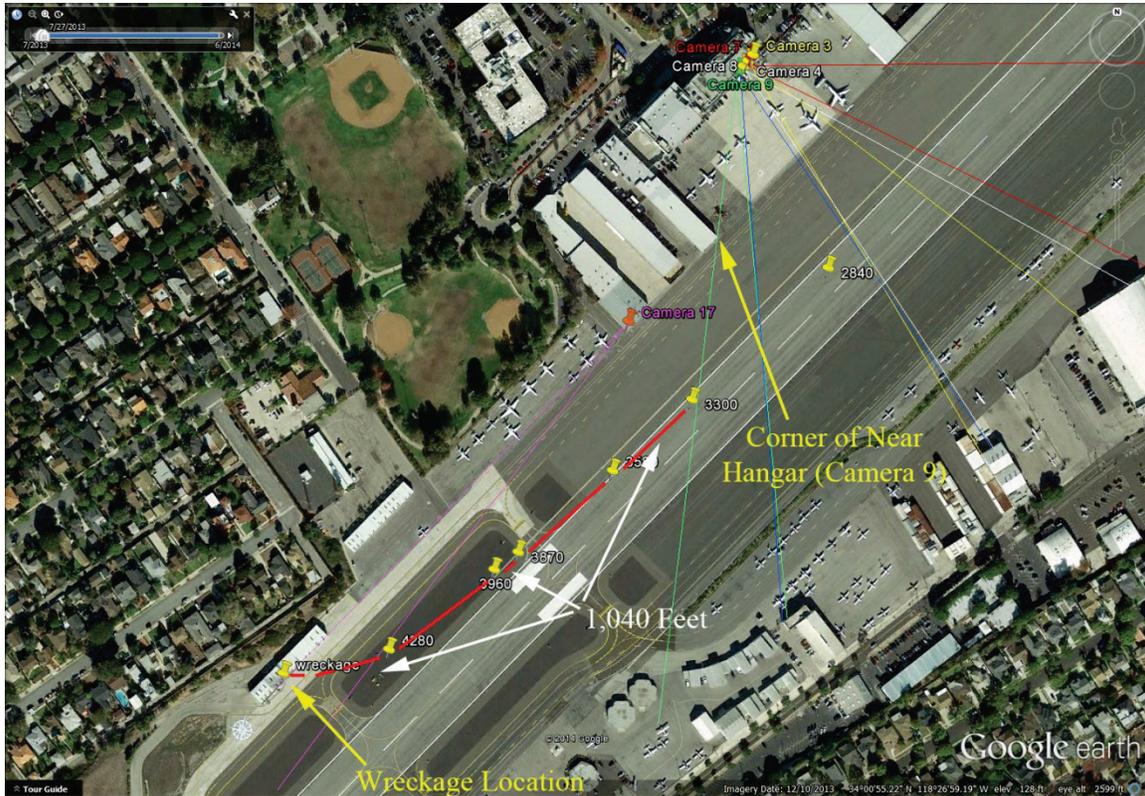
The accident aircraft's speed can be averaged throughout a portion of Runway 03/21 that is not covered by security camera footage. Figure 16 shows an image from camera 9 in which the aircraft is shown passing behind a hangar structure near the FBO's ramp area at a recorded common timestamp of 6:20:54 and 2 carryover frames (6:20:54.50). The nose of the accident aircraft appears 9.75 seconds later at a recorded common timestamp of 6:21:04 and 1 carryover frame (6:21:04.25) on the recording from Camera 17. Figure 21 shows a map of Runway 03/21 in this area which includes the location of tire witness marks recorded on the tarmac during the on-scene portion of the investigation. The distance measured using Google Earth resulted in approximately 1,040 feet.

Figure 21. The distance measured between likely locations of the aircraft from camera 9 and 17 video recordings. The distance was measured to be 1,040 feet. The value next to the plotted tire witness marks are the distance value in feet measured from the Runway 21 threshold.

Using the equation for average groundspeed, an average groundspeed of 63.2 knots was obtained for this segment.

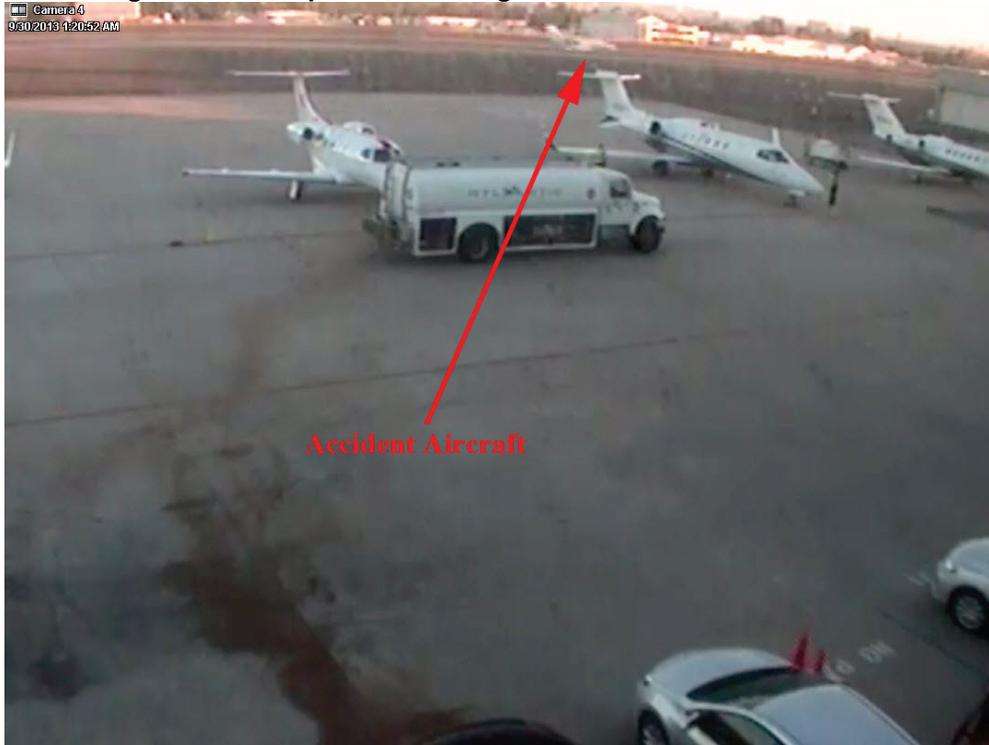
Figure 32. An exported still image from camera 4 at 6:20:52 PM.

Figure 32 is a second exported still from 6:20:52 PM. The position of the aircraft's flap position is inconclusive. Figure 33 is the same image, enhanced to attempt to recognize the aircraft's flap position.

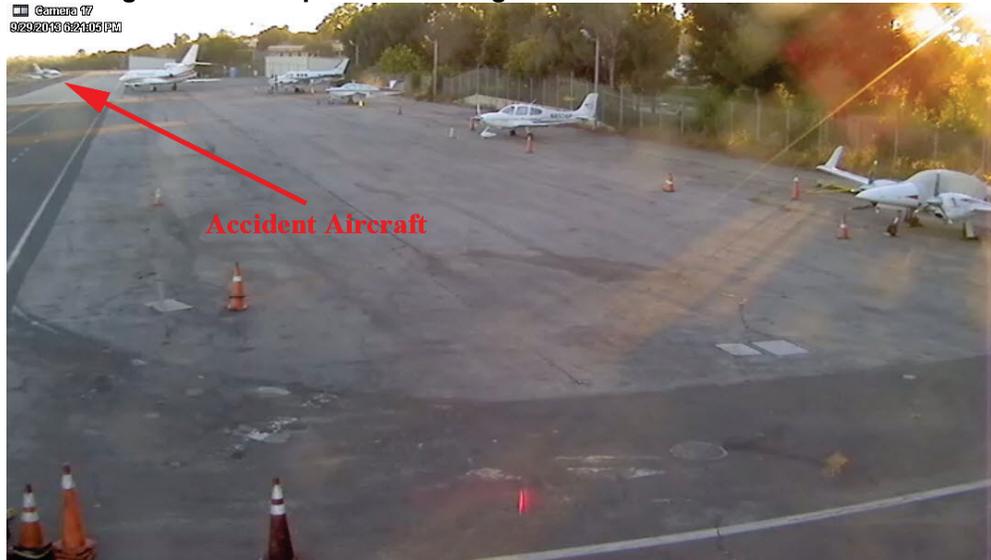
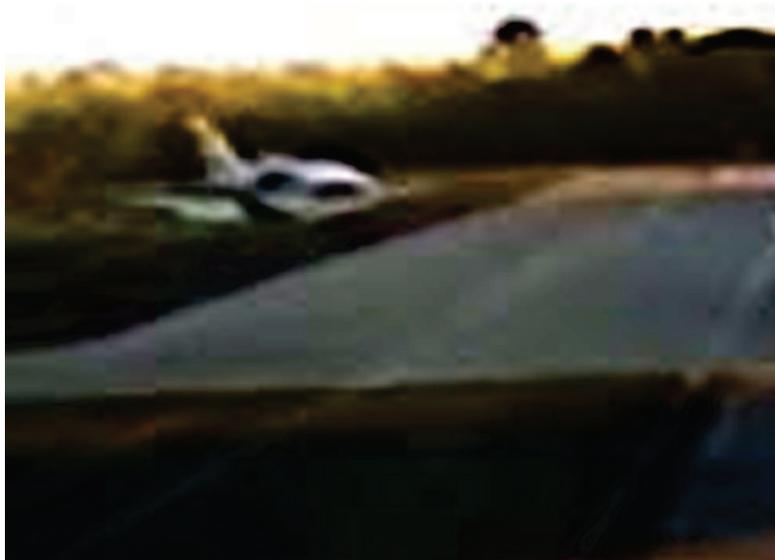
Figure 36. An exported still image from camera 17 at 6:21:05 PM.

Figure 36 is an exported still from 6:21: 05 PM. The position of the aircraft's flap position is noted as in an unquantified extended position. Figure 37 is the same image, enhanced to attempt to recognize the aircraft's flap position.

Figure 37. An enhanced image from camera 17 at 6:21:05 PM. The flap position is in an unquantified extended position.
