NATIONAL TRANSPORTATION SAFETY BOARD
Office of Research and Engineering
Washington, D.C. 20594

Video Study

**NTSB Case Number:
HWY15FH010**

Location: Houston, Texas
Date: September 15, 2015
Time: 7:03 a.m.
Vehicle No. 1: 2008 IC Integrated CE school bus
Vehicle No. 2: 2003 Buick LeSabre passenger car ('accident car')

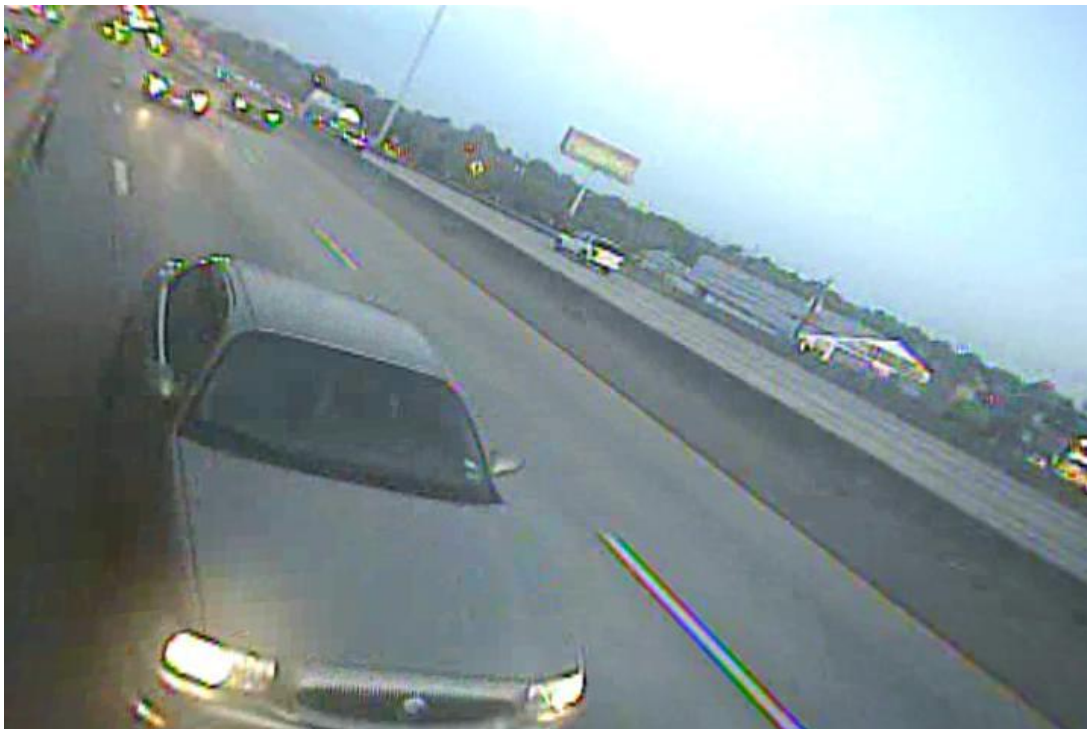
Figure 1 Frame from the Video Used for Vehicle Motion Analysis

Figure 1 shows a frame from the video after the barrel distortion was corrected. It shows the accident car crossing from the third lane into the second lane, toward the school bus, 0.8 seconds before it impacted the left side of the bus.
