**NATIONAL TRANSPORTATION SAFETY BOARD**  
Office of Research and Engineering  
Washington, D.C. 20594

## **Video Study**

**NTSB Case Number:**  
**CEN15MA290**

Location: Frisco, Colorado  
Date: July 3, 2015  
Time: 1339 MDT  
Aircraft: Airbus Helicopter AS350 B3e

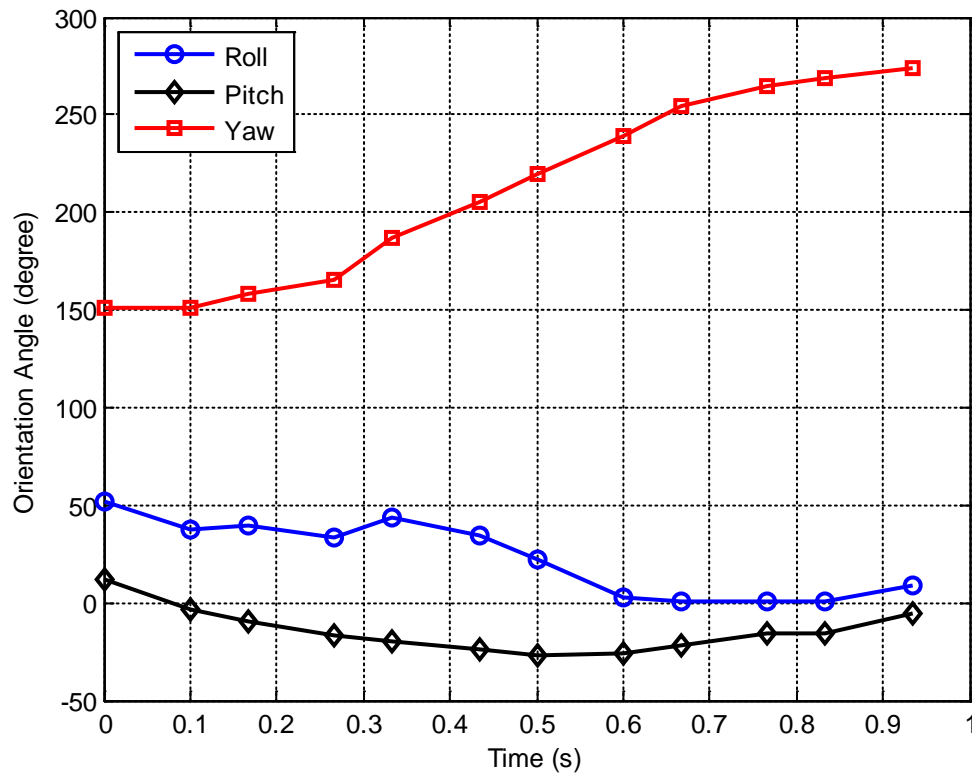
**Figure 1. Estimated Helicopter Euler Orientation Angles**

Figure 1 shows the three angle estimates. Time is set to zero at the first analyzed point. The accuracy of these estimates is  $\pm 3^\circ$ . Note that just before ground impact, at time 0.93 seconds, the pitch and roll angles were small.

Figure 1 shows a small pitch rate at the time of ground impact. The polarity of the pitch rate is positive, meaning that it reduces the magnitude of the vertical speed of points aft of the helicopter nose relative to the nose speed. However, the pitch rate was relatively small and was difficult to estimate at time of ground impact because the helicopter nose was pointed toward the camera. Additionally, just before the fuselage impacted ground, the skid landing gear impacted ground, collapsed, and probably altered the fuselage pitch rate. The magnitude and polarity of this effect were not measurable from the video. Consequently, since it was not possible to estimate it accurately, the possible pitch rate contribution to vertical speed was accounted for in the tolerance of the ground impact speed estimate and it was specified as  $58 \pm 5$  ft/s.

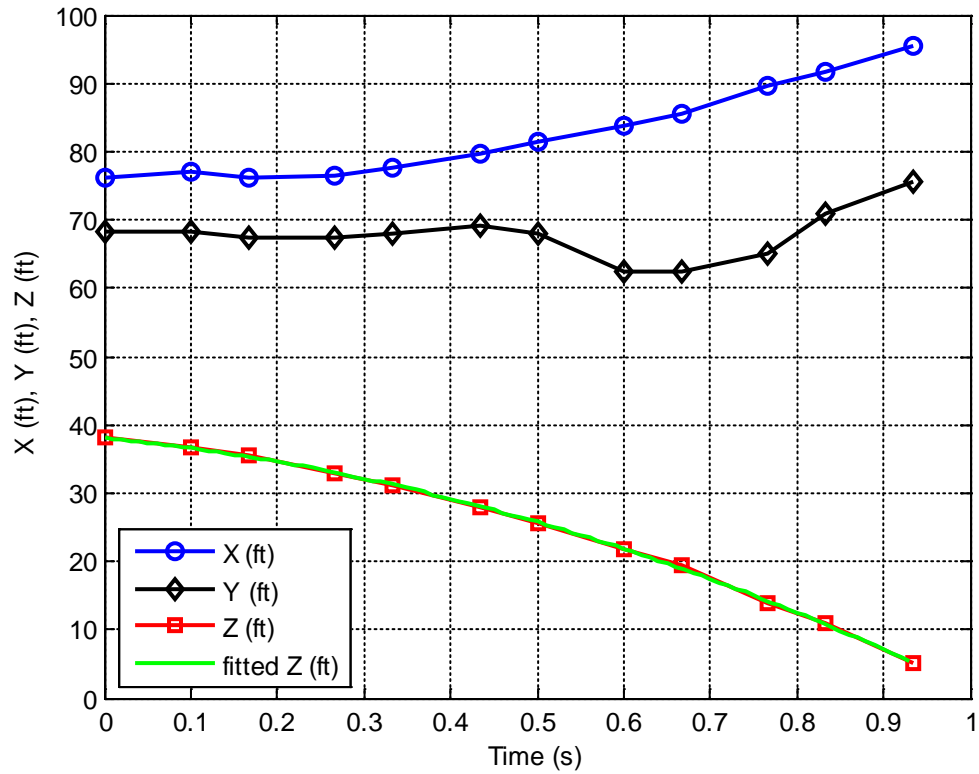
**Figure 2. Estimated Helicopter Locations**

Figure 2 shows the estimated locations of the helicopter in ground coordinates. The locations are those of the helicopter nose. The accuracy of these estimates is  $\pm 3$  ft. The last point in the figure is just before ground impact. The coordinate of interest is Z, the vertical location. A second order polynomial curve was fitted to it and matched it very accurately, as seen in Figure 2. The two curves virtually overlap. The vertical speed, computed based on the polynomial fit, is shown in Figure 3. It was 58 ft/s just before ground impact.

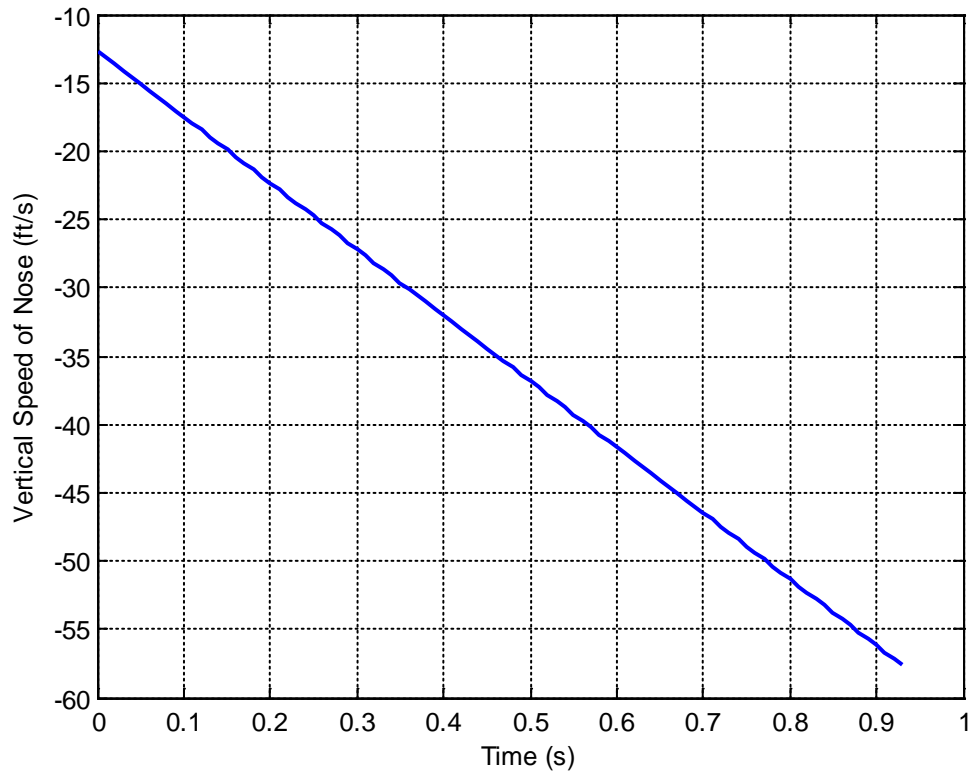
**Figure 3. Estimated Helicopter Vertical Speed**

The estimated nose vertical acceleration was constant -1.5 g, as evident by the straight line in Figure 3. It had to be constant because of the second order polynomial curve fit. During the analyzed 0.93 seconds, the helicopter was undergoing 3D translation and rotation with the rotor spinning. Therefore, one should not expect the nose acceleration to be -1.0 g.

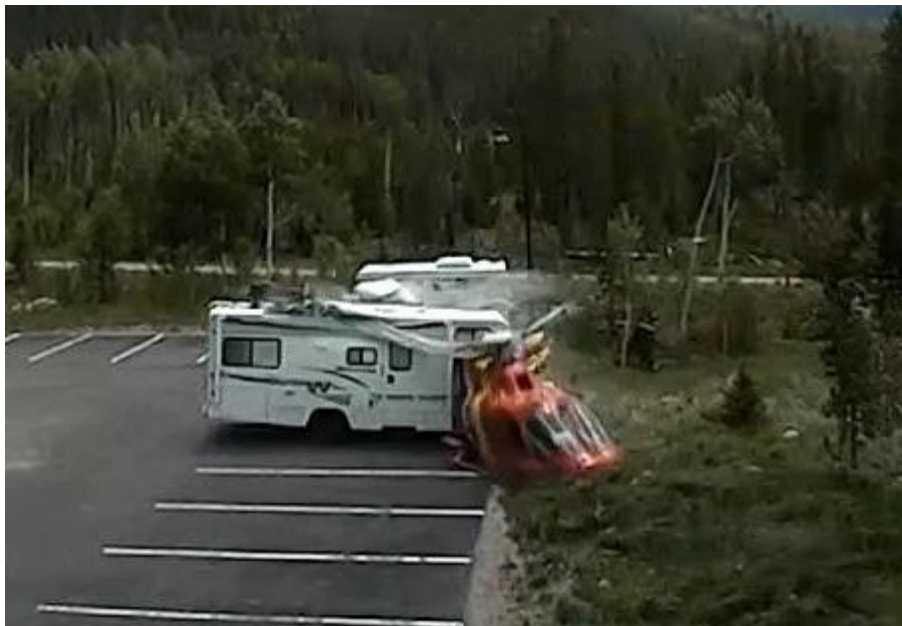
**Figure 4. Accident Helicopter at Time of Ground Impact**

Figures 4, 5 and 6 illustrate the severe fuselage damage caused by ground impact. Figure 4 is at time of impact, with the fuselage still intact. Figure 5 shows the helicopter 0.33 seconds after ground impact. It has already rolled approximately 90 degrees to right. Figure 6 shows the helicopter one second after ground impact.

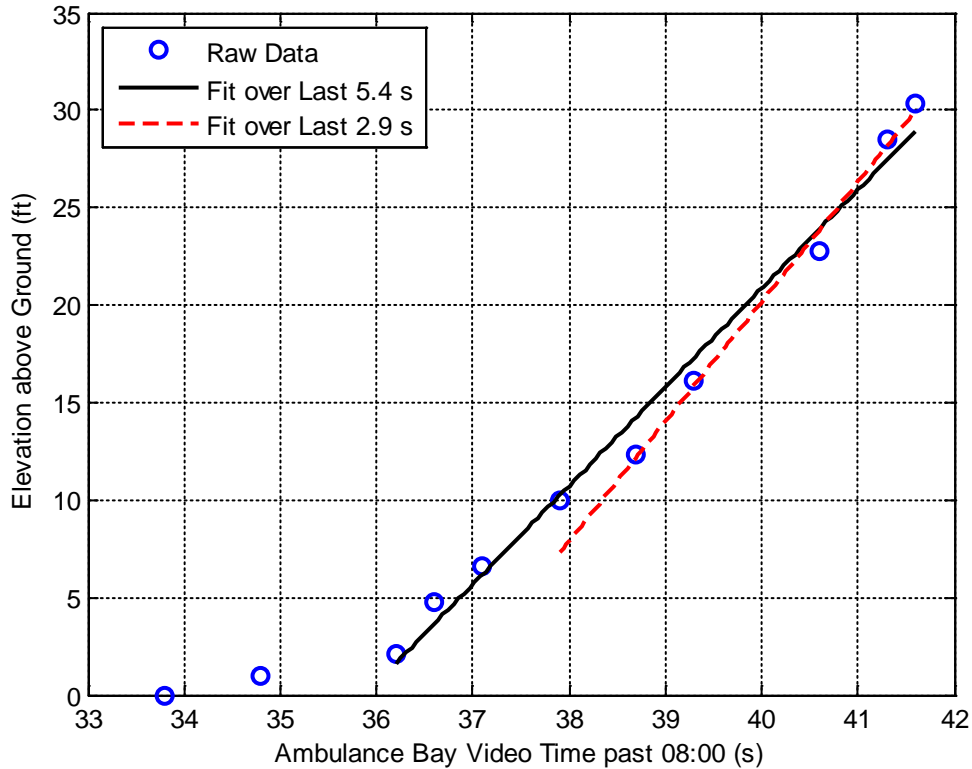
**Figure 7. Estimated Helicopter Elevation above Ground after Takeoff**

The Ambulance Bay camera captured the first eight seconds of flight of the helicopter and was used for estimating its vertical speed. The camera was calibrated based on dimensional information measured in Google Earth images. Figure 7 shows the estimated elevation above ground of the helicopter. Two fixed-speed lines were fitted to the elevation data, one over the last 5.4 seconds and the other over the last 2.9 seconds. The slopes of these lines can be viewed as the lower and upper bounds on the estimated climb rate. They are 5.1 ft/s and 6.1 ft/s, respectively. Therefore, the estimated vertical speed shortly after takeoff is  $5.6 \pm 0.5$  ft/s.
