NATIONAL TRANSPORTATION SAFETY BOARD

Video Study

NTSB Case Number: CEN17LA192

Location:	Canon City, Colorado
Date:	May 20, 2017
Time:	1340 MDT
Aircraft:	Robinson R66 helicopter

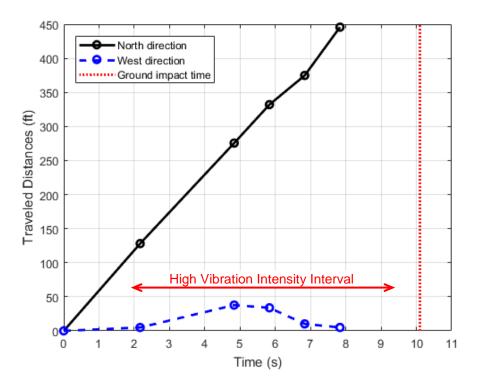
Figure 2. Estimated Distances Traveled by the Helicopter

The helicopter was 89 feet north of the northern edge of Route 50 and flying north when its first location was estimated. In the analysis, the time corresponding to this location was set to zero. Also set to zero at the first location were the distance traveled in the north direction, the distance traveled in the west direction, and the altitude. The altitude was determined from reference points far behind the helicopter, so it is not possible to accurately determine the height above ground; it is possible to determine accurately the altitude relative to the distant points and so determine the altitude relative to the first point accurately. Figure 2 shows the distances traveled by the helicopter in the north and west directions vs. time.

Forward speed of the helicopter can be estimated by dividing the total travel during the 7.8 seconds by that time. The estimate is 33.7 knots. The contribution of the speed in west direction to the total speed is small. It is the highest between 2.1 seconds and 4.9 seconds where the speed in the west direction is highest. The total forward speed in that time interval is 34.3 knots. Because the video-based estimation involves unavoidable uncertainties, the estimated forward speed during the analyzed 7.8 seconds is set to 34 ± 3 knots.

The video shows a time interval where the helicopter vibration intensity was significantly higher than during the rest of the flight. This interval lasted about seven seconds and is marked in red in Figure 2.

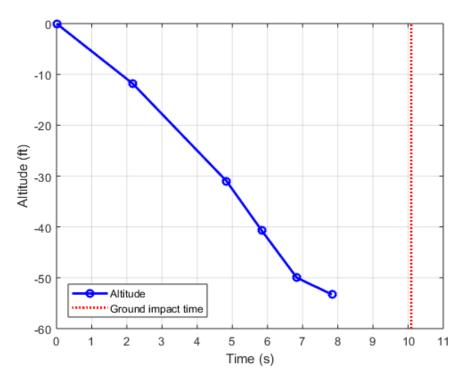
Figure 3. Estimated Altitude of the Helicopter

Figure 3 shows the estimated altitude of the helicopter measured with respect to the altitude at time zero. Estimated vertical descent speed from time zero to the fifth point at time 6.8 seconds is 439 feet/minute. The highest estimated speed of descent of 571

CEN17LA192 Video Study Page 3 of 5 feet/minute is between 4.8 seconds and 6.8 seconds. A 10% tolerance is assigned to the estimated speeds. Therefore, the highest estimated descent speed is set at 570±60 feet/minute.
