NATIONAL TRANSPORTATION SAFETY BOARD
Office of Research and Engineering
Washington, D.C. 20594

Video Study

**NTSB Case Number:
HWY17MH009**

Location: Chattanooga, Tennessee
Date: November 21, 2016
Time: 3:20 p.m.
Vehicle: Thomas school bus operated by Durham School Services

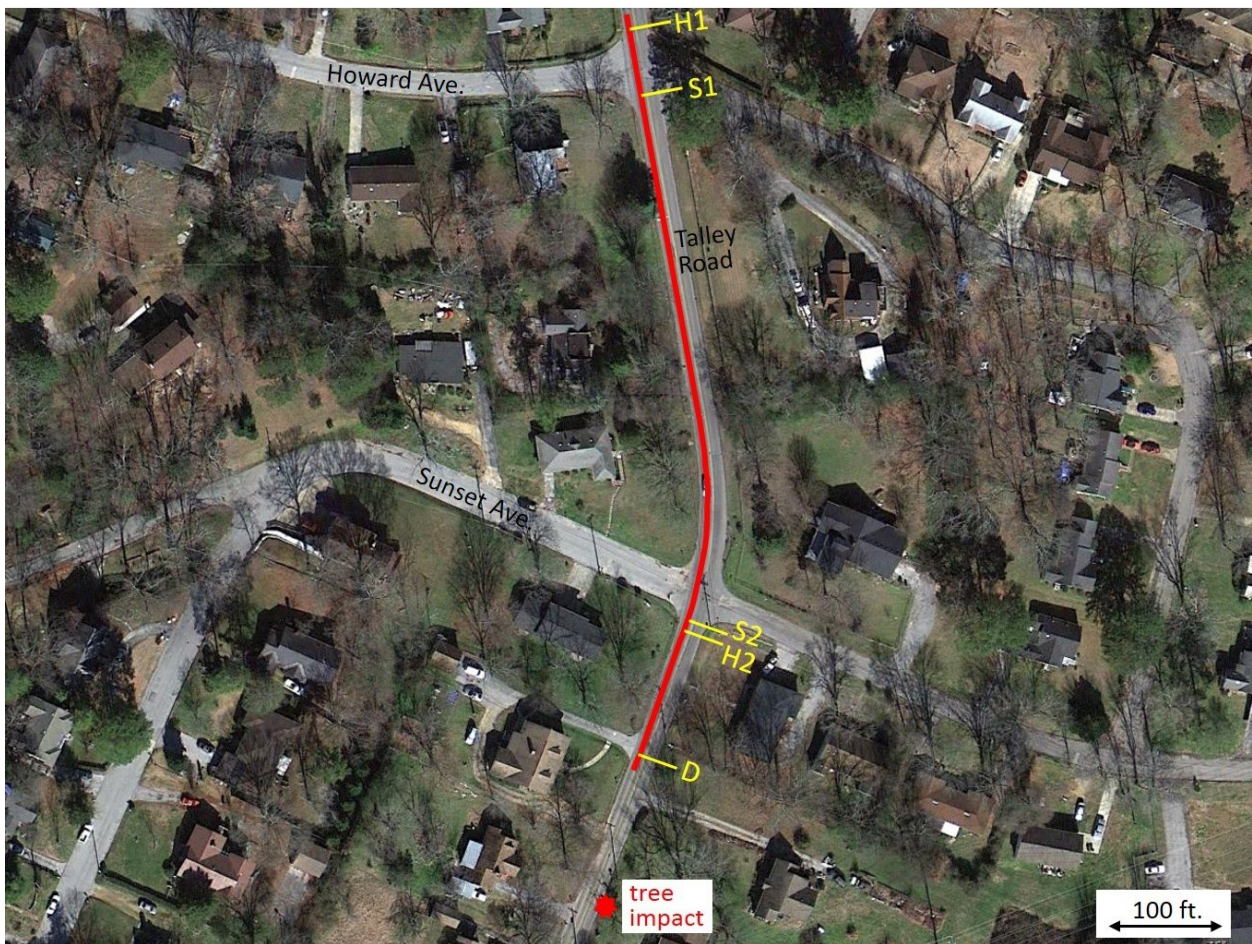
Figure 1. Google Earth Image of the Accident Area

Figure 1 shows an overhead Google Earth image of the accident area. The school bus was moving south on Talley Road, rolled over, and impacted a tree south of Sunset Avenue. The location of the impacted tree is marked in the figure. The red line in the figure marks the segment of Talley Road along which speed was estimated. Five reference locations are marked along the road segment. Distances between these reference locations were used for estimating the speed of the bus based on travel times between these locations. The travel times were estimated based on video frame timing.

The reference locations along Tally Road that are marked in Figure 1 are:

- H1 fire hydrant No. 1
- S1 brick sign 'Hemphill Neighborhood' No. 1
- S2 brick sign 'Hemphill Neighborhood' No. 2
- H2 fire hydrant No. 2
- D south edge of a paved driveway

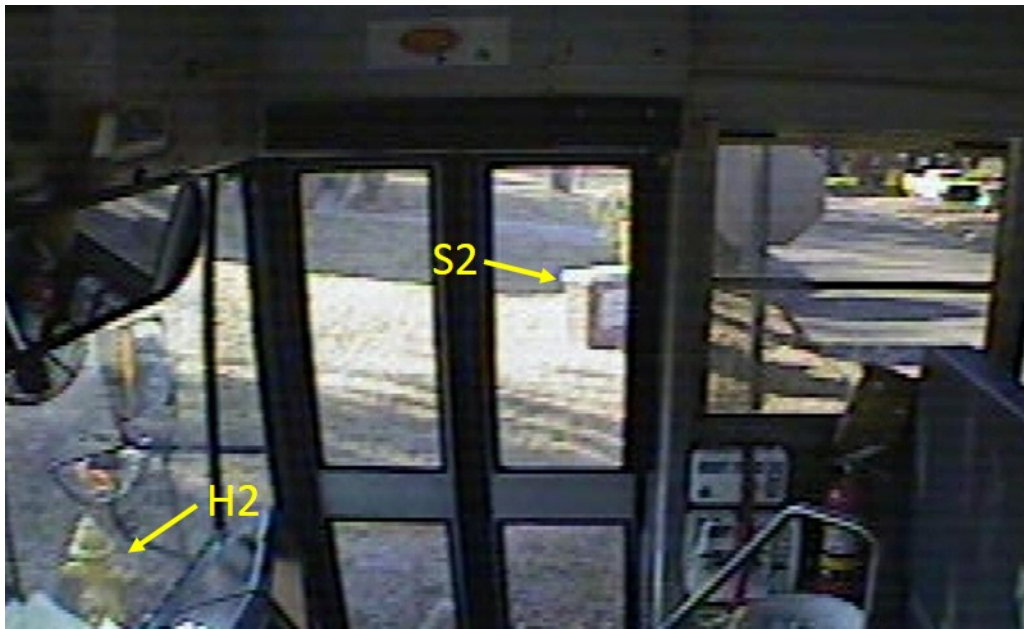
Figure 2. Frame from Camera No. 2 Video

Figure 2 shows a subset of a frame from Camera No. 2 video. Brick sign S2 and fire hydrant H2 are visible and marked in the frame.

The brick signs were seen in Camera No. 2 video. The S1-S2 travel distance is approximately 444 feet and the time to travel this distance is 5.73 seconds. The estimated speed is 77.5 ft/s or 52.8 mph.

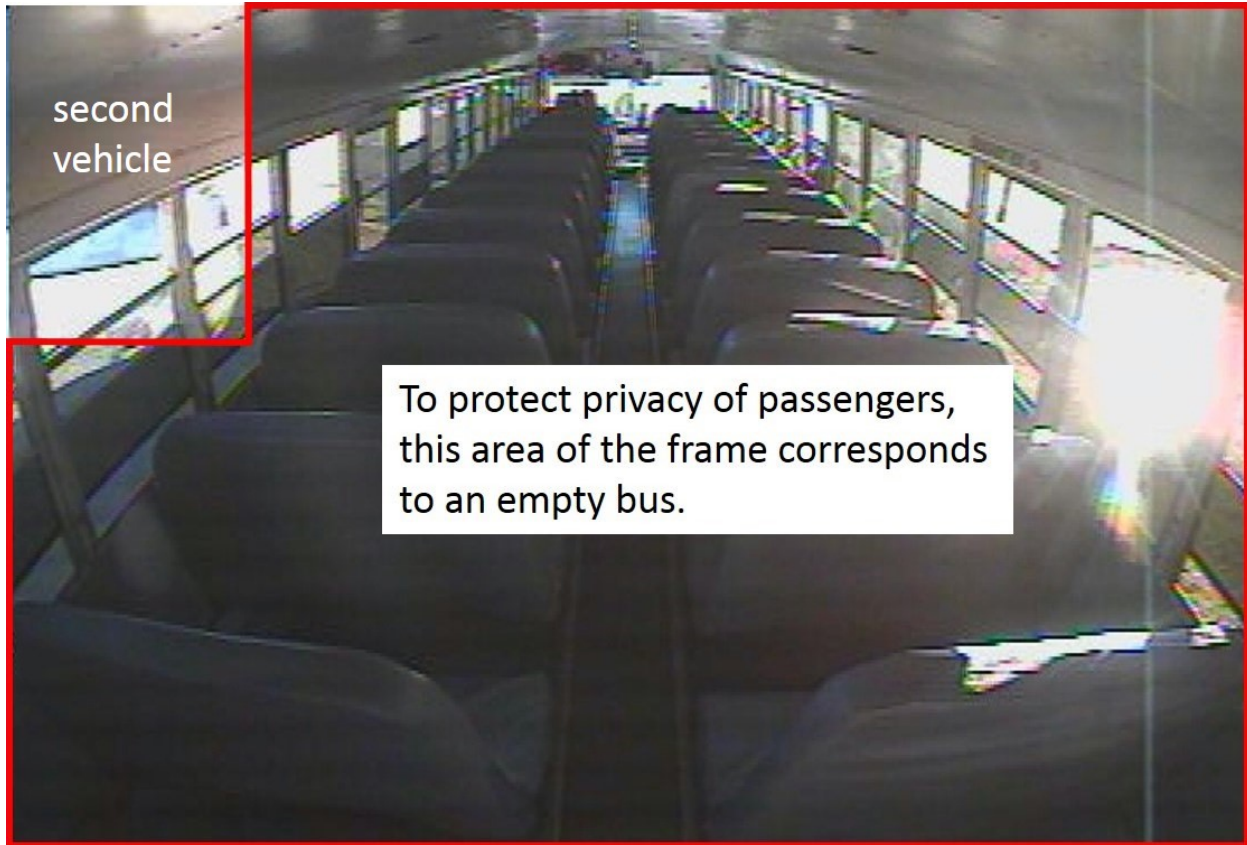
Figure 3. Video Frame Showing a Second Vehicle

Camera No. 3 captured the image of a second vehicle, a white car, pickup truck or van, that was traveling north on Talley Road at the time of the accident. The white vehicle is seen in the video frame in Figure 3. The school bus and the white vehicle were at the same location along Talley Road less than two seconds after the bus steered to the right to follow the curve on Talley Road at Sunset Avenue.

Once the bus was past the second vehicle, it yawed abruptly to the left, subsequently rolling over to the right. Less than one second after the two vehicles were at the same location along the road, the video ended.

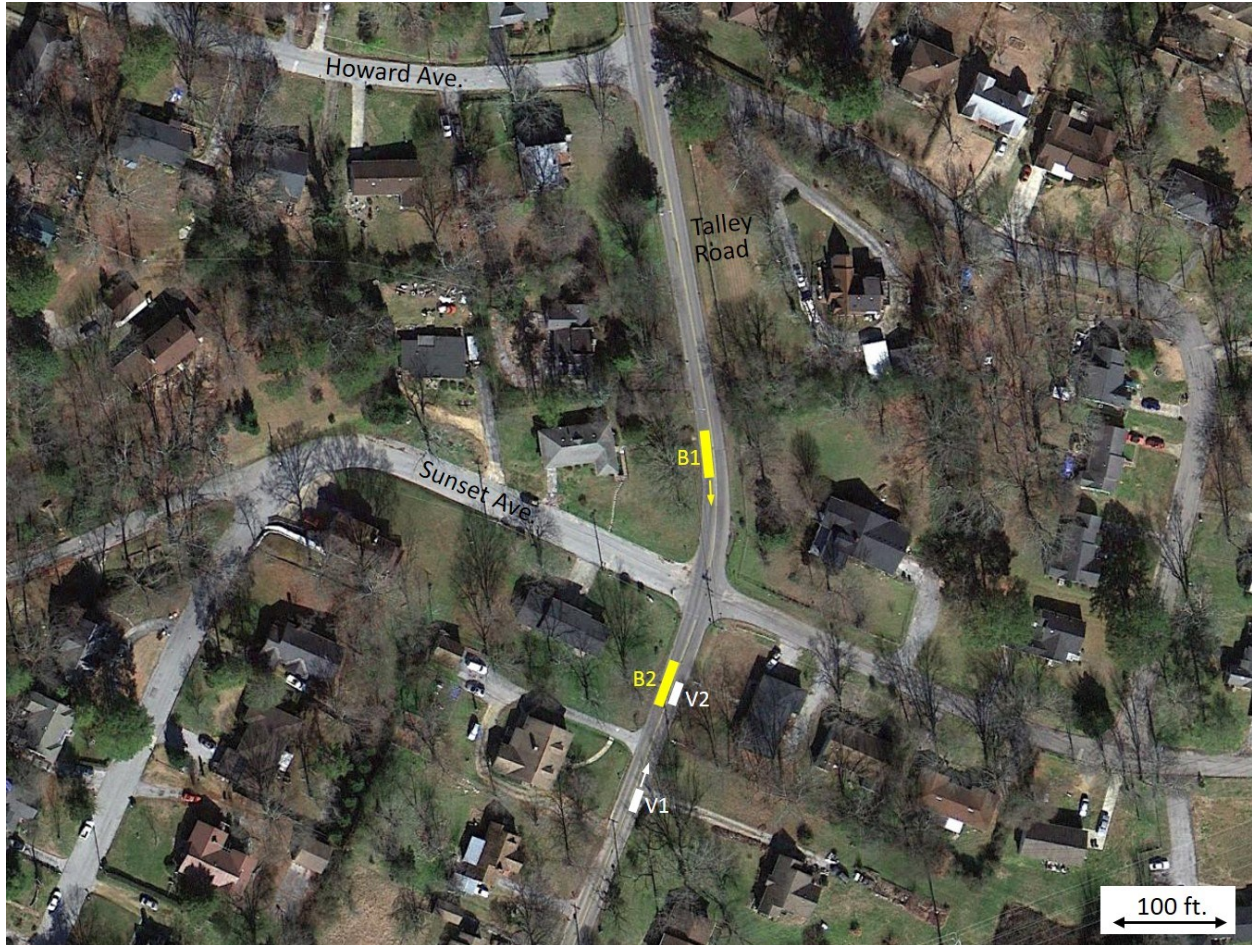
Figure 4. Google Earth Image of the Accident Area Showing Vehicle Locations

Figure 4 shows the approximate locations of the school bus and of the second vehicle on Talley Road. B2 and V2 show the bus and the vehicle at the time the frame in Figure 3 was acquired. B1 and V1 show the bus and the vehicle 2.5 seconds before the frame in Figure 3 was acquired. The location of V1 is based on assumed speed of 25 mph of the second vehicle. Its speed cannot be estimated based on the videos.

As can be seen in Figure 4, Talley Road changes its direction by 31° to the west from the segment north of Sunset Avenue to the segment south of Sunset Avenue. The radius of the curve connecting the two segments is approximately 300 feet. The lateral acceleration of a vehicle negotiating a circle with 300-foot radius at the speed of 52 mph is 0.60 g. Since the school bus traveling at 52 mph was only about two seconds on the short curved segment of Talley Road, simulations were performed to estimate the maximum acceleration the accident bus would have developed.
