NATIONAL TRANSPORTATION SAFETY BOARD
Office of Research and Engineering
Washington, D.C. 20594

Video Study

**NTSB Case Number:
DCA17FA109**

Location: Charleston, West Virginia (CRW airport)
Date: May 5, 2017
Time: 6:51 am EDT
Aircraft: Shorts SD3-30

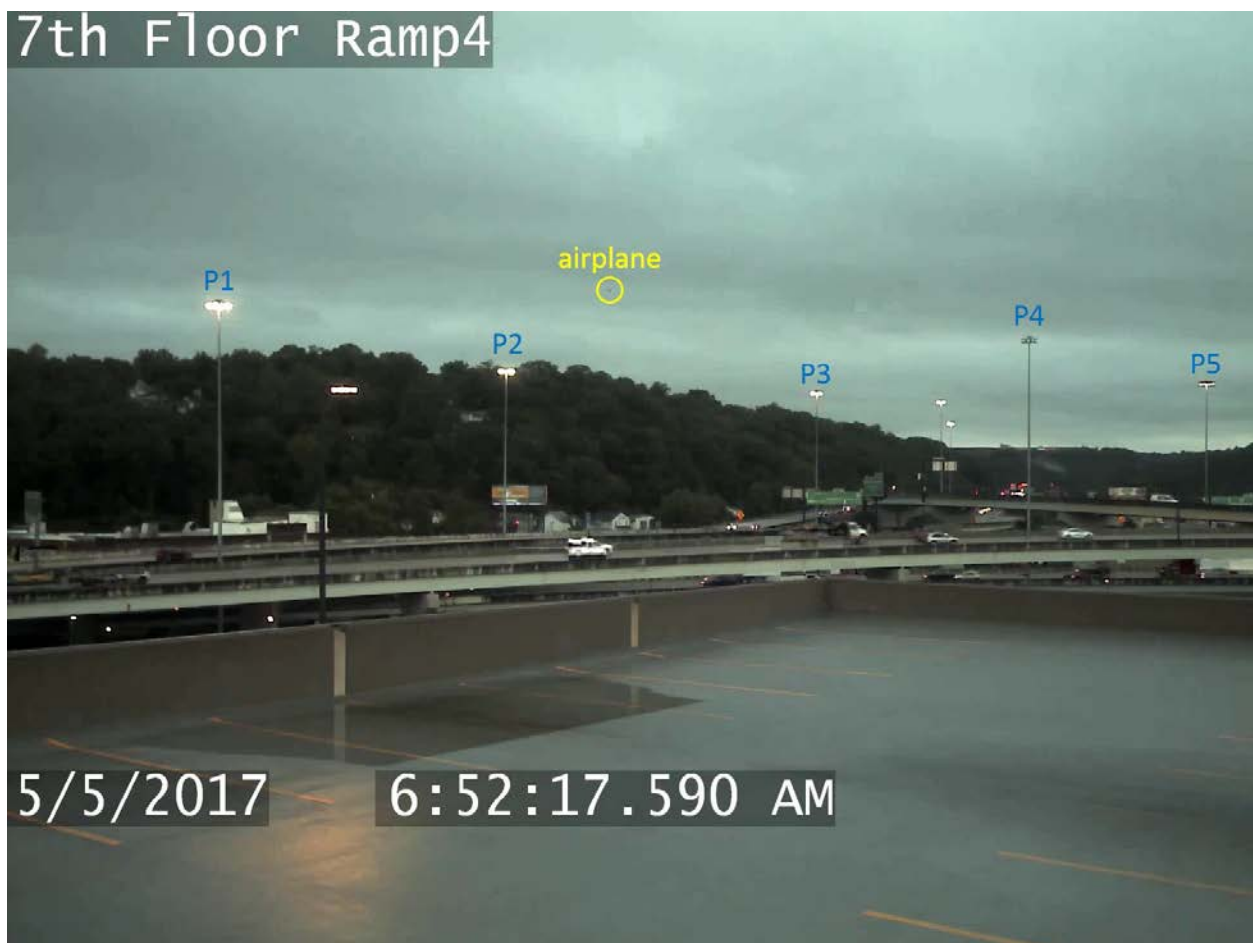
Figure 1. Frame from the Garage Building Video

Figure 1 shows the frame from the video when the descending airplane was seen for the first time. The airplane image is marked by the yellow circle. Five highway light poles, P1-P5, are also marked in Figure 1. These light poles are also visible and marked in the Google Earth aerial view shown in Figure 2.

The location of the airplane image in Figure 1, the video frame resolution of 1600×1200 , the estimated HFOV and the camera yaw and pitch estimates result in a line-of-sight from the camera to the airplane that is 52.8° east of north and is elevated by $7.5^\circ \pm 0.3^\circ$ above horizontal.

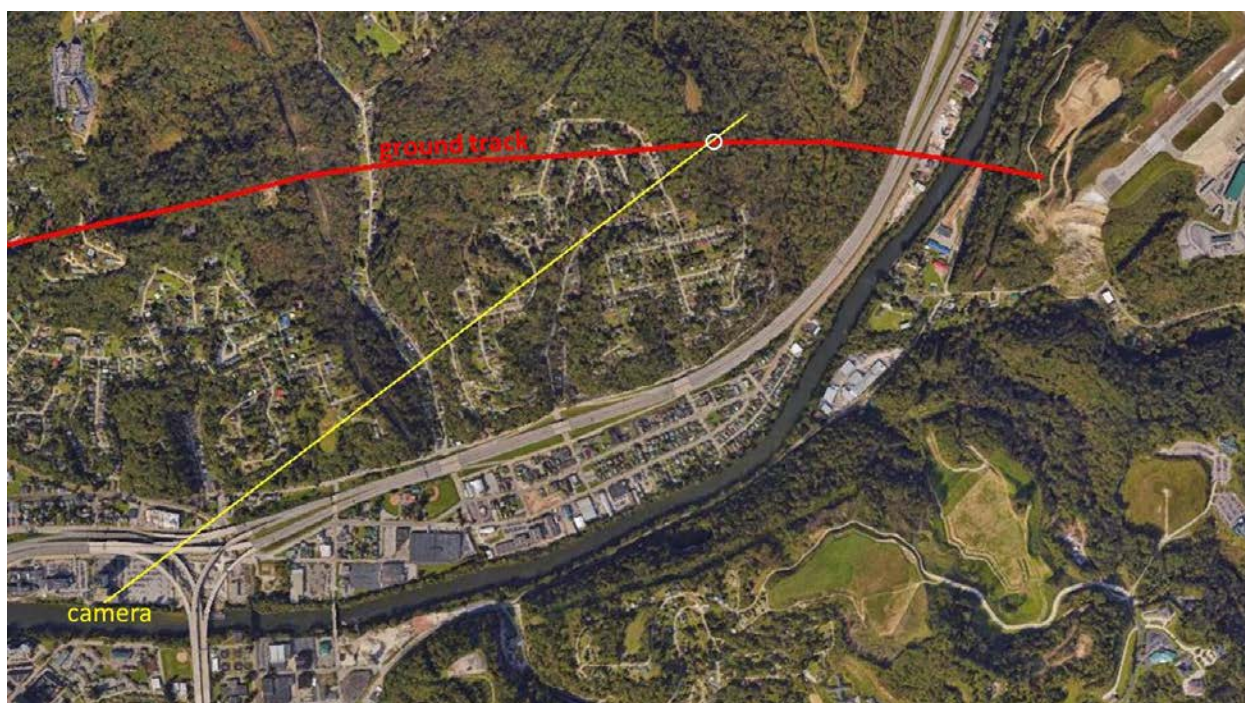
Figure 3. Airplane Location Estimate

Figure 3 shows in red the ground track of the airplane estimated from radar returns as described in the *Airplane Performance Specialist Report* available in the docket for this

accident. It also shows in yellow a line-of-sight from the camera that is oriented by the estimated 52.8° east of north. A white circle shows the intersection of the ground track with the line-of-sight. The ground-level distance from the camera to the intersection point is 7340 feet. Consequently, the elevation of the airplane above the camera is given by $7340 \times \tan(7.5^\circ \pm 0.3^\circ) = 966 \pm 40$ feet.

The ground near the parking garage is at the elevation of 591 feet above mean sea level (MSL), based on Google Earth. The camera was estimated to be 72 feet above ground level, i.e., at 663 feet MSL. This results in estimated nominal airplane altitude of $966 + 663 = 1629$ feet MSL. The inaccuracy of this estimate was previously estimated as ± 40 feet due to camera pitch angle uncertainty only. Adding to this inaccuracy ± 20 feet to account for other sources of error, the estimated airplane altitude is 1629 ± 60 feet MSL when it is seen first in the video.

The elevation of runway 5 at CRW is 946 feet MSL. Therefore, the estimated cloud ceiling at the airport is $1629 \pm 60 - 946 = 683 \pm 60$ feet. Note that this estimate is based on the limited information that was available. It is based on airplane location and cloud elevation at a location about 3800 feet west of the landing spot on runway 5. Additionally, it is based on video from a camera that is 7340 feet southwest of the location of the airplane.

This video-based estimate of the altitude of the airplane (as it becomes visible breaking through the clouds) is consistent with the altitude indicated by the airplane transponder for the radar return nearest to the point marked by the yellow circle in Figure 3. The *Airplane Performance Specialist Report* shows the reported altitude as 1600±50 feet MSL.

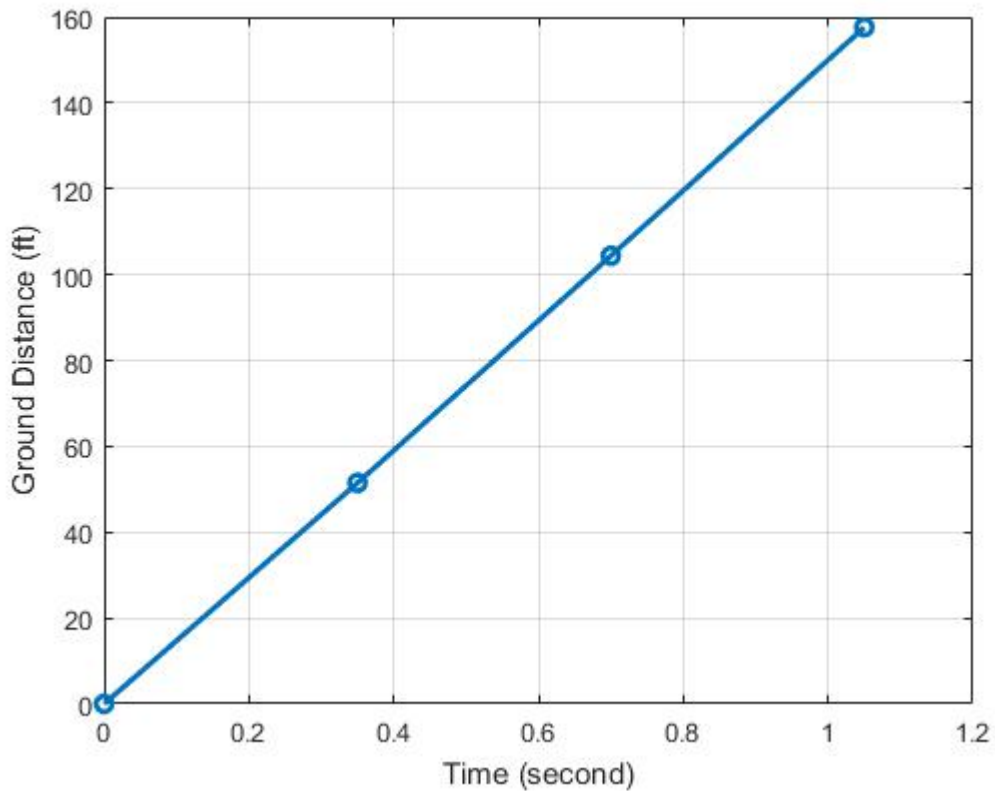
Figure 6. Distance along Ground Path vs. Time

There were four frames in the video that were taken before the fuselage contacted the runway. Locations and orientations of the airplane were estimated at the four times corresponding to these video frames. Figure 6 shows the ground track distances traveled by the airplane between the first and the fourth frame. The distance traveled at time zero

was set to zero. The slope of the distance vs. time curve in Figure 6 is constant and corresponds to ground speed of 89.0 knots.

The airplane nose altitude was decreasing at the rate of approximately 22.8 knots (2309 feet/minute) between the first and the fourth locations. The vector sum of the ground speed and the vertical speed is $(89.0^2+22.8^2)^{1/2}=91.9$ knots. To account for estimation errors, a tolerance must be assigned to the nominal speed estimate. With the tolerance, the estimated ground impact speed is 92 ± 4 knots. This is the estimated magnitude of the three-dimensional velocity vector of the airplane nose when it contacted the runway.

An airport camera video was used for estimating the speed with which the airplane impacted the runway. The estimated speed was 92 ± 4 knots. The left wing contacted the runway first because the left-wing-down roll angle was approximately 42° . The fuselage was at an approximate 14° nose-down pitch angle at that time.
