NATIONAL TRANSPORTATION SAFETY BOARD

Video Study

NTSB Case Number: ERA18FA006

Location:	Front Royal, Virginia
Date:	October 7, 2017
Time:	1345 EDT
Aircraft No. 1:	Piper PA-25-235 ('towplane')
Aircraft No. 2:	Schleicher ASK 21 ('glider')

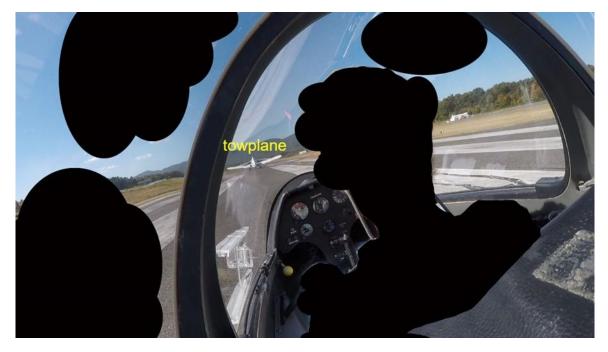
The camera had a wide field of view that resulted in barrel distortion of the video frames. The distortion was corrected mathematically using video frames such as the frame from the first video that is shown in Figure 1. Note that images and image reflections of individuals on board the glider were masked to protect their privacy. The runway white stripes were used as the reference for barrel distortion correction. The analysis described below was based on the corrected video frames.

The three camera orientation angles and the HFOV angle were estimated based on video frames similar to the one shown in Figure 1. The frames selected for analysis were those in which the two aircraft were moving and the tow line was straight. Its length was set to 160 feet based on the post-accident investigation and a discussion with the glider operator.

Figure 1. Frame from the First Video Showing the Towplane on the Runway

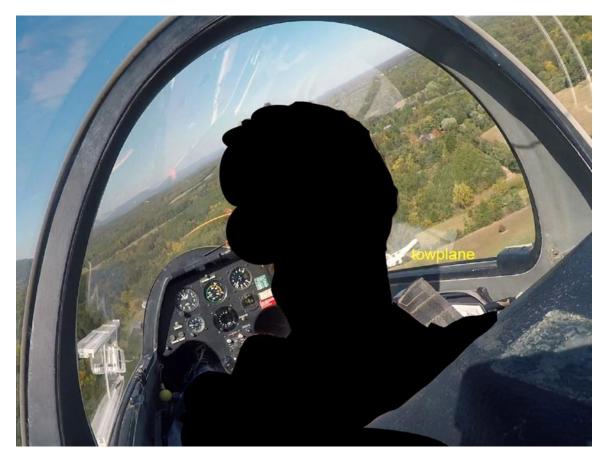
Figure 2. Frame from the Second Video Showing the Towplane in Flight

ERA18FA006 Video Study Page 3 of 5 Figure 2 shows a frame from the second video at a time when the towplane was seen for the second time in that video, at video time 8.8 seconds. The location of the towplane with respect to the glider at the time this video frame was acquired was estimated with the camera optics model with its orientation angles and HFOV set to their calibrated values. The process was similar to the calibration process. The wireframe model was superimposed on the video frame and the location and orientation of the wireframe model with respect to the glider were varied iteratively until there was an optimal match between the model and the image of the towplane, and the tow line length constraint was satisfied. At that time, the location and orientation of the wireframe model were the optimal estimates of these quantities.

Note in Figure 2 that the left wing and much of the fuselage of the towplane are not visible in the video frame. Therefore, the location and orientation estimates were based primarily on the right wing and the empennage.

The nominal estimate of the altitude difference between the glider and the towplane was 63 feet (glider at a higher altitude than the towplane). To account for analysis uncertainties, a $\pm 10\%$ tolerance band is assigned to the nominal estimate, resulting in 63±6 feet. With a 160-foot-long tow line, the nominal altitude difference to tow line length ratio is 63/160=0.39.

The time gap between the end of the first video and the beginning of the second video was about 5 seconds. Therefore, the time elapsed between the end of the first video and the time when the video frame shown in Figure 2 was acquired was about 14 seconds. Based on the glider altimeter readings that can be seen in the videos, the glider climbed about 50 feet during this time, from 890 feet MSL to 940 feet MSL. Video analysis showed that the towplane altitude relative to the glider decreased by 63 feet during these 13 seconds. Therefore, the towplane altitude relative to ground decreased by about 63-50=13 feet during these 13 seconds.

Consequently, it is estimated that the towplane started its descent toward ground impact shortly before the time when the video frame shown in Figure 2 was acquired. It impacted ground about 12 seconds past the time when the video frame shown in Figure 2 was acquired.
