NATIONAL TRANSPORTATION SAFETY BOARD

Video Study

**NTSB Case Number:
HWY17MH015**

Location: Flushing, New York
Date: September 18, 2017
Time: 6:16 a.m. EDT
Vehicle: 2015 MCI Motorcoach

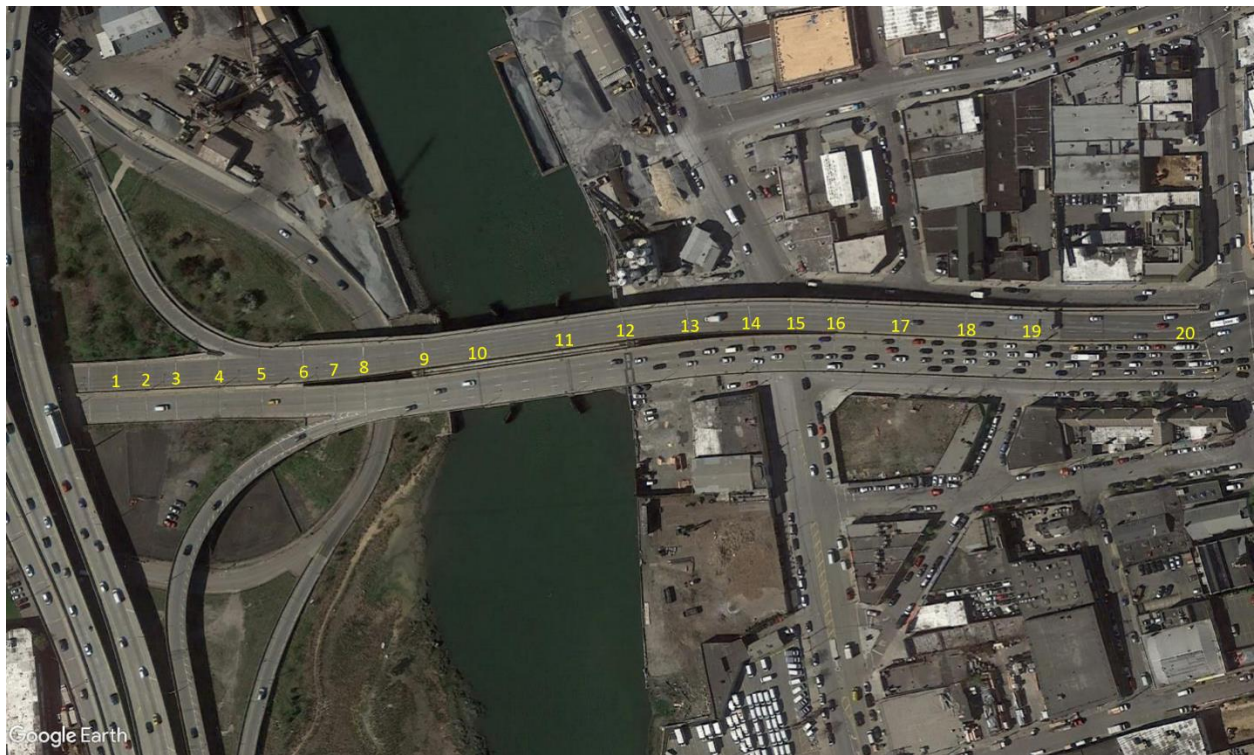
Figure 1. Locations at which Speed Was Estimated

Figure 1 shows an aerial map of Northern Boulevard with 20 marked locations (19 joints and one pavement marking) at which speed was estimated based on the video. Figure 2 shows the estimated speeds. The point numbers in Figure 2 correspond to location numbers in Figure 1.

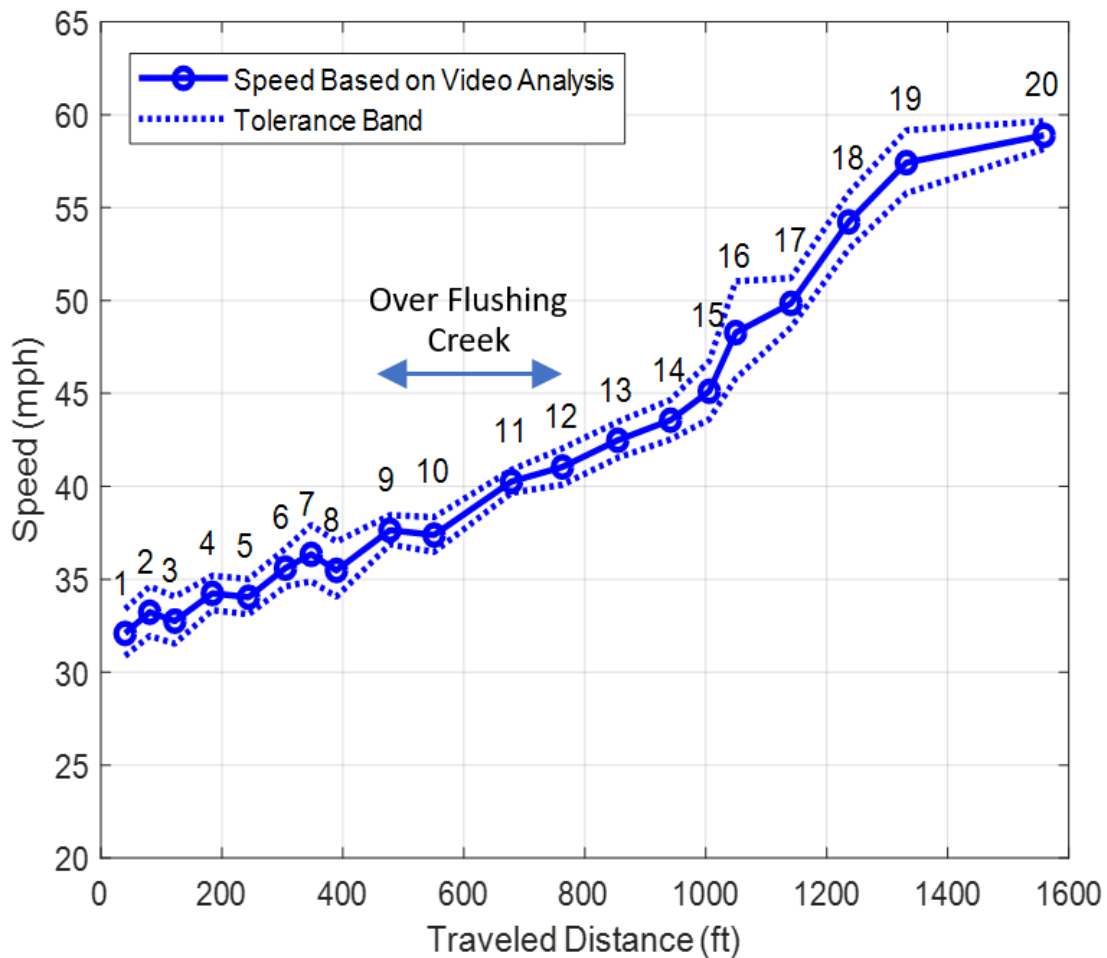
Figure 2. Estimated Speed vs. Traveled Distance

The solid line in Figure 2 is the nominal speed estimate and the dotted lines mark the tolerance of the estimated speeds. The tolerances account for inaccuracies in estimating the video frame when the motorcoach was at a joint location, a process that required interpolation between frames. Note that the tolerance band is smaller when the distance over which speed was estimated is long and is larger when the distance is short.

Figures 2 and 3 show that the motorcoach was accelerating during the entire analyzed distance. This included the approach to the bridge over Flushing Creek on a 5.5% upward sloped road. It continued accelerating once it was past the bridge on a 5.3% downward slope. The acceleration between points 1 and 15 was approximately 0.03 g.

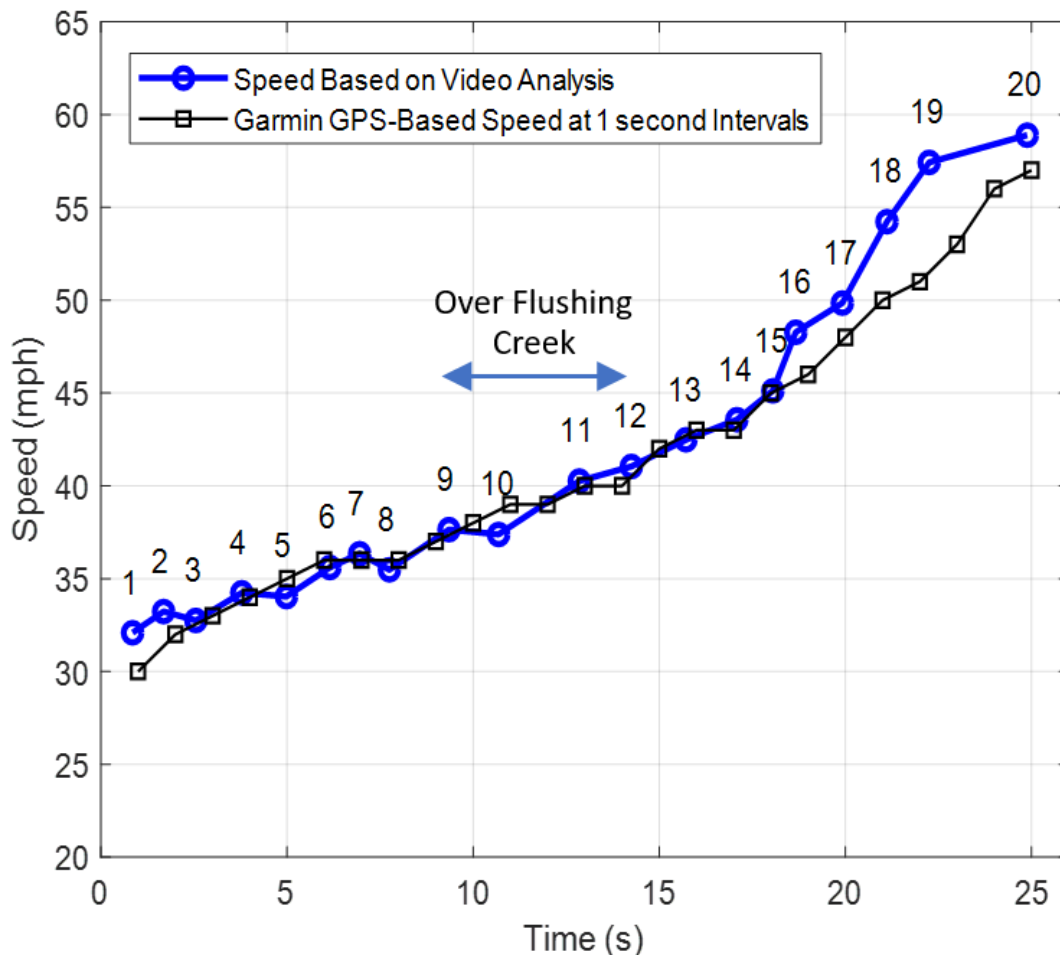
Figure 3. Video-Based Speed and GPS-Based Speed Estimates

Figure 3 compares the video-based nominal speed estimates with Garmin GPS-based speeds. Both curves are shown vs. time. The video-based speed points are at the times when the motorcoach was at the locations shown in Figure 1. The Garmin GPS-based speeds at one second intervals corresponding to times when speeds were updated and overlaid on the video. The speed curves are in close agreement up to time 18 seconds. Past that time, the video-based speed estimate is somewhat higher.
