NATIONAL TRANSPORTATION SAFETY BOARD
Office of Research and Engineering
Washington, D.C. 20594

Video Study

**NTSB Case Number:
ERA18MA099**

Location: New York, NY
Date: March 11, 2018
Time: 1908 EDT
Aircraft: American Eurocopter A350 B2 helicopter

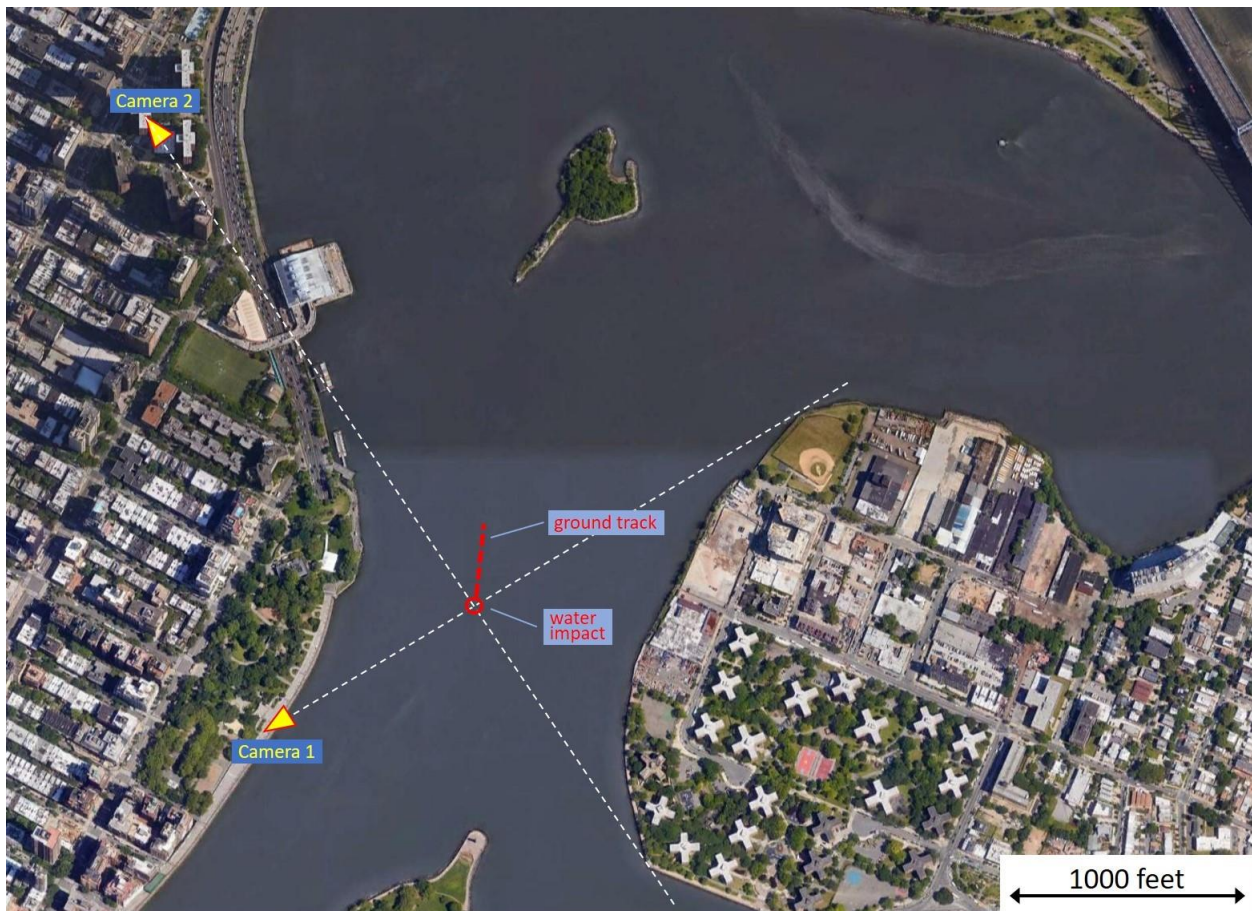
Figure 1. Aerial View of the Accident Area

Having images of the helicopter taken by both cameras at approximately the time of water impact made it possible to estimate the location of water impact. Figure 1 shows lines of sight from both cameras that pass through the helicopter at the time of water

impact and through reference points on land. The intersection of the lines of sight is the estimated water impact location.

Figure 1 shows in red the ground track of the helicopter as it was approaching the water impact location. The heading indicated by the broken red line was not known and had to be estimated. It was assumed that the helicopter heading was aligned with its longitudinal axis of symmetry. The calibrated camera optics model corresponding to the video frame shown in Figure 2 was then used to superimpose a wireframe model of the A350 B2 helicopter onto the video frame at the estimated water impact location. The model was then rotated in the yaw direction until its nose and tail matched the nose and the tail in the video frame. The yaw angle that generated optimal match was 186° , which is the heading angle of the ground track line in Figure 1.

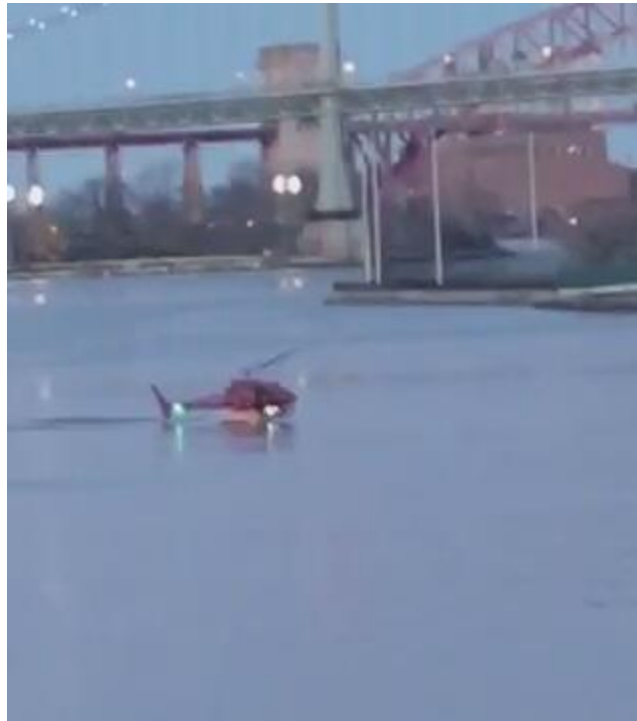
Figure 2. Top 320x360 Segment of a Frame from the Video Recorded by Camera 1

The estimation was based on references that were visible both in aerial images and in video frames. The references used for calibration were baseball field light poles seen on the right in Figure 2, the four large bright soccer field lights seen left of the center, bridge columns seen left of the center, and points along the coastline.

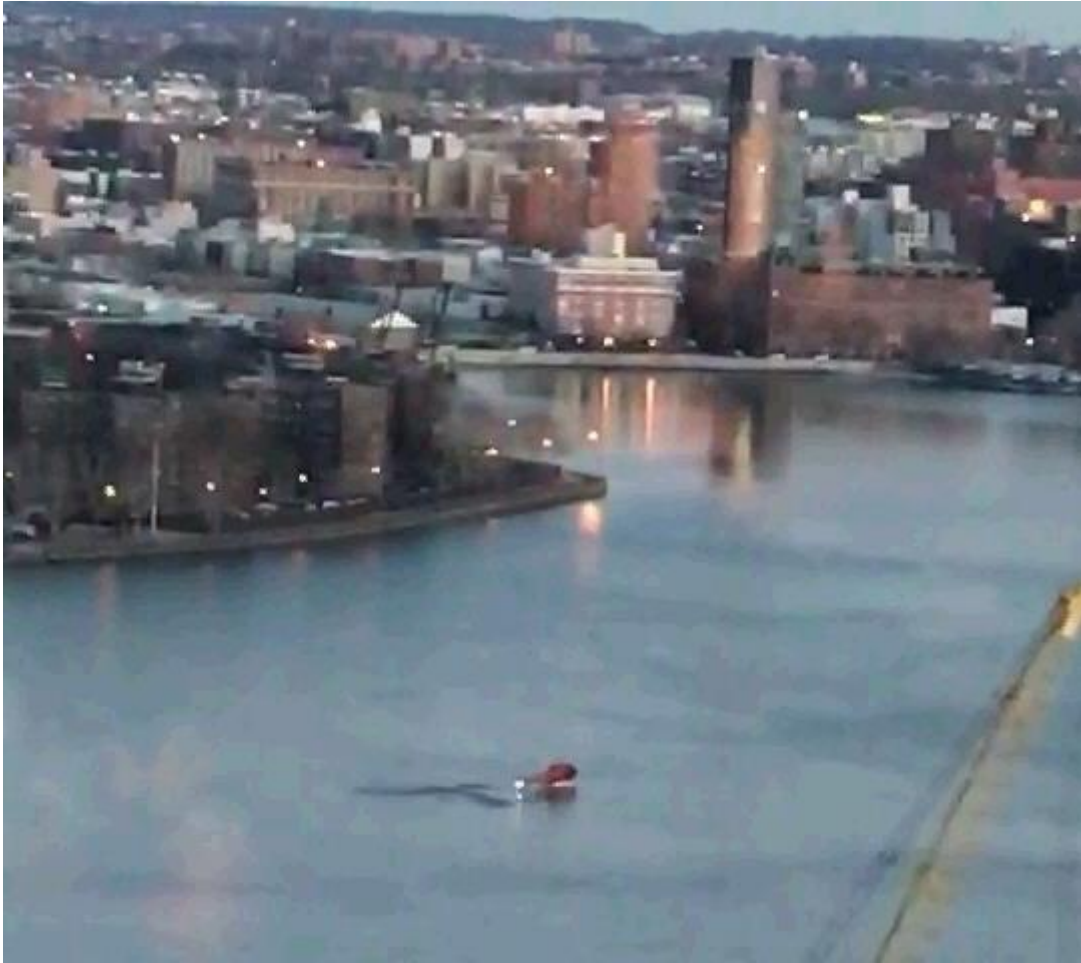
Figure 3. Top Half of a Frame from the Video Recorded by Camera 2

The 186° heading estimate was then validated using the Camera 2 video. It was accomplished without a seven-parameter calibrated camera optics model. The HFOV of Camera 2 was first estimated using land-based references. Then, considering the line of sight shown in Figure 1, the heading that generated helicopter nose-to-tail distance as seen by the camera that matched the distance in the video frame was estimated. The estimated heading matched the 186° heading estimated based on the Camera 1 video.

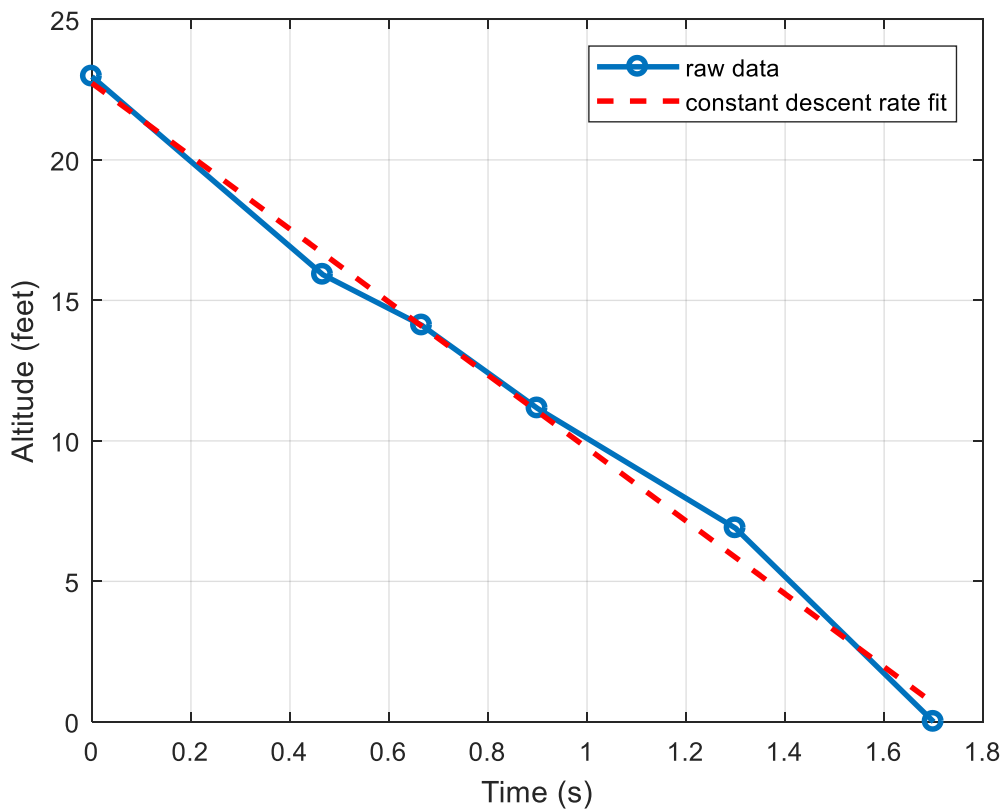
Figure 4. Estimated Helicopter Altitude vs. Time

Figure 4 shows a plot of six altitude estimates. Superimposed on the raw data plot is a constant descent rate fit. The constant descent rate estimate is 13 feet/second. Converting to units of feet/minute and adding a $\pm 10\%$ uncertainty range yields 780 ± 80 feet/minute.

The descent rate can be added vectorially to the ground speed to get the magnitude of the velocity vector at the time of water impact. The velocity vector magnitude estimate is 23 ± 2.5 knots (or 27 ± 3 mph).
