**NATIONAL TRANSPORTATION SAFETY BOARD**  
Office of Research and Engineering  
Washington, D.C. 20594

## **Video Study**

**NTSB Case Number:  
HWY18FH013**

Location: Fort Lauderdale, Florida  
Date: May 8, 2018  
Time: 6:46 p.m. EDT  
Vehicle: Tesla Model S

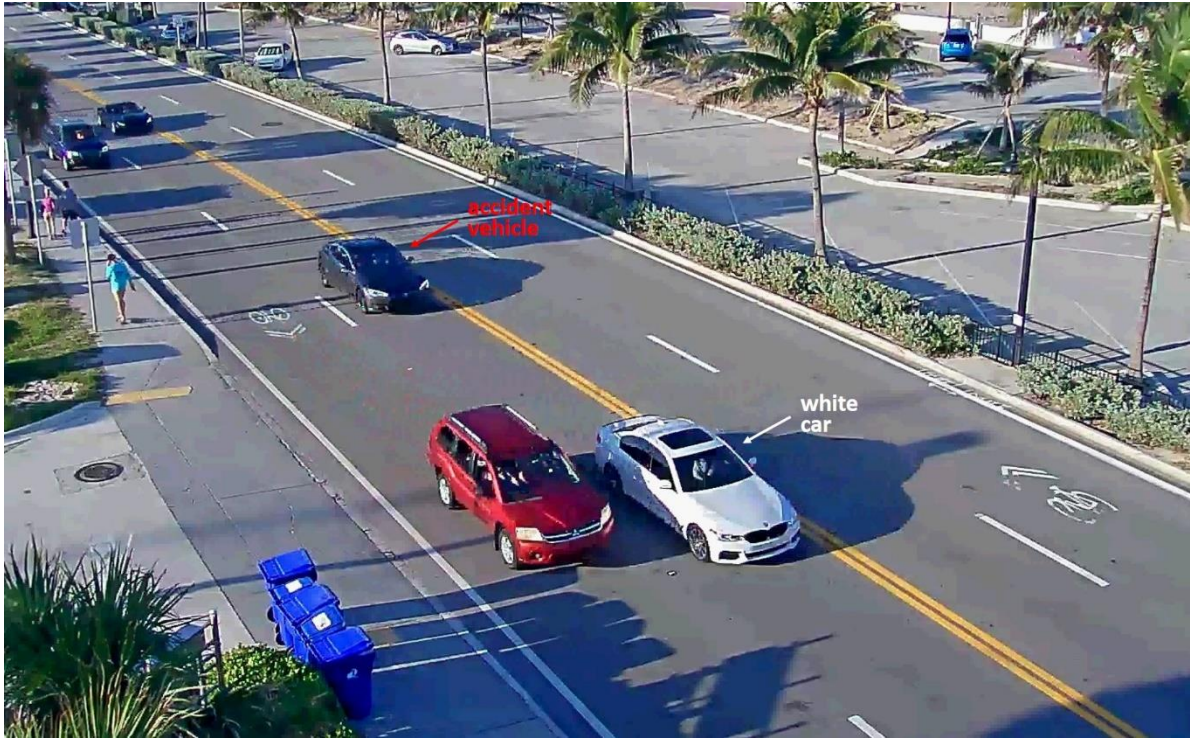
**Figure 2. Segment from a Frame from Camera C1 Video (T=0 seconds)**

There are five reference locations, P1, P2, P3, P4 and P5, marked in Figure 1. Camera C1 was used to estimate the speed of the accident vehicle as it was approaching from the north. It was estimated over a 280-foot-long road segment that ended at P1. The estimated average speed over that segment was  $48\pm 1$  mph. The accident vehicle was moving behind a white car that was moving at the same speed.

Figure 2 shows a segment from a frame recorded by camera C1. The accident vehicle and the white car are marked in the figure. For analysis and presentation purposes, the time corresponding to the video frame in Figure 2 was set to  $T=0$  seconds.

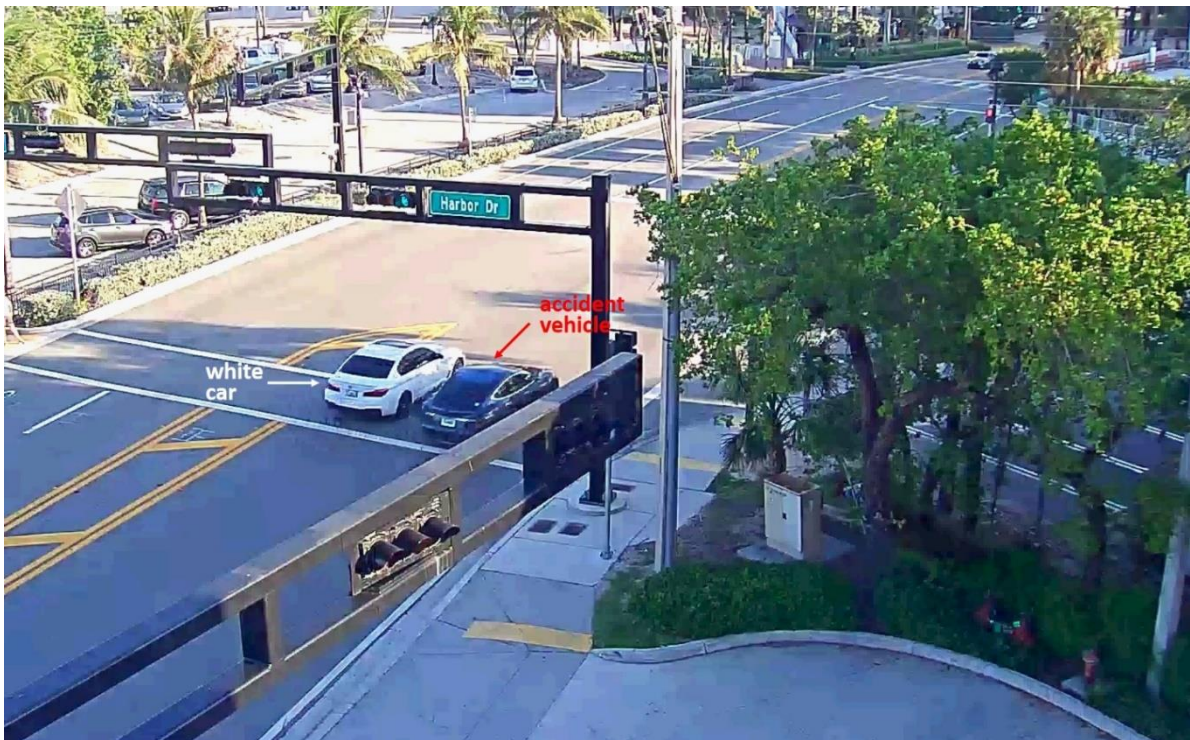
**Figure 3. Segment from a Frame from Camera C2 Video (T=4 seconds)**

Camera C2 was used to estimate the average speed of the accident vehicle as it traveled from reference point P2 to reference point P3, a distance of approximately 248 feet. The estimated speed was  $75\pm 2$  mph. The estimated average speed of the white car on this road segment was  $47\pm 1$  mph. The average speed of the accident vehicle was about 1.6 times the average speed of the white car.

Figure 3 shows a segment from a frame from the video recorded by camera C2. Note that the accident vehicle already moved from the left lane to the right lane and was in the process of passing the white car. The frame in Figure 3 was recorded at time  $T=4$  seconds, about 4 seconds after the frame shown in Figure 2 was recorded.

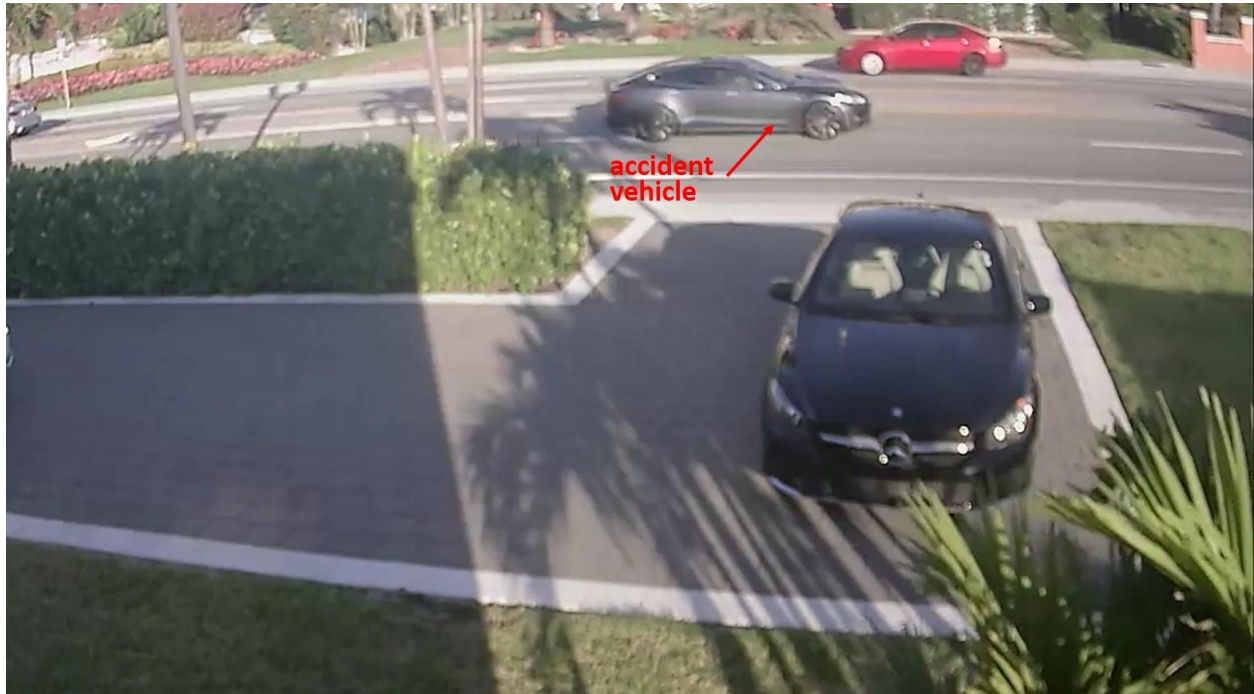
**Figure 4. Segment from a Frame from Camera C4 Video (T=12 seconds)**

Camera C4 was used to estimate the average speed of the accident vehicle as it traveled from reference point P4 to reference point P5, a distance of approximately 120 feet. The estimated speed was  $112\pm 3$  mph. A segment of a frame from camera C4 video, acquired at about  $T=12$  seconds, is shown in Figure 4.

The white car was approximately 4 seconds behind the accident vehicle when it reached reference point P4. Its estimated average speed between reference points P4 and P5 was  $55\pm 2$  mph. The average speed of the accident vehicle was about twice the average speed of the white car.

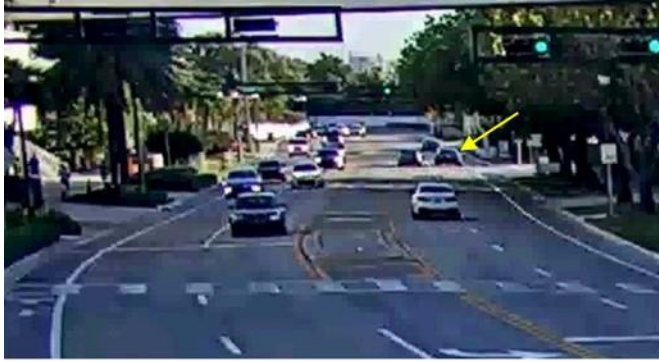
T=11 seconds

In right lane.

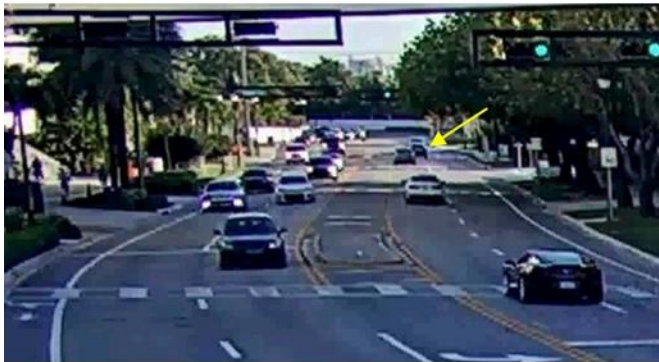
T=12 second

Moving to left lane.

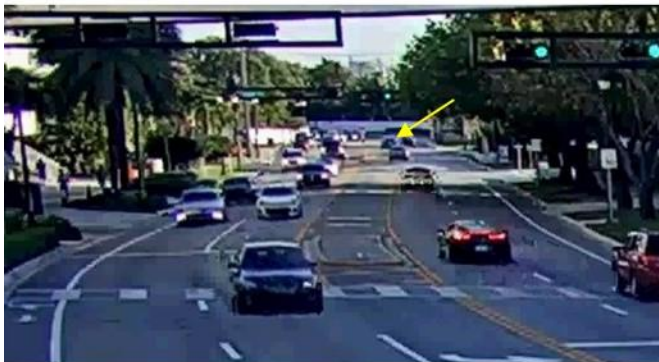
T=13 seconds

In left lane.

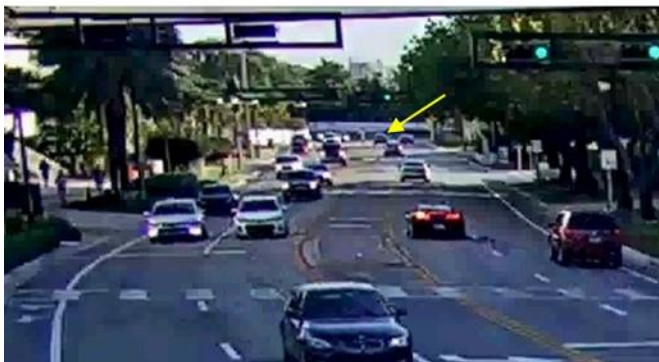
T=14 seconds

At time  $T=11$  seconds, the vehicle is still in the right lane. At time  $T=12$  seconds, it is seen moving into the left lane. At time  $T=13$  seconds, it is already in the left lane. It is believed that at time  $T=14$  seconds, it is left of being centered in the left lane, possibly indicating difficulties negotiating the lane change and the curve ahead.

Because of the distance from the camera, it is not possible to estimate accurately the lateral position of the vehicle relative to the left lane at time T=14 seconds. It is estimated that the vehicle impacted a wall on the west side of Seabreeze Boulevard at about time T=16 seconds and came to rest on the east side of the boulevard at about time T=18 seconds.

Beyond left lane.

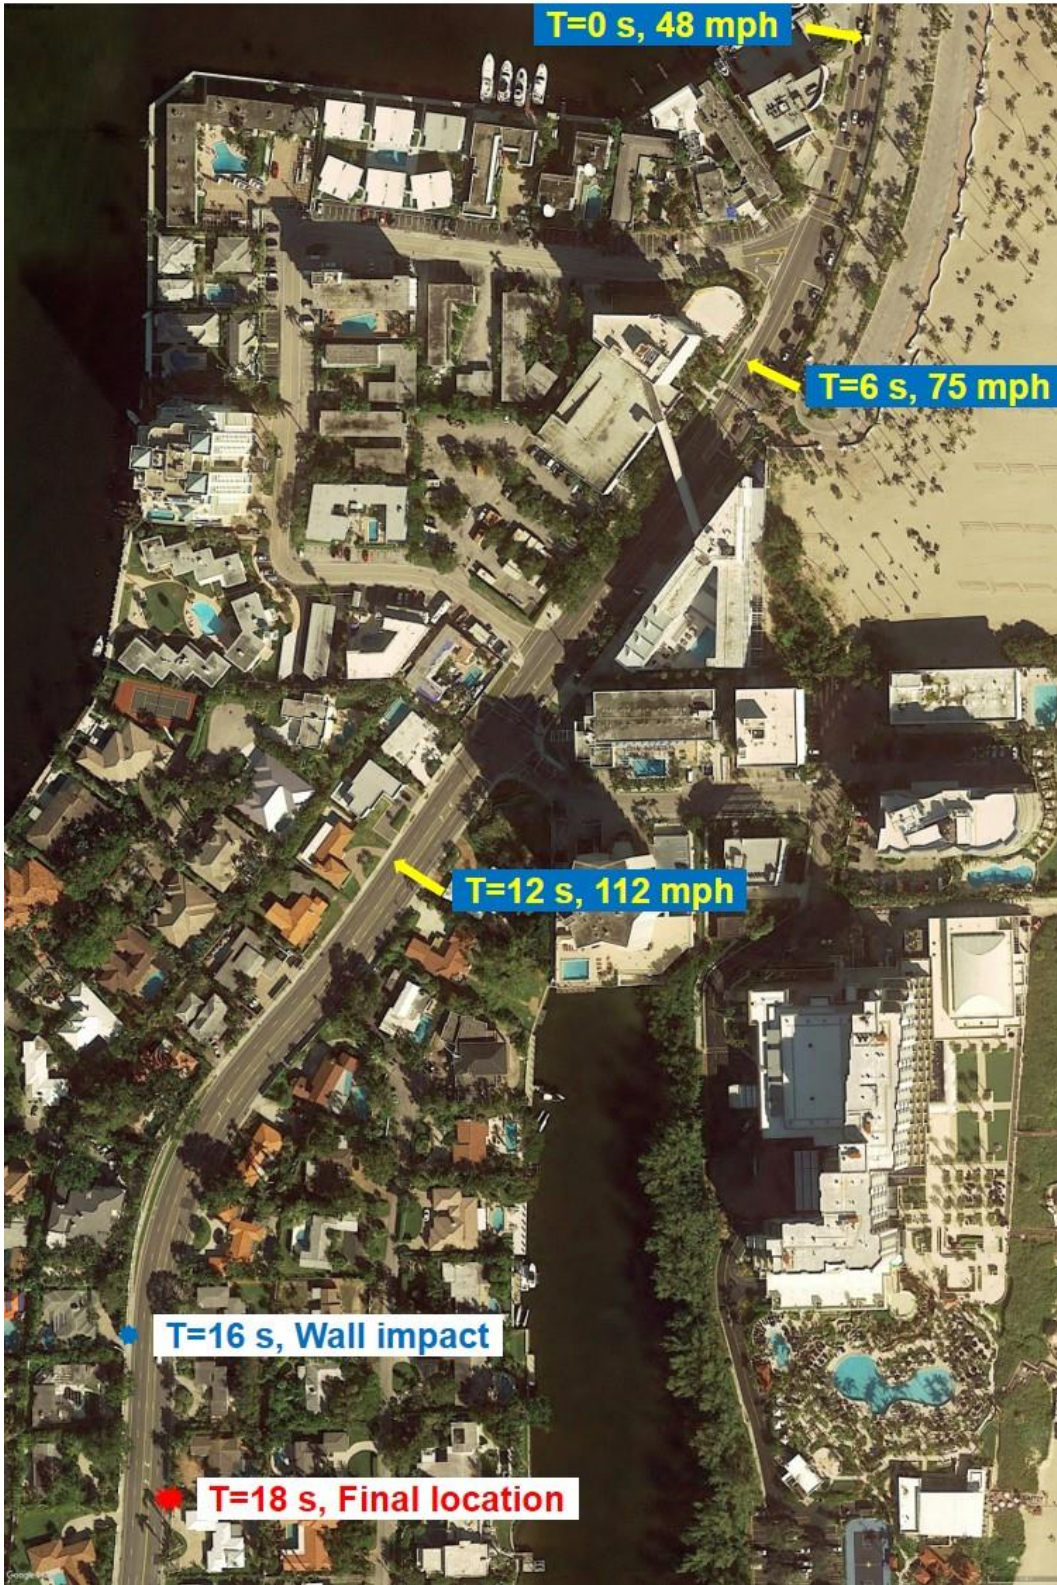
Figure 6. Estimated Speeds along Seabreeze Boulevard

Figure 6 shows the estimated speeds of the accident vehicle superimposed on the aerial map of the accident area. The speed labels are at the ends of the road segments over which speeds were estimated.

Videos acquired by four cameras were used for estimating the motion and speed of a vehicle before it crashed into a wall. The highest speed was  $112\pm 3$  mph, estimated about 4 seconds before the vehicle impacted a wall.
