NATIONAL TRANSPORTATION SAFETY BOARD
Office of Research and Engineering
Washington, D.C. 20594

Video Study

**NTSB Case Number:
WPR18FA119**

Location: Scottsdale, Arizona
Date: April 9, 2018
Time: 2048 MST
Aircraft: Piper PA-24-260

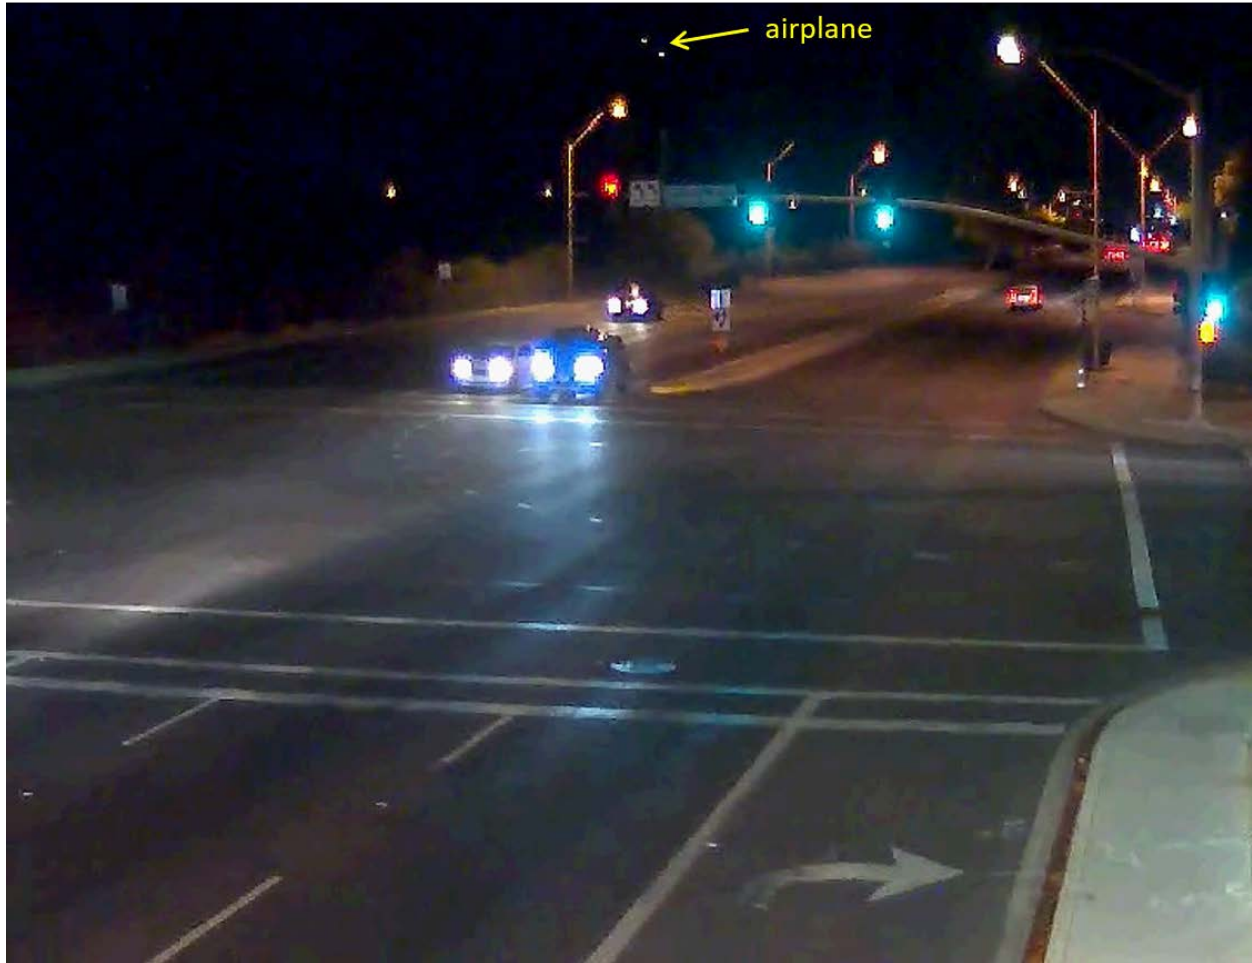
Figure 1. Frame from the Traffic Camera Video

Figure 1 shows a frame from the video acquired by the traffic camera. The video had 720x576 resolution and frame rate of 25 fps. Only the two airplane wingtip lights (the two white dots) are visible in this frame and in all the other frames that recorded the airplane. The two white dots are not sufficient for uniquely estimating the location of the airplane based on a video frame. It is so because there are infinitely many combinations of airplane distance from the camera, altitude, yaw angle and roll angle that place the two white dots at the same locations in a video frame.

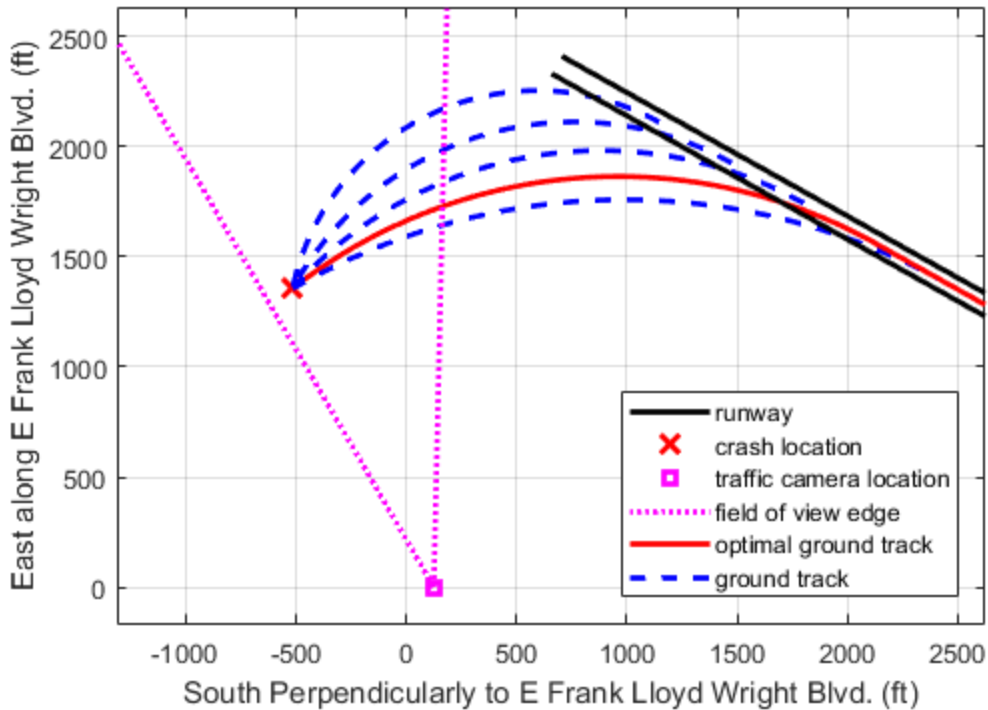
Figure 2. Accident Geometry Related to the Traffic Camera

Since it was not possible to uniquely estimate the airplane locations based on frames from the traffic camera video, five hypothetical ground track trajectories were examined. Figure 2 shows the geometry of the problem. The airplane took off along the runway and was flying above it. Then it turned to the left and crashed at the location marked with the red 'X'. It was assumed that the airplane ground track from the runway to the crash site was along a circular arc. Five arcs were considered, each tangent to the centerline of the runway and ending at the crash site. Each arc was specified by the center of the circle and the radius of the arc. One of the arcs, the 'optimal ground track,' is shown in red. It was determined to be the optimal arc based on information from the analysis of the airport tower camera that is described below.

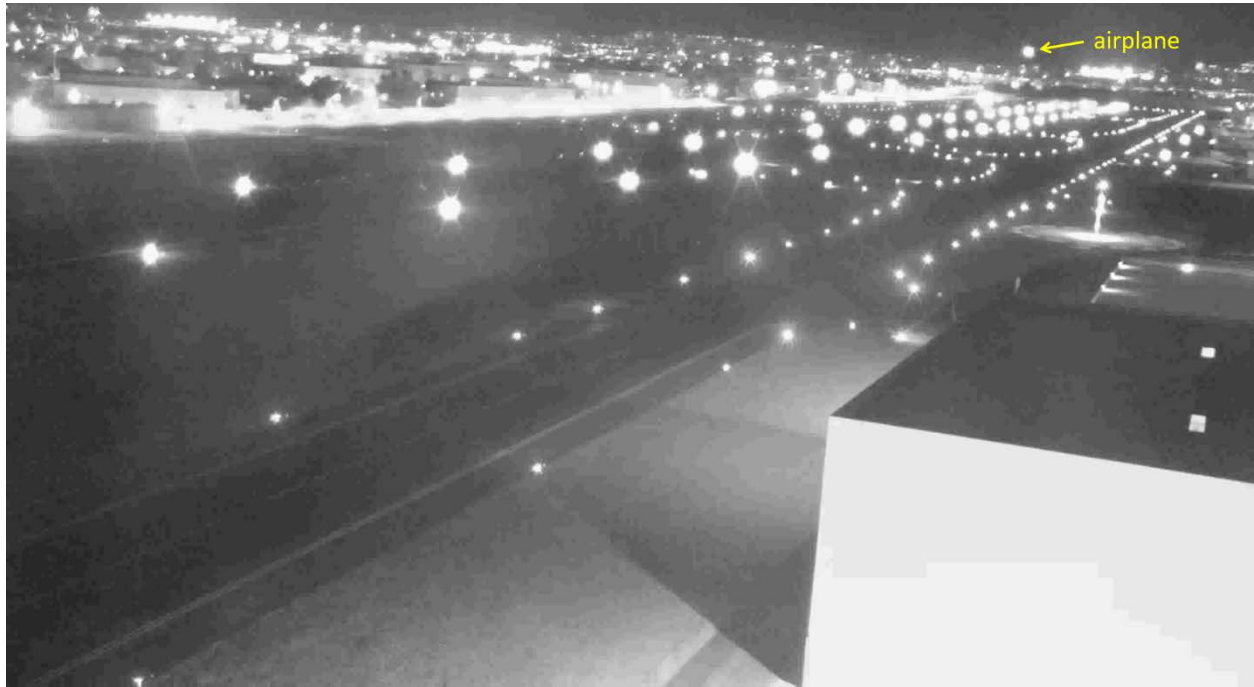
Figure 3. Frame from the Airport Tower Camera Video

Figure 3 shows a frame from the video acquired by the tower camera. The video had 1280x720 resolution and frame rate of 24 fps. As can be seen in Figure 3, only the tail light of the airplane is visible. The airplane tail light and the runway lights saturated the image sensor of the camera and, therefore, they appear in the video frame much larger than their real dimensions.

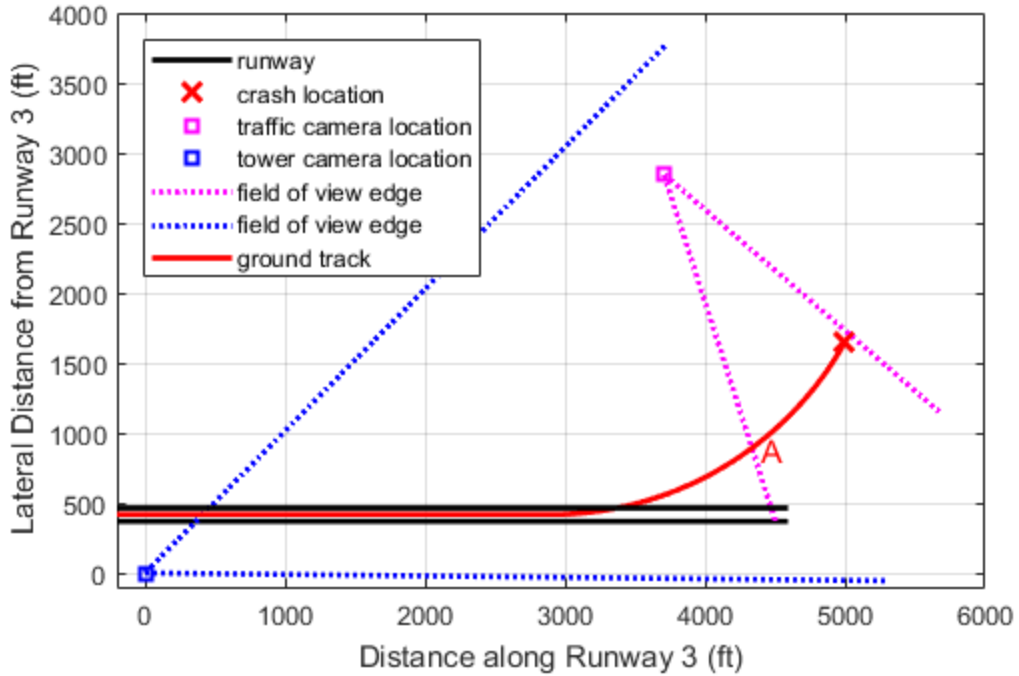
Figure 4. Accident Geometry Related to the Airport Tower Camera

Figure 4 shows the geometry of ground track estimation as it relates to the airport tower camera. Locations of both the airport tower camera and the traffic camera and their horizontal fields of view are marked in the figure. The ground track shown in the figure is the optimal ground track from Figure 2.

Of particular interest was point A on the ground track that is marked in Figure 4. At that point, estimates of speed and altitude were available both from the traffic camera and from the airport tower camera. The circular ground track segment in Figure 4 and the 'optimal ground track' shown in red in Figure 2 generated close agreement between the two speed estimates and the two altitude estimates. Therefore, this hypothetical track was determined to be the closest to the actual ground track of the accident airplane.

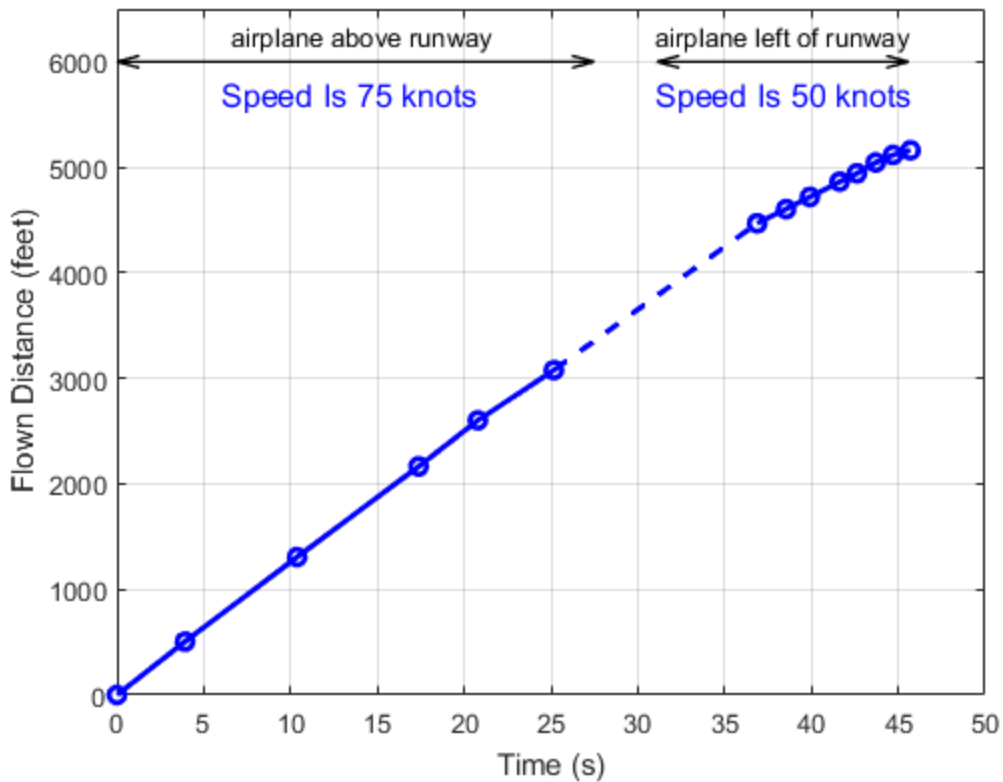
Figure 5. Estimated Distances and Ground Speeds

Once the ground track was known, the airport tower camera was used to plot the ground distance traveled by the airplane versus time. Figure 5 shows the plot. Time zero in the plot corresponds to the first analyzed point. That point is above the runway centerline, just after the airplane crossed into the field of view of the tower camera. It could be determined with certainty that the airplane was above the runway up to time 25 seconds in Figure 5. During these 25 seconds, its estimated ground speed was 75 ± 4 knots. It could be determined with certainty that the airplane was above the circular ground track segment after time 36 seconds. The estimated speed between time 36 seconds and time 45 seconds was 50 ± 4 knots, a significant decrease from the speed above the runway. Note that the last point, at 46 seconds, indicates speed decreasing below 50 knots. The airplane impacted the ground at about time 52 seconds. Between time 25 seconds and time 36 seconds, the airplane was beginning to turn left but was still close to the runway. Since the camera was looking along the runway and only the tail light was visible, accurate airplane location estimates could not be derived in this segment. Therefore, this segment in Figure 5 is drawn as a broken line.

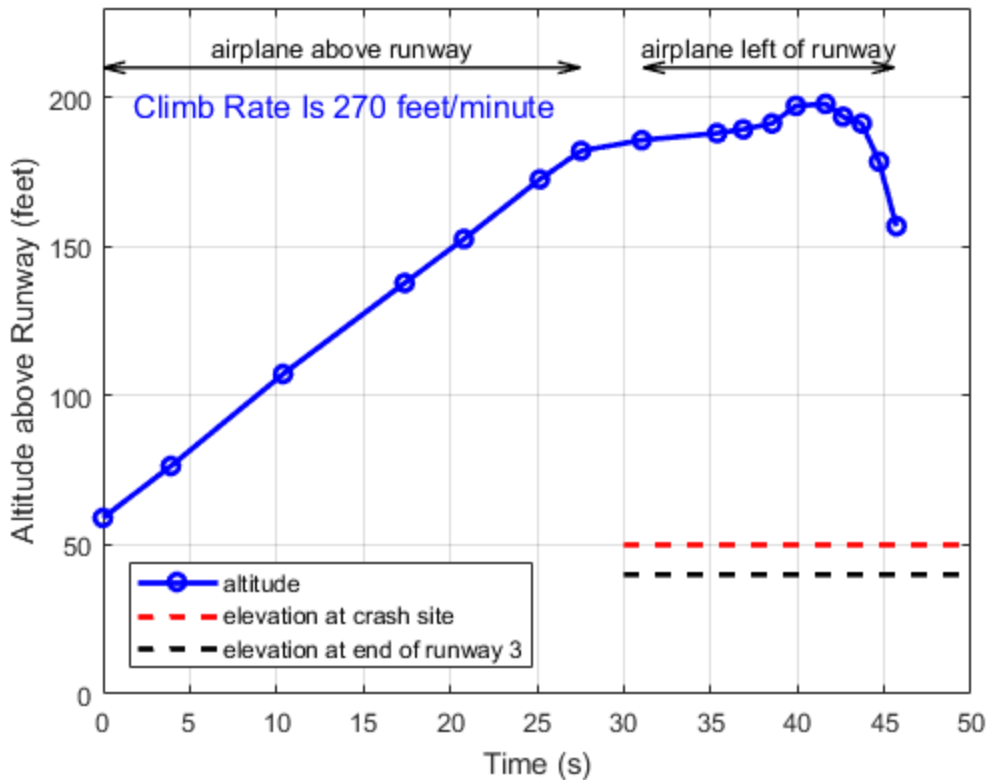
Figure 6. Estimated Altitude of the Airplane

Figure 6 shows the estimated altitude of the airplane above runway elevation at the location of the tower. The elevation of the runway at the location of the tower is set to zero in the figure. The airplane entered the field of view of the tower camera when it was already airborne. Therefore, at time zero, its altitude was already 59 feet above the runway. Its climb rate over the first 27 seconds was low, only 270 feet/minute. Past time 27 seconds, it virtually stopped climbing, never exceeding altitude of 200 feet. At time 42 seconds, the airplane started a rapid descent and impacted the ground at about time 52 seconds.

Runway 3 has a gradient of 0.8%. Due to the gradient, the runway elevation at the end of the runway is about 40 feet higher than its elevation at the tower location. The elevation at the crash site is about 50 feet higher than the runway elevation at the tower location. Figure 6 shows the elevations at the end of the runway and at the crash site. These elevations are with respect to the zero elevation that was assigned to the runway at the tower location.
