NATIONAL TRANSPORTATION SAFETY BOARD
Office of Research and Engineering
Washington, D.C. 20594

Video Study

**NTSB Case Number:
ERA17FA274**

Location: Charlottesville, Virginia
Date: August 12, 2017
Time: 1649 EDT
Aircraft: Bell 407 helicopter

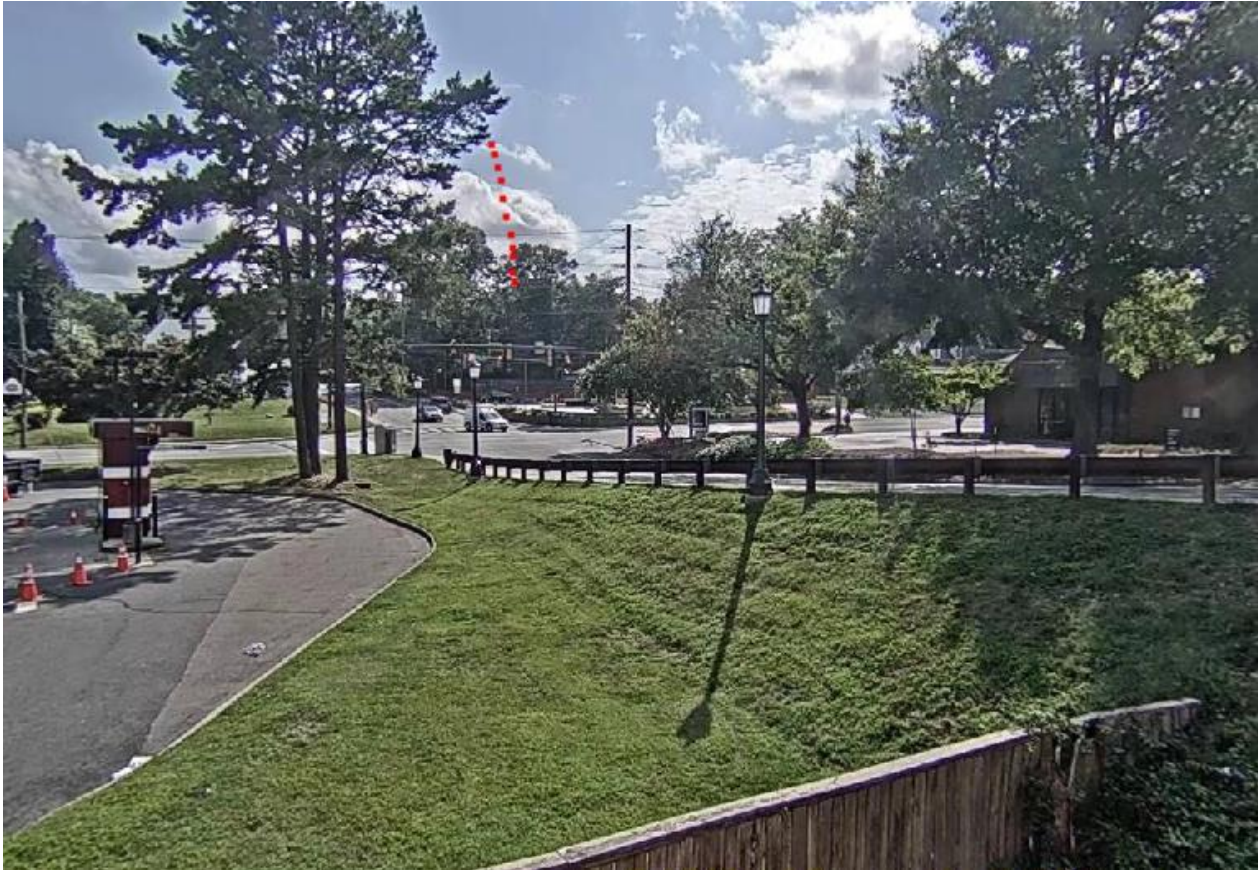
Figure 1 shows a frame from the video after barrel distortion correction with superimposed red markers at the locations that were used for estimating the helicopter altitude. These points were not spaced evenly in time or in altitude. They were selected because the image of the helicopter was clearly visible in these video frames. It was assumed that the ground distance from the camera to the helicopter was 6250 feet, corresponding to the distance from the camera to the crash site. With a calibrated camera and assumed ground distance to the helicopter, it was possible to estimate the above sea level (MSL) altitude of the helicopter at each of the 11 points marked in Figure 1.

Figure 1. Frame from the Video with Marked Analyzed Points

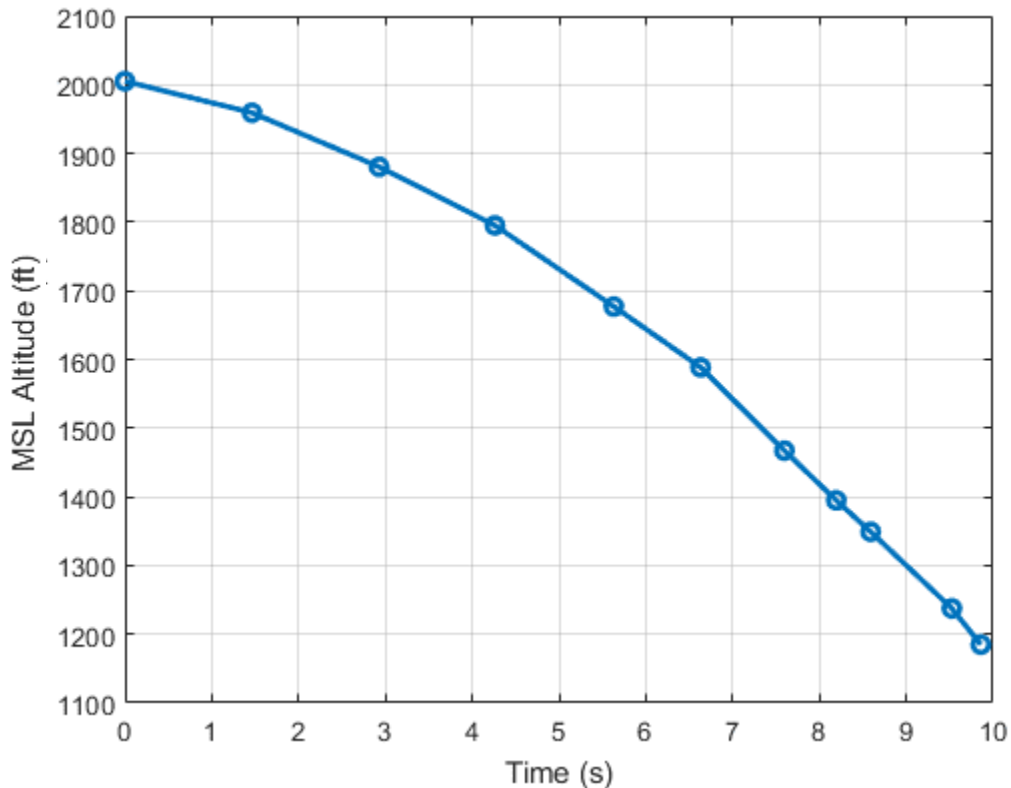
Figure 2 is a plot of the MSL altitude of the helicopter at the 11 points marked in Figure 1. The time was set to zero at the first point. A second order polynomial fit to the 11 points generates a curve that matches the curve in Figure 2 very closely. The maximum difference between the 11 points and the fitted curve, not shown in Figure 2, is less than 10 feet.

Figure 2. Estimated Above Sea Level Altitude of the Helicopter vs. Time

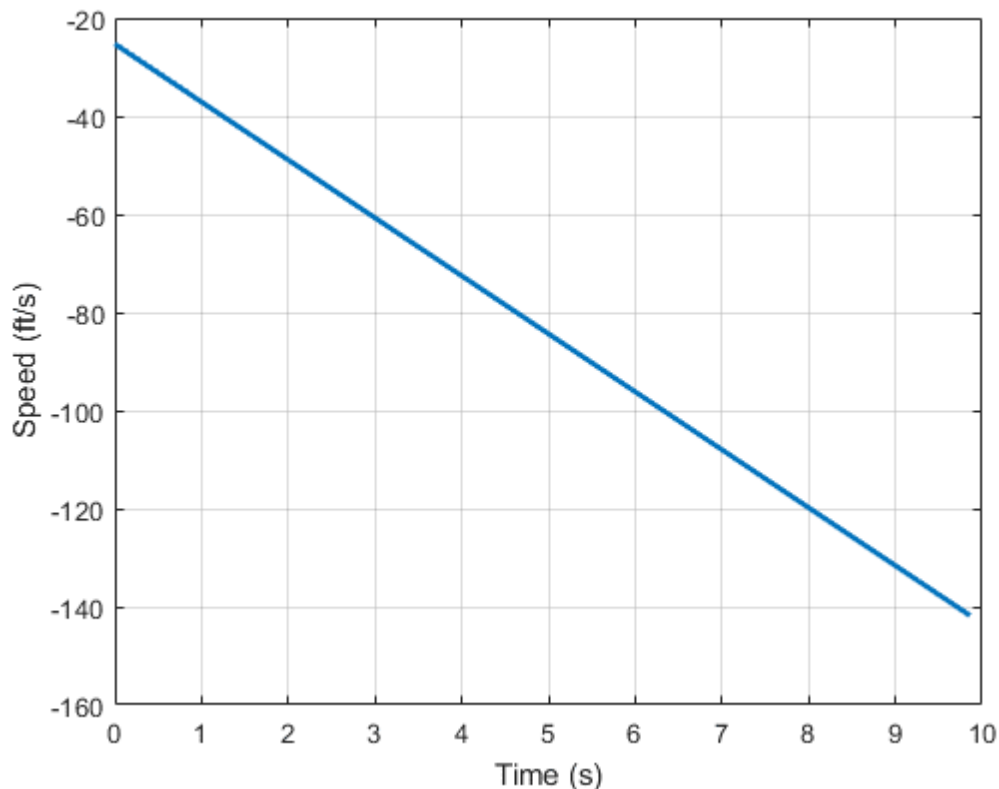
The accurate fit with a second order polynomial indicates that the helicopter was descending with a constant acceleration. Figure 3 shows a plot of the helicopter vertical speed vs. time. At the beginning of the 10 second interval, its descent speed was about 25 ft/s (1500 feet/minute). At the end of the interval, the speed was about 142 ft/s (8520 feet/minute). The constant acceleration was 0.37 g. In a mostly free fall, the acceleration would have been close to 1.0 g. The relatively low acceleration of 0.37 g indicates that the descending helicopter was generating lift but not enough lift to maintain altitude. The accuracy of the 0.37 g acceleration estimate is about $\pm 10\%$, resulting in acceleration estimate of 0.37 ± 0.04 g.

Figure 3. Estimated Vertical Speed of the Helicopter vs. Time

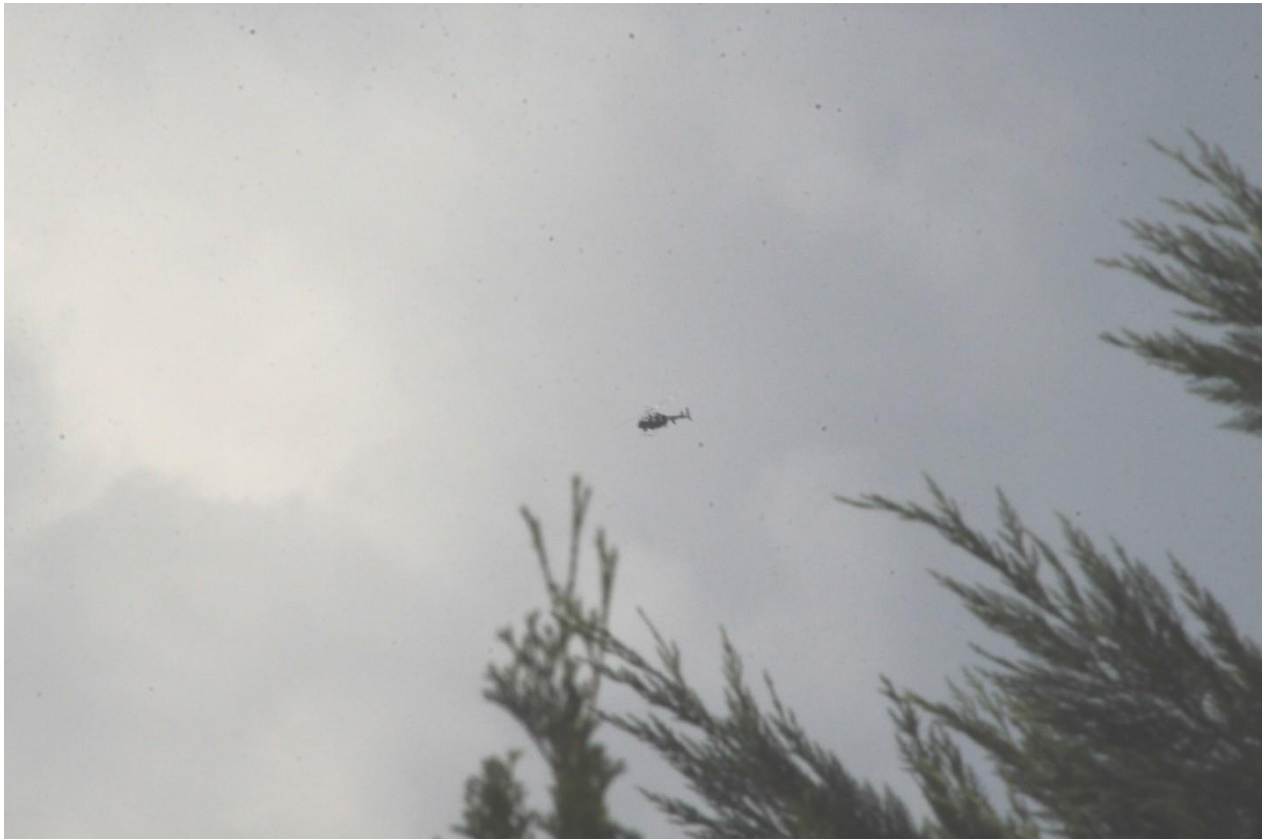
Since there was a relatively small difference between photographs 1, 2 and 3, it is assumed that they were taken in the 'Continuous, High' mode at the rate of 5.7 fps. Figure 4 is photograph No. 3. The fourth photograph shows the helicopter nose oriented to the right in contrast to its orientation to the left in photograph No. 3 shown Figure 4. This excludes the possibility of the fourth photograph being part of the 5.7 fps burst because such a yaw angle change in $1/5.7$ seconds would require an unrealistic helicopter yaw rate of above 800 degrees per second.

Figure 4. Photograph No. 3 that Was Used in the Analysis

The estimated yaw rate during the first 0.35 seconds (from the time photograph No. 1 was taken to the time No. 3 was taken) is $(-143+174)/0.35=89$ degrees/second. The lower limit on the yaw rate estimate between the times corresponding to photographs No. 3 and photograph No. 4 is $(9+143)/(2.00-0.35)=92$ degrees/second. The lower limit on the roll rate estimate between the times corresponding to photographs No. 3 and photograph No. 4 is $(-30+53)/(2.00-0.35)=14$ degrees/second. The accuracy of the angular rate estimates is about $\pm 5\%$.

The helicopter tail structure appears undamaged in the last available photograph (No. 4). At that time, the helicopter was already experiencing a high yaw rate.
