NATIONAL TRANSPORTATION SAFETY BOARD
Office of Aviation Safety
Washington, D.C. 20594

Video and Image Study
11 imbedded images
John Clark

A. ACCIDENT: ERA14FA182

Location: Summerfield, FL
Date: April 6, 2014
Time: Local
Airplane: RV-7

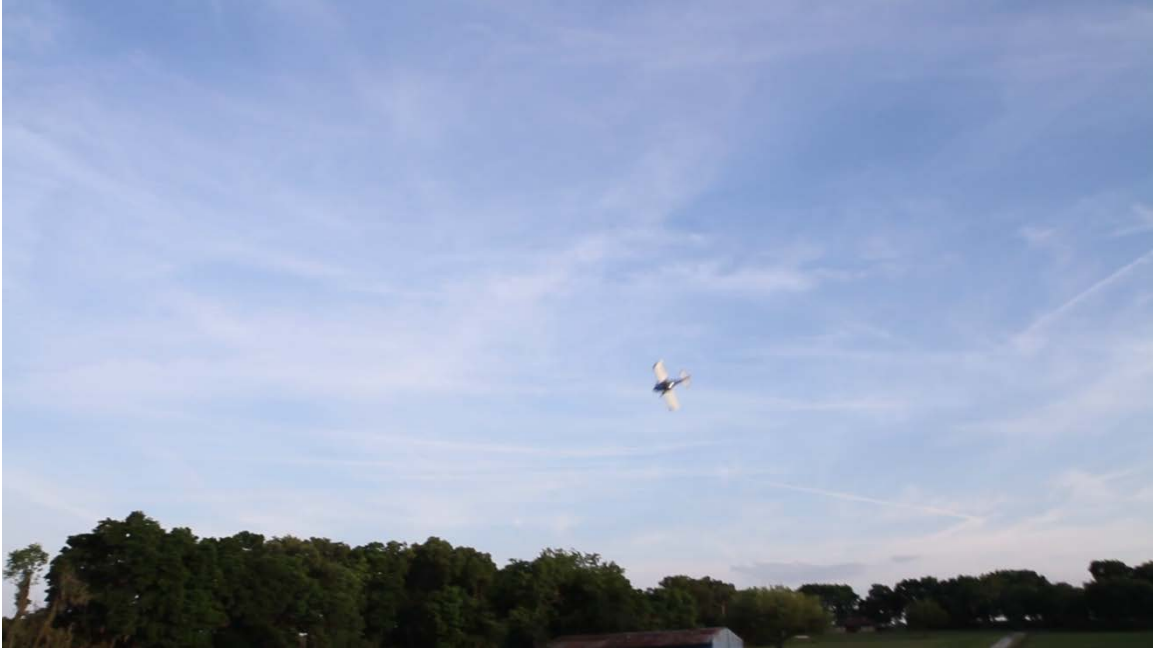
Image 1 – The airplane is low, about 20 degrees nose down and 90 degrees left wing down.

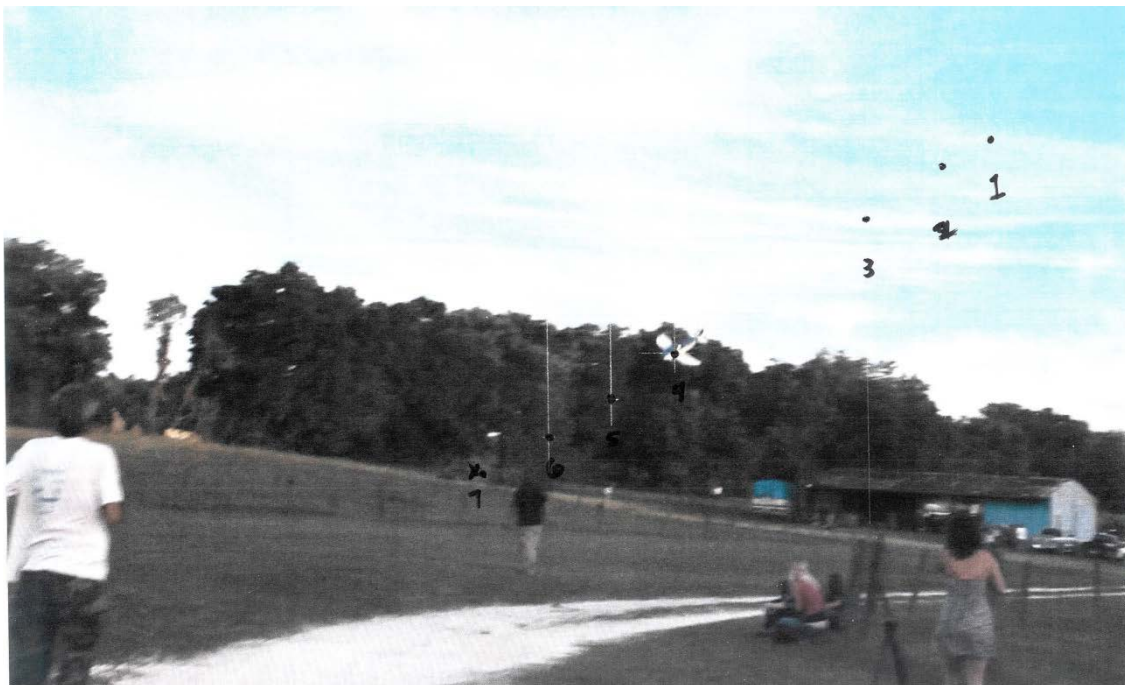
Image 8 - Image 4 was used as the baseline photo. The relative position of the airplane in each of the other photos was transposed to Image 8.

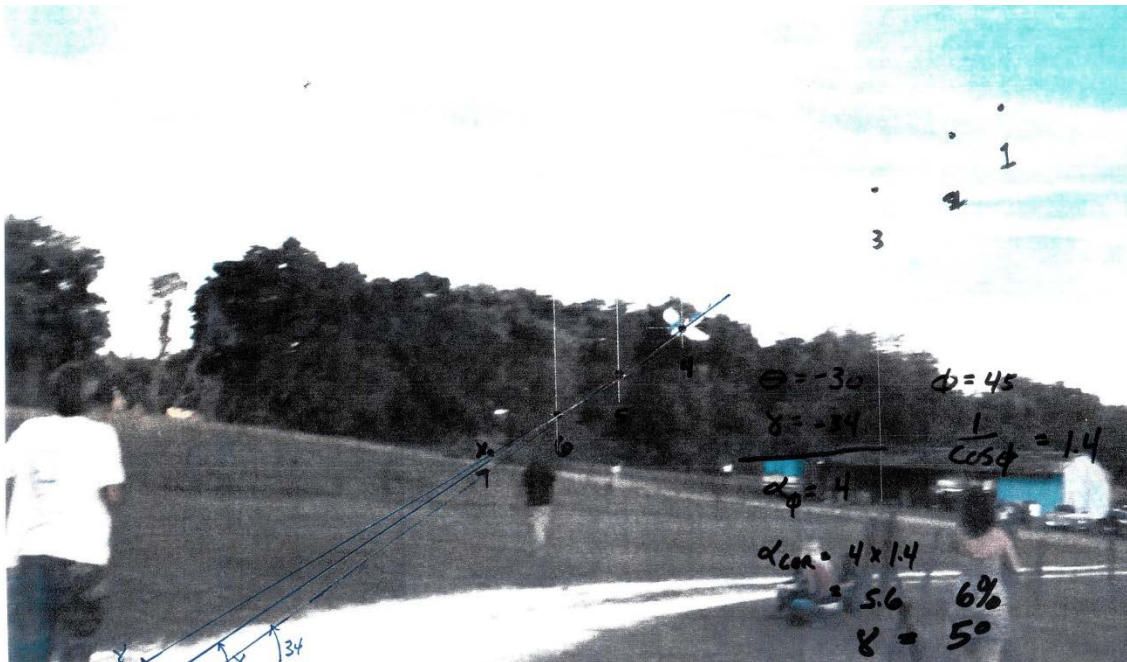
Image 9 - The measured flight path is -34 degrees. The measured pitch attitude is -30 degrees. The difference is a perceived angle of attack of 4 degrees. The airplane is banked about 45 degrees. The airplane is about 20 degrees from perpendicular to the viewing angle. The correction due to the bank angle is +40% and the correction due to the viewing angle is -6%. The corrected angle of attack is 5 degrees.

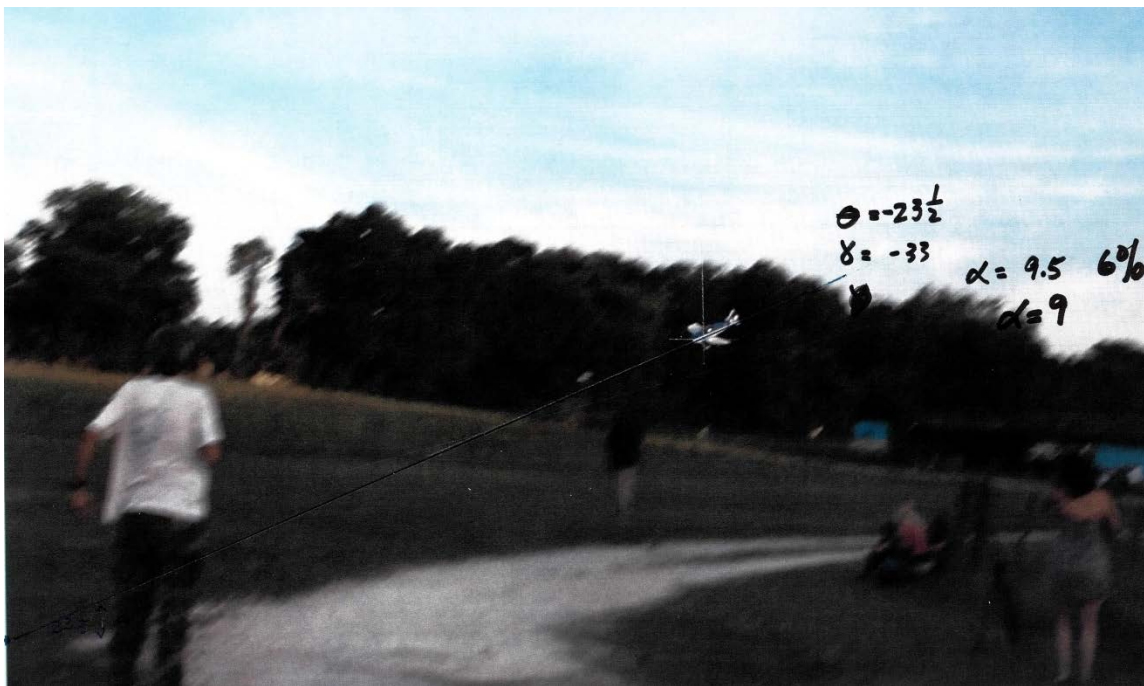
Image 4 - The measured flight path is -33 degrees. The measured pitch attitude is -23.5 degrees. The difference is a perceived angle of attack of 9.5 degrees. The airplane is about 20 degrees from perpendicular to the viewing angle. The corrected angle of attack is 9 degrees.

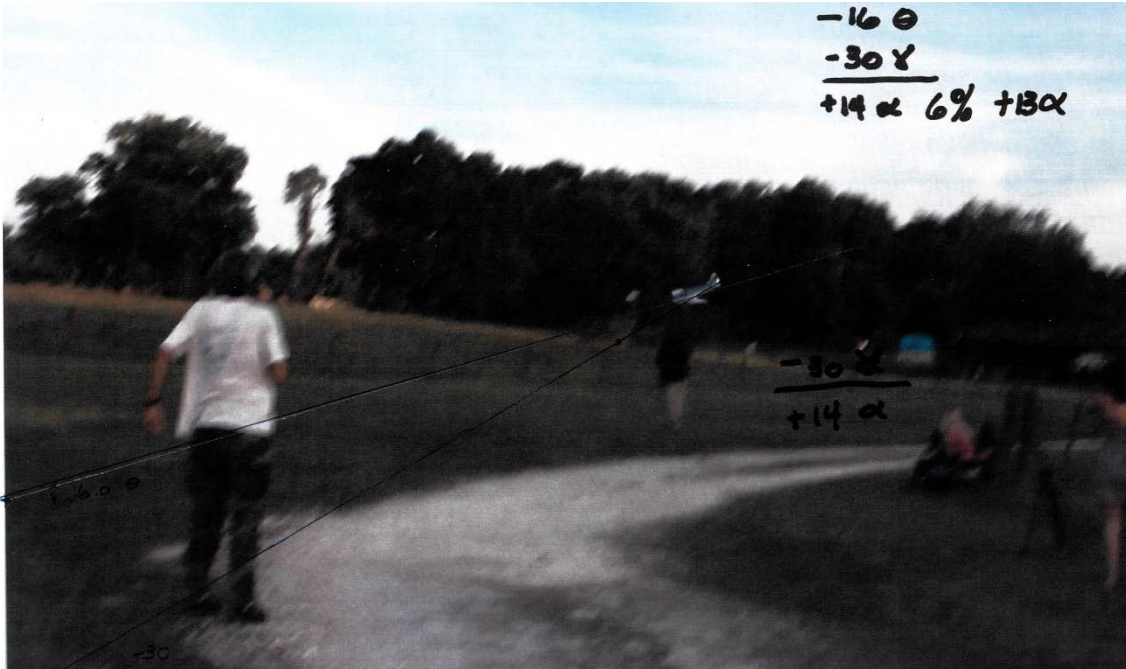
Image 5 – The measured flight path is -30 degrees. The measured pitch attitude is -16 degrees. The difference is a perceived angle of attack of 14 degrees. The airplane is about 20 degrees from perpendicular to the viewing angle. The corrected angle of attack is 13 degrees.
