The information in this report is preliminary and may be supplemented or corrected.

On July 18, 2013, CSX train no. Q704-19, consisting of two locomotives and 24 loaded flat cars carrying municipal waste, derailed at milepost 9.99 on Metro-North's Hudson Division in the Bronx New York while traveling northbound towards Spuyten Duyvil station, Figure 1.

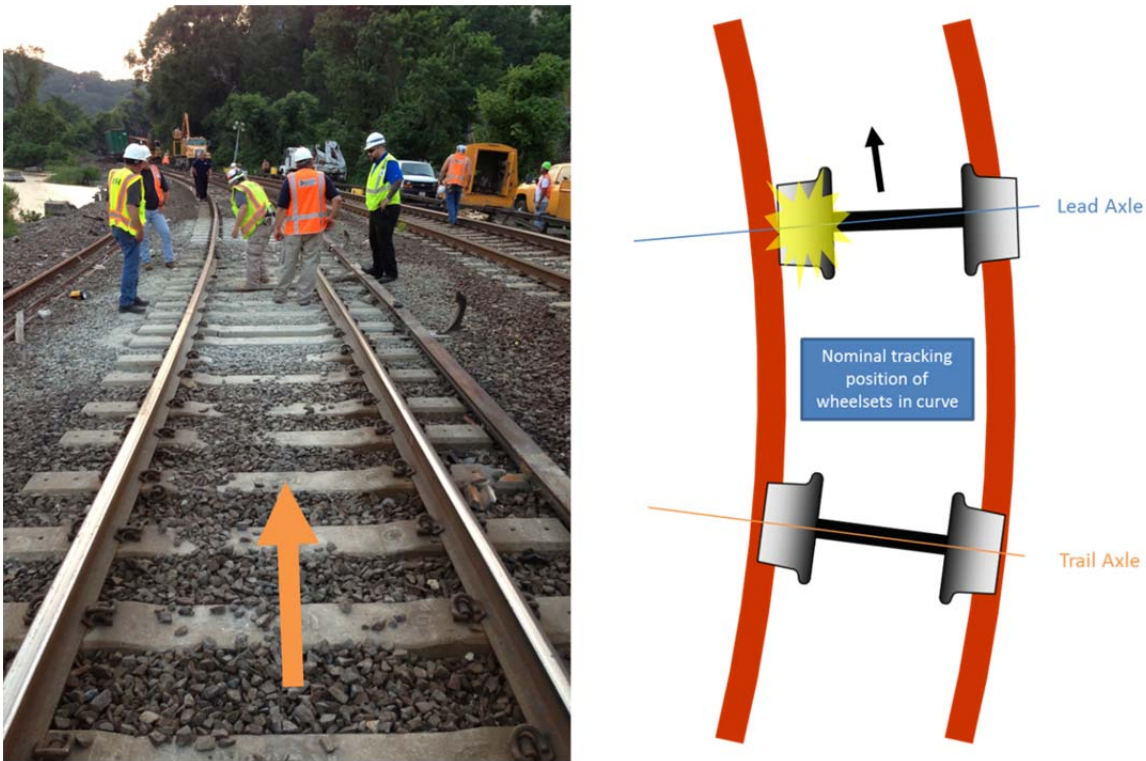
This wide-gage derailment scenario, described again in greater detail later, is probable if the orientation of a truck during curve negotiation results in flange contact on one axle and not on the other, a condition that depends upon a number of factors including axle spacing, curve radius, and cant deficiency. The sketch in Figure 2 illustrates the nominal tracking position of axles in a freight truck resulting from the normal orientation of a freight truck during negotiation of the relatively sharp curve present at the derailment at low cant deficiency. In this case, the lead axle offsets laterally from the track centerline to the point that flange contact on the high-rail is established and a large angle of attack is developed (resulting in increased risk of derailment) at the same time that the trailing axle of a truck tends to be centered between the rails with low angle of attack.

Figure 2: Car 11 low-rail wheel of lead-truck-lead-axle dropped within the gage while traveling northbound through left-hand curve at approximately 17 mph.

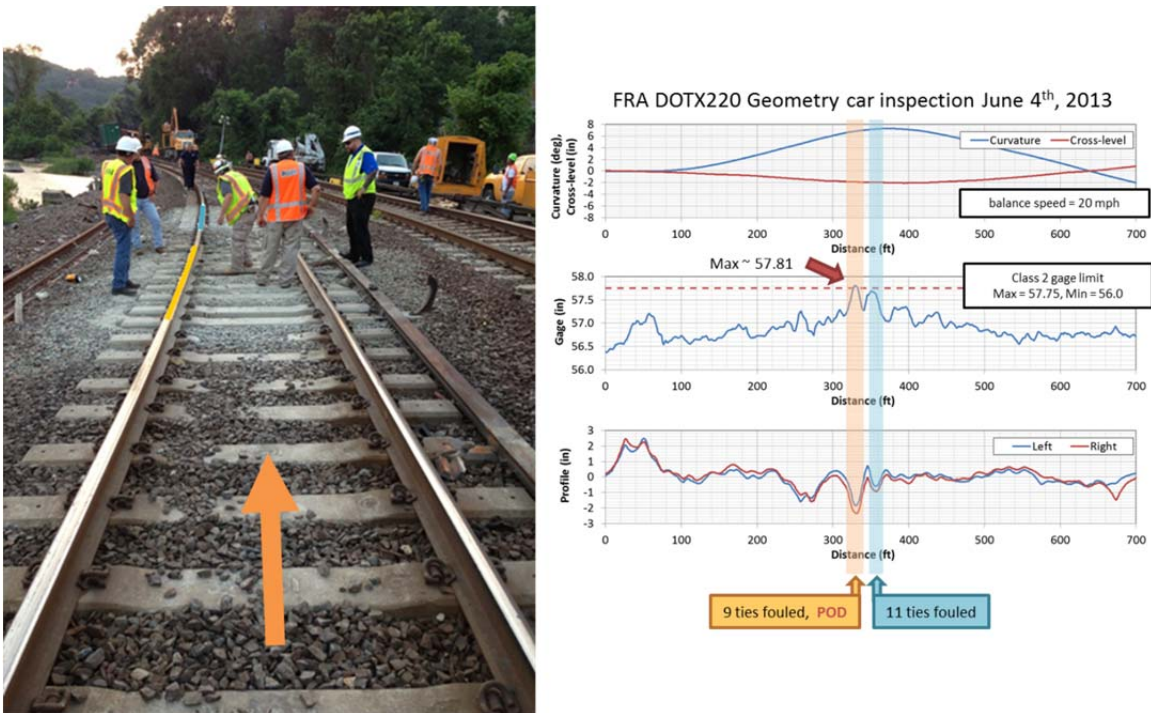
Two FRA geometry car surveys taken approximately one month prior to derailment (one on June 4, 2013 and one on June 19, 2013) indicated the existence of a combination track geometry deviation at the POD – namely, a minimally compliant gage deviation (57.81 inches) and a relatively large amplitude short wavelength profile geometry deviation (dip) on both rails (approximately 2 inch amplitude in 40 feet). Figure 3 shows a plot of the measured gage and profile at the derailment site as recorded by FRA’s DOTX220 track geometry measurement car on June 4th. For interpretation purposes, the top surface on low rail in the figure on the left was shaded gold and blue to correspond to the same shaded sections in the track geometry data. While neither deviation was considered an exception to the FRA Track Safety Standards (TSS), the TSS in general address specific track conditions that exist in isolation and there sometimes can be a combination of track conditions (none of which individually amounts to a deviation of the TSS) that require remedial action to provide for safe operations over that track.

Figure 3: Measured track geometry in derailment zone with low rail (left picture) shaded gold and blue to correspond to the same shaded sections in the track geometry data.

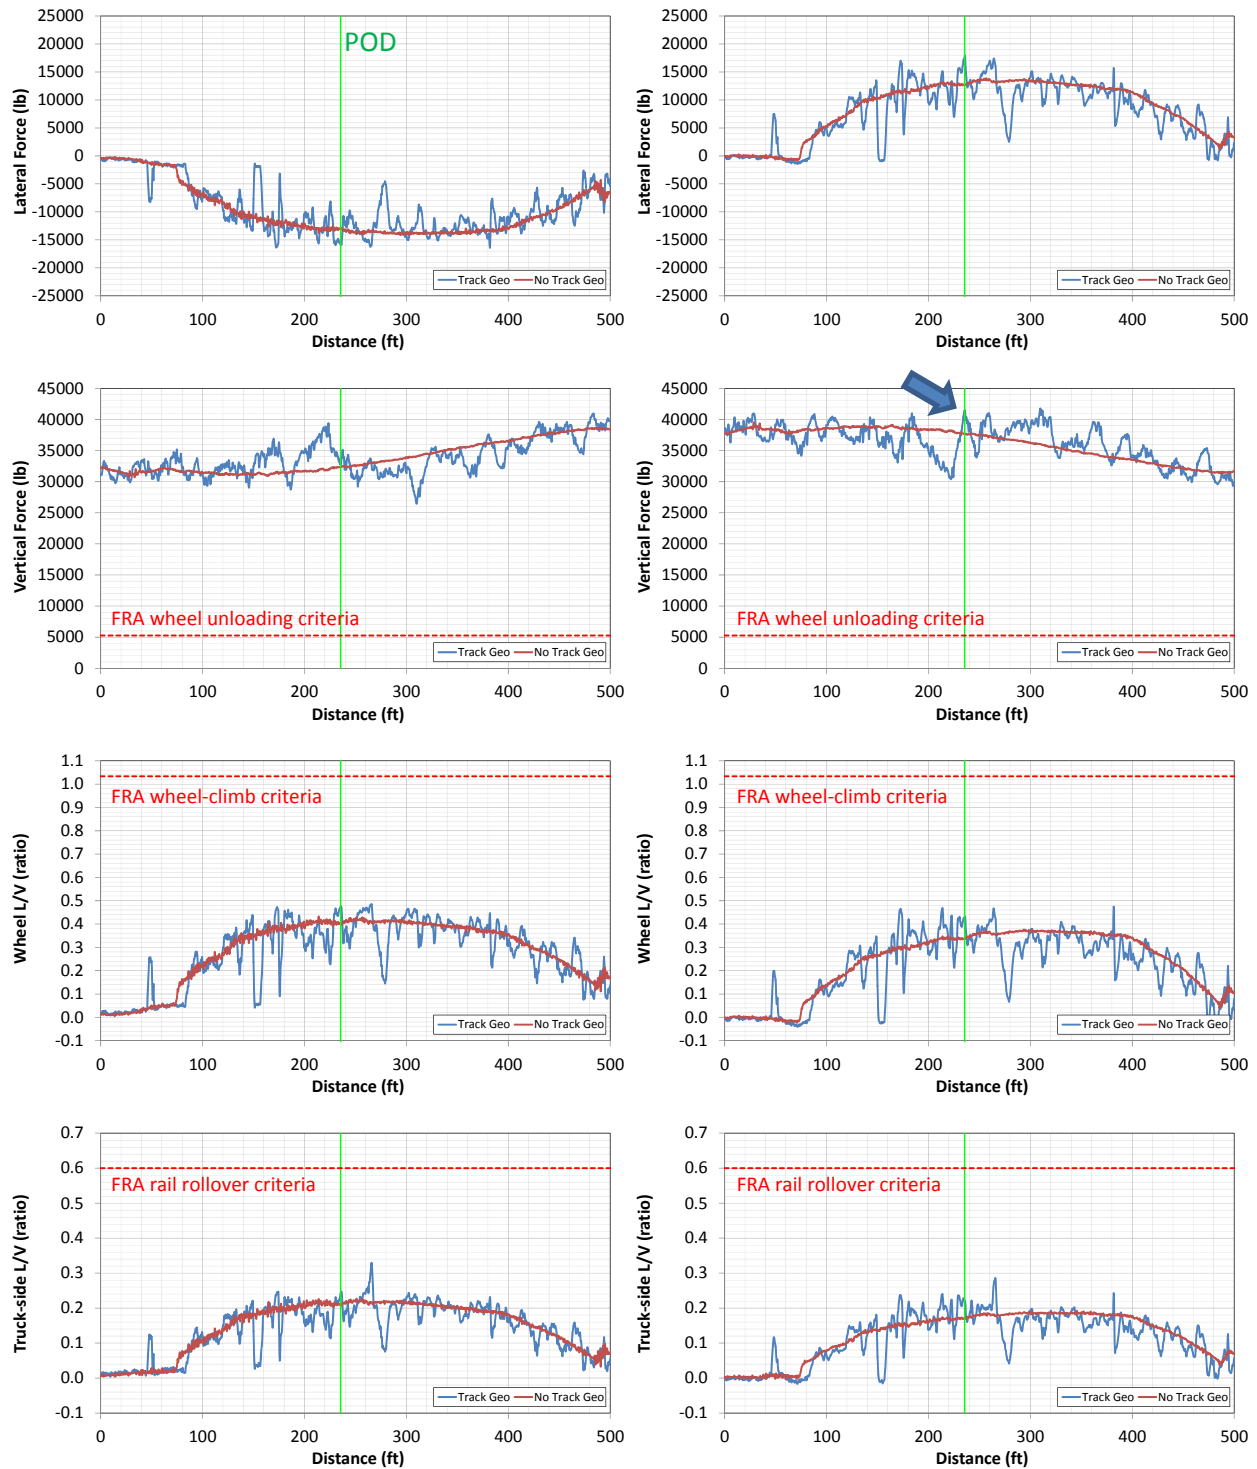
All of the predicted wheel-rail forces in the area around the point of derailment are shown to be well within the FRA VTI Safety Criteria for wheel-unloading, wheel-climb, and rail rollover indicating these modes of derailment were unlikely and that it is unlikely that the derailment was solely due to the combination of track geometry deviations as measured before the accident. Furthermore, Figures C1 and C2 in appendix C show the results of additional simulations conducted to examine parametric variations in vehicle weight and center of gravity respectively. These results indicate that these factors are unlikely to have contributed to this particular derailment for the range of values considered.

Although the predicted wheel-rail forces are well within the FRA VTI Safety Criteria, the FRA criteria do not establish a limit on maximum dynamic vertical wheel loads. Dynamic vertical wheel loads may exceed the capacity of the track or its components and result in progressive (rapid) deterioration under repetitive loading arising from multiple wheel passes. The critical magnitude of wheel load depends on the design and in-service condition of the overall track structure and its components. The maximum dynamic vertical load predicted in the derailment zone is approximately 41 kips. It occurs at the POD as indicated by the blue arrow annotation in Figure 5 and represents a 10% increase in vertical force due to the presence of the profile variations. While this force magnitude may not be a concern for well-maintained track conditions, it is significant for the damaged components (damaged concrete crossties in particular) and deteriorated ballast support conditions (center-bound support in particular) that were present in the derailment area; these track conditions are described in greater detail later in the Track Condition section below.

Figure 5: Axle 1 predicted wheel-rail forces in derailment curve for baseline case defined by a car weight of 280 kips and center of gravity of 93 inches: comparison of simulations with and without measured track geometry deviations, plots in the left column are wheel-rail forces on the low-rail, plots in the right column are wheel-rail forces on the high-rail.

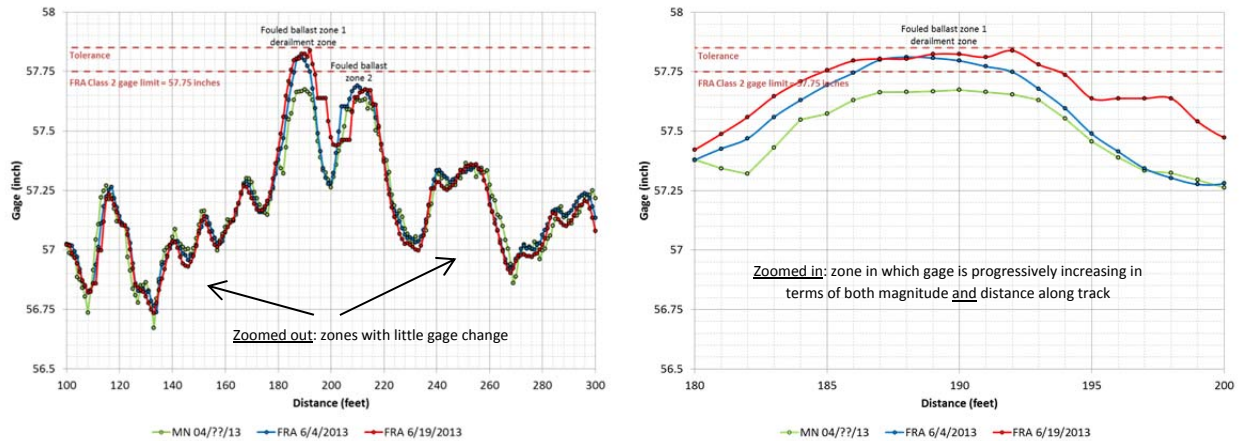
Figure 9: Overlay of track gage in derailment zone recorded on three different dates: zoom out (left) and zoom in (right). Gage in the derailment zone increased significantly in 2 months (green to blue) and then again in 2 weeks (blue to red), an indication that multiple cross-ties in the derailment zone were deteriorating rapidly.

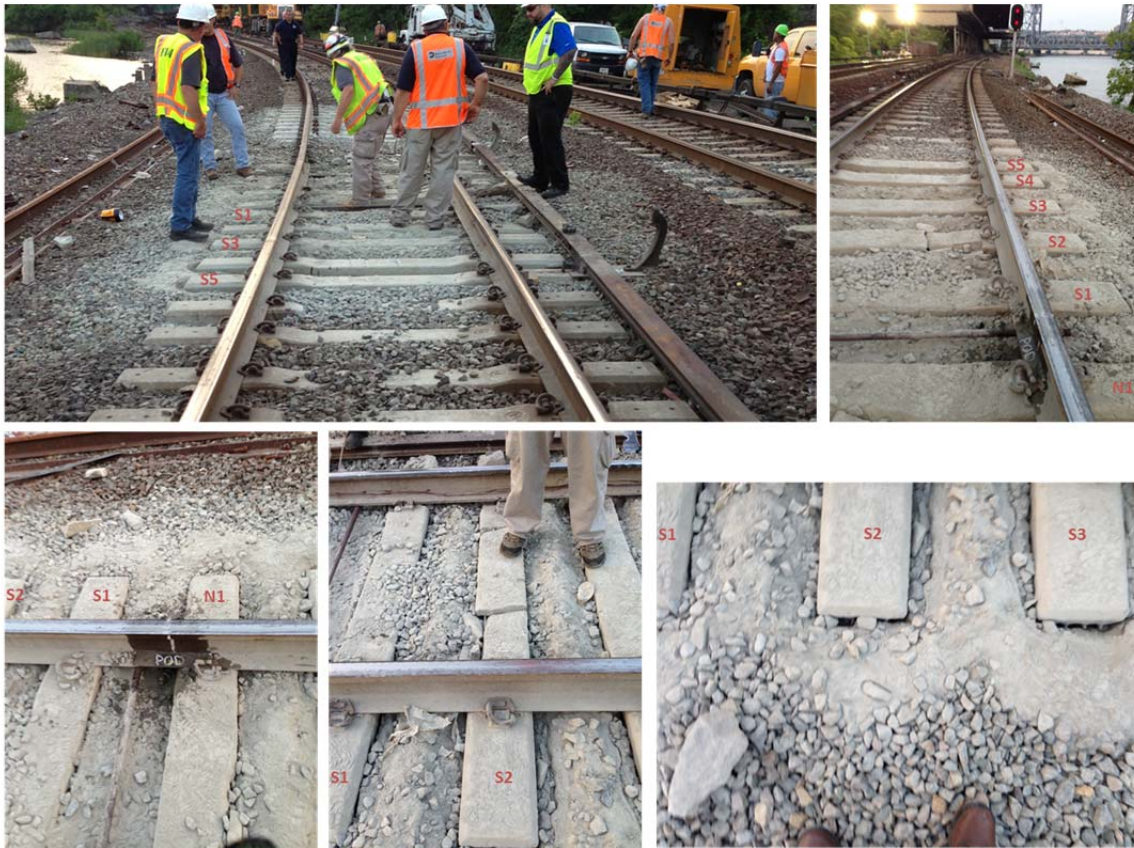
Figure 10 shows multiple views of the derailment site⁶ taken shortly after the derailment. Car 11 of the train was traveling northbound through the left-hand curve (first curve of the reverse curve in Figure 10a) at approximately 17 mph when the low-rail-wheel of its lead axle dropped down within the gage between crossties S1 and N1 – crossties were numbered incrementally north and south from POD. The remaining axles of car 11, and cars 12 through 20, derailed in the right-hand curve as a result of further damage to the track. The wide-gage wheel-drop derailment occurred in a fouled ballast zone that encompassed 9 crossties. Four crossties north of the subject fouled ballast zone was another fouled ballast zone that encompassed 11 crossties. Figures 10c, 10d, and 10e show gaps between crossties and ballast, particularly at the crosstie-ends, an indication of significant dynamic (up-and-down) pumping action of the crosstie-ends. Inspections carried out at the derailment site prior to removal of the crossties from the ballast, also revealed that several of the concrete crossties in the fouled ballast zone exhibited a pattern of multiple, evenly spaced, center-bound cracks, Figure 10, and that crosstie S2 was broken, indicative of catastrophic crosstie failure.

Figure 10: Damaged concrete crossties in derailment curve: (10a, upper left) POD looking northbound; (10b, upper right) POD looking southbound; (10c, lower left) POD facing gage side of inside rail; (10d, lower center) POD facing field side of inside rail; and, (10e, lower right) gaps at the crosstie-ends on inside of curve.

⁶ The gage rods shown in Figure 10 near the POD were installed post derailment.

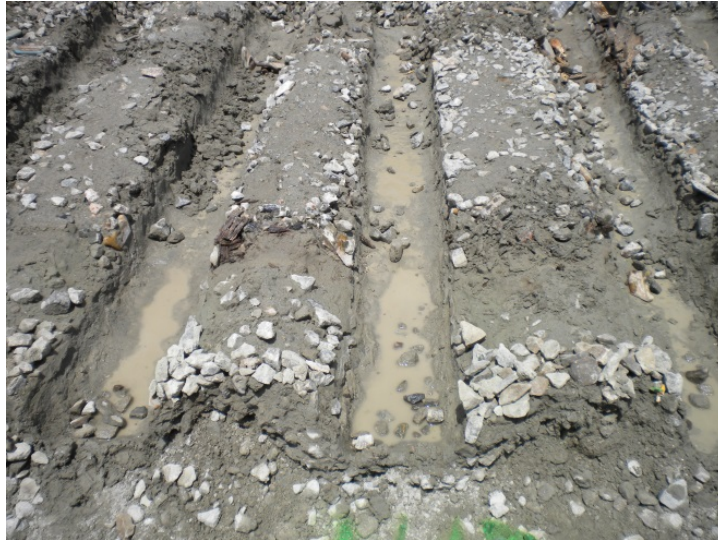
While visual inspection of the surface indicated that the fouled ballast appeared dry, inspection carried out after digging out and removing the crossties revealed that water was trapped below the crossties in the fouled ballast, Figure 11.

Figure 11: Presences of water beneath crossties and ballast layer.

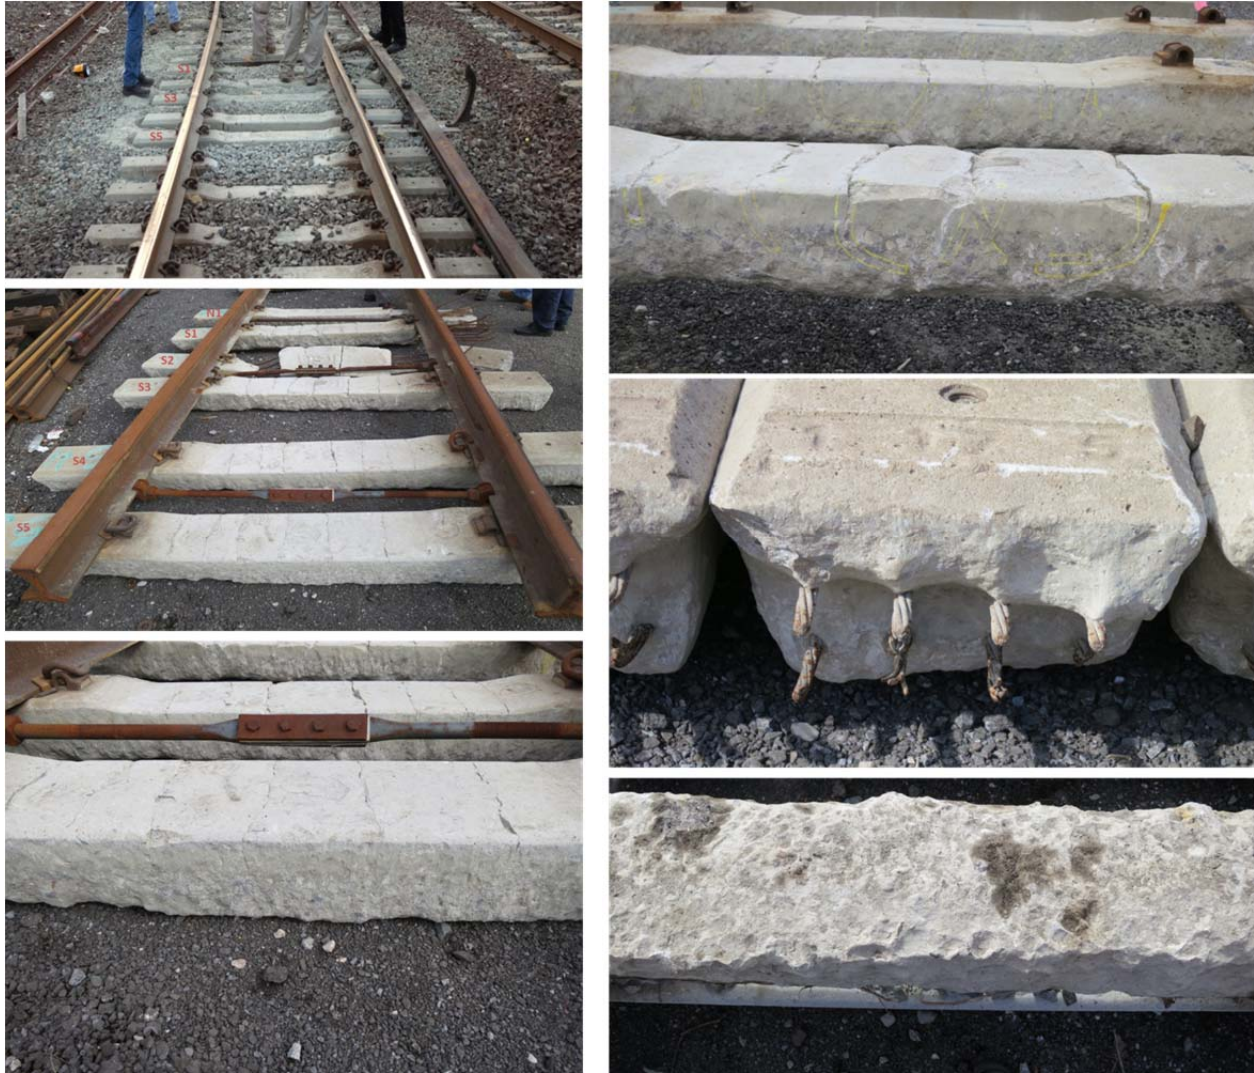
Removal of the crossties near the POD, Figure 12, further revealed that crossties N1 and S1 were also broken in the vicinity of the rail seat of the high rail, indicative of catastrophic crosstie failure. In addition, the concrete crossties in this zone were abraded on the bottom due to dynamic up-and-down pumping action against the ballast. The center-bound cracks and the greater abrasion towards the ends of the crossties (to the point of exposing reinforcement strands) are indicators that the crossties were center-bound, in which the center of the crossties is supported while the ends behave like cantilever beams, as a result of the fouled ballast condition, see illustration in Figure 13.

Figure 12: Damaged concrete cross-ties in derailment curve:
(12a, upper left) POD looking northbound – S2 broken;
(12b, middle left) cross-ties at POD after removal – N1, S1, and S2 broken;
(12c, lower left) close-up of cross-ties at POD after removal – reduced section of cross-ties;
(12d, upper right) characterization of center cracks on cross-ties near POD;
(12e, middle right) ends of cross-ties near POD; and,
(12f, bottom right) typical bottom of cross-ties near POD.

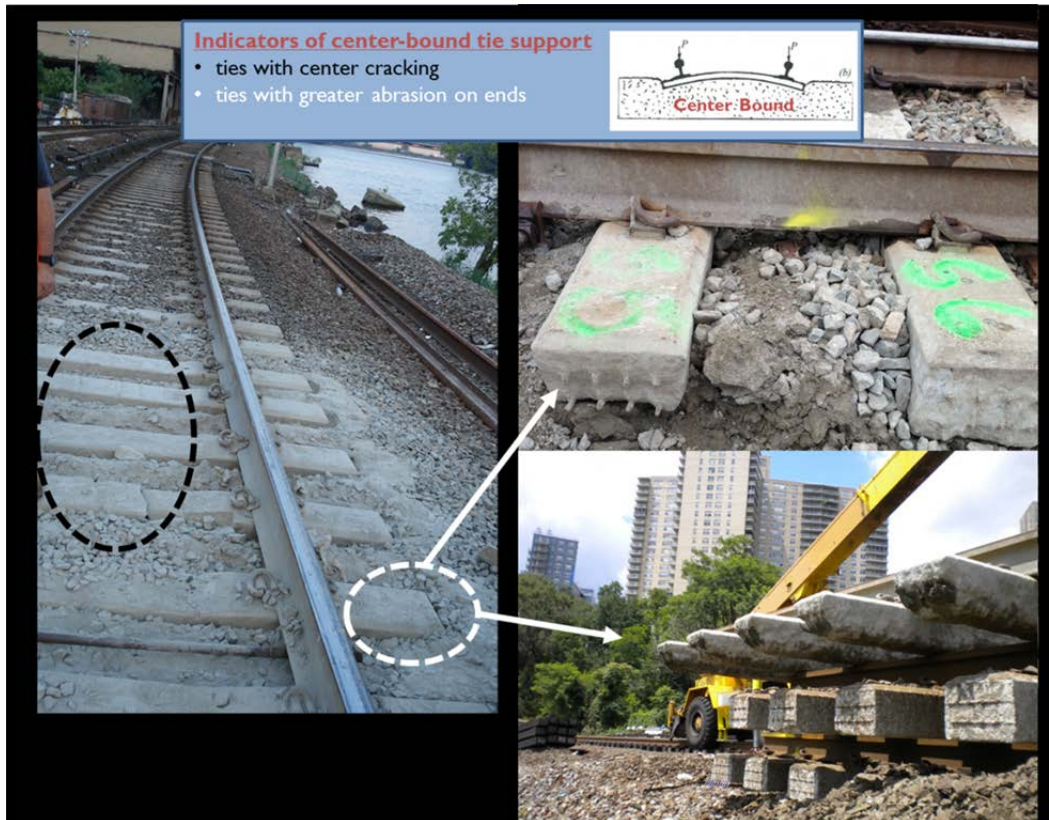
Figure 13: Indicators of center supported crossties (center-bound crossties).

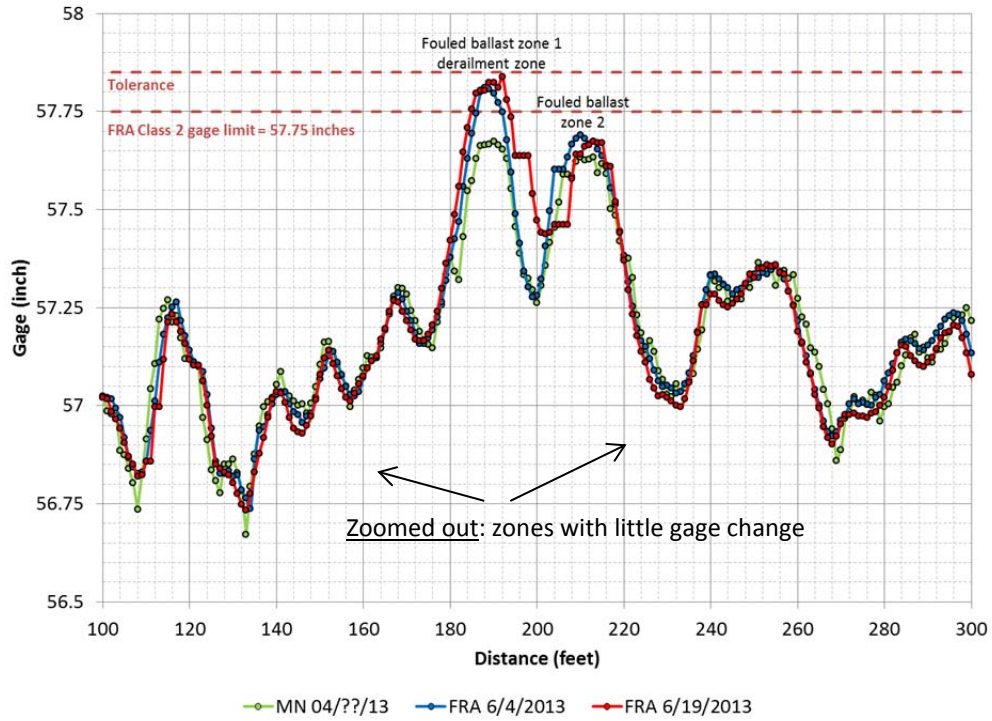
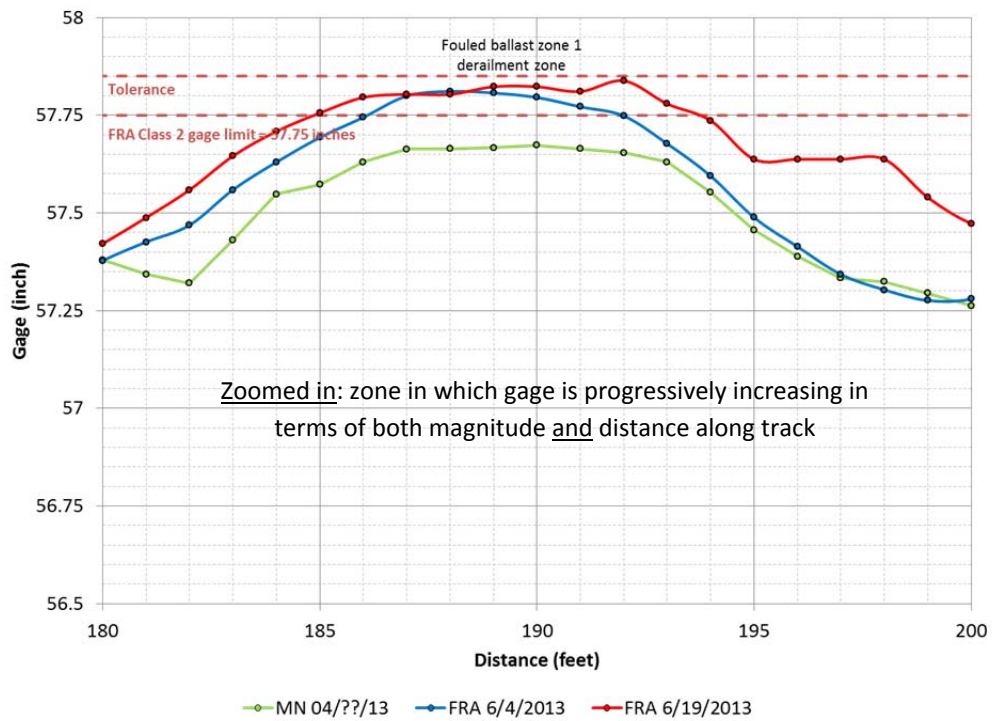
It is likely that the profile deviations developed over time as a result of degradation of the ballast support condition due to ballast fouling (localized change in track stiffness) and many passes of dynamic wheel/rail forces. As a result of the damaged crossties (multiple crossties with center-bound cracks and reduced height cross-section – i.e. reduced bending resistance), the dynamic wheel/rail forces, and the poor support condition (center-bound crosstie), the crossties were flexing under load producing a maximum gage of 57.81 inches (larger than the FRA class 2 limit of 57.75 inches but not considered a defect because of a 0.1 inch tolerance applied to geometry car measurements). While the gage recorded on June 4th is below that which is needed for wheel drop (typically a gage between 59.5 and 60 inches is needed for wheel drop depending on the flange thickness, etc.), the gage was progressively increasing in terms of both magnitude and distance along track with accumulated tonnage and time, Figure 14; an indication that the track conditions, in particular the crossties, were deteriorating relatively fast considering the tonnage present on that line. The gage was incrementally and permanently widened from its initial position by the repetitive application of vertical wheel loads. It is likely that progressive track failure was occurring under a cycle of repeated dynamic loading, Figure 15, that involved individual crossties becoming increasingly damaged (some to the point of sudden catastrophic failure) at the same time that damage on neighboring crossties was developing, and so on.

Figure 14: Overlay of track gage in derailment zone recorded on three different dates: zoom out (top) and zoom in (bottom). Gage in the derailment zone increased significantly in 2 months (green to blue) and then again in 2 weeks (blue to red), an indication that multiple cross-ties in the derailment zone were deteriorating rapidly.

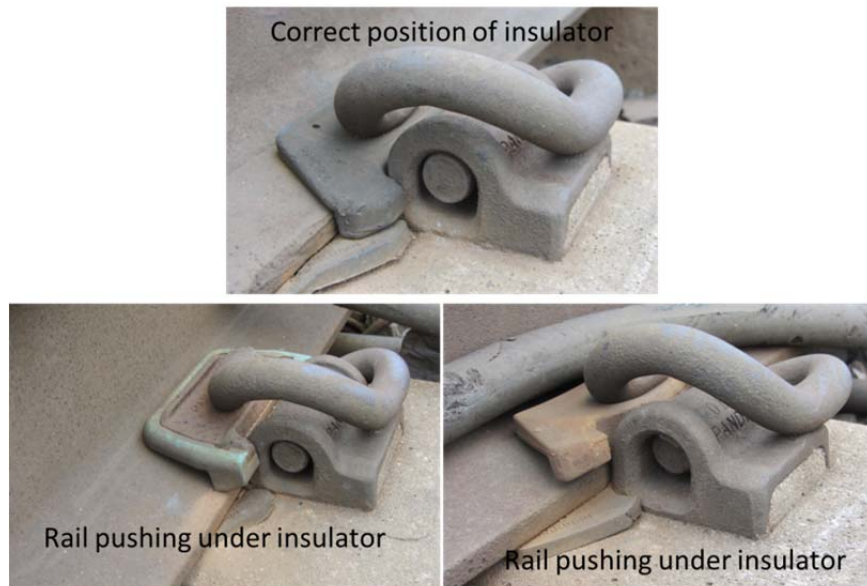
During the time of the accident, the New York City area had been experiencing a heat wave. The daytime high temperature had been above 90° F each of the three days preceding the derailment. The weather at the time of the accident was reported as 91° F with clear skies, no precipitation. As a result of the high temperatures, both rails were spread towards their respective field side increasing the unloaded gage to 58.25 inches by slipping under the insulator shoulders, Figure 16.

Figure 16: High and Low Rails Pushing Under the Insulator Clips.

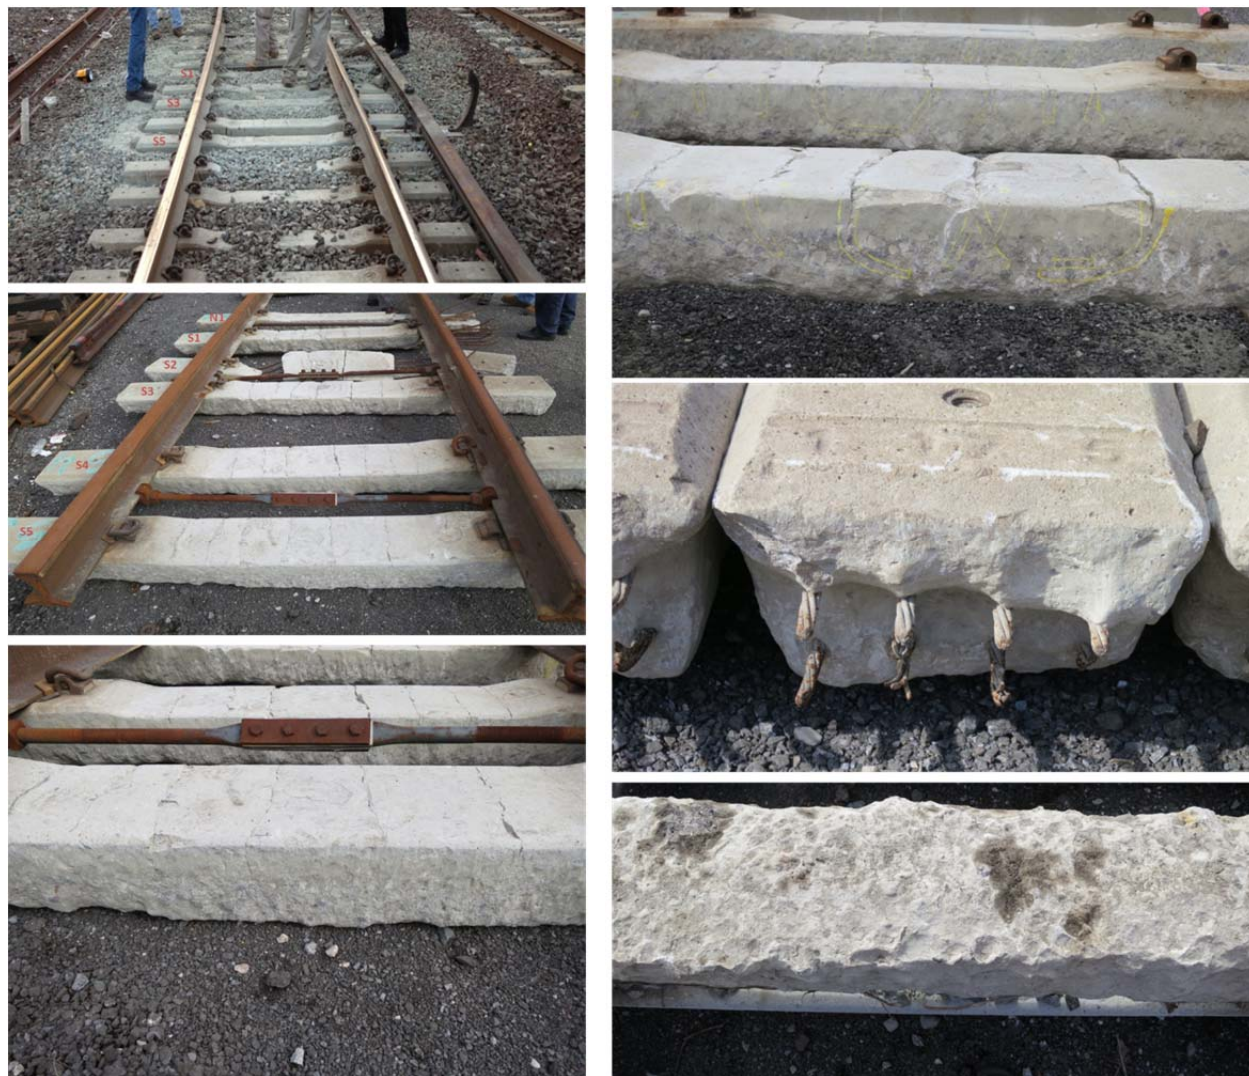
All five of the concrete crossties retrieved from the fouled ballast zone exhibited damage similar to that shown in Figure 19 – namely, a pattern of multiple, evenly spaced, center-bound cracks and abrading on the bottom due to dynamic up-and-down pumping action against the ballast resulting in a reduced height cross-section (i.e. reduced bending resistance).

Figure 19: Concrete crossties in derailment curve:
(19a, upper left) POD looking northbound – S2 broken;
(19b, middle left) crossties near POD after removal – N1, S1, and S2 broken;
(19c, lower left) close-up of crossties near POD after removal – reduced section of crossties;
(19d, upper right) characterization of center cracks on crossties near POD;
(19e, middle right) ends of crossties near POD; and,
(19f, bottom right) typical bottom of crossties near POD.

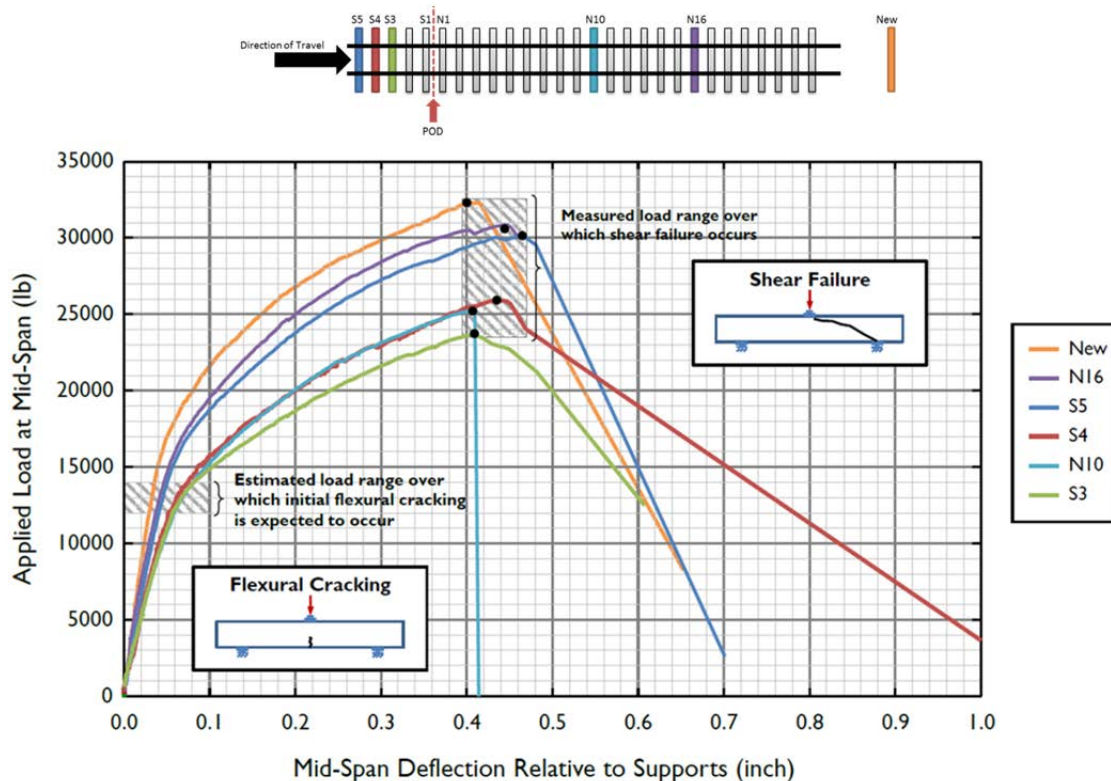
Figure 20 shows the measured load-deflection for each of the tested crossties. After the initial linear response around 0.05 inch mid-span deflection, flexural cracks develop. The peak load in each curve at around 0.4 inch mid-span deflection corresponds to sudden, catastrophic failure of the crosstie (i.e. shear failure or ultimate failure of the crosstie). The ultimate failure load is higher for the new crosstie, approximately 32.3 kips, as might be expected. Crossties S3 and S4 (which were the closest to the POD and most representative of crossties N1, S1, and S2 in terms of reduced cross-section) exhibited the lowest ultimate failure loads, crosstie S3 being the lowest – approximately 23.5 kips.

Figure 20: Measured load-deflection behavior of Metro-North concrete crossties using AREMA center negative test configuration.
