## **Warning-Unit readout and decoding from EC135 P2 N62UP**

On May 25, 2017 an EC 135 P2 helicopter crashed during a Single Pilot IFR Training Flight near Wilmington, New Castle Airport, USA.

Accident of EC135 P2, S/N: 0475, Reg.N62UP,  
25 May 2017, USA, BFU Az: 17-0587-DX

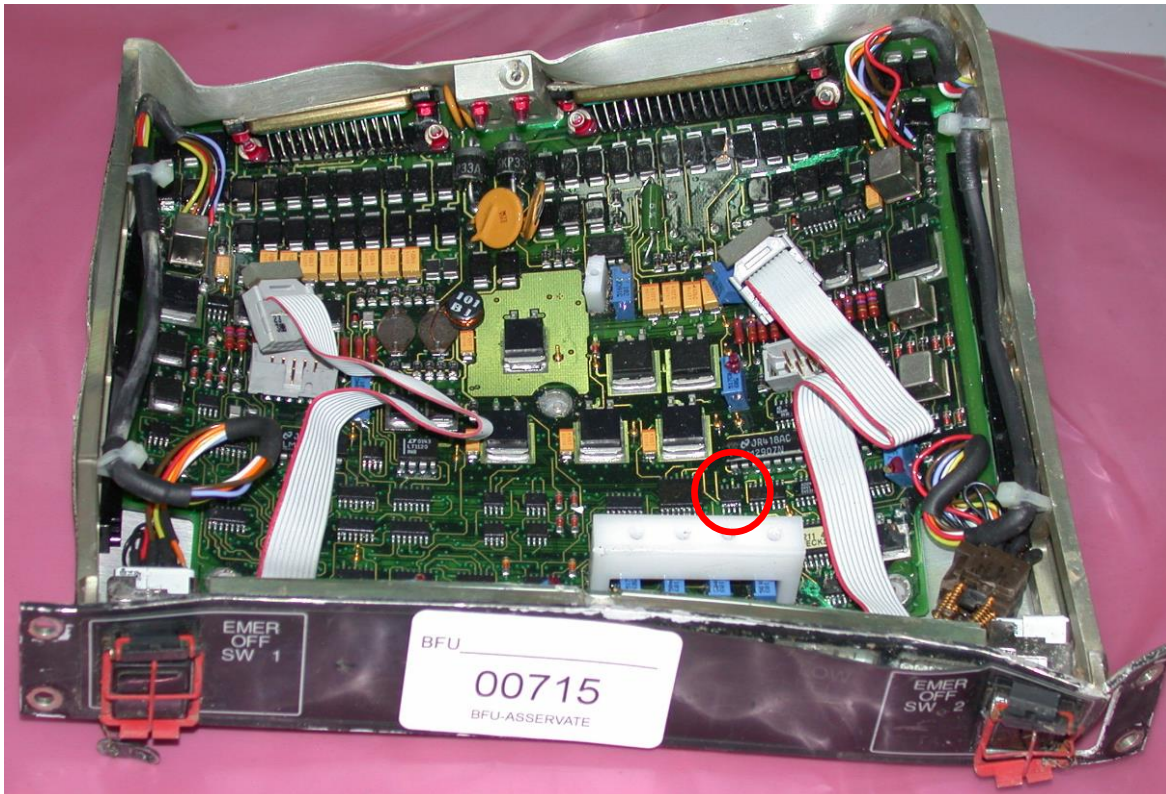
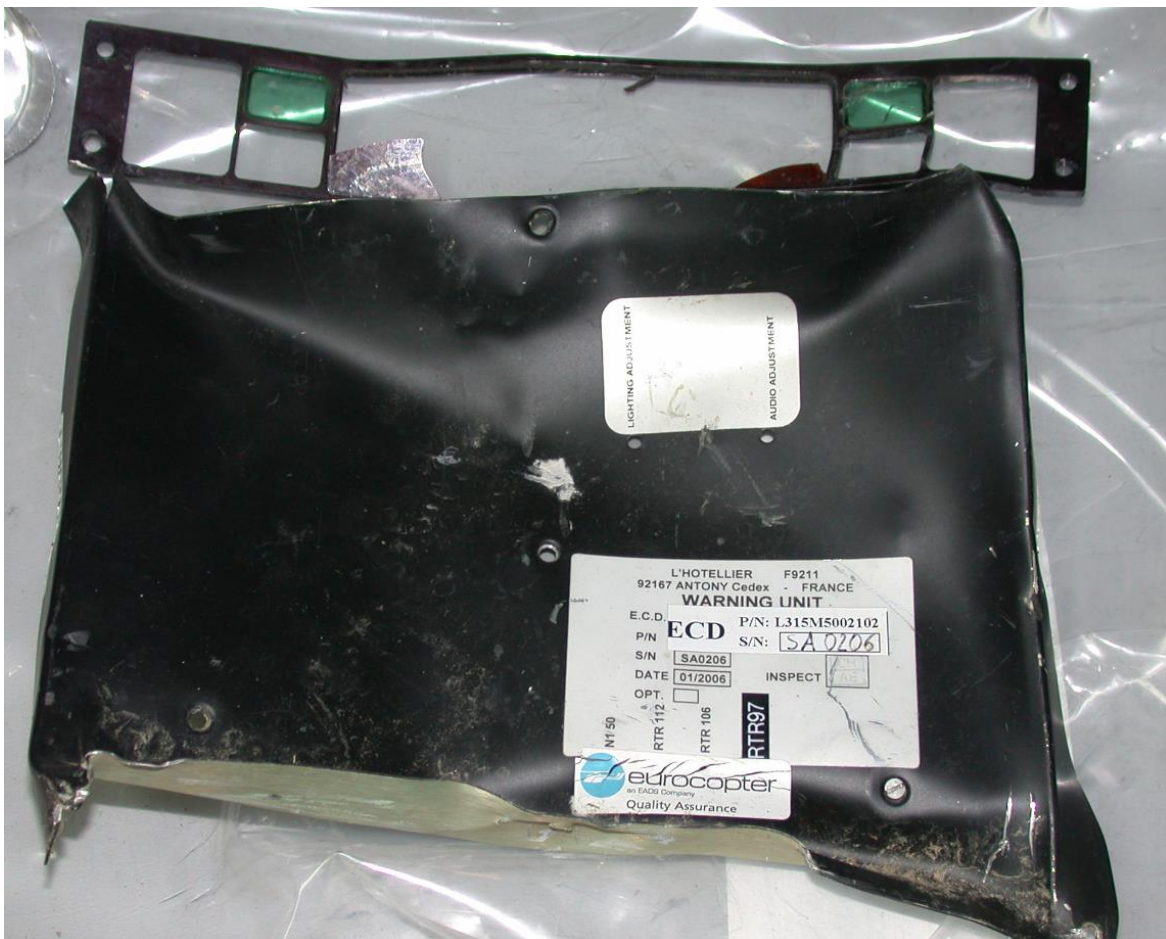
Overview of damages to the Warning-Unit, Opening December 23, 2017

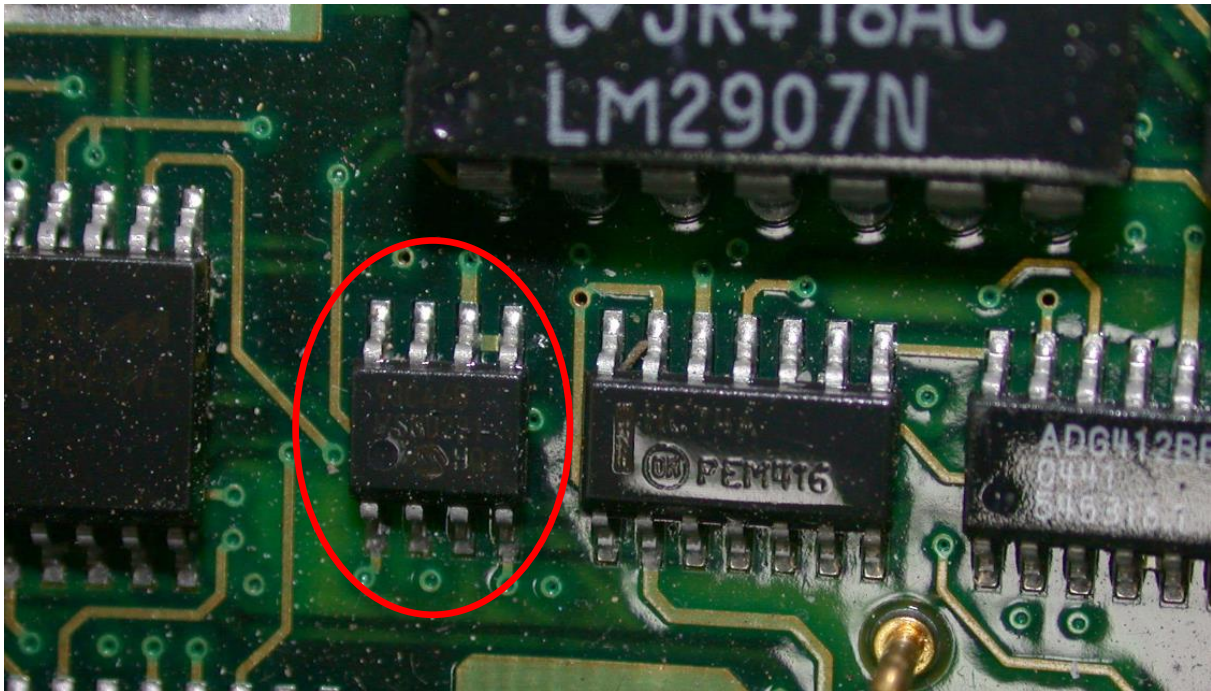
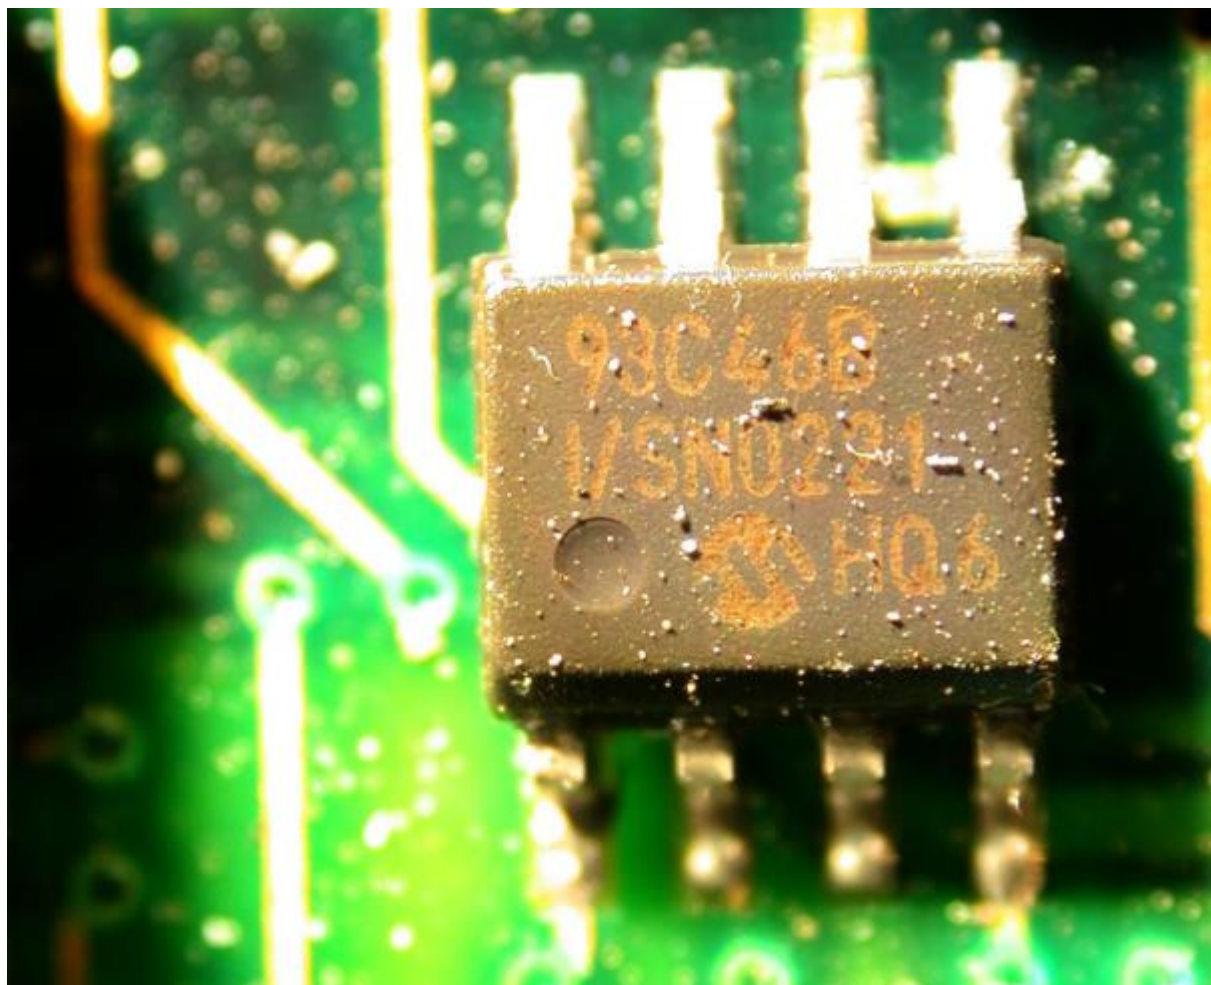
Unsoldering of memory chip

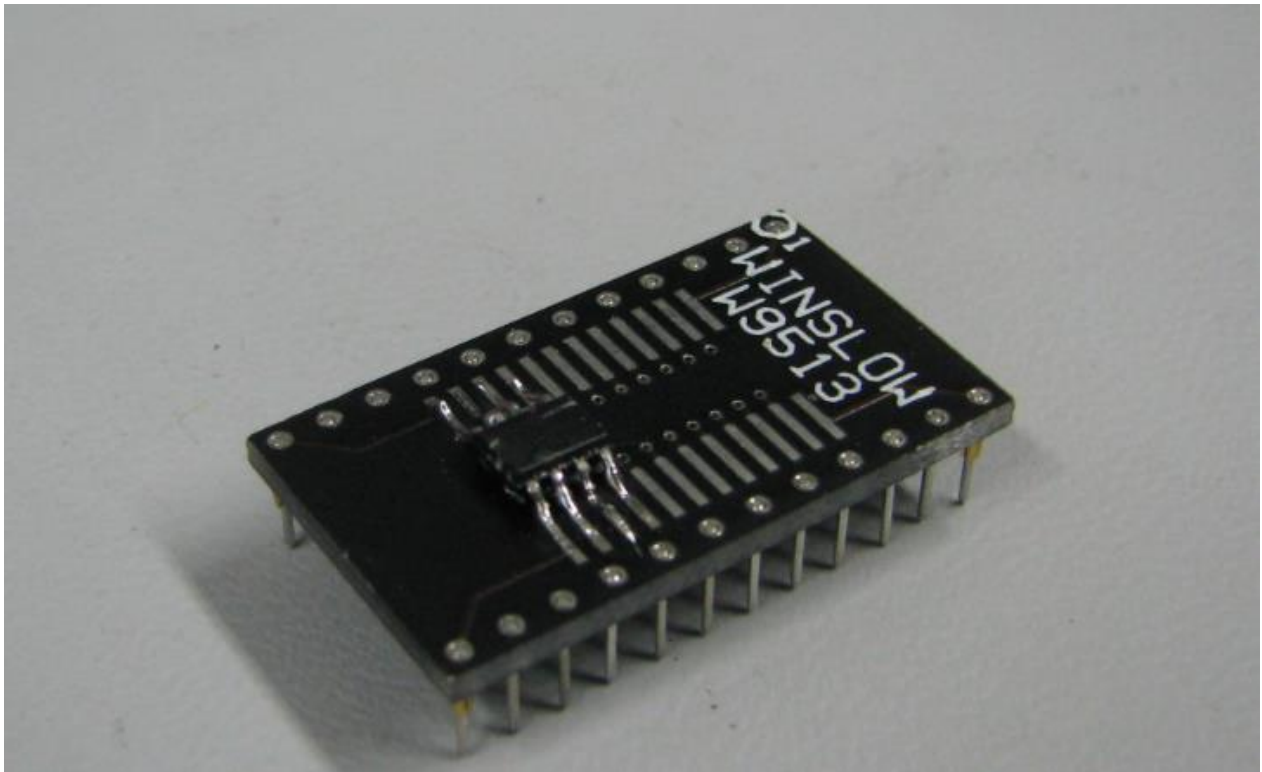
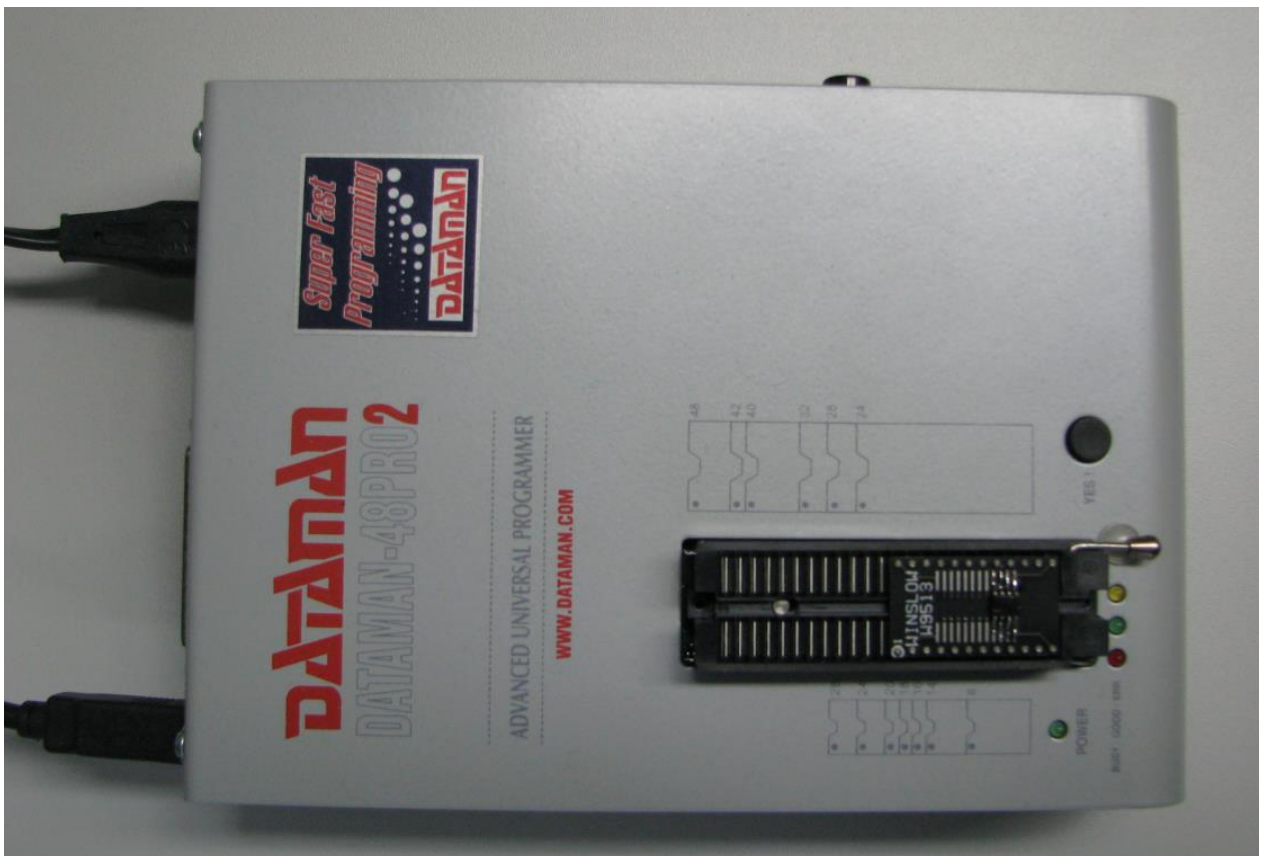
Preparing of memory chip for readout
