**BUILDING EXPLOSION AND FIRE  
8701 ARLISS STREET  
SILVER SPRING, MARYLAND  
ACCIDENT NUMBER – DCA16FP003**

**PREPARED BY:  
WASHINGTON GAS  
SUBMITTED TO:  
NATIONAL TRANSPORTATION SAFETY BOARD (NTSB)**

**JUNE 7, 2017**

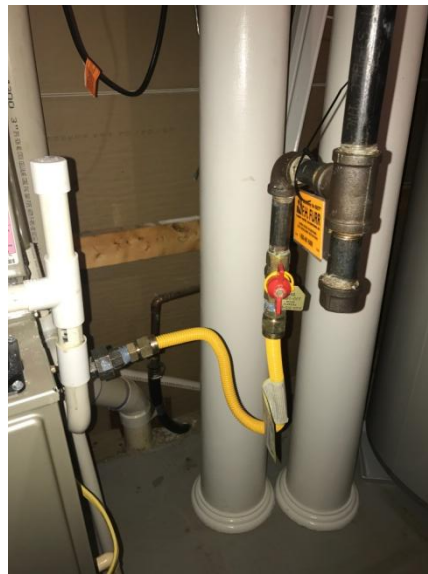
**Photo showing use of flex connector/pig tail between steel house piping and appliance connection**

3. In multi-family buildings where the water heater and gas piping is exposed and unprotected from human activities and storage of materials, investigate the use of flexible gas piping ‘pig tails’ between the steel gas houseline and the connection rigidly mounted appliances, such as the water heater control valve found in 8701 Arliss Street. This will eliminate the vulnerable threaded connections that would be subject to significant stress if an unsupported steel houseline serving the appliance is inadvertently bumped or moved;

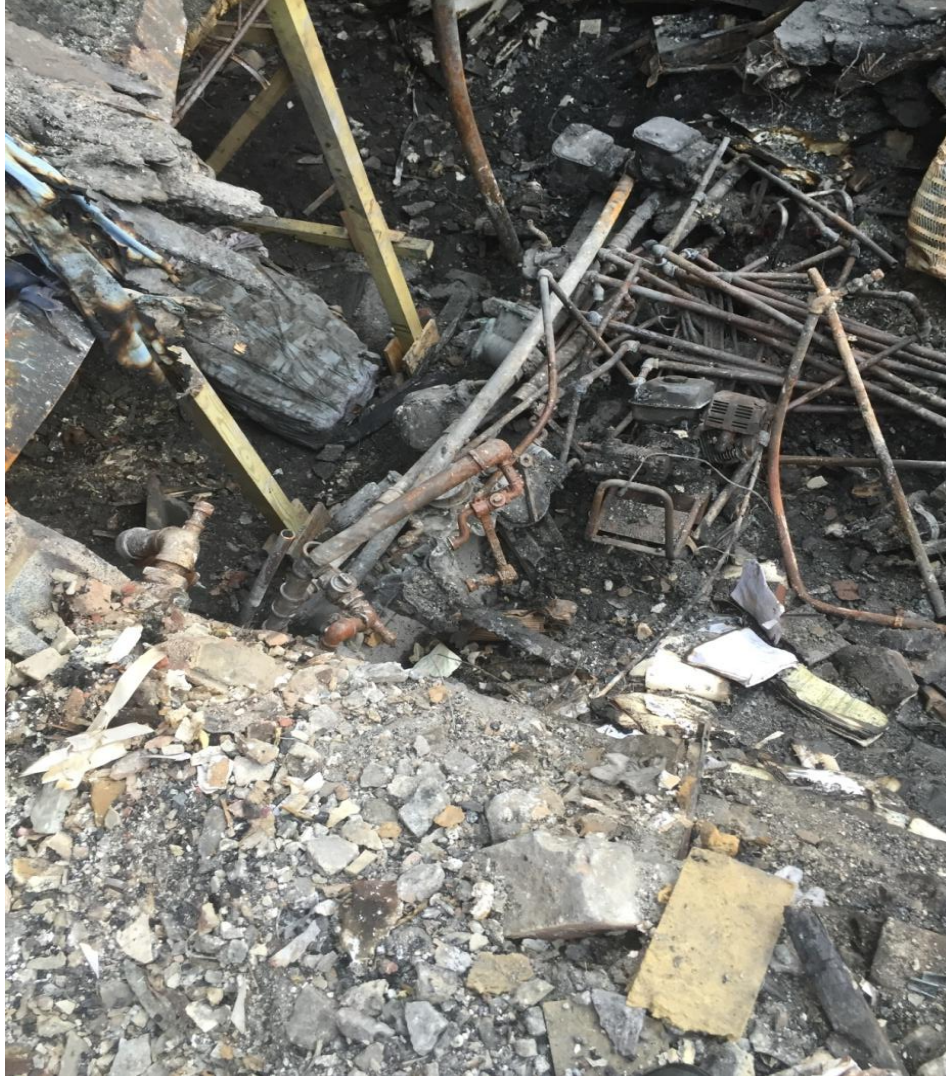
Fact 6: All components listed above were found damaged, broken, bent, separated, rusted, melted and displaced from their original positioning after the incident. This was noted in the ATF Report as well as observed by party members and documented in photographs. (See Figure 2)

**Figure 2: View into basement level meter/storage room of 8701 Arliss Street from grade level post removal of debris**

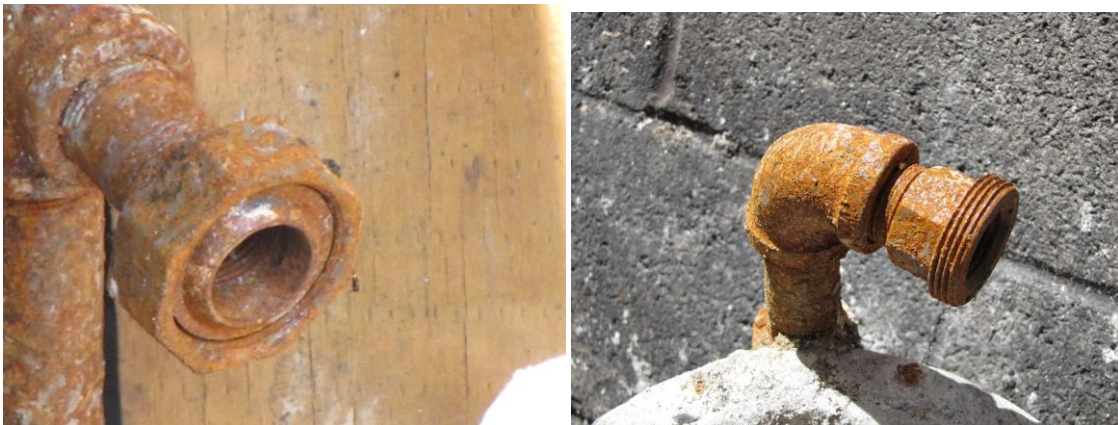
It appears that, beyond the *post*-collapse observation that the union fitting was separated, there is no other evidence to suggest that the union fitting was separated prior to the explosion and collapse. Because there were many threaded fittings which were found separated following the building collapse, it is not reasonable to conclude which of those fittings, if any, were separated prior to the accident without appropriate analysis and support for such a conclusion. The ATF arrived at the determination that the fitting was “disconnected prior to the explosion”<sup>7</sup> based on visual examination of the fitting as found on site, covered in rust (Figure 3A and 3B), post-explosion and fire, and without the aid of any laboratory testing or enhanced observations of the fitting, which proved to be necessary to establish its pre-collapse configuration.

**Figure 3A: Lower Union as found on site post explosion**

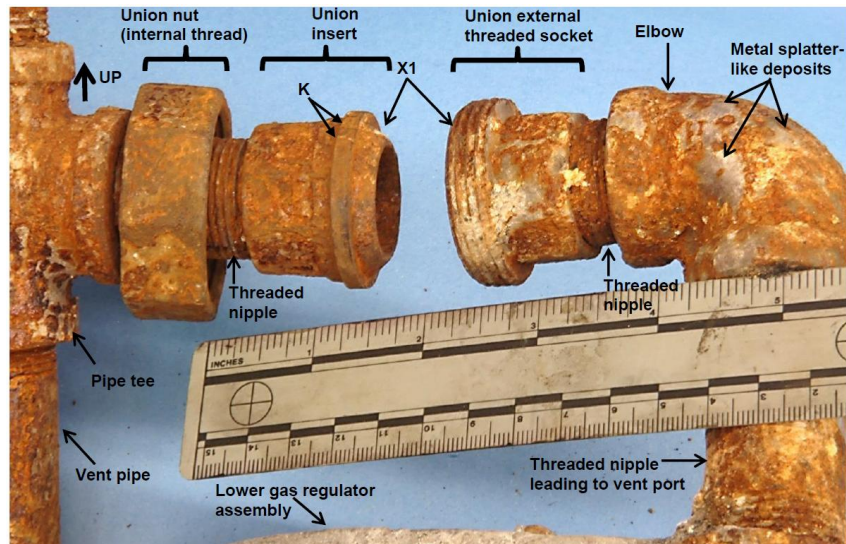
Figure 3B: Lower regulator vent union

The NTSB investigation’s close inspection and testing of the regulators, the vent piping and the lower regulator union fitting, revealed numerous factors that support a finding that the union fitting on the vent pipe was connected prior to the explosion/building collapse, and therefore, was not the source of fugitive natural gas that caused the explosion.

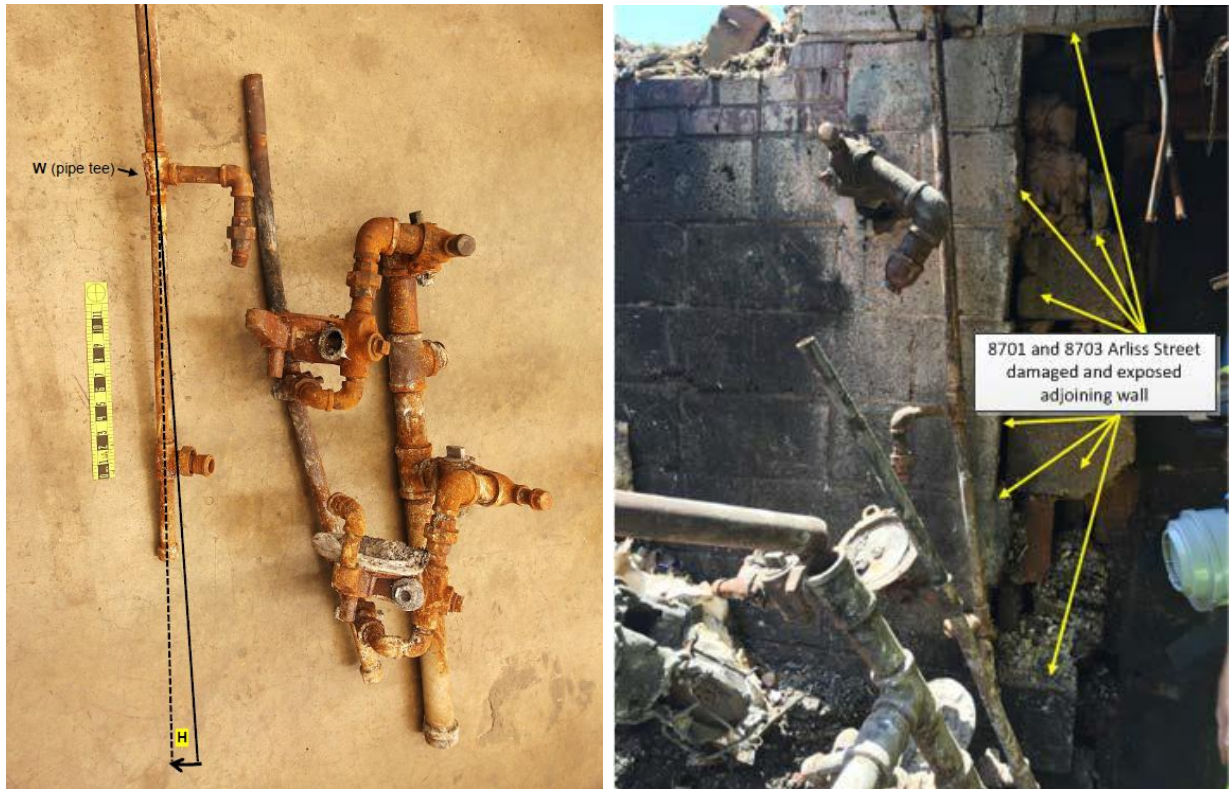
**Analysis:** For a bend to occur as shown in Figure 4A and 4B, a force would have needed to be applied to the lower section of the vent pipe below the connected tee (W) to the upper regulator. This force could only come from a connected vent line of the lower regulator during the collapse of the building and ensuing collapse of the meter set. The direction of this force is consistent with a force that would result from the meter set collapsing forward and toward the floor, along with the upper regulator connected to the vent line. For an explanation of how this series of events could have occurred, see Figures 4A and 4B.

Figure 4A: Bending evident in lower section of vent line

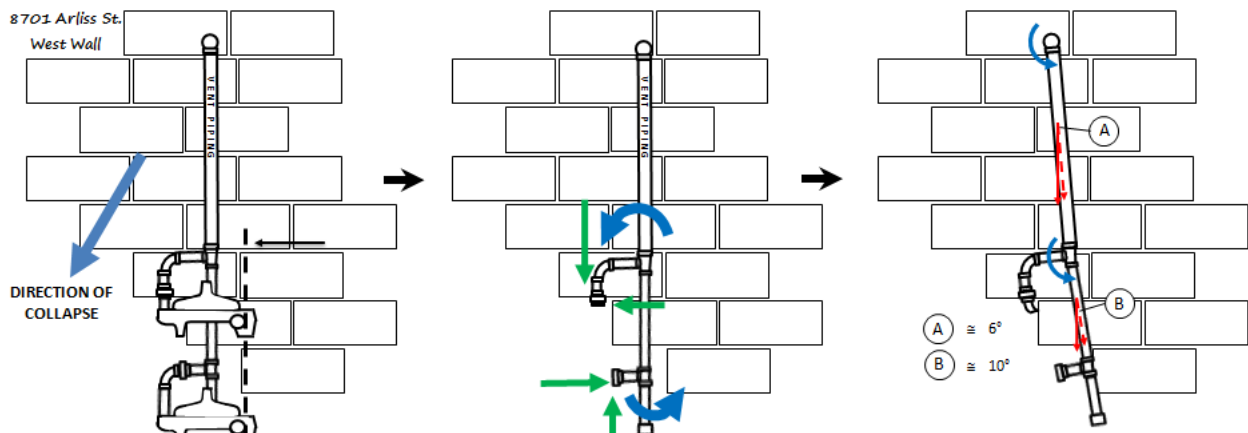
**SCENARIO:** BOTH VENT LINES ARE ORIGINALLY CONNECTED (LEFT IMAGE). AS THE REGULATOR OUTLET PIPING AND METER BANK ARE FORCED DOWN AND AWAY FROM THE NORTH WALL, FORCES ARE TRANSFERRED TO THE VENT PIPING. FORCES ON REGULATOR CONNECTING PIPING RESOLVE INTO HORIZONTAL AND VERTICAL COMPONENTS (CENTER IMAGE). THESE FORCES IMPART A MOMENT AT THE TEE CONNECTING THE VENT LINE TO THE UPPER REGULATOR AND CAUSE PERMANENT DEFORMATION (RIGHT IMAGE, ACTUAL DEFLECTIONS SHOWN) AND A MOMENT AROUND THE WALL PENETRATION, ROTATING THE ENTIRE VENT ASSEMBLY. WITHOUT A PHYSICAL CONNECTION AT THE LOWER VENT TO TRANSMIT FORCE, THE DEFLECTION OBSERVED AT B IS NOT POSSIBLE.

Figure 4B: Before/after image detailing the forces associated with the lower vent line connection where both regulator vent lines are connected prior to damage

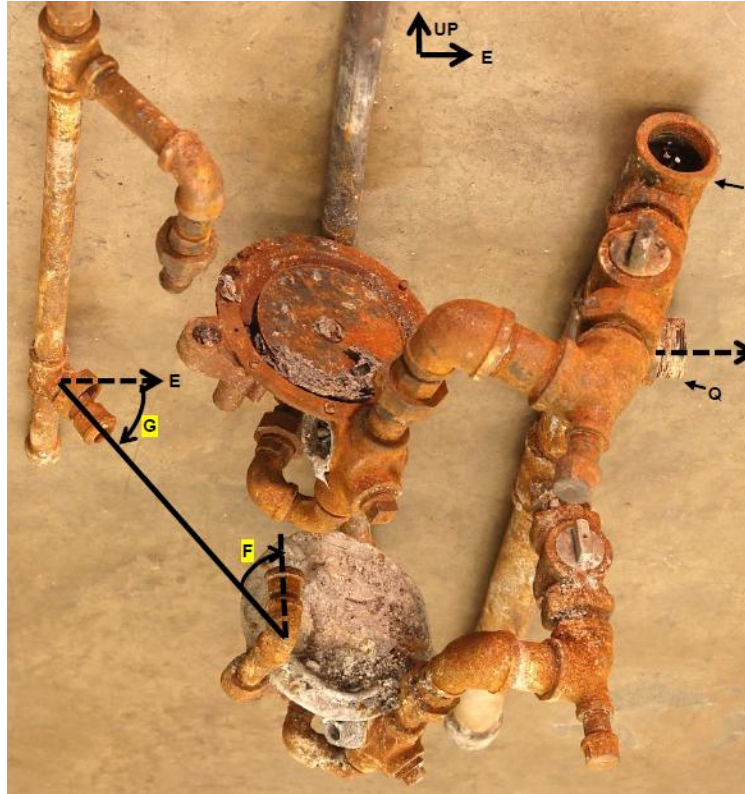
Fact 2: The fittings and nipples that led from the regulator to this union fitting were found to be out of line with the vent connection and were rotated clockwise (Angle 'F' in Figure 5).

**Analysis:** Rotation clockwise would further tighten the fitting into the regulator, which on a 50 year old connection such as this, requires a significant amount of force. If this piping was rotated clockwise by an individual there would have been significant wrench marks on the fittings due to the force required to turn them; no wrench marks were noted. Additionally, an individual seeking to disconnect this union fitting, professional or laymen, regardless of ill-intent or good intent, would ordinarily not do so by forcefully turning the fitting clockwise which would be to further tighten the fitting (virtually everybody knows the phrase “righty-tighty, lefty loosey”, with “righty” in this configuration being clockwise). The clockwise rotation of this fitting indicates that it occurred as a result of considerable force, not manual disconnection of the union fitting. Furthermore, the clockwise rotation of this section of piping from the lower regulator to the union appears to be consistent with the forces available during the collapse of the meter set and in the direction consistent with the direction the meter set was forced during the collapse of the building. The application of these available forces is consistent with the union fitting on the vent pipe being connected at the time of the collapse.

**Figure 5: Rotation of vent line segment in lower regulator (Angle 'F')**

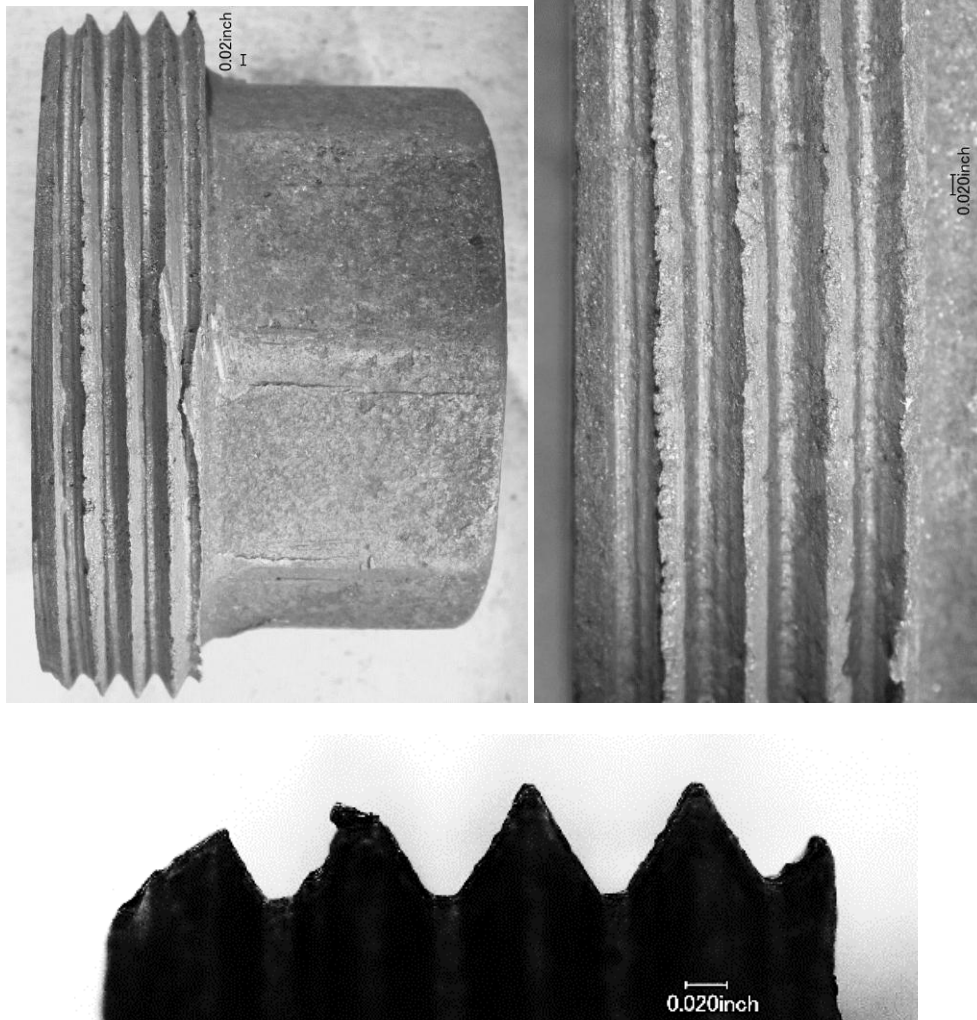
Fact 3: There is damage to the threads of the lower regulator union fitting as shown in Figure 6, which was observed during the NTSB's more in-depth examination of the lower regulator union fitting.

**Analysis:** The direction of the damages to the threads are consistent with the fitting being pulled apart by force, and are consistent with the forces that would exist with the collapse of the building and meter set, particularly if there was minimal thread engagement due to the ill-fitting union nut (female).

**Figure 6: View of the disassembled union external threaded adapter from the lower gas regulator (top left); close-up photograph of the external threads (top right); side profile of external threads (bottom)**

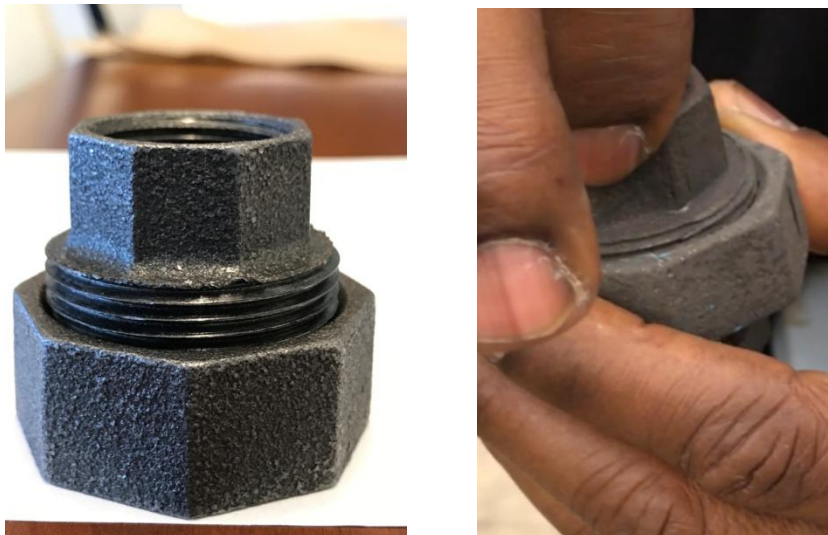
Fact 4: During the examination of the lower regulator union fitting in the NTSB lab, the union nut (female) was found to be enlarged resulting in minimal thread engagement with its male counterpart. Where a typical union fitting would have thread engagement at the immediate point of contact between the male and female counterparts (pictured on the left of Figure 7), the threads from the female and male counterparts of the lower regulator union fitting did not engage until 3+ of the 5 threads of the Union External Threaded Socket (male component) were recessed into the Union Nut (female component) as shown in the right side photo of Figure 7.

**Analysis:** The design of the fitting, accompanied by the purpose it served in the piping arrangement (a component of the non-gas carrying/non-pressurized relief vent piping) would allow a minimally engaged union fitting to serve its purpose, even though its threads were not fully and completely engaged. The forces and extreme heat that were in play following the explosion enabled this fitting, with minimal thread engagement, to expand and separate. It is important to note that the x-ray of the upper union fitting shown in the *Materials Laboratory Factual Report*<sup>8</sup> (See Figure 8), which had normal immediate thread engagement, only has three threads engaged when fully connected. An investigation based on full knowledge of all the relevant facts, including the minimal thread engagement of the lower union, the oversized nut, and the thread damage found, could not reliably conclude that the lower union must have been separated pre-explosion, pre-collapse. The ATF did not have the benefit of these facts.

**Figure 7: Disparity in fitment; Comparison of the point of thread engagement of a typical union fitting (left) versus the point of engagement found with the lower regulator union fitting (right).**

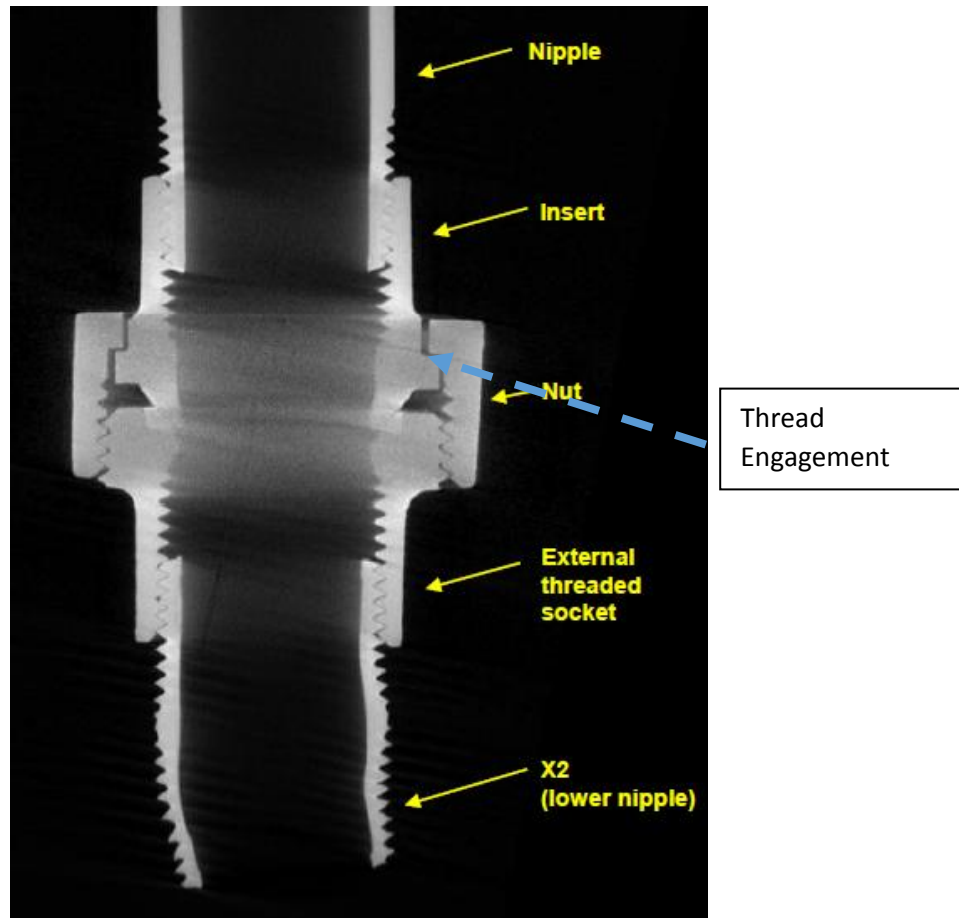
**Figure 8: X-ray showing upper vent union coupling nut thread engagement**

It is most reasonable to conclude that the incomplete thread engagement and observed thread damage, coupled with the enlarged female nut, is consistent with the union separating under the force of the collapsing meter set, especially when considering the potential for further heat expansion of the enlarged nut from the ensuing fire.

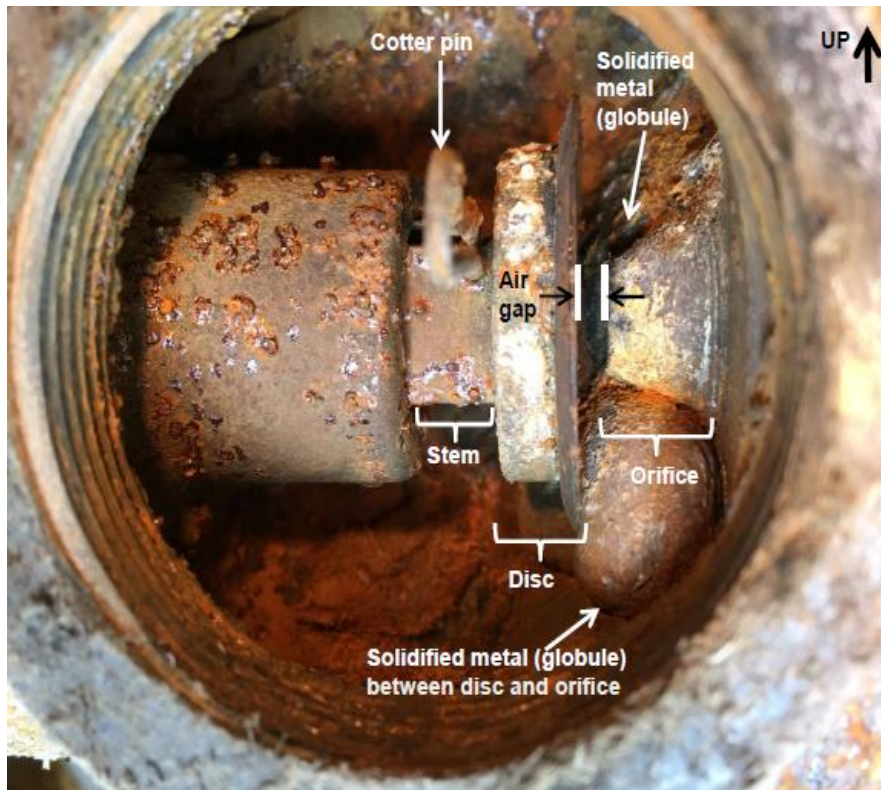
Fact 1: The two mercury regulators that served 8701 Arliss Street were examined and disassembled in the NTSB lab. Both were heavily damaged by the fire. Aluminum components melted, but observation of some key components was accomplished. In both regulators, the valve seat was intact and connected to the lever arm. In both regulators, the operating lever arms were intact, indicating a failure of these key components did not occur (Figure 12), nor does Washington Gas have any historical evidence or testimony that these components have ever been found to have failed.

**Figure 12: Lower gas regulator valve seat area**

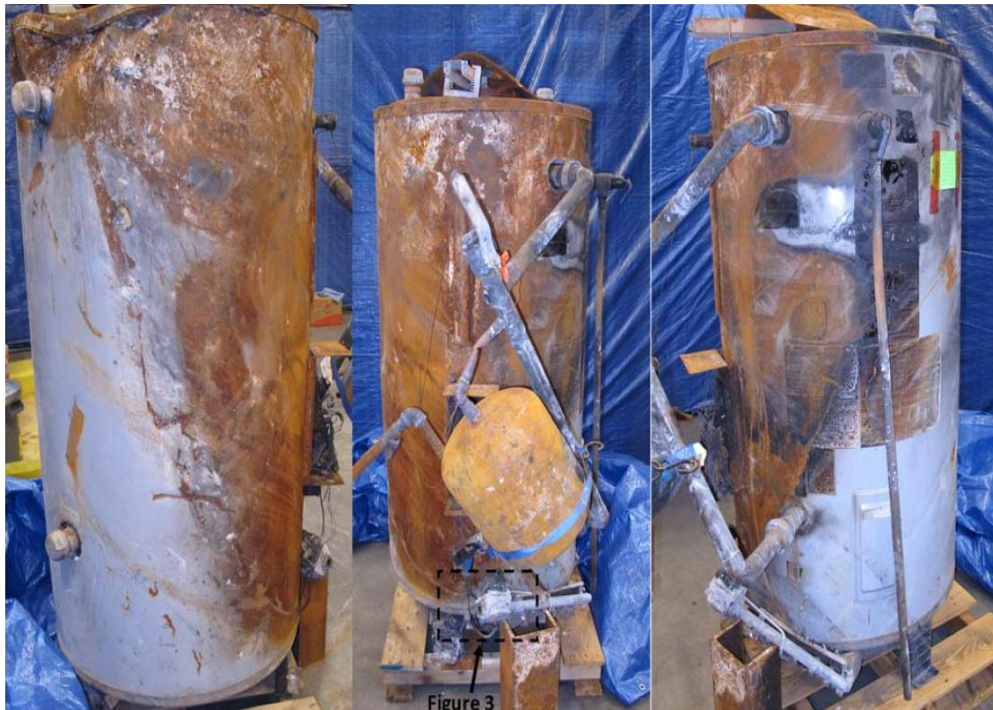
**Figure 17: Water heater burn pattern**

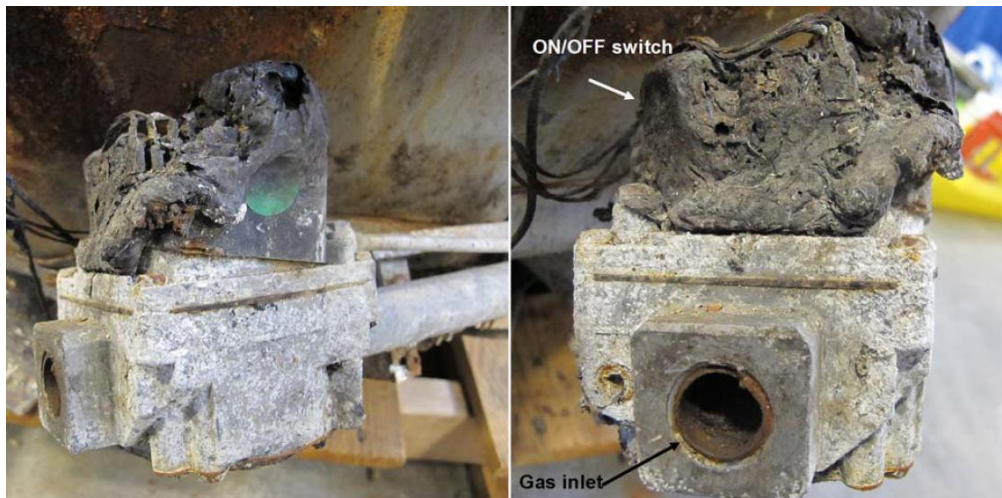
**Figure 18: Water heater fuel control valve**

lever arm capable of transmitting and multiplying any force applied to the house piping system to the observed point of failure at the fuel control valve.

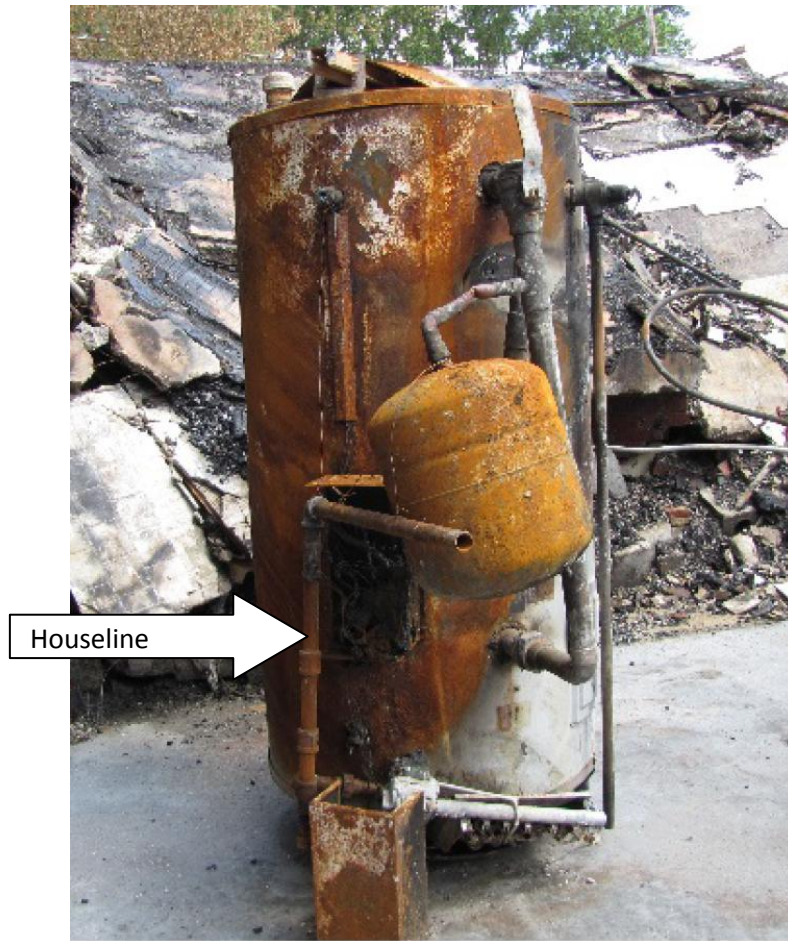
**Figure 20: Water heater from 8701 Arliss Street; placed during ATF reconstruction, with fuel supply piping segment severed at elbow where pipe then ran up to connect to pipe at ceiling.**

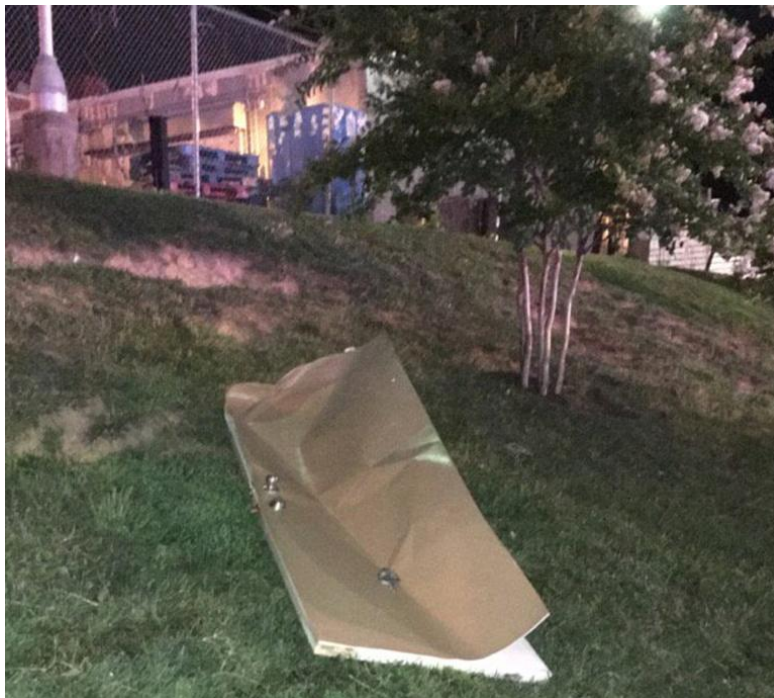
Fact 3: The steel door to 8701 Arliss Street Apartment 101, which was dead-bolt locked at the time of explosion, was blown laterally away from the front of 8701 Arliss Street, approximately 300 feet directly outward and west from building 8701 (See Figure 21). Other debris was forcefully blown laterally westward from the first floor level directly into parked vehicles out in front of 8701 Arliss Street.<sup>20</sup>

**Figure 21: 8701 Arliss St, Apartment 101, externally facing fire door**

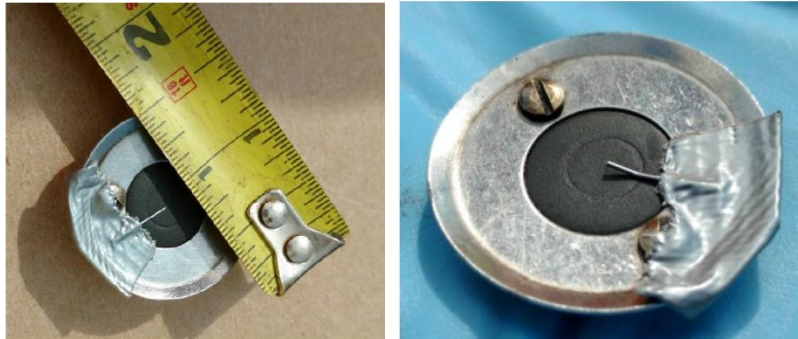
In order for a regulator to properly seal off the downstream system (the houseline) from the upstream system, the regulator's orifice needs to contact the valve seat continuously around its circumference. A disruption of this seal will allow a steady stream of gas to enter the houseline, raising its pressure until it overcomes the resistance provided by the column of mercury. Gas then escapes through the regulator vent. During the test, a pin with a diameter of 0.020" was taped across the valve seat's sealing area. The houseline system was locked-in, and its pressure increased until it reached 11.5" w.c.. At this point, the pressure held steady. No flow passed through the vent line; the orifice sealed against the valve seat, despite the presence of debris. See Figure 2.

**Figure 2. 0.020" Diameter Pin Taped Across Valve Seat (Left). Deformed Pin on Valve Seat, Removed After Regulator Lock-Up (Right).**

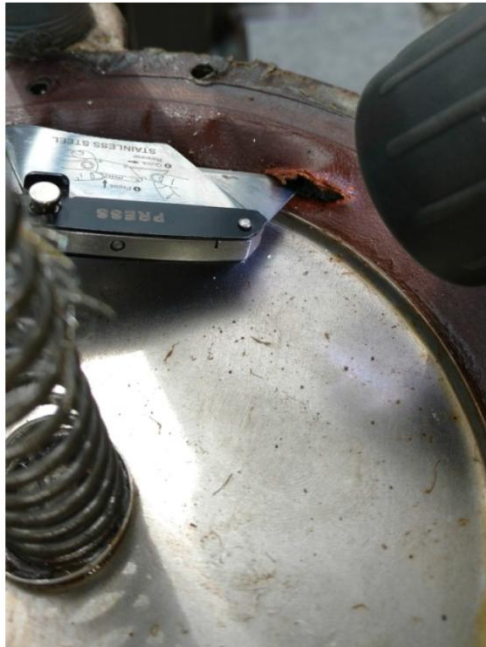
Figure 3. Torn Leather Diaphragm
