From: Richards Michael
Sent: Monday, July 29, 2019 3:03 PM
To: Sorensen Tim
Cc: Richards Michael
Subject: CEN19FA177 wx

Mr. Sorensen, here is factual information regarding weather for your investigation CEN19FA177.

Mike Richards
Aviation Safety Investigator - Senior Meteorologist
Operational Factors Division
National Transportation Safety Board

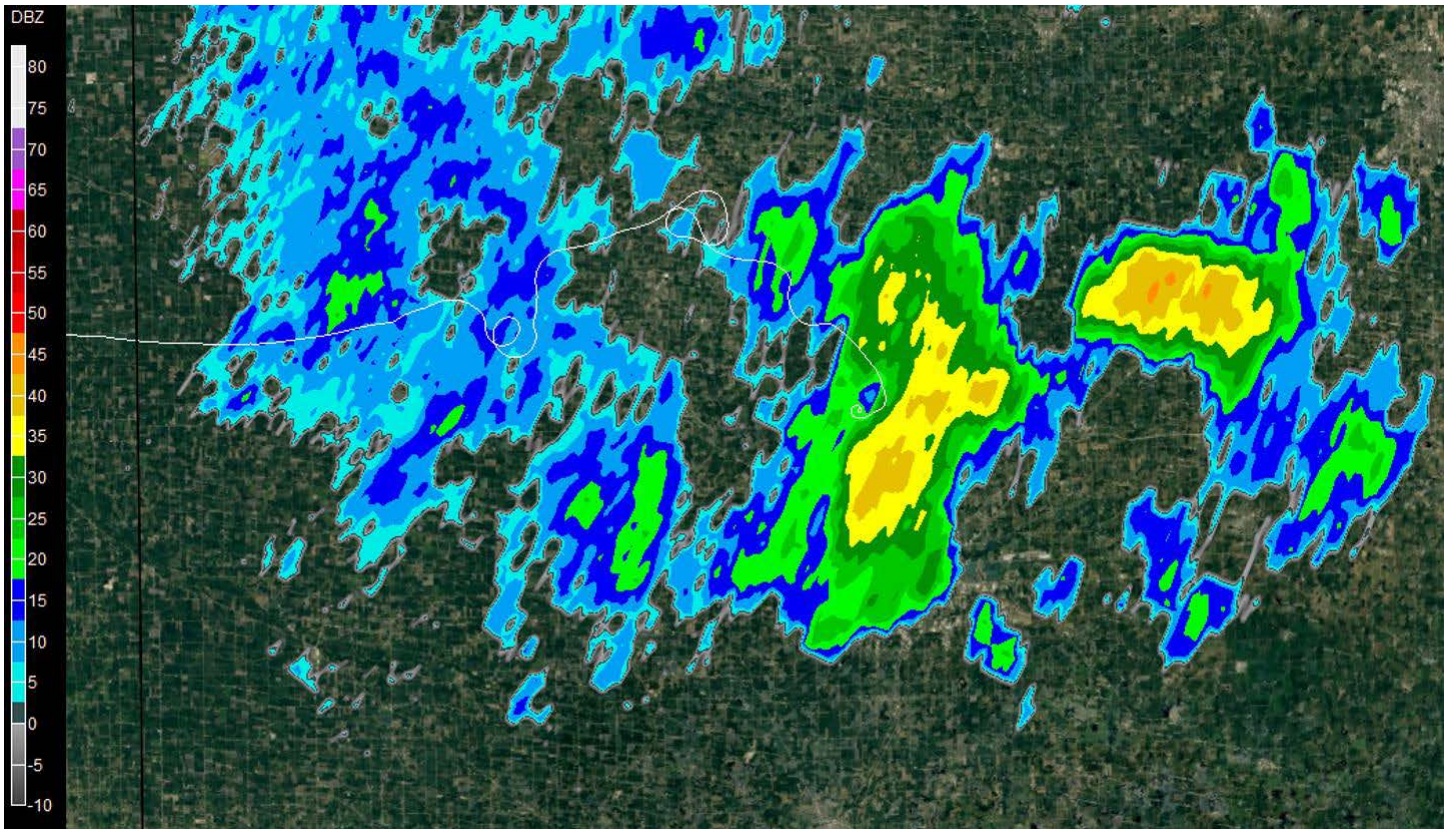
- Weather radar imagery depicted dBZ values associated with light to heavy intensities of precipitation across the accident region. The following figure depicts the base reflectivity imagery from KIWX (Level-II, 0.483° tilt) from about 1610 EDT, along with the accident aircraft's flight track plotted as a white line. The accident occurred following an approach to an area of dBZ values associated with moderate to heavy precipitation.

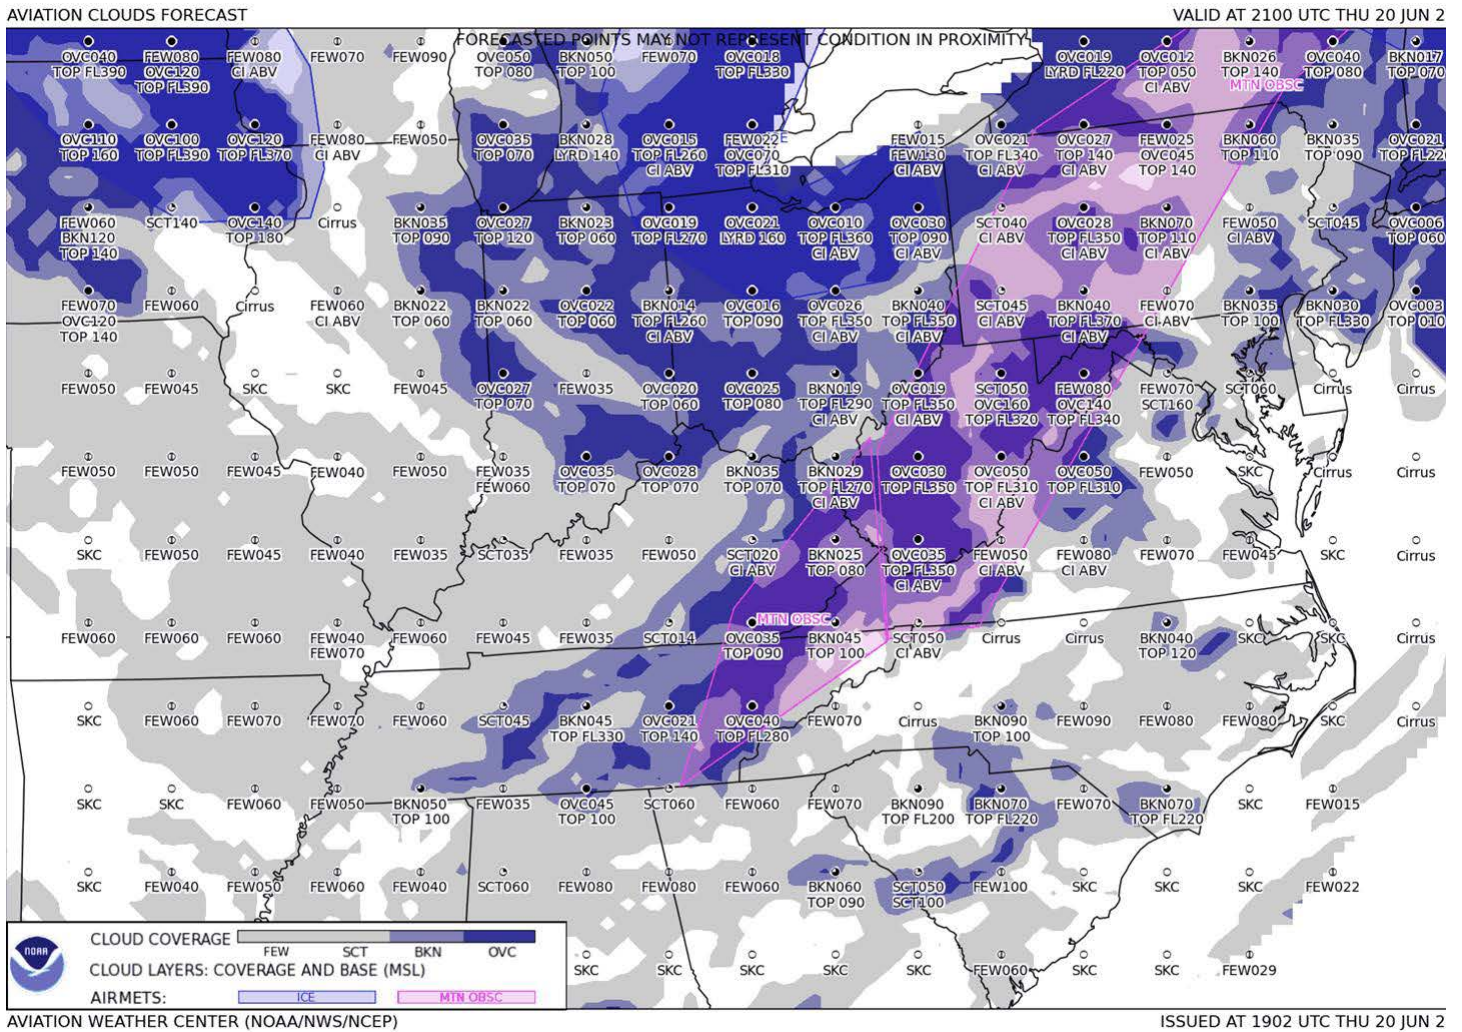
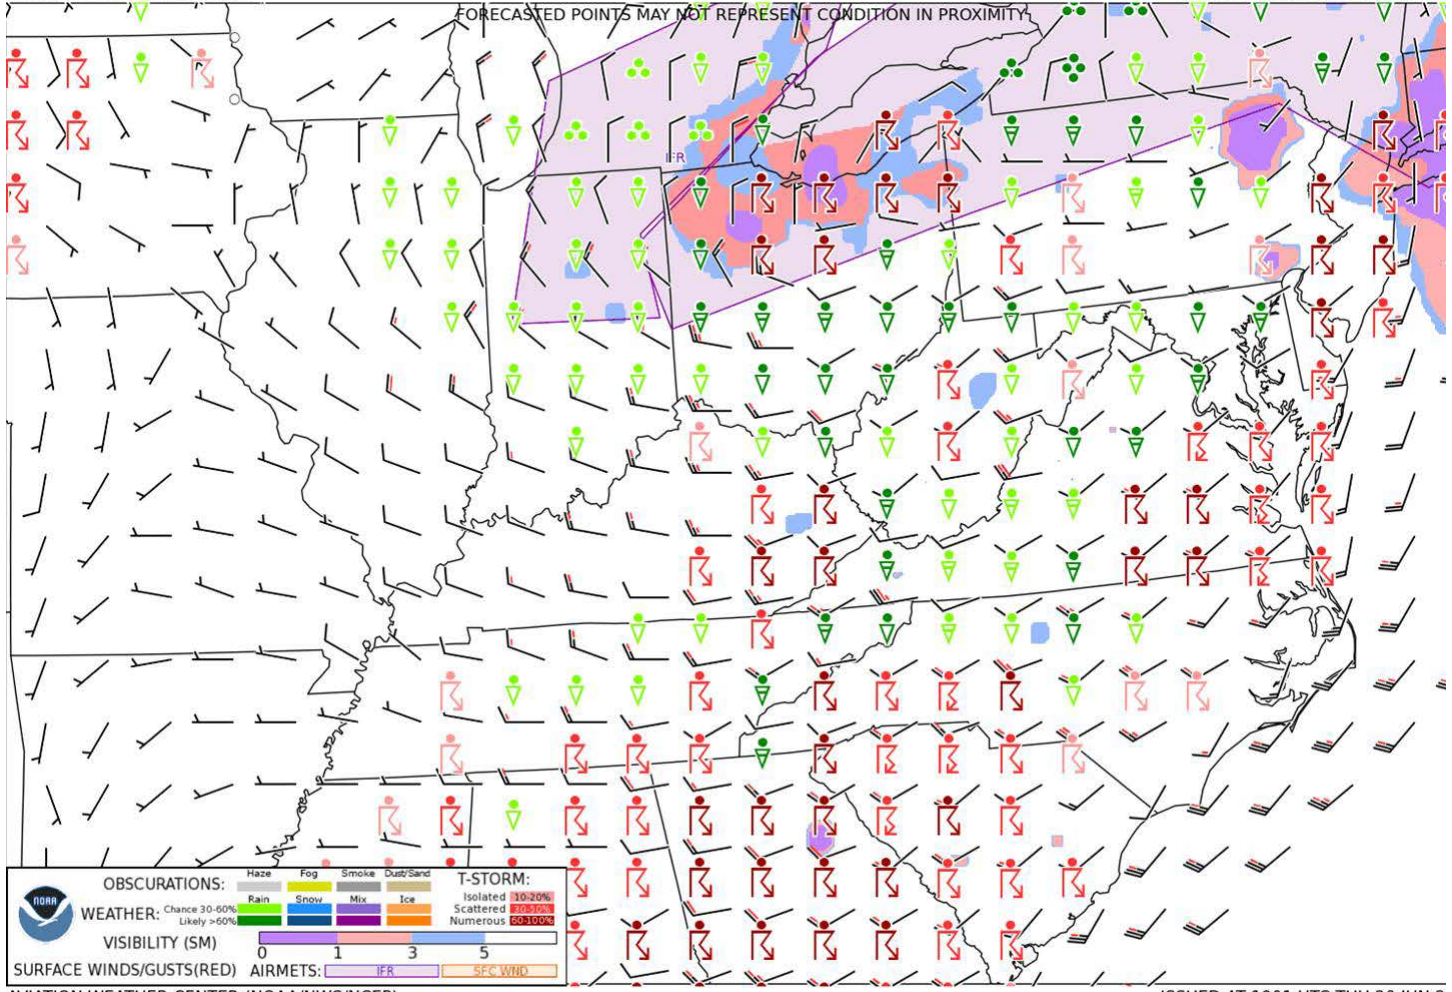
- Graphical Forecast for Aviation (GFA) forecast products issued at about 1500 EDT and valid for 1700 EDT forecasted cloud bases between of 1,900', 1,600' and 1,400' feet and light rain at the closest data points to the accident location, as well as MVFR or IFR conditions and an AIRMET for IFR conditions at the accident location.

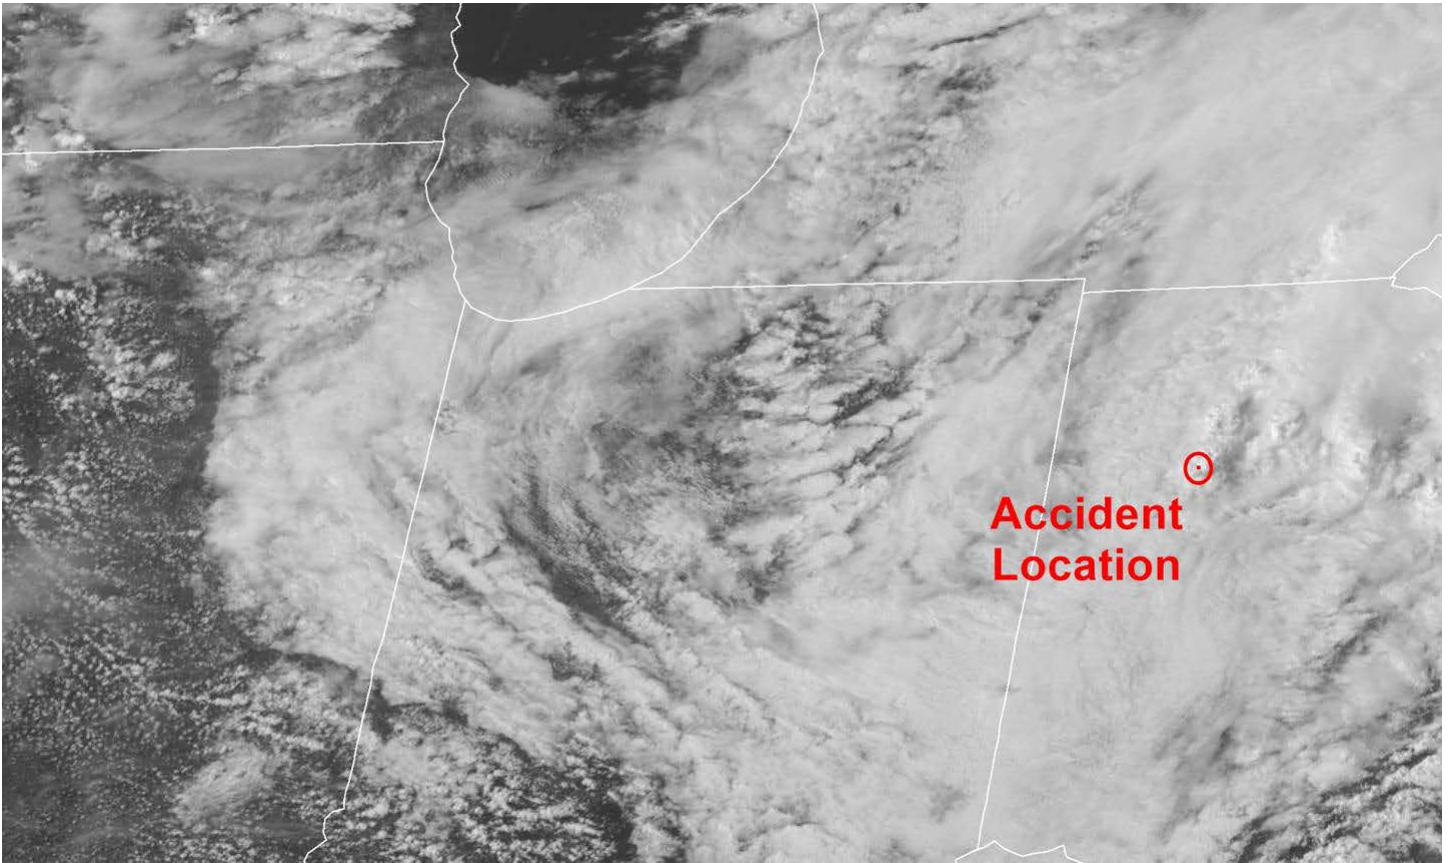
- Satellite weather imagery depicted cloudy conditions across the region that stretched eastward toward the departure location. Around the accident location, overcast conditions prevailed with tops above about 10,000 feet, with the highest tops close the accident location at about 30,000 feet. Layering is unknown.
