NATIONAL TRANSPORTATION SAFETY BOARD

Group Chairman's Factual Report

METEOROLOGY

ERA17FA145

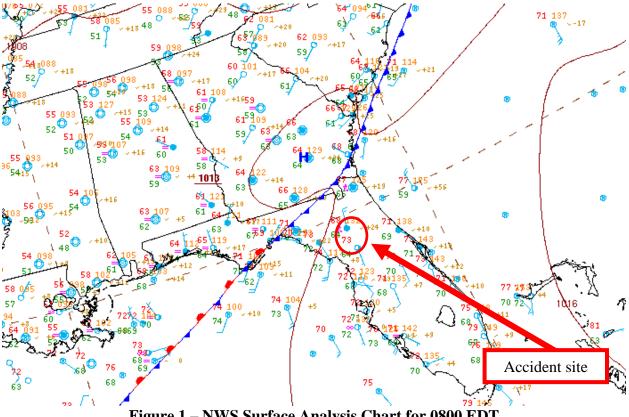
Figure 1 – NWS Surface Analysis Chart for 0800 EDT

The NWS Surface Analysis Chart for 0800 EDT is provided as figure 1 with the approximate location of the accident site marked within the red circle. The chart indicated that there was a cold frontal boundary located in northern Florida, with the boundary stretching northeastward into the western Atlantic Ocean. The front was depicted as a stationary front across the southern Panhandle of Florida stretched southwestward into the central Gulf of Mexico. There was a surface high pressure center located in southern Georgia with a pressure of 1013-hectopascals (hPa) (figure 1).

The station models around the accident site depicted air temperatures in the upper 60's to low 70's degrees Fahrenheit (°F), with dew point temperatures in the mid to upper 60's °F. The station models over central Florida indicated relatively clear skies with winds from the south at 5 to 10 knots over land and winds up to 20 knots along and coast and in the Gulf of Mexico. Over northern Florida near the frontal boundary overcast cloud cover and thunderstorms and rain showers were reported. In the immediate vicinity of the accident site, the Gainesville, Florida station model immediately north of the accident site depicted northerly wind at 15 knots, a thunderstorm and rain showers, overcast clouds with a temperature of 68° F, and a dew point of 64° F.

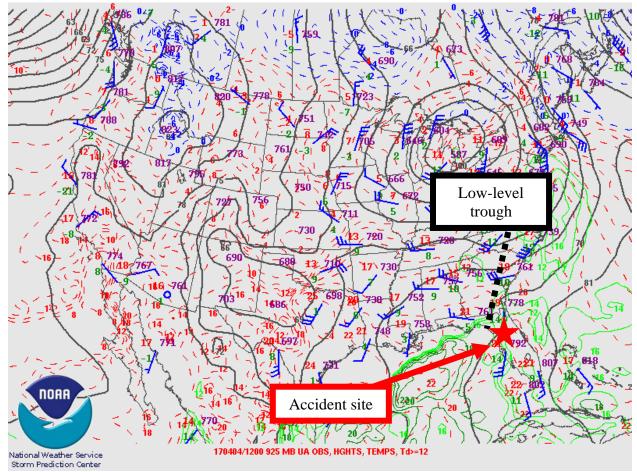
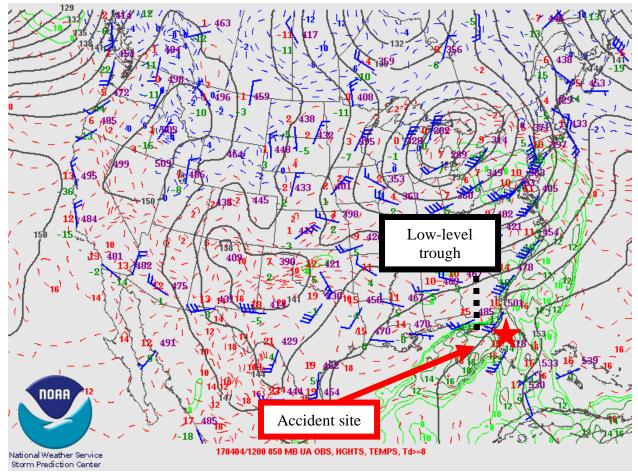
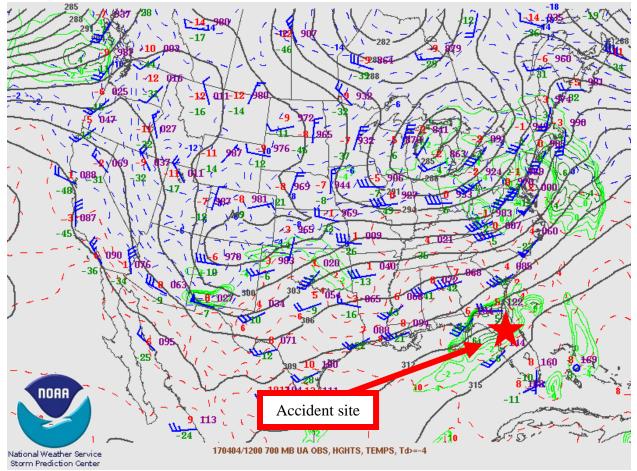
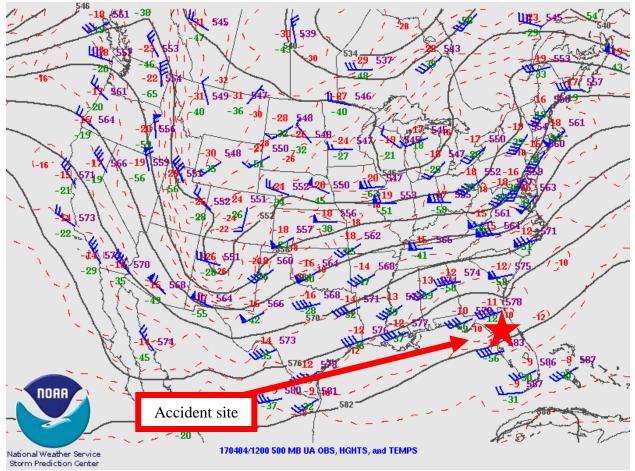
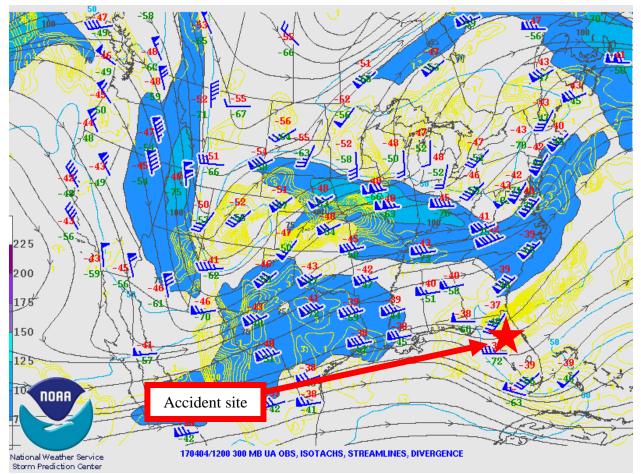
The NWS Storm Prediction Center (SPC) Constant Pressure Charts for 0800 EDT at 925-, 850-, 700-, 500-, and 300-hPa are presented in figures 2 through 6. There was a low-level trough¹ located along the eastern United States coast from northern Florida northward into Georgia, South Carolina, and North Carolina, at 925- and 850-hPa. This low-level trough was associated with the cold front located in the southeastern United States (figure 1). There was a south wind of 20 to 25 knots at 925-hPa (figure 2) above the accident site. The wind became southwesterly by 700-hPa with a wind speed of 25 knots (figure 4). The 25-knot southwesterly wind at 700-hPa became a 40-knot west-southwest wind by 300-hPa (figure 6). Troughs and surface frontal boundaries (section 1.1) can act as lifting mechanisms to help produce clouds and precipitation if sufficient moisture is present.

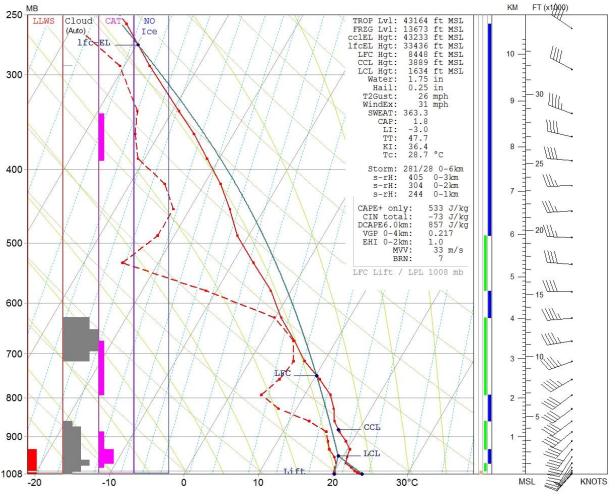
Figure 13 – 0900 EDT HRRR sounding for the accident site

The 0900 EDT HRRR sounding indicated a conditionally unstable environment with 533 J/kg of CAPE¹⁸. The Maximum vertical velocity (MVV) for this atmosphere was calculated as 33 meters/second (about 6,496 ft per minute).¹⁹ Downdraft CAPE (DCAPE; 6 kilometers agl)²⁰ was measured at 857 Joules/kilogram. RAOB identified the possibility of clouds between the surface and 5,000 ft with another cloud layer between 10,000 ft and 14,000 ft. No areas of icing were indicated by RAOB outside of rain showers or thunderstorms. The 0900 EDT HRRR sounding indicated the strongest wind speeds possible with a microburst, outflow boundary, or gust front would have been 26 mph (23 knots) as indicated by the T2Gust parameter or 31 mph (27 knots) as indicated by the WindEx parameter.

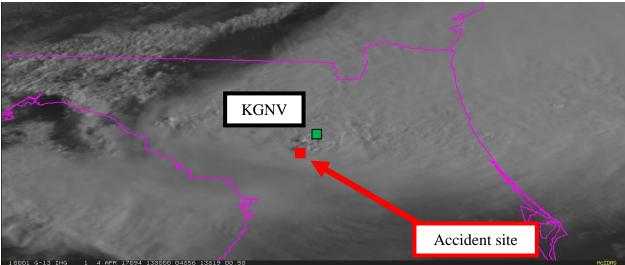
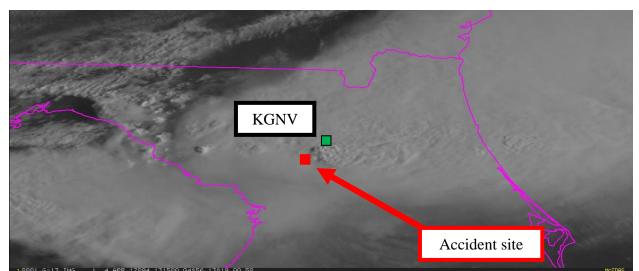
Figures 14 and 15 present the GOES-13 visible imagery from 0900 and 0915 EDT at 2X magnification with the accident site marked with a red box. The visible imagery indicated cloud cover above the accident site at the accident time with the cloud cover cumuliform in nature moving from west to east (attachment 1). Figure 16 presents the GOES-13 infrared imagery from 0915 EDT at 6X magnification with the accident site highlighted with a red square. Inspection of the infrared imagery indicated cloud cover over the accident site with that cloud cover moving from west to east (attachment 2). The lower brightness temperatures (blue and green colors, higher cloud tops) were located above the accident site and in a band oriented from west to east across northern Florida. Based on the brightness temperatures above the accident site and the vertical temperature profile provided by the 0900 EDT HRRR sounding, the approximate cloud-top heights over the accident site were 41,000 ft at 0915 EDT. It should be noted these figures have not been corrected for any parallax error.

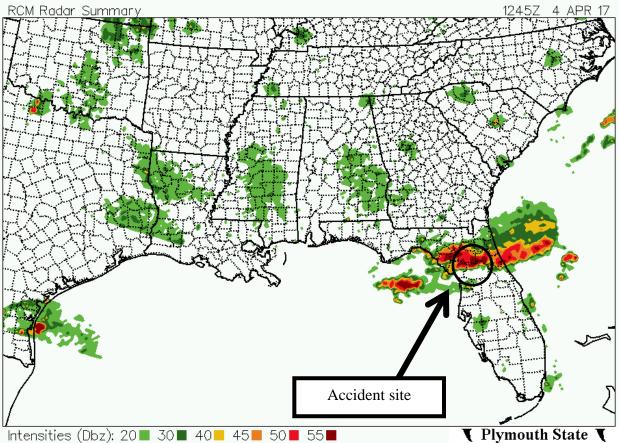
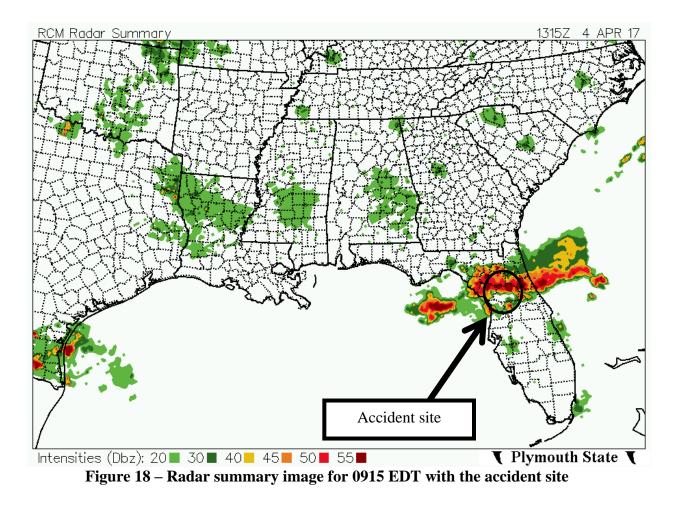
Figure 17 – Radar summary image for 0845 EDT with the accident site

Figures 17 and 18 provide a radar summary image from 0845 and 0915 EDT with reflectivity values over the southeastern United States. The accident site was located in an area of 40 to 55 dBZ values at 0845 and 0915 EDT. These reflectivity values indicated heavy to extreme echoes at the accident site around the accident time with severe turbulence, lightning, large hail, extensive surface wind gusts, and turbulence all possible (section 6.3). The area of 40 to 55 dBZ values stretched across the entire width of northern Florida at 0845 and 0915 EDT.

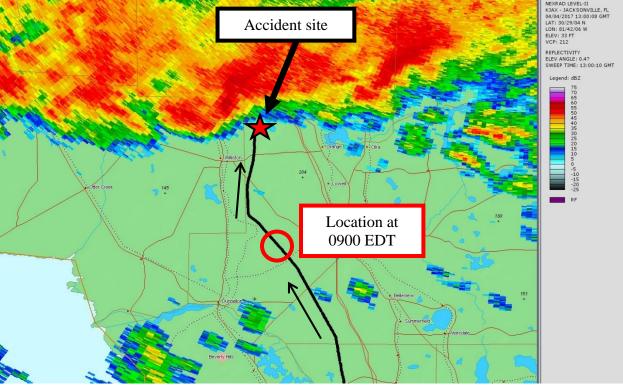
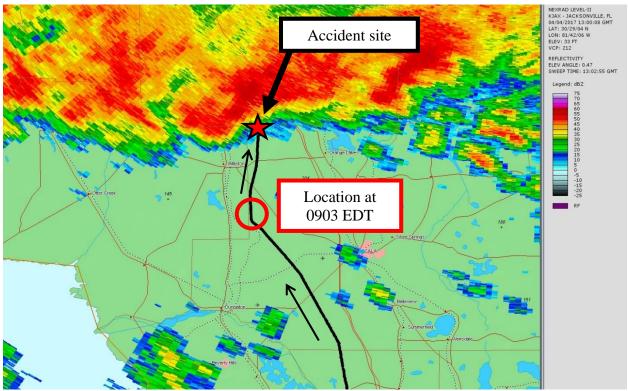
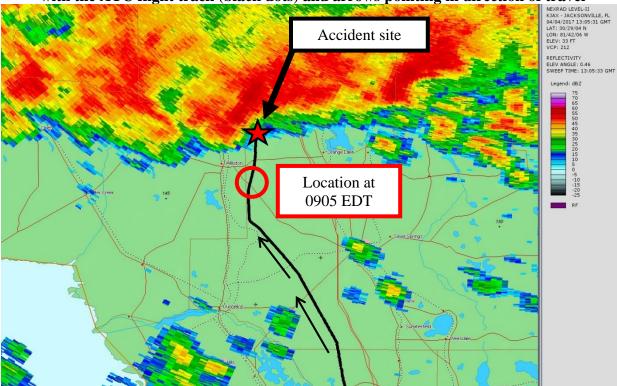
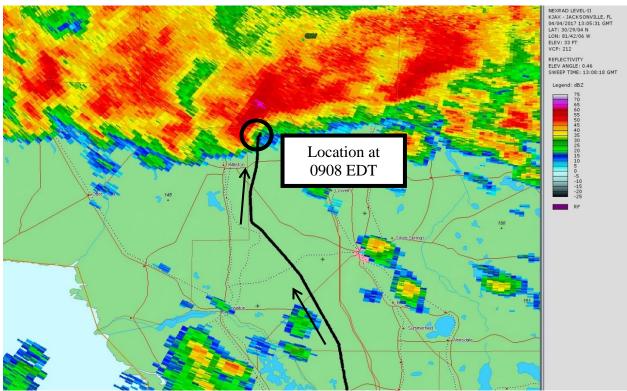
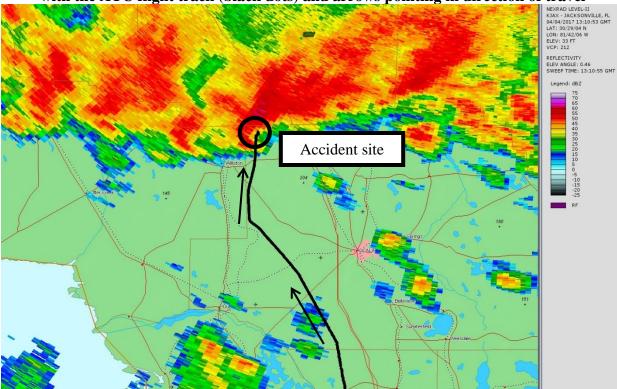
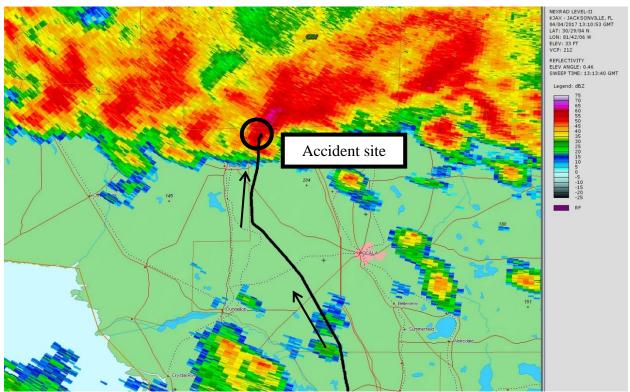
Figures 19 through 24 present the KJAX WSR-88D base reflectivity images for the 0.5° elevation scans initiated at 0900, 0903, 0905, 0908, 0911 and 0914 EDT with a resolution of 0.5° X 250 meters. The ATC flight track is also included with the arrows pointing in the direction of travel. The accident flight track depicted the flight entering the southern edge of the area of convection and into echoes of 10 to 30 dBZ between 0905 and 0908 EDT (figures 21 and 22). With echoes of 40 to 60 dBZ over the accident site at 0908 and 0914 EDT (figures 22, 23, and 24). The reflectivity values above the accident site at the accident time would correspond to very heavy rain with hail possible (section 6.3). The base reflectivity images depicted a large convective cell which had a sharp rainfall gradient. There were lightning flashes²⁹ and strikes surrounding the accident site around the accident time with over 4,800 lightning flashes associated with the thunderstorms between 0855 and 0915 EDT (figure 25).³⁰ The accident flight was located within 510 ft of one of the lightning flashes at 0907:30 EDT (attachment 3).³¹ The KJAX WSR-88D base velocity data indicated that a combination of outbound wind (away from KJAX, red colors) and inbound wind (towards KJAX, green colors) was located above the accident site at 0908 and 0911 EDT (figures 26 and 27).

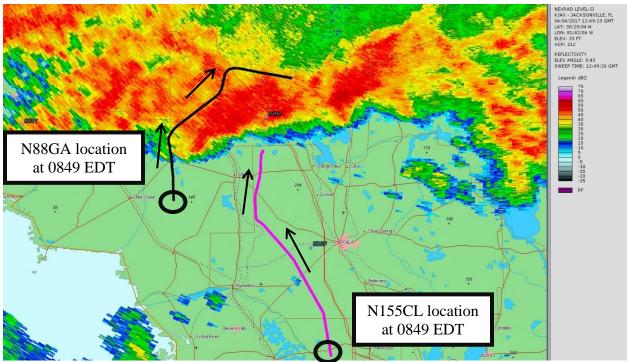
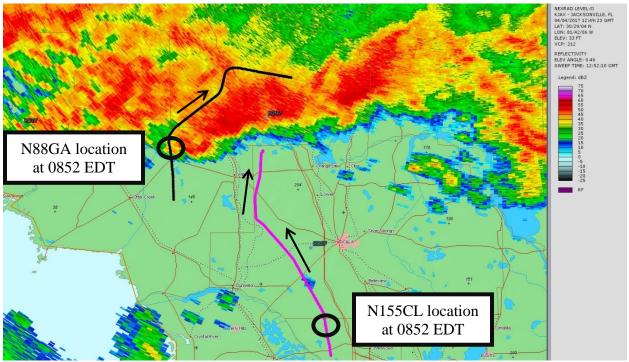
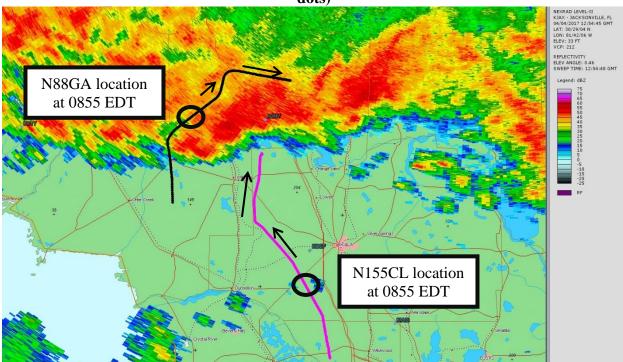
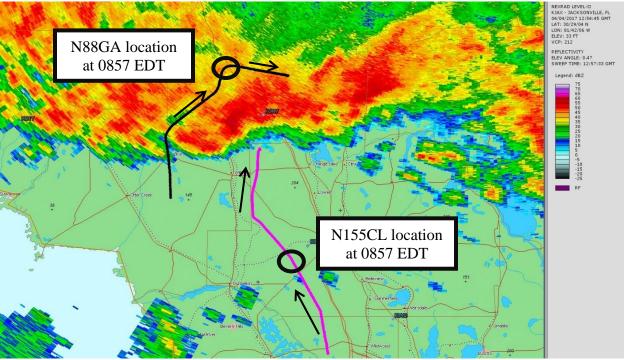
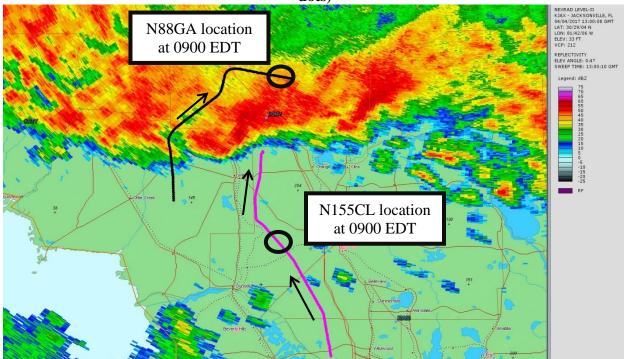
Figures 28 through 32 present the KJAX WSR-88D base reflectivity images for the 0.5° elevation scans initiated at 0849, 0852, 0855, 0857, and 0900 EDT with a resolution of 0.5° X 250 m. The ATC flight track is also included with the arrows pointing in the direction of travel. The ATC data and audio indicated that N88GA, on approach into KGNV about 20 minutes before the accident time, deviated west of the 40 to 60 dBZ cell that N155CL encountered. On approach into KGNV, N88GA reported "a pretty good downdraft" around 0851 EDT. By 0853 EDT, N88GA reported that "got pretty rough there for a minute, but now picking up some heavy rain." None of the information provided by N88GA to ATC was reported into the National Airspace System (NAS) in the form of a pilot report (PIREP). Another PIREP for KGNV included, microburst and lightning strike information, was provided to ATC by 0904 EDT, but this PIREP was not distributed into the NAS. The ATC recordings revealed that ATC did provide PIREP and weather information to N88GA and N155CL before the accident time, but checking the PIREPs available in the NAS, no PIREPs were issued into the NAS from the weather information provided by N88GA or N155CL in accordance with the FAA JO Order 7110.65, Air Traffic Control.³³ A review of the radar images indicated that N88GA flew through dBZ values as high as 50 on approach into KGNV (figures 28 through 32).

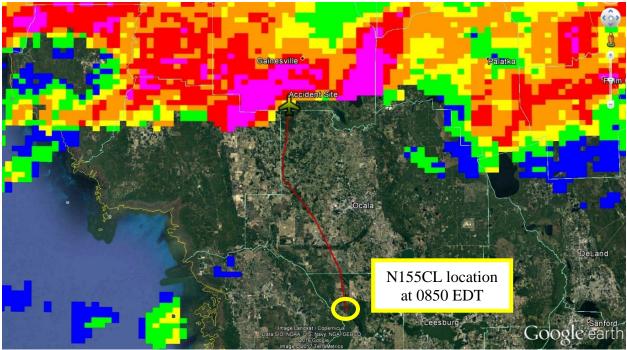
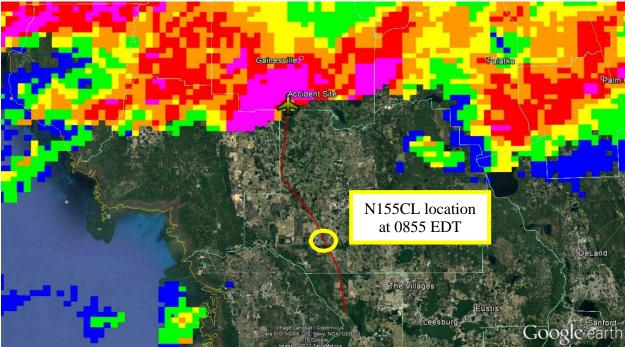
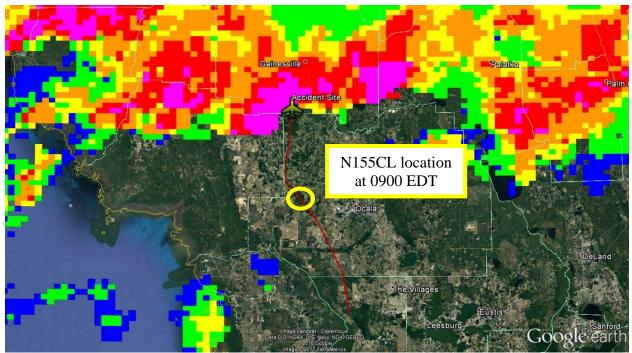
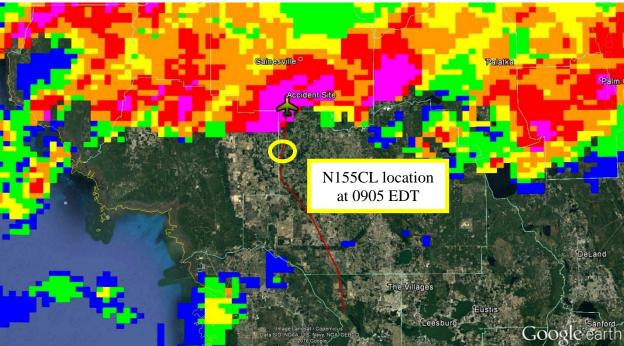
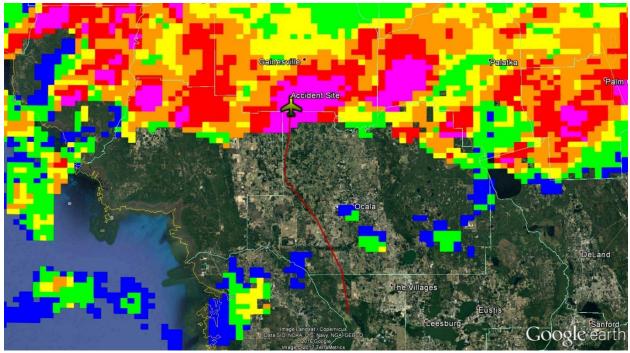
Figures 37 through 41 are the regional NEXRAD weather radar data available to the pilot in the cockpit from Flight Information Services–Broadcast (FIS-B), if the accident pilot had the regional NEXRAD weather radar screen selected (at this horizontal scale) on his electronic equipment.³⁶ The FIS-B regional NEXRAD weather radar data is updated once every 5 minutes and is based upon composite NEXRAD reflectivity data. The FIS-B data indicated that the accident aircraft would have passed through an area of purple on the regional NEXRAD plot (figures 40 and 41) between 0905 EDT and the accident time. For additional information regarding the regional NEXRAD weather radar data please see attachments 10 and 11. For the exact dBZ scales used in the FIS-B regional NEXRAD please see attachment 12.

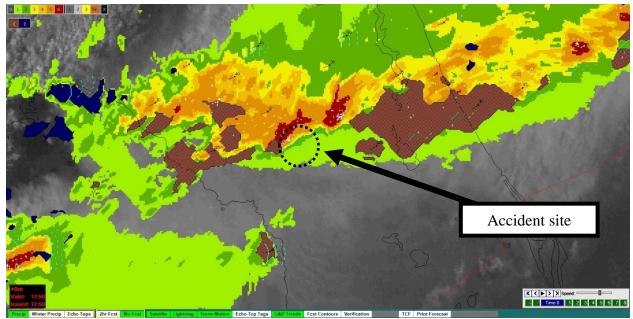
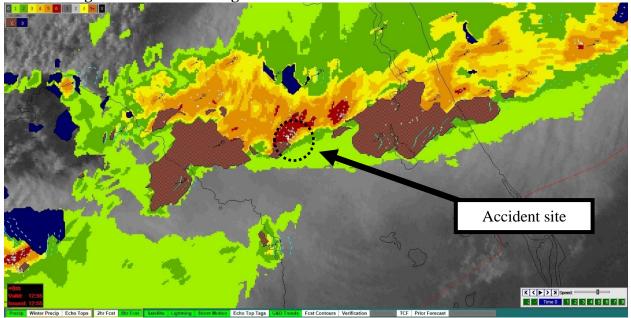
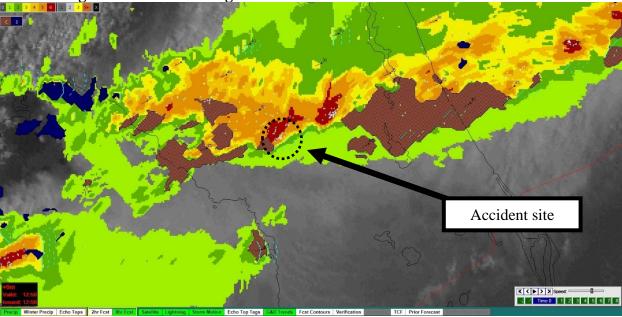
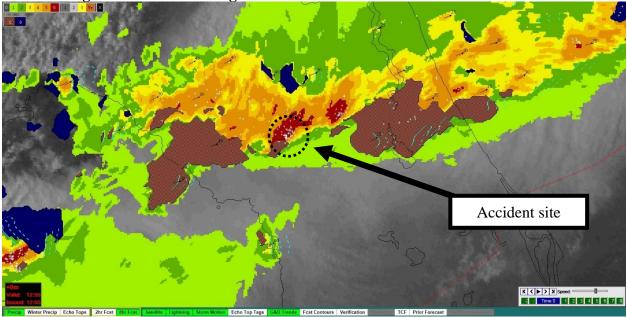
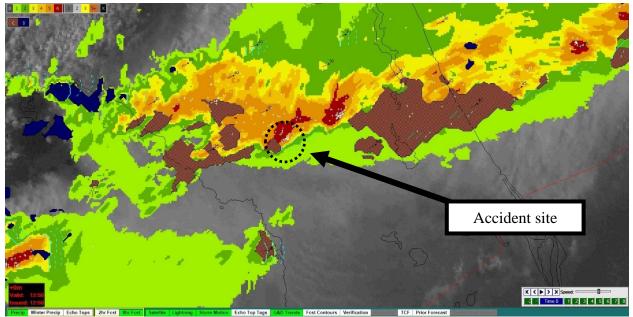
The Consolidated Storm Prediction for Aviation (CoSPA) images were retrieved for 0850, 0855, 0900, 0905, and 0910 EDT and provided in figures 48 through 52 with the accident site marked. The CoSPA, along with depicting NWS weather radar VIP levels, lightning data, weather satellite, and storm motion, forecast areas of likely rain shower or thunderstorm growth (orange hatched areas) and areas of likely rain shower or thunderstorm dissipation (blue hatched areas). The thunderstorm activity across northcentral Florida moved from west to east between 0850 and 0910 EDT. VIP levels increased in intensity and coverage above the accident site between 0850 and 0910 EDT. CoSPA indicated a likely area of updraft growth above the accident site as early as 0855 EDT (figure 49).
