NATIONAL TRANSPORTATION SAFETY BOARD

Group Chairman's Weather Study Report

CEN15FA400

Location: 10 miles west-southwest of Silverton, Colorado
Date: September 5, 2015
Time: approximately 1408 mountain daylight time (2008 UTC¹)
Aircraft: Cessna 310H, registration: N1099Q

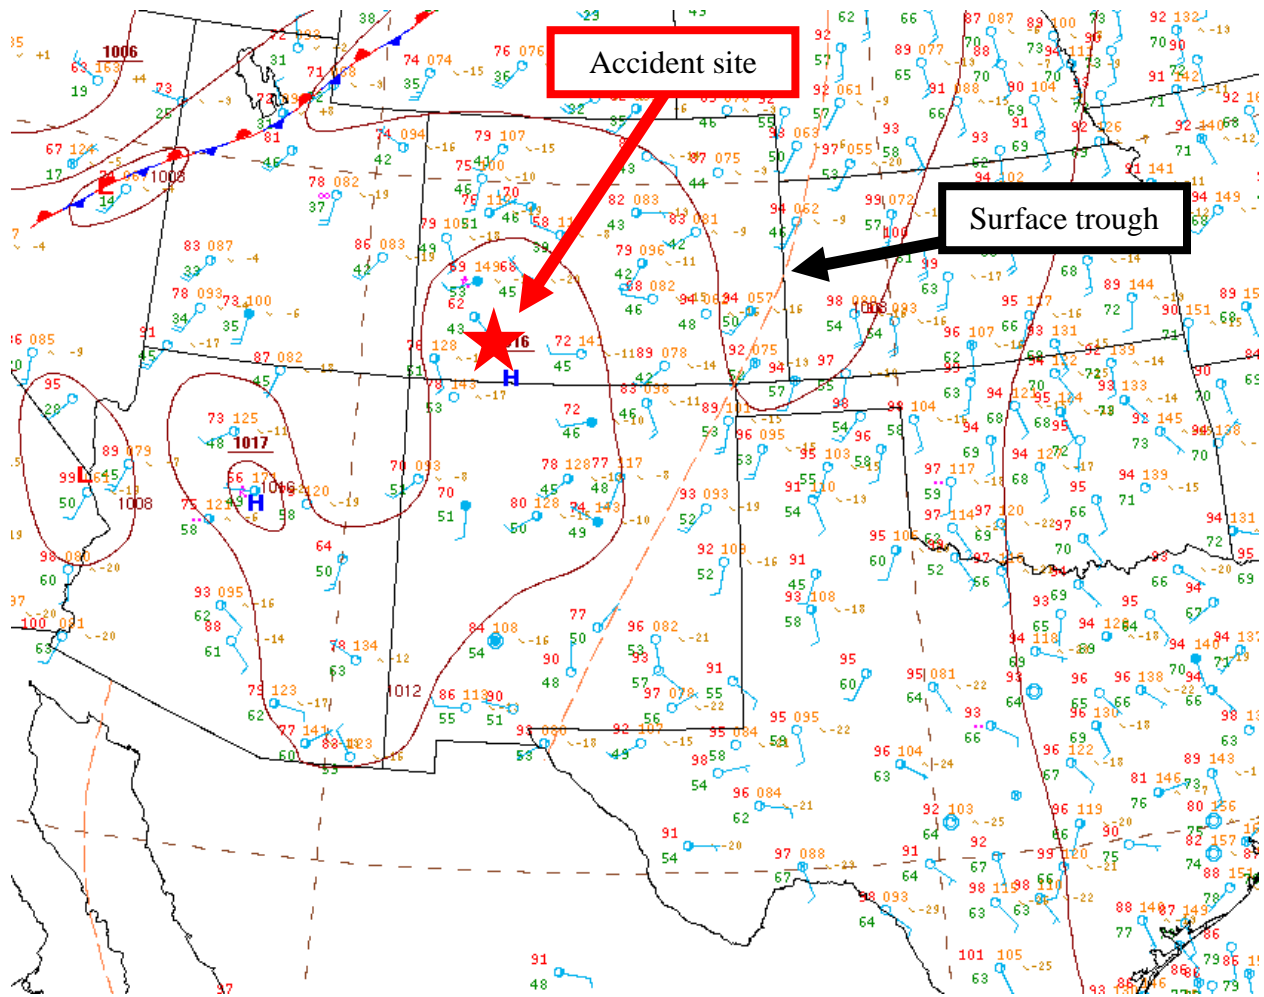
Figure 1 – NWS Surface Analysis Chart for 1500 MDT

The NWS Surface Analysis Chart for 1500 MDT is provided as figure 1 with the approximate location of the accident site marked. The chart depicted a surface trough² stretched from southern New Mexico northeastward into central Nebraska. A stationary front was located over central Nevada stretched northeastward into central Wyoming. A surface high pressure center with a pressure of 1016-hectopascals (hPa) was located just southeast of the accident site with another surface high pressure center located in central Arizona with a pressure of 1017-hPa. A surface low pressure center with a pressure of 1006-hPa was located in eastern Nevada. The station models around the accident site depicted air temperatures in the mid 60’s to mid 70’s Fahrenheit (F), with temperature-dew point spreads of 16° F or more, a variable wind between 5 and 10 knots, partly cloudy skies, and thunderstorms reported north of the accident site at 1500 MDT. With the large temperature-dew point spreads located around the accident area, gusty winds would be expected with any thunderstorm or rain shower in the mountainous terrain.

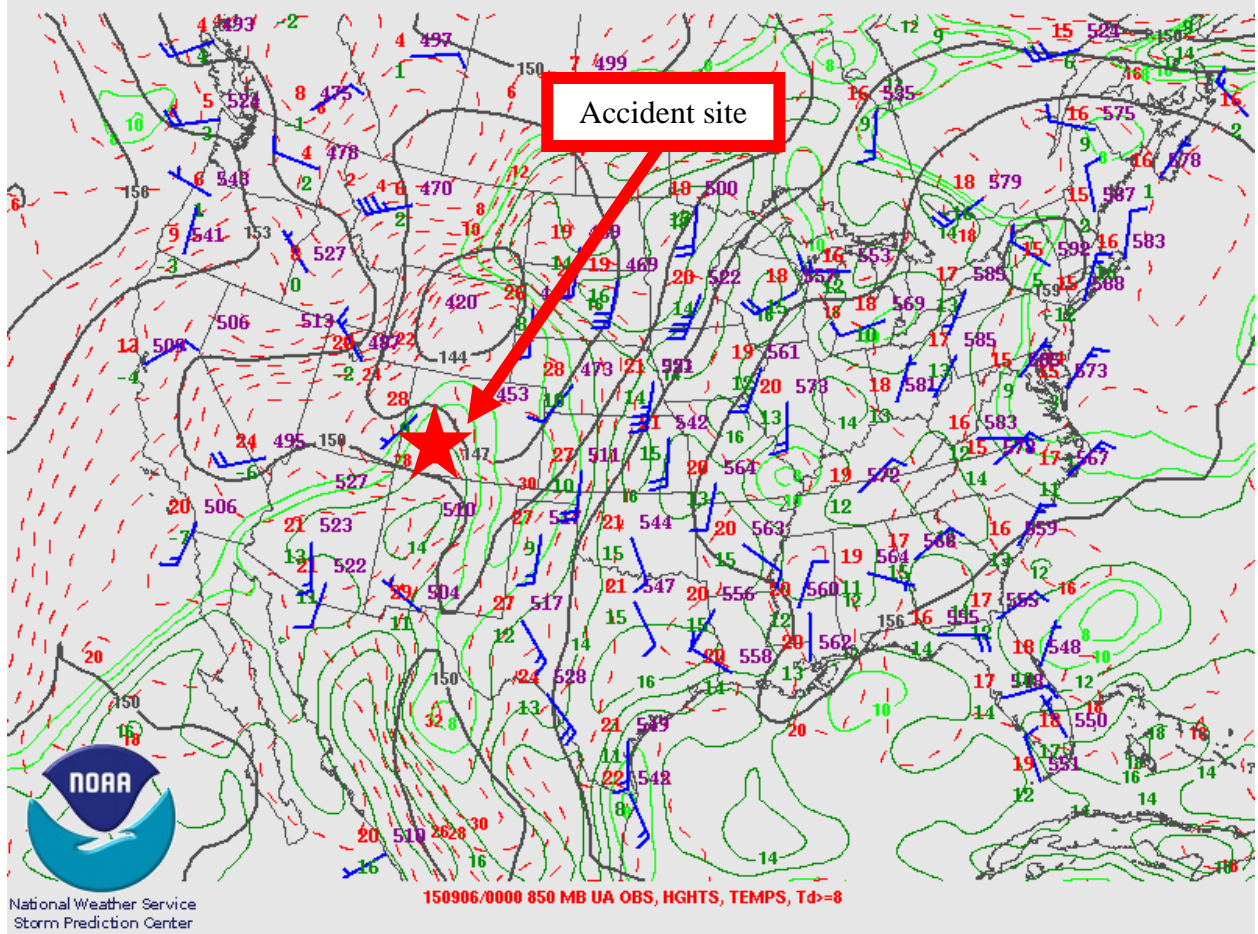
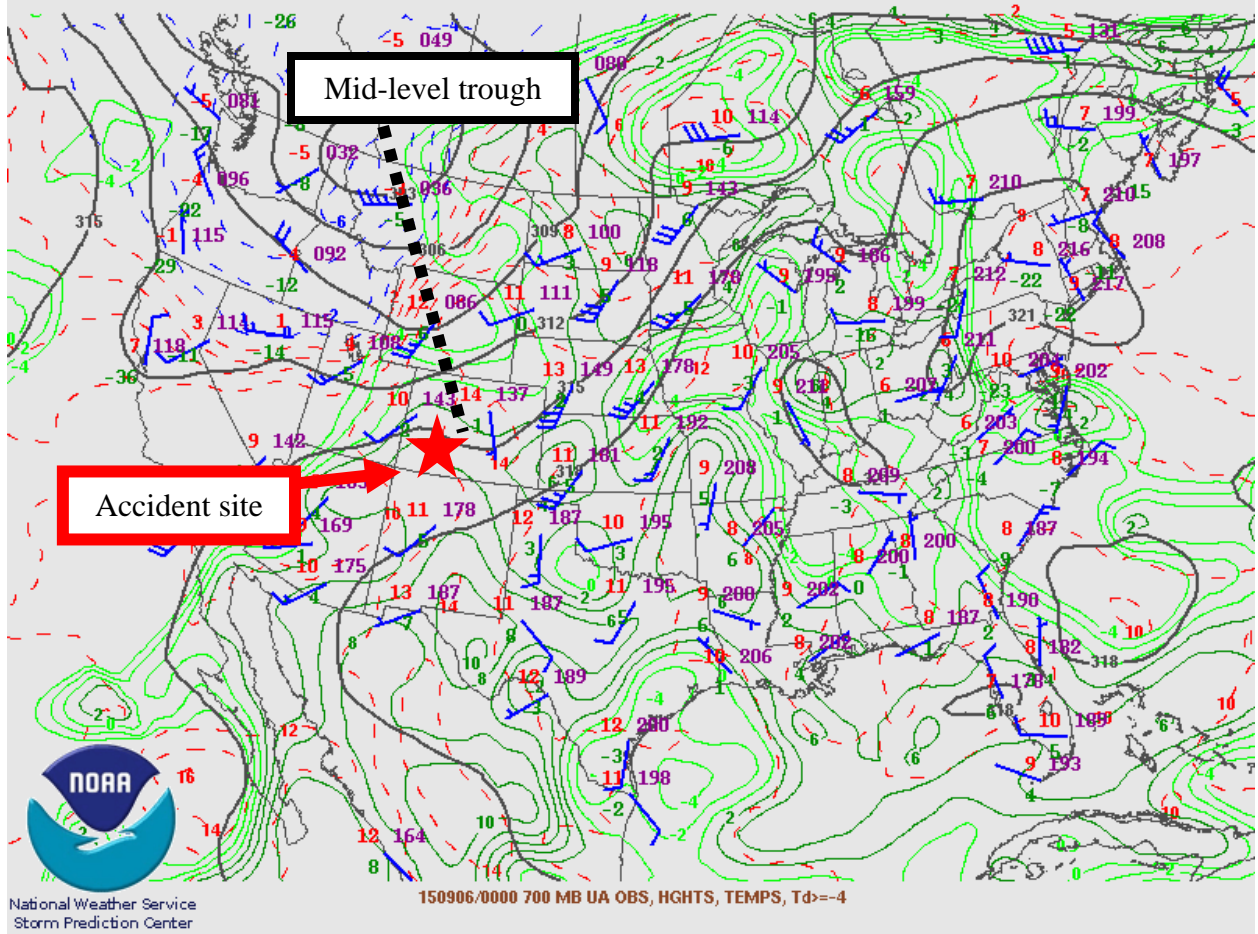
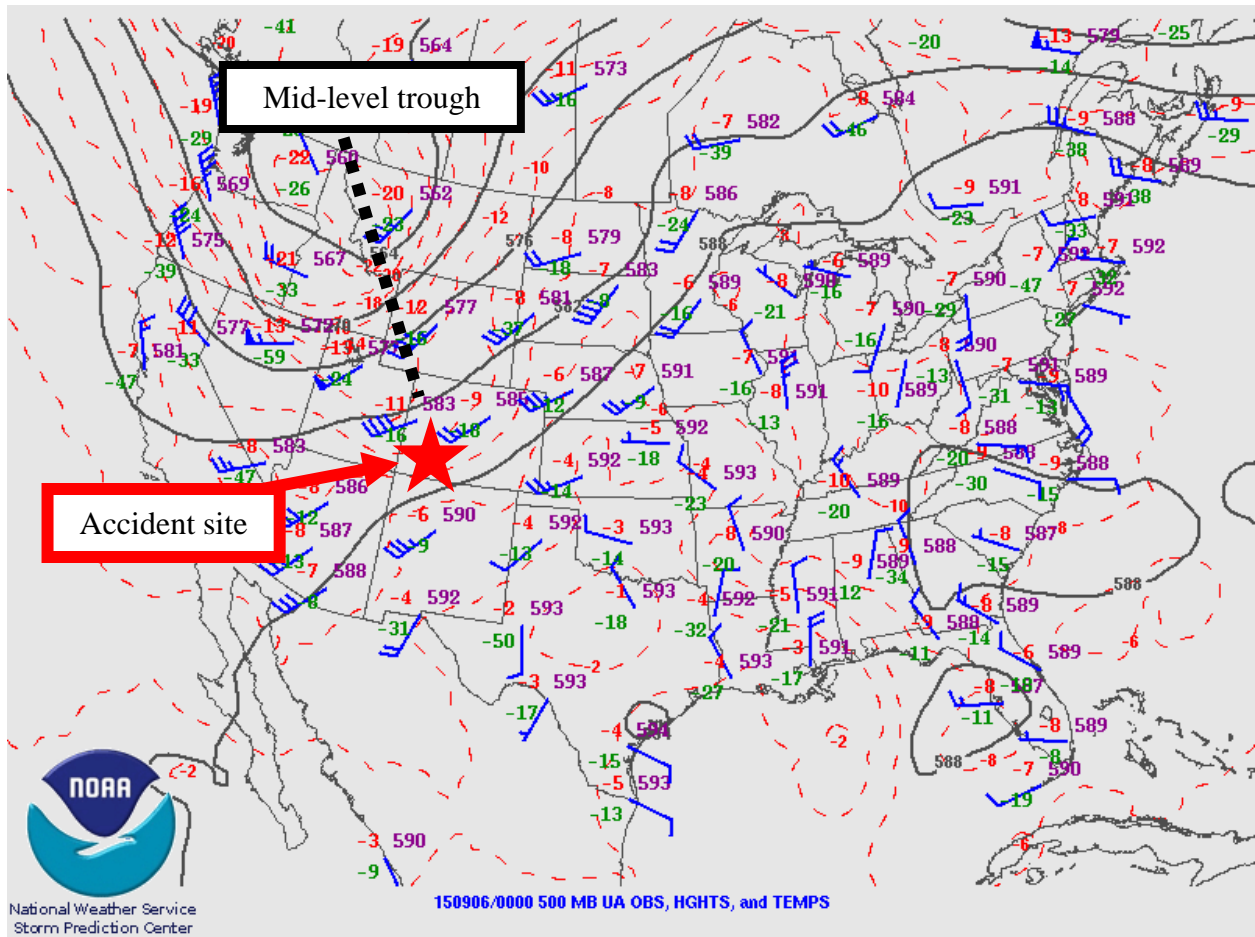
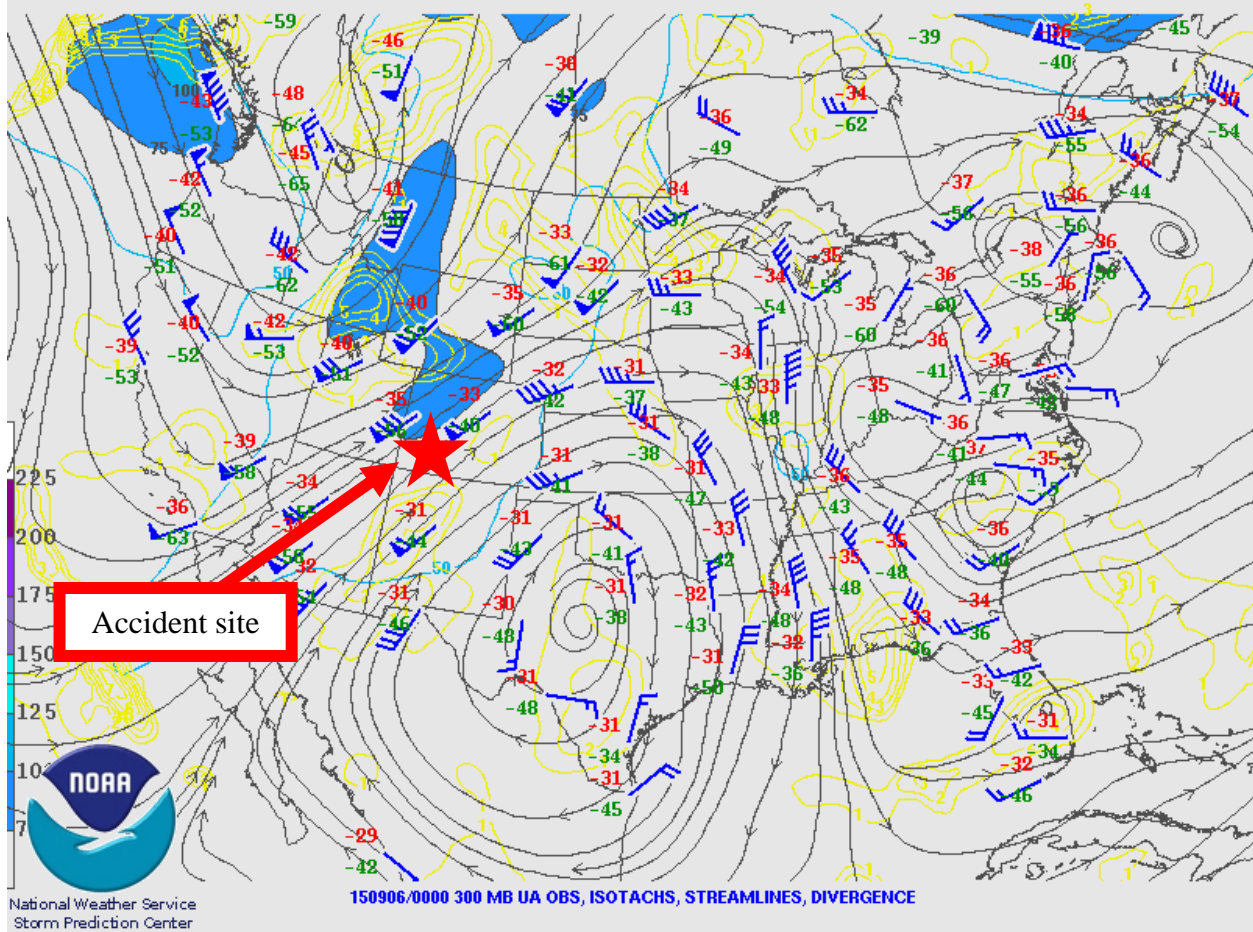
The NWS Storm Prediction Center (SPC) Constant Pressure Charts for 1800 MDT at 850-, 700-, 500-, and 300-hPa are presented in figures 2 through 5. The upper air charts indicated an environment favorable for clouds and precipitation with mid-level troughs near the accident site at 700- and 500-hPa (figures 3 and 4). Areas near troughs and low pressure centers are considered favorable locations for upward motion and therefore clouds and precipitation, especially in mountainous terrain. The wind remained light from the south at 850- and 700-hPa, with the wind increasing in speed to near 30 knots by 500-hPa while turning to the southwest (figure 4). The wind remained out of the southwest through 300-hPa with the wind speed near the accident site at 300-hPa between 60 and 90 knots (figure 5). The strong southwest wind at 500- and 300-hPa would help any rain shower or thunderstorm that formed over the mountainous terrain to move from southwest to northeast.

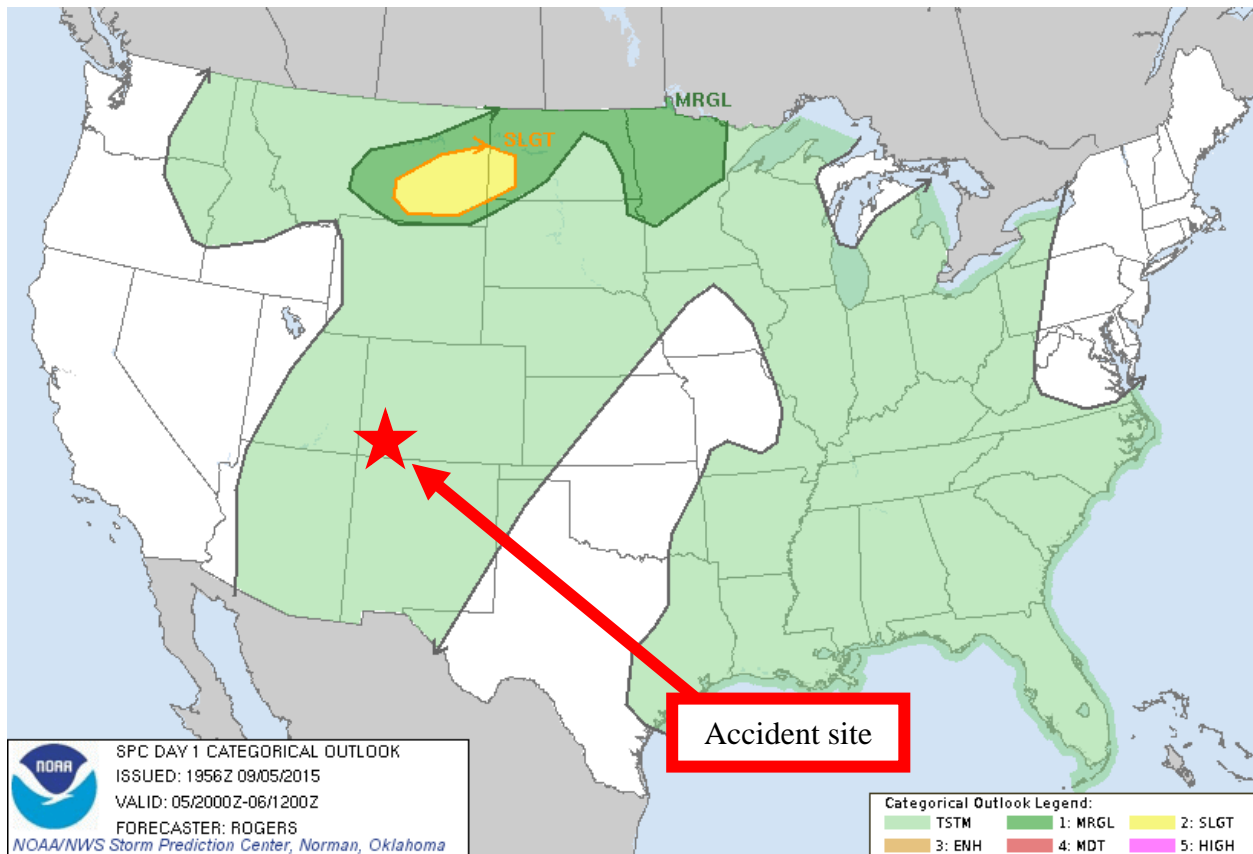
Figure 6 – Storm Prediction Center day 1 Convective Outlook valid at the time of the accident

SPC issued the following Day 1 Convective Outlook at 1356 MDT (figure 6) with areas of thunderstorms forecast for the accident site. Severe thunderstorms were not forecast. The previous Day 1 Convective Outlook was issued at 1026 MDT with no differences in forecast for the accident site at the accident time:

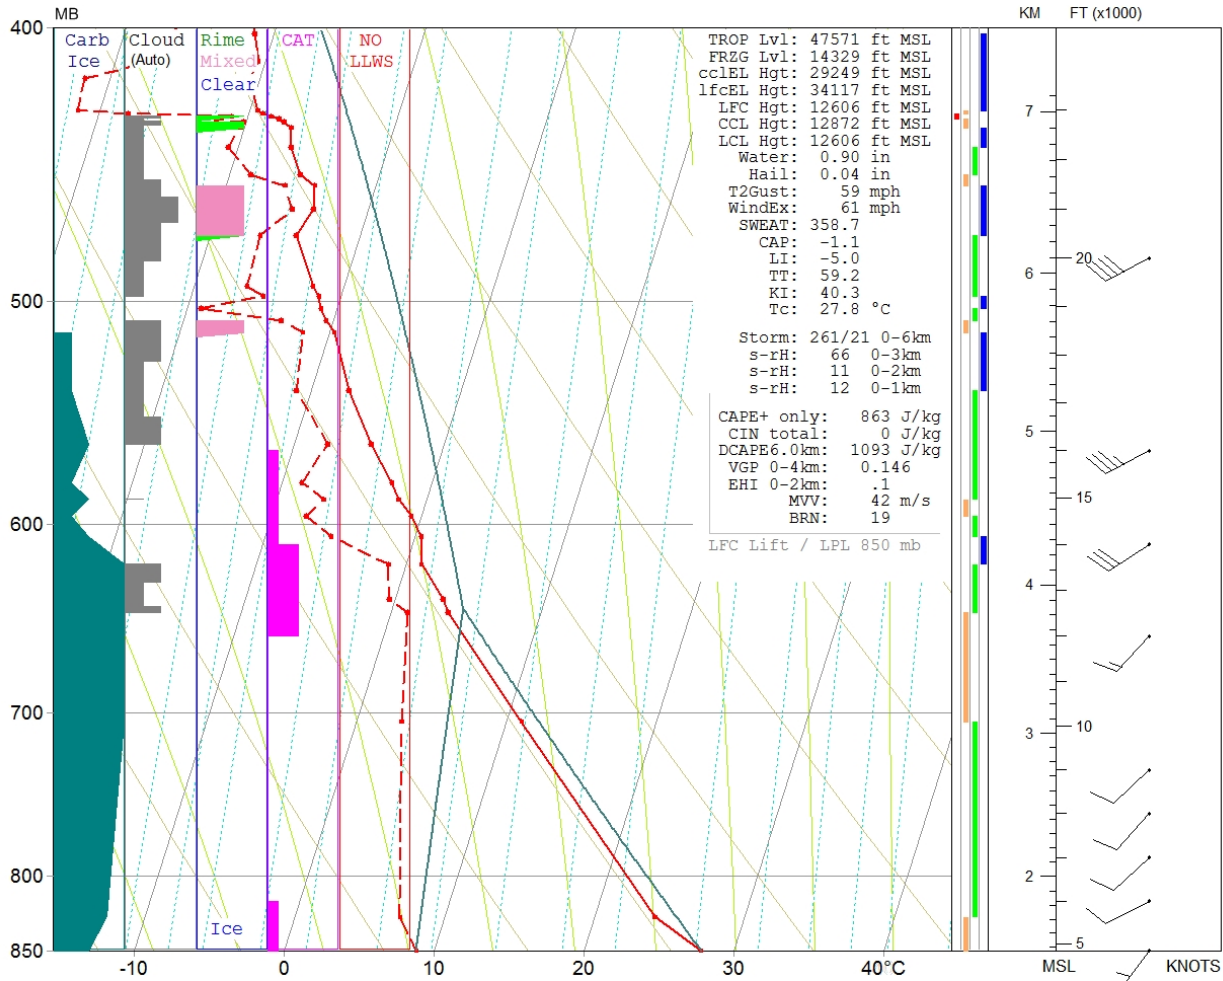
Figure 13 – 1800 MDT KGJT sounding

The 1800 MDT KGJT sounding indicated a conditionally unstable environment with 863 J/kg of CAPE¹⁵ lifting a parcel from the ground. This environment would have been supportive of cloud formation, rain showers, and thunderstorms, especially with the lifting mechanisms in the area of the accident site at the accident time (section 1.1 and 1.2). The maximum vertical velocity (MVV) possible within rain showers or thunderstorm updrafts was 42 meters per second (m/s) or 82 knots given the 1800 MDT KGJT sounding environment. RAOB identified the possibility of clouds in several layers between the 13,000 feet msl and 23,000 feet msl. No areas of icing were likely below 17,000 feet. With rain showers and thunderstorms possible given the environment, the KGJT sounding indicated the strongest wind speeds possible with a microburst, outflow boundary, or downburst (section 18.0) would have likely been 59 mph as indicated by the T2Gust parameter or 61 mph as indicated by the WindEx parameter. The surface wind observations (section 3.0) indicated similar wind gust speeds conditions as the indicated by the KGJT sounding.

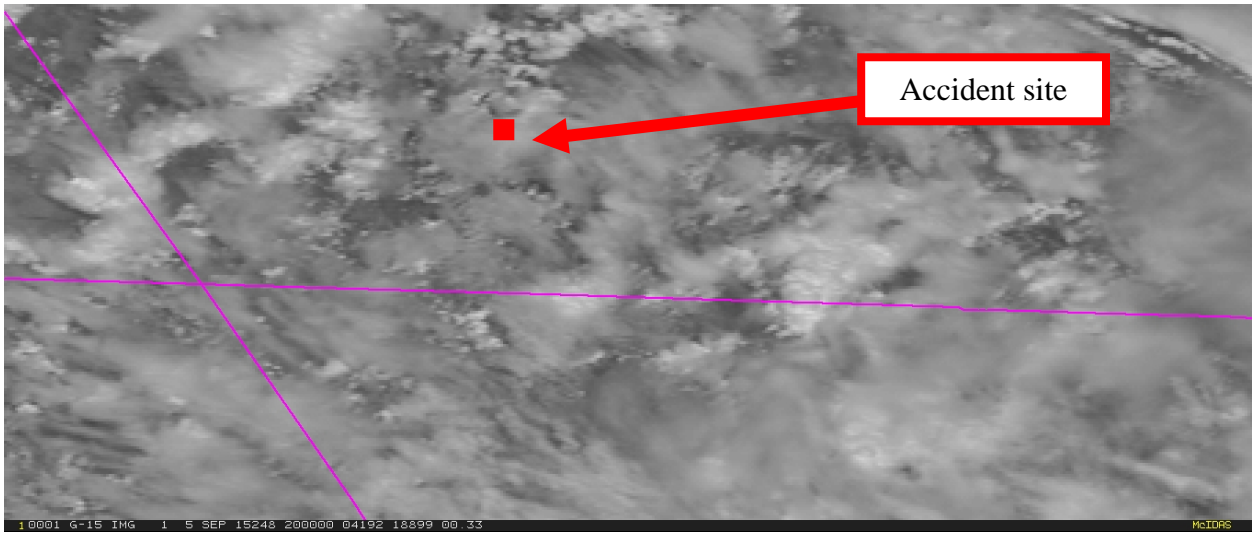
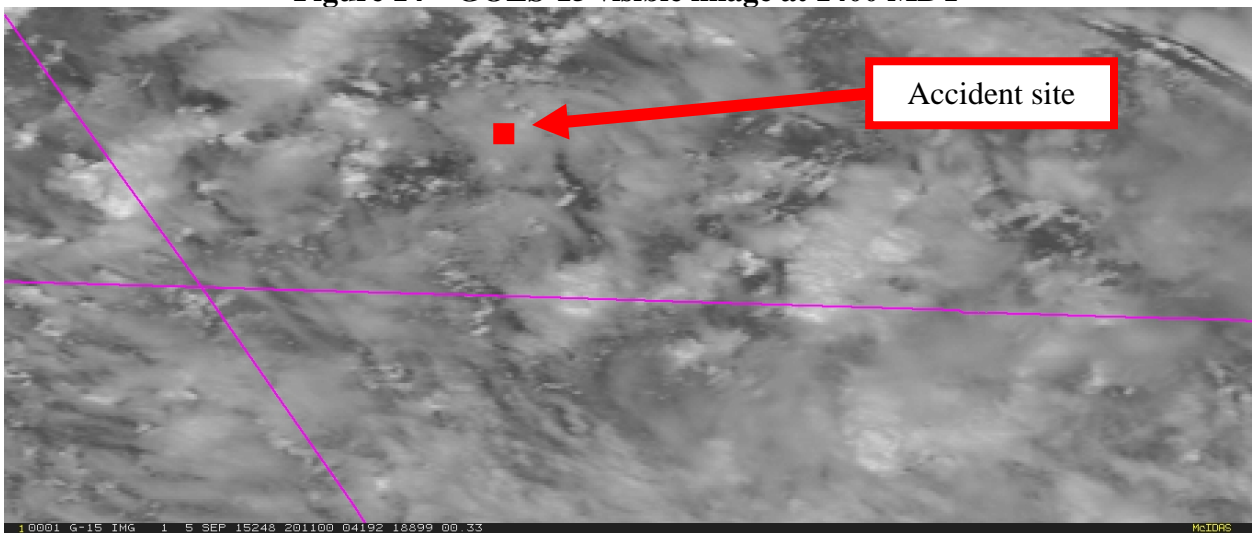
Figures 14 and 15 present the GOES-15 visible imagery from 1400 and 1411 MDT at 3X magnification with the accident site marked by a red square. The visible imagery indicated abundant cloud cover over and around the accident site at the accident time with the cloud cover moving generally from southwest to northeast (attachment 2). In addition, attachment 2 presents an animation of the visible imagery from 1200 MDT through 1411 MDT at 1X magnification with the accident site marked with a red square, KFLG (the departure airport) being the left blue square, KABQ (Albuquerque International Sunport Airport) being the middle blue square, and KTCC being the right blue square. The visible imagery from 1200 through 1411 MDT showed the cloud cover moving from southwest to northeast with the most abundant high and mid-level cloud cover west and north of KABQ. East of KABQ the cloud cover coverage dropped of significantly through KTCC. Figures 16 and 17 present the GOES-15 infrared imagery from 1400 and 1411 MDT at 3X magnification. Inspection of the infrared imagery indicated cloud cover over the accident site at the accident time. The more enhanced clouds (blue and green colors, higher cloud tops) were over and mainly oriented southwest to northeast from southern Arizona to northern Colorado. In addition, the highest cloud tops remained west and north of KABQ (attachment 3) from 1230 through 1430 MDT. Based on the brightness temperatures above the accident site and the vertical temperature profile provided by the KGJT sounding, the approximate cloud-top heights over the accident site were 28,000 feet at 1411 MDT.

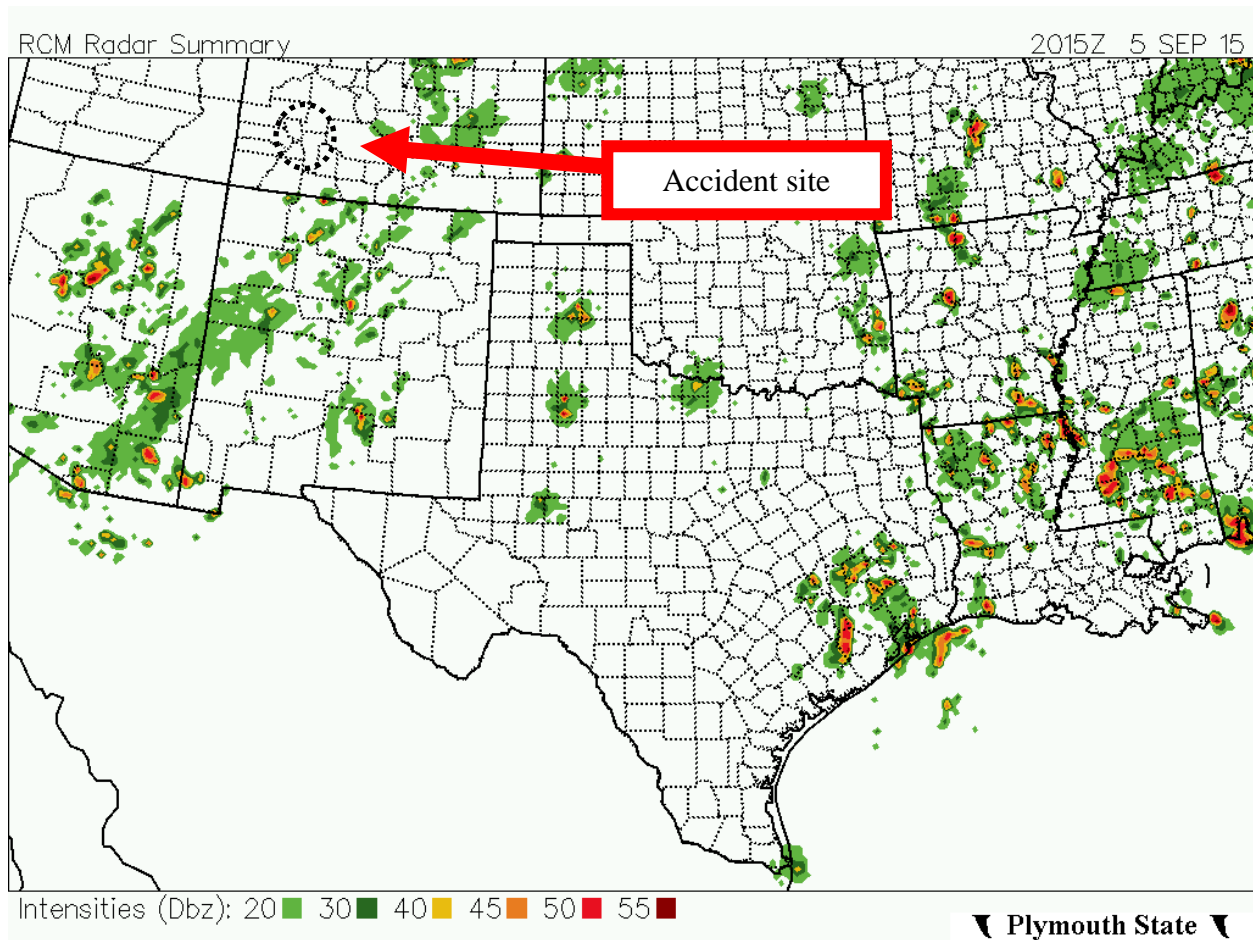
Figure 18 – Radar summary image for 2115 MDT with the accident site

Figure 18 provides a radar summary image from 1415 MDT with reflectivity values over the southern United States, with the accident site located in an area with no dBZ greater than 20 dBZ values. It is likely the radar summary image missed capturing some of the weather radar echoes that were located at the accident site at the accident time (section 6.5) due to the compositing nature of the radar summary image.

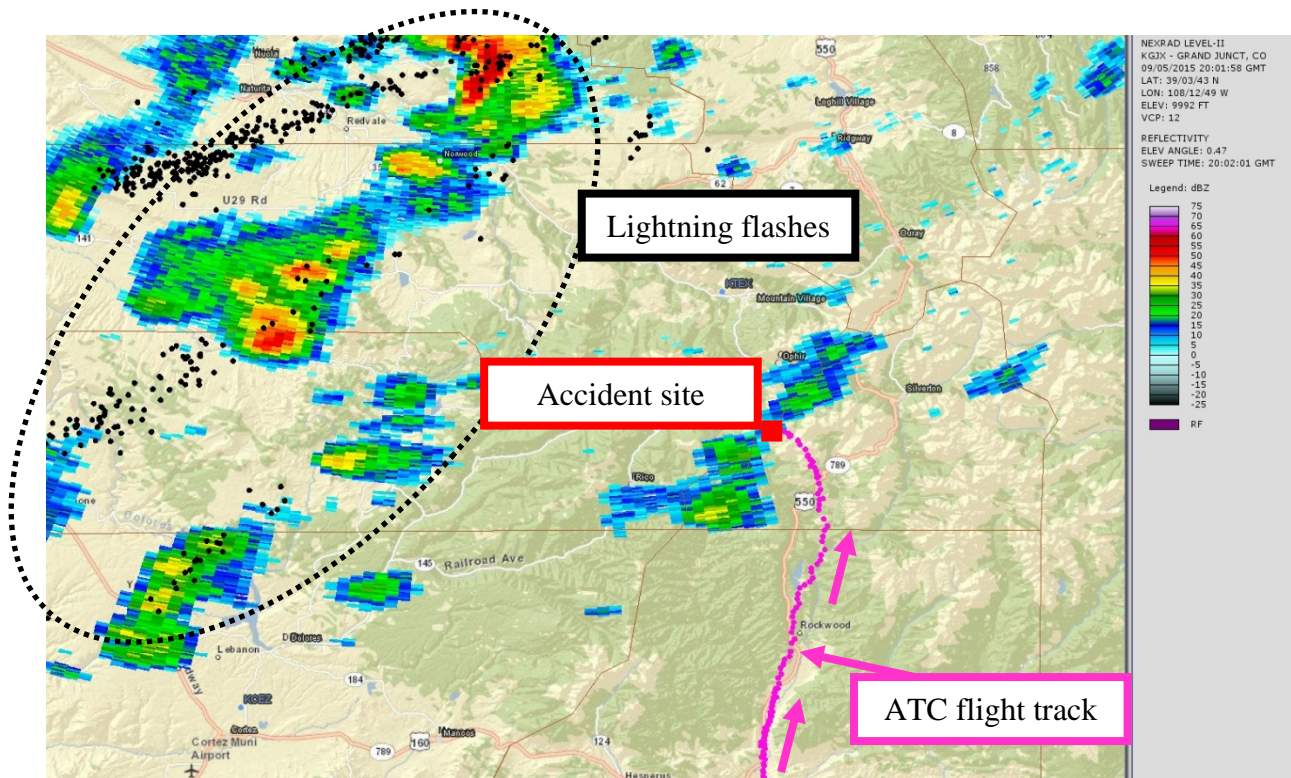
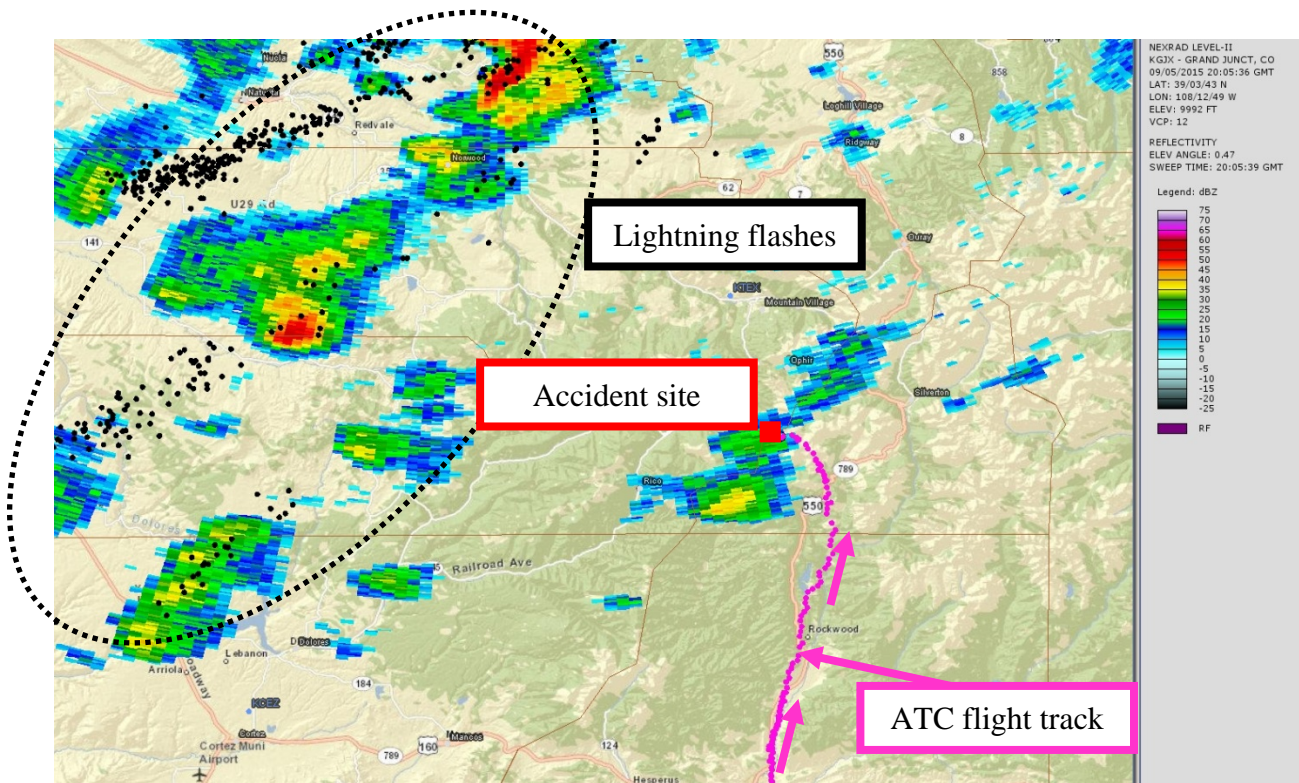
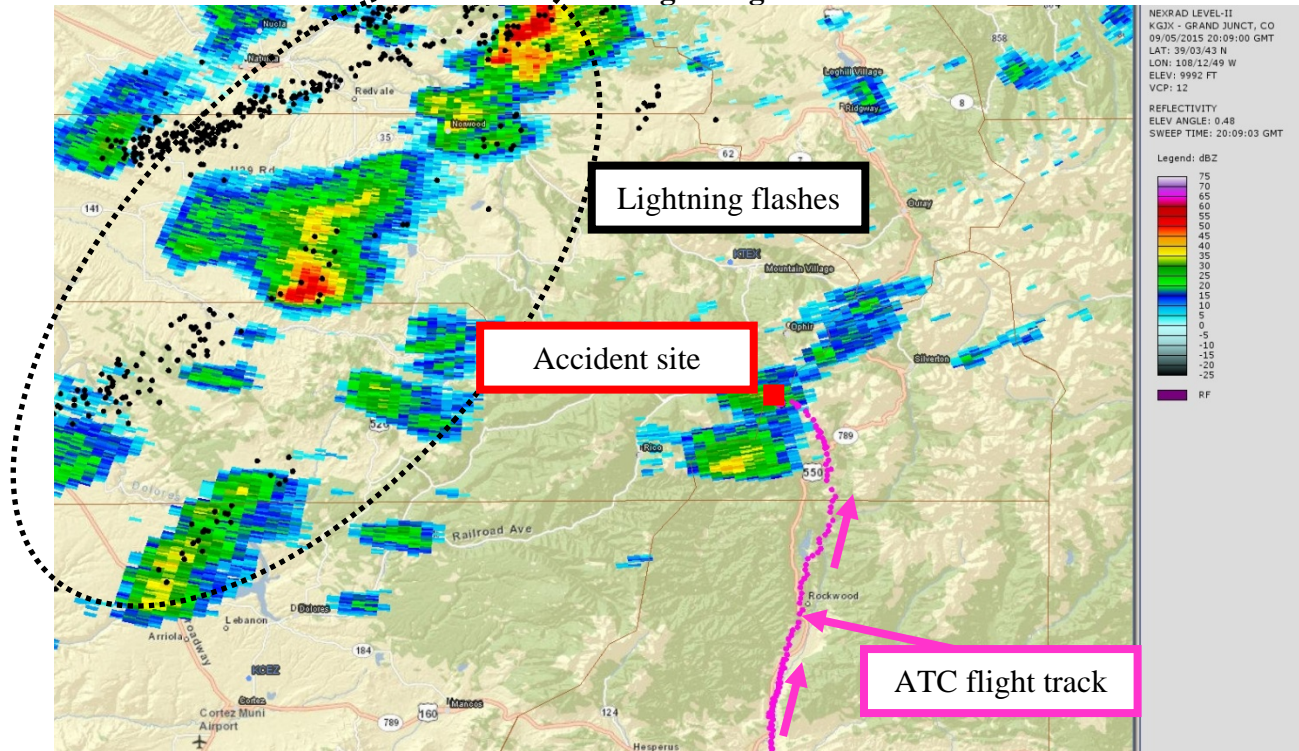
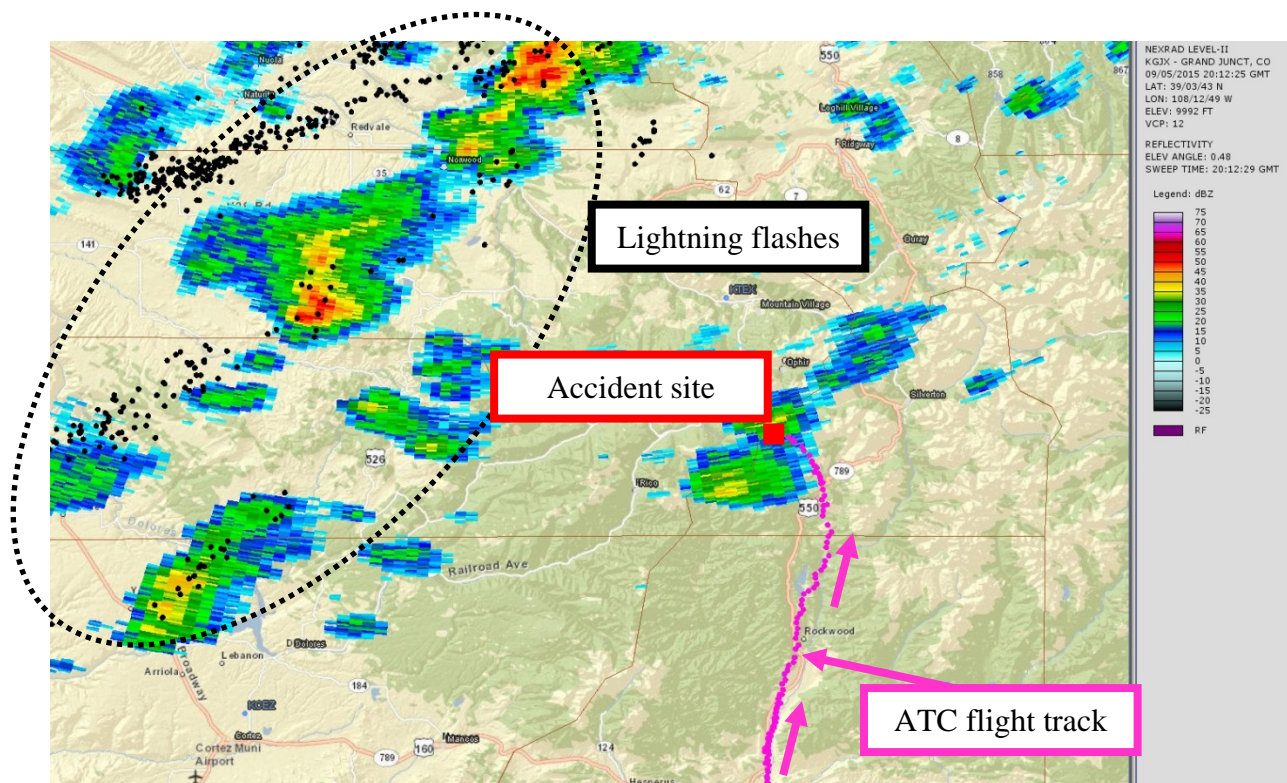
Figures 19, 20, 21, and 22 present the KGJX WSR-88D base reflectivity images for the 0.5° elevation scans initiated at 1402, 1406, 1409, and 1412 MDT with a resolution of 0.5° X 250 m. All the lightning flashes²² and strikes were north and west of the accident between 1300 and 1500 MDT (black dots on figures 19 through 22). The accident site was located in an area of 15 to 35 dBZ reflectivity values at the accident time, with those reflectivity values increasing in areal coverage and moving northeastward with time. These reflectivity values are indicative of rain shower activity in the mountainous terrain with light to moderate turbulence and with mountain obscuration and IMC due to clouds and precipitation. LLWS was also likely given the increasing areal coverage of the rain shower activity and likely growth of those rain shower cells within the mountainous terrain.

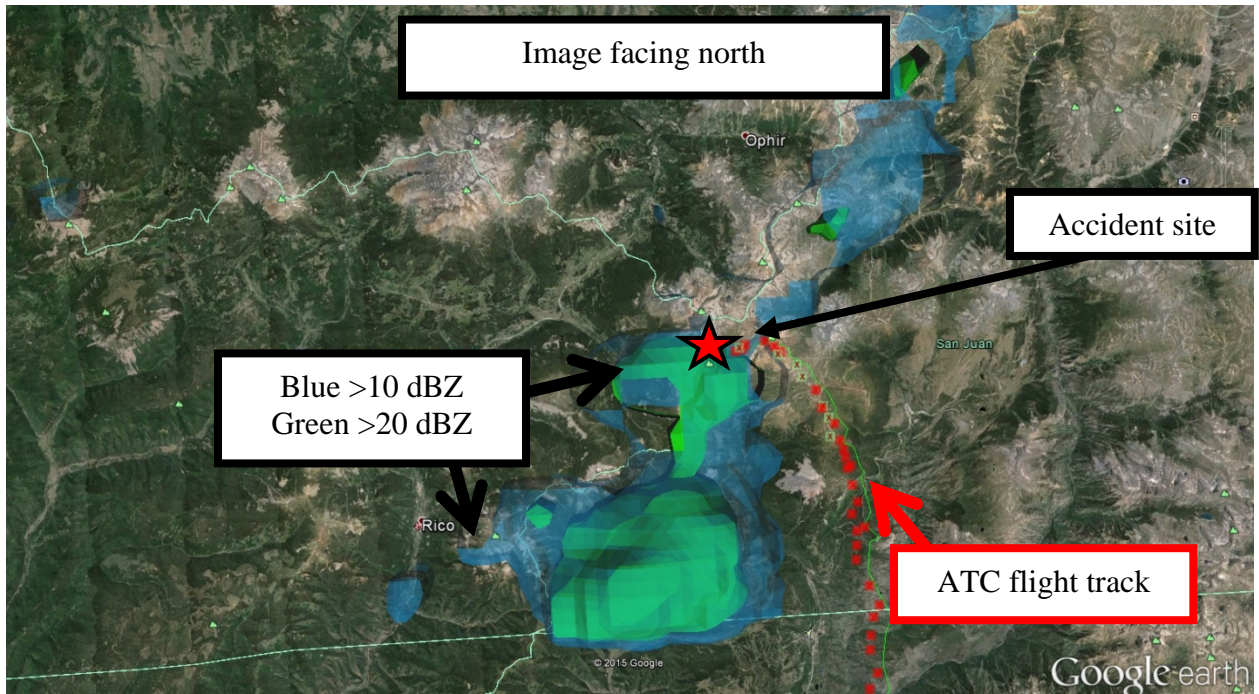
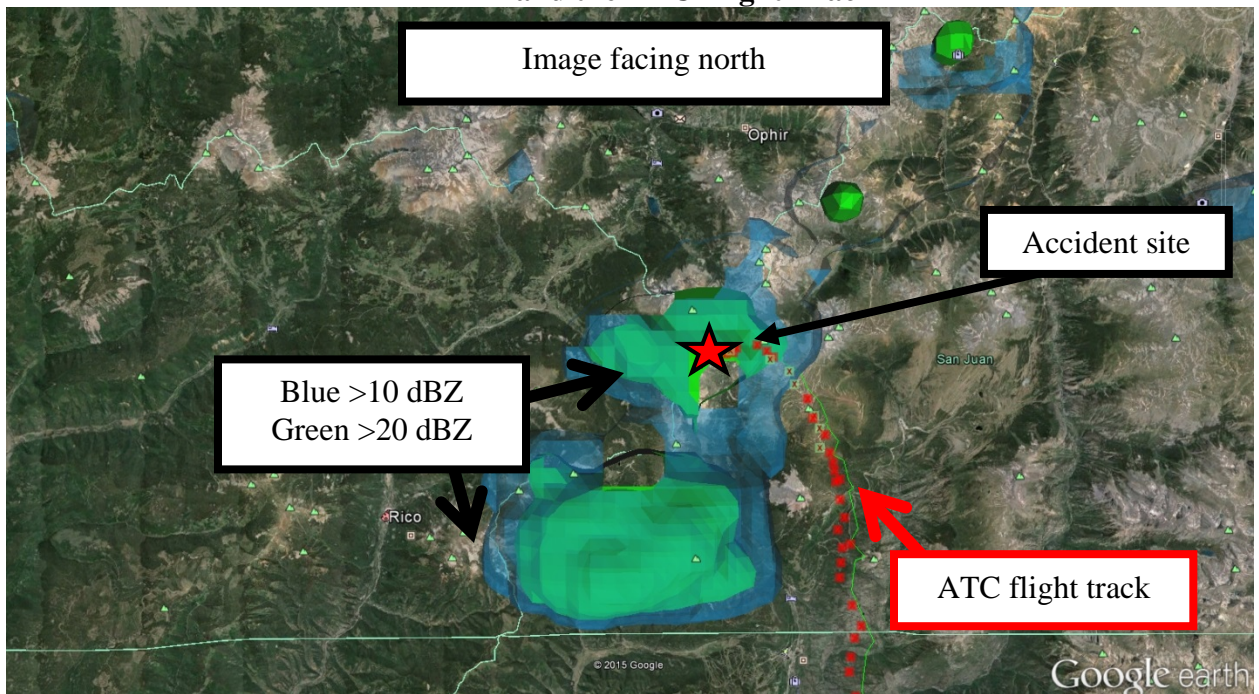
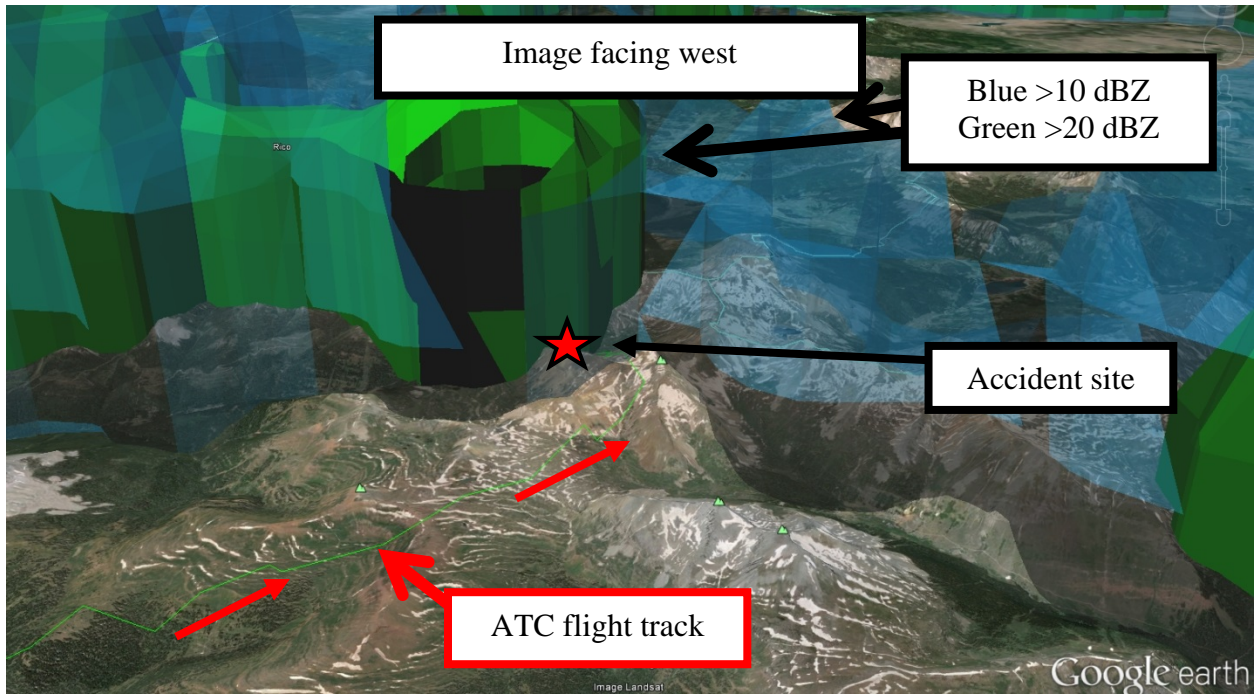
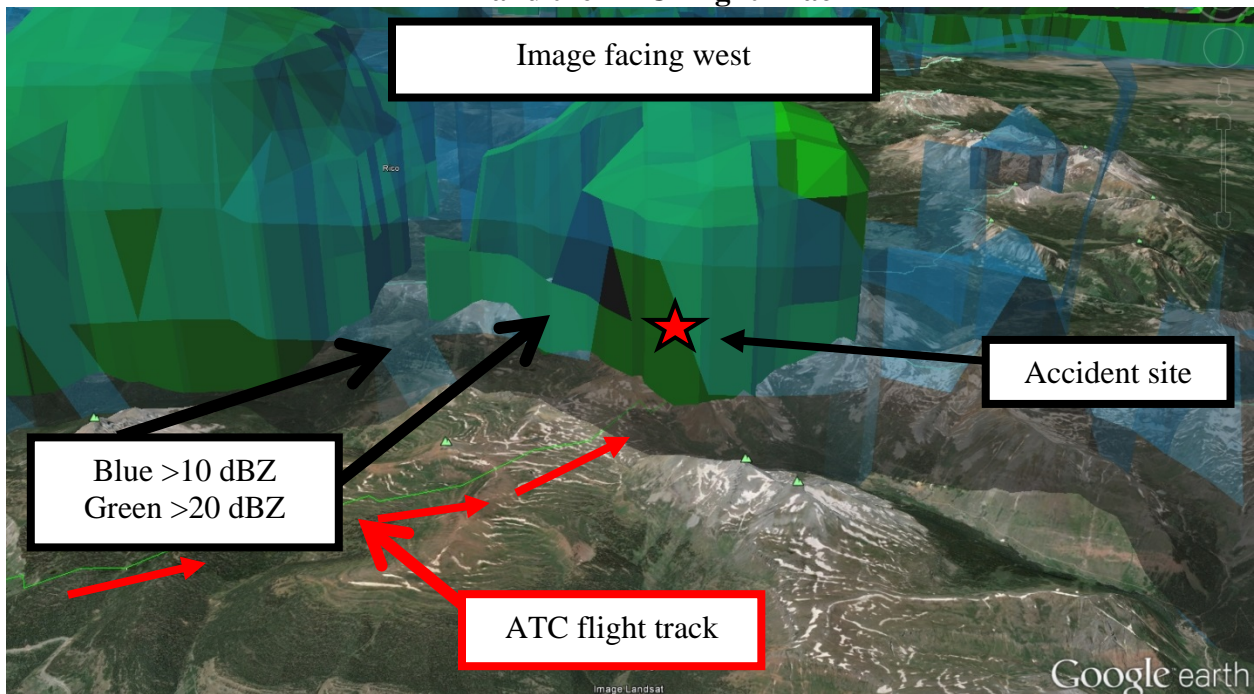
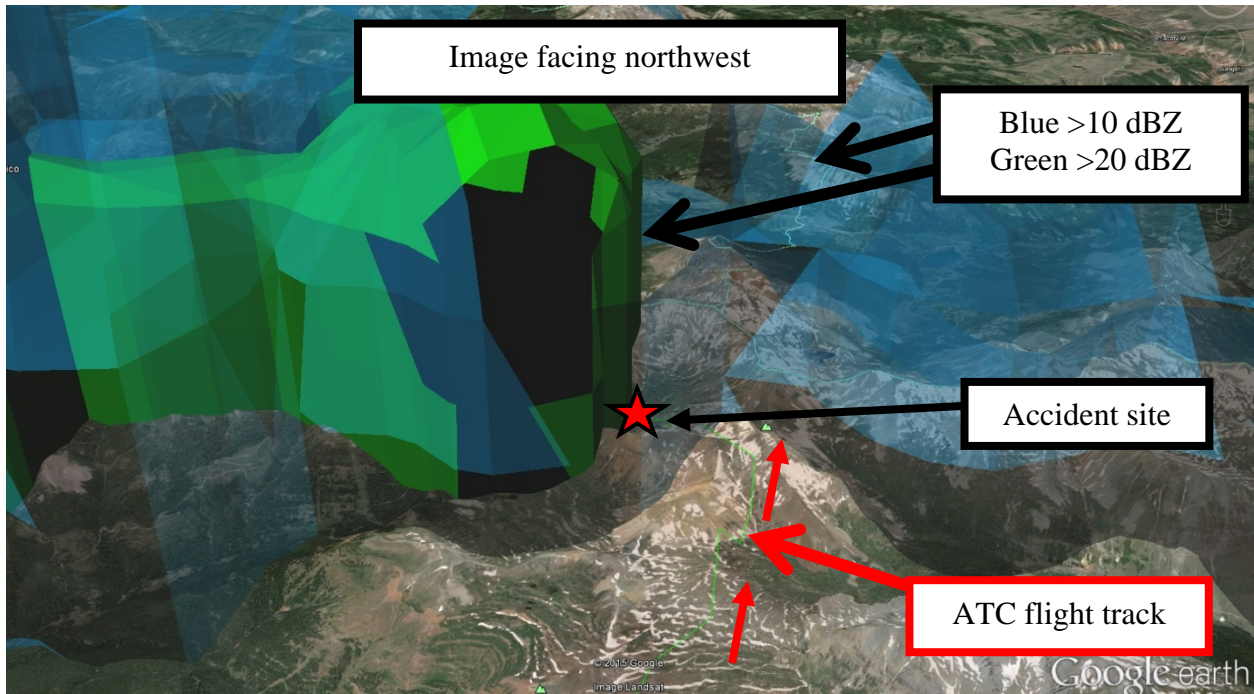
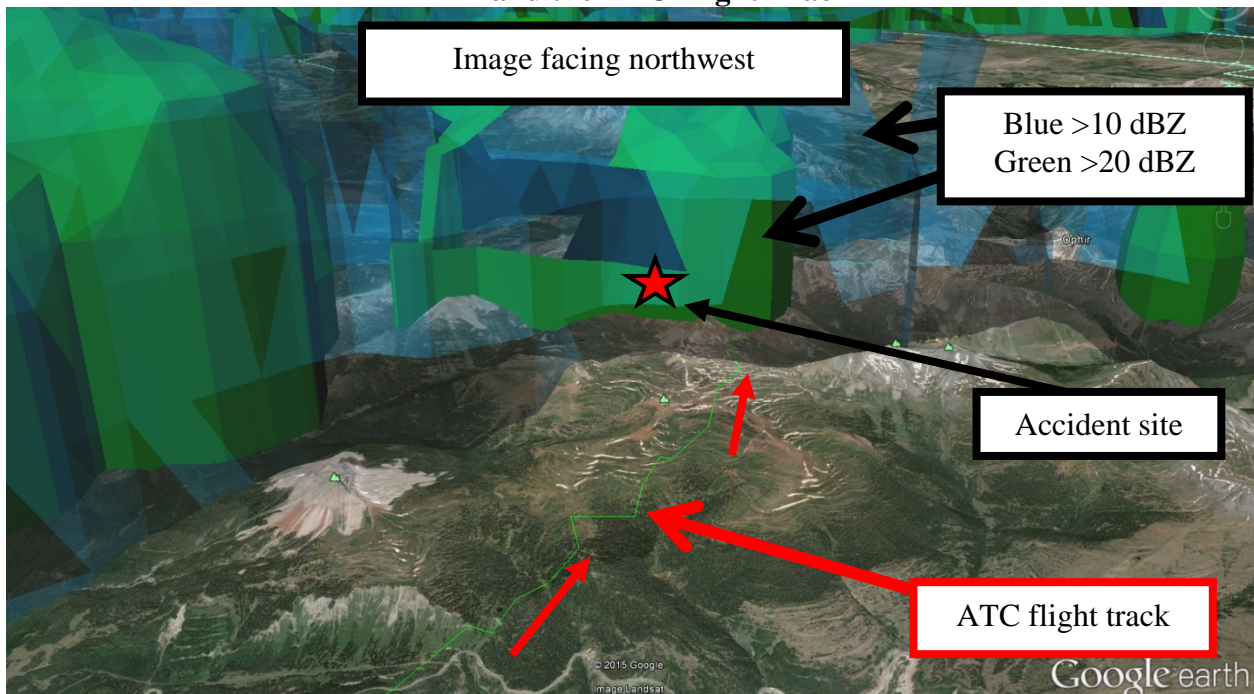
Figures 23 through 28 present a 3-dimensional view of the KGJX WSR-88D base reflectivity for the elevation scans initiated at 1406 MDT (figures 23, 25, and 27) and 1409 MDT (figures 24, 26, and 28). The accident aircraft's flight track obtained from ATC²³ was also plotted on the Google Earth image for a time comparison with the base reflectivity images. The images showed the accident flight located within greater than 20 dBZ values at 1409 MDT. The areal coverage of greater than 20 dBZ values increased between 1406 and 1409 MDT with the overall coverage of the base reflectivity moving from southwest to northeast. It is likely the accident flight encountered precipitation, mist, and mountain obscuration near the end of the flight with the rain shower activity moving across the accident site from southwest to northeast at the accident time.
